Dr.- Ing. L. Satrapa, Dr.- Ing. P. Valenta, (CZ)
CTU Prague, Faculty of Civil Engineering,
Department of Hydrotechnology

Foundation of the Mseno Dam; Analysis and the Study of Remedial Measures

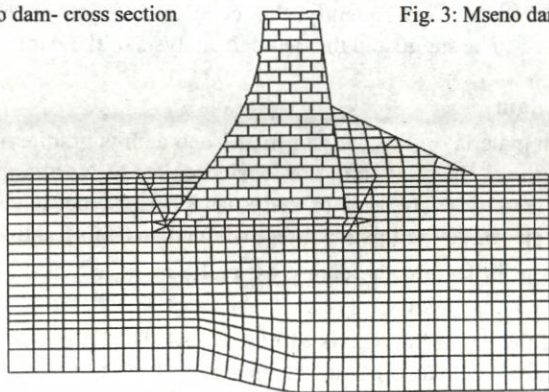
Fig. 4:
Seepage analysis
- FEM mesh

The 2D mesh of finite elements consists in 1305 elements and 4088 nodes (Fig. 4). Some results of seepage analysis are presented in Fig. 5. The drawing presents path lines and equipotential lines in the case of full reservoir.

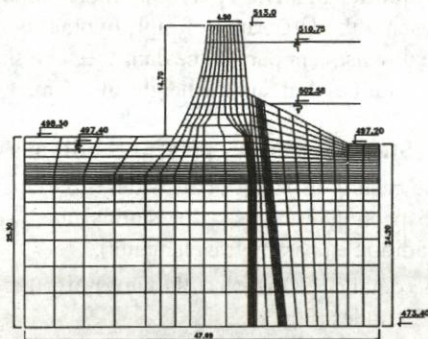
Fig. 7: Statical analysis - FEM mesh (2D analysis)

The detailed 3D mesh (2D view) of finite elements consists in 720 elements and 5323 nodes (Fig. 7).
