Conference Paper, Published Version

Scour of Railway Embankment Foundation Located on Sea-Cliff in Japan

Hiroto Suzuki¹, Makoto Shimmura²

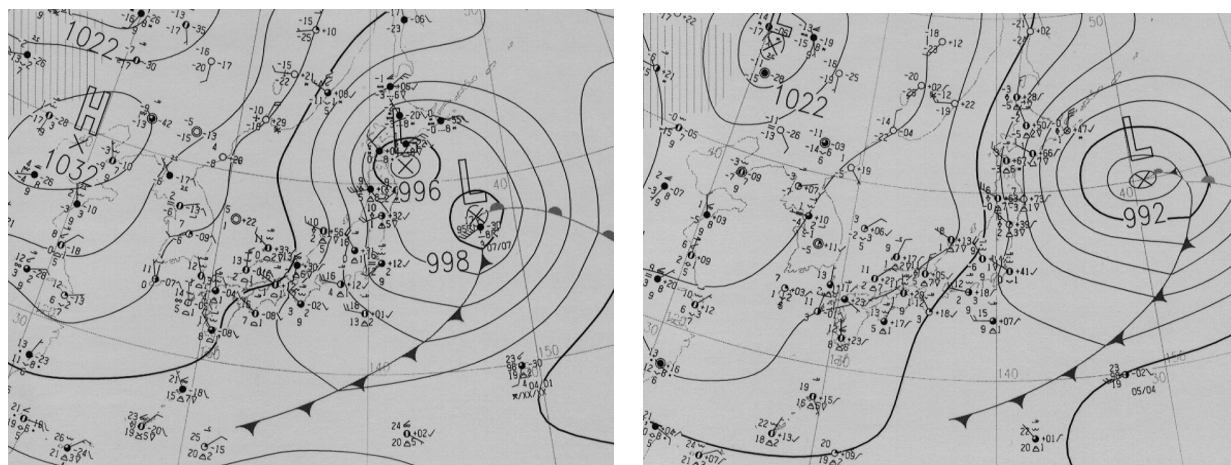
Figure 3 is weather maps at 15 o'clock and 21 o'clock of the collapse day, on December

Figure 3 Weather maps at 15 o'clock (left) and 21 o'clock (right) on December 19, 2000. At 15 o'clock there were two deepening lows in the Pacific Ocean which traveled toward the northeast. At 21 o'clock two lows became one and the pressure of low was lower. In the Eastern and Northern Japan it blew strong wind under influence of these lows.

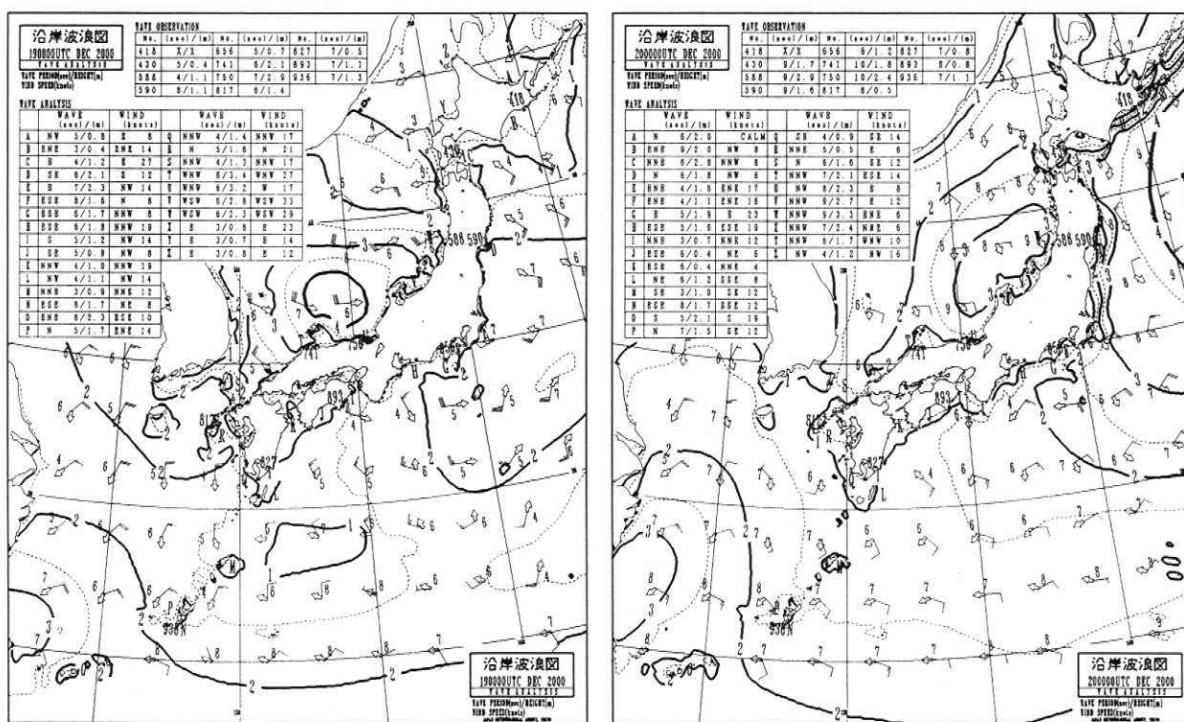
Figure 5 is wave maps at 9 o'clock on December 19 and 20, 2000. In the eastern area of the Sea of Japan waves were high. Figure 3 also shows time history of significant wave height at Atsumi (Figure 1), where is the nearest wave observations site of JMA from the collapse site. The significant wave height grew gradually high from 9 o'clock. The maximum significant wave height and wave height, which were 6.19 m and 11.8 m, were recorded at 18 o'clock when almost accords with the time of the wave protection work collapse. Table 3 shows return period of them, it is below 2 years.

Figure 5 Wavemaps at 9 on December 19 and 20, 2000
