## **Piping Failure in Subway Construction due to Internal Erosion of Silty Sand**

Ishihara, Kenji; Lee, Wei F. (2008): Piping Failure in Subway Construction due to Internal Erosion of Silty Sand. In: Sekiguchi, Hideo (Hg.): Proceedings 4th International Conference on Scour and Erosion (ICSE-4). November 5-7, 2008, Tokyo, Japan. Tokyo: The Japanese Geotechnical Society. S. 505-512.

# PIPING FAILURE IN SUBWAY CONSTRUCTION DUE TO INTERNAL EROSION OF SILTY SAND

Kenji ISHIHARA<sup>1</sup> and Wei F. LEE<sup>2</sup>

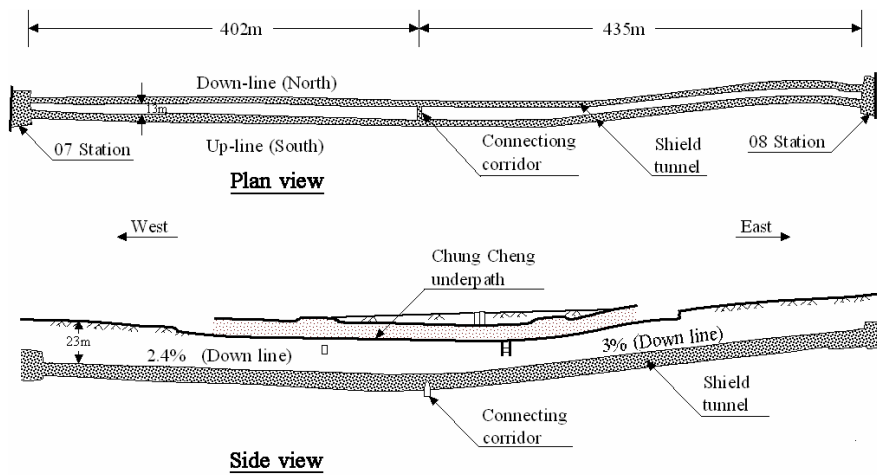
The feature of the cave-in on the ground surface is displayed in Fig. 1. A bird-eye view over the cave-in is displayed in Fig. 2. The plan and side view of the tunnel are shown in Fig. 3. It is to be noted that there was an underground roadway called Chung Cheng underpath just above the subway tunnel. The dual tunnels were constructed by the tunnel boring machine (TBM) which can advance by rotating a large steel disk equipped with cutting blade, while the cutting face is balanced by the mud pressure.

Fig.3 Plan and side view of the tunnel.

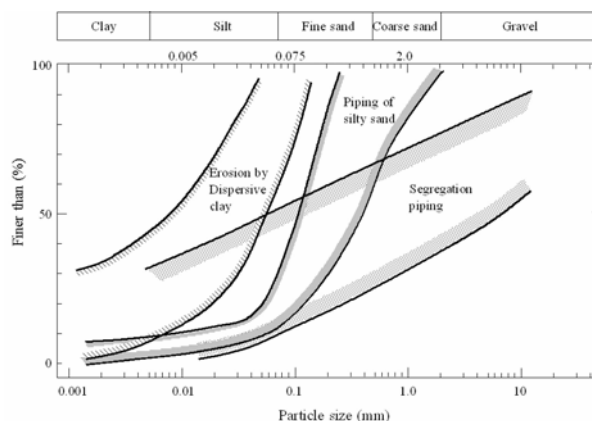
With respect to the piping or erosion, there would be three types of categories to be distinguished depending upon the range of grain size of soil materials in question. These are shown in a graphical form in Fig. 7. The segregation piping has been the target of extensive studies in the past in association with the filter criteria for the design of rock fill dams. There are many studies reported in this context such as those by Terzaghi (1939), Kenny-Lau (1986), Skempton-Brogan (1994) and Sherad (1979).

The outcome of the grain-size analyses for the silty sand at Kaohsiung has shown that the soil there belongs neither to the broadly graded gravelly sands for the segregation piping nor to the dispersive clay related to the erosion or gully formation. In fact, the grain size in Kaohsiung soil lies midway in the range of silt and sand, as indicated in Fig. 7, which is coarser than the dispersive clay and finer than the soils related with segregation piping. Thus, the collapse of the silty sand in the subway construction in Kaohsiung was considered to have posed a new challenge and addressed a novel problem area. The solution for this is not yet settled, but performing some tests was regarded as a useful attempt to shed some light on this problem. In this context, a set of pinhole tests and measurements of specific surface were performed as described below.

Fig.7 Three groups of soils in terms of grain size range associated with erosion and seepage instability.

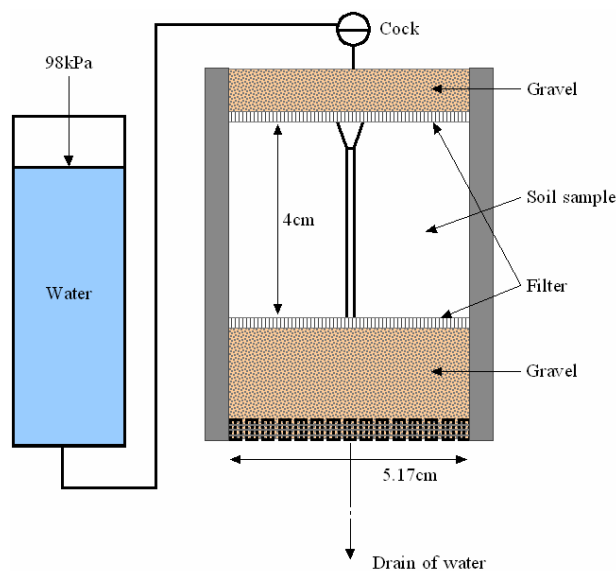
Fig. 8 Layout the pinhole test.

In order to examine the vulnerability of the silty sands at Kaohsiung to the internal erosion or piping, what might be called “Pinhole test” was carried out. The layout of the test system is displayed in Fig. 8. The sample 4cm thick and 5.17cm in diameter was sandwiched by highly pervious gravel layers at the top and bottom with filter meshes placed between the sample and gravel. A vertical hole 3mm in diameter was drilled as shown in Fig. 8. Water was then circulated through the sample. In this type of test, water is supposed to flow mainly through the pinhole. If the silty portion is erodible, the water coming out is expected to be muddy, but otherwise the water transparent.

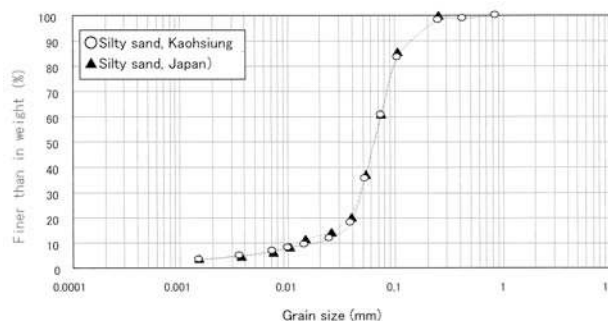
Fig. 9 Grain size distribution curves of silty sands used for the pinhole tests.

The silty sand from Kaohsiung tested had a grain size distribution as shown in Fig. 9. For comparison sake, another material from a site in Chiba, Japan, was secured and used for the same testing. The grading of this Japanese soil was almost the same as indicated in Fig. 9. It is to be noticed that both silty sands had an average grain size of about D<sub>50</sub>=0.075mm and fines content was about 50%. The physical characteristics of these two materials are shown in Table 1. The two samples were compacted so as to have the same wet density of 1.902 g/cm<sup>3</sup>.
