## Chen, Meng-Yi; Chu, Jyh-Cheng Scour Monitoring Around the Breakwater Head at Mailiao Harbor

## SCOUR MONITORING AROUND THE BREAKWATER HEAD AT MAILIAO HARBOR

Key Words : breakwater, field measurement, bed topography, Mailiao harbor, equilibrium scour depth

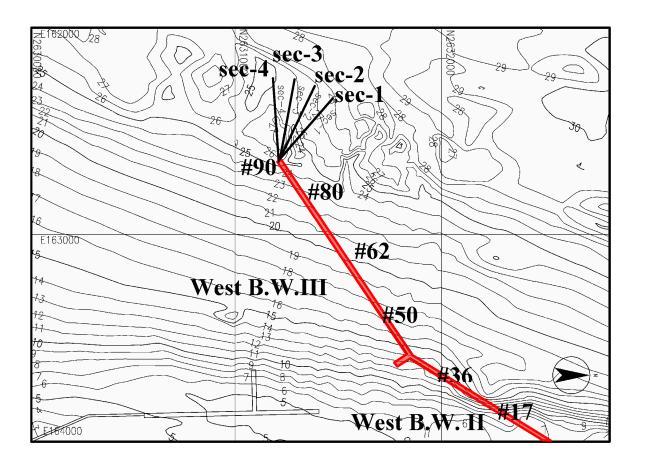
Figure 2 Seabed topography in May 1996 prior to WB III was built.

Figure 2 displays the bed topography in the neighborhood of WB III in March 1996 when WB III has not been built yet. It can be seen that prior to the construction of the breakwater, the slope of seabed in the near shore region where the water depth is less than 25m is rather mild. The slope of seabed in the region where the bed level is between
