Gateway to the Earth

Rural water supply functionality

Survey 2 forensic assessments

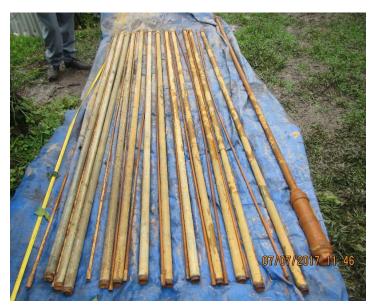
Pump component condition

Issues with India Mk 2 corrosion.

In Uganda, corrosion affects:

- 80% Rods
- 60% RM

Need to maintain and replace rising main and rods.

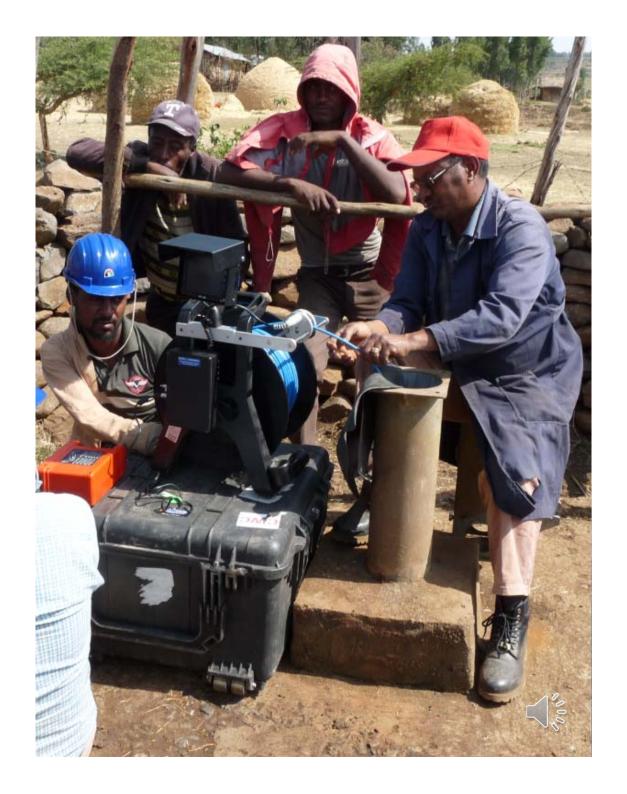
Borehole construction

Pump position, screen length and position are important

Pump >40 m in 13% of sites (Ethiopia >30%)
