Upstream Tailings Dam - Liquefaction

**Problem report submitted to the
Benjamin M. Statler College of Engineering and Mineral Resources
At West Virginia University
in partial fulfillment of the requirements
for the degree of**

**Master of Science
In
Mining Engineering**

Morgantown, West Virginia 2020

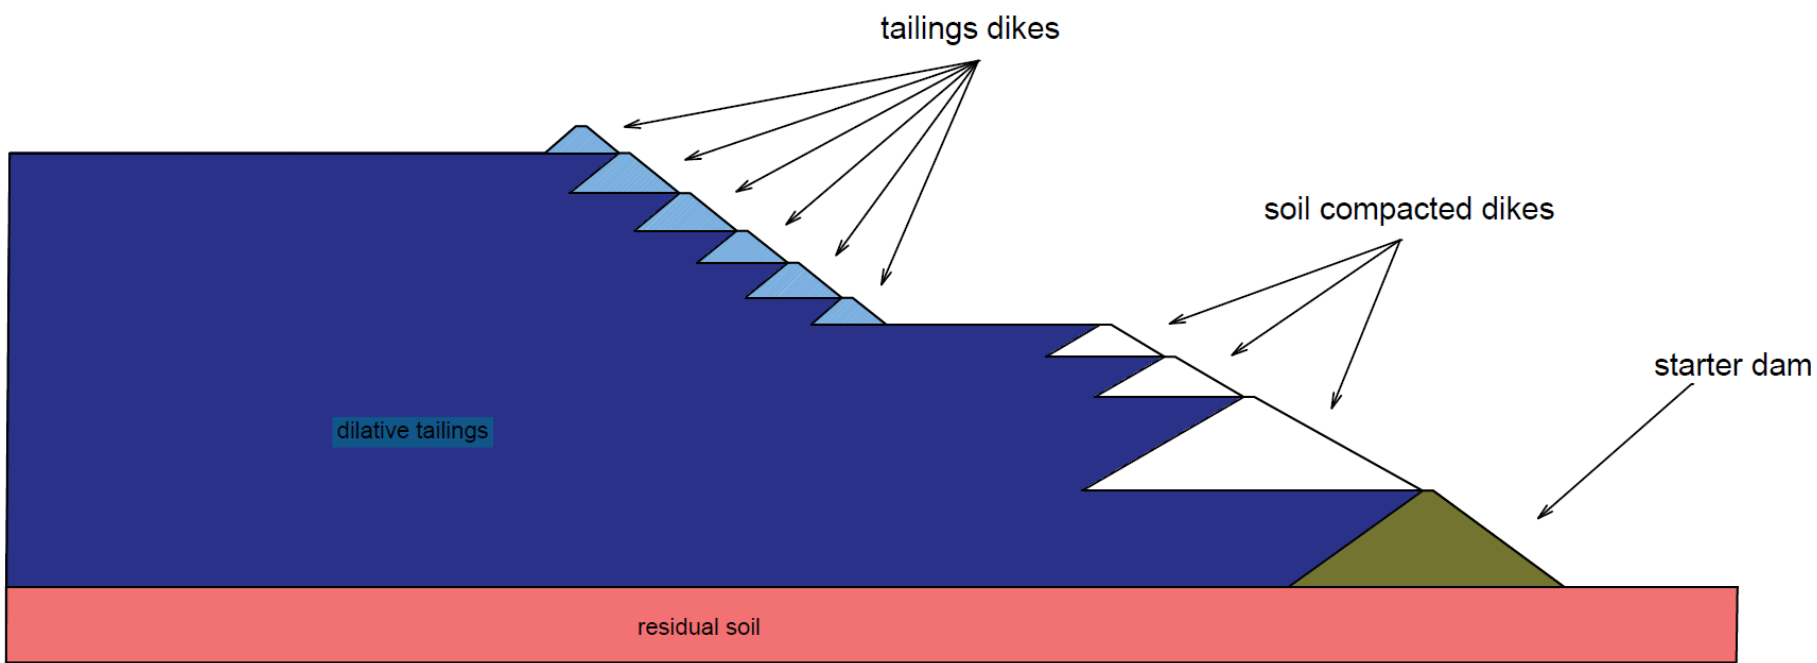
Figure 11 - Tailings Dam I profile

Firstly, the dam construction is simulated, presented by Pirete (2013), and then, as shown in Figure 11, the model is drawn in AutoCAD 2019 with all its Geotechnical characteristics, followed by a different color for each type of material. After the initial drawing, the image was exported to Slide 2018, whereby each type of material (Table 2) is assigned, and then the water table was added along with the constant distribution load of 50 kPa at the crest of the dam simulating the pond (Figure 12).

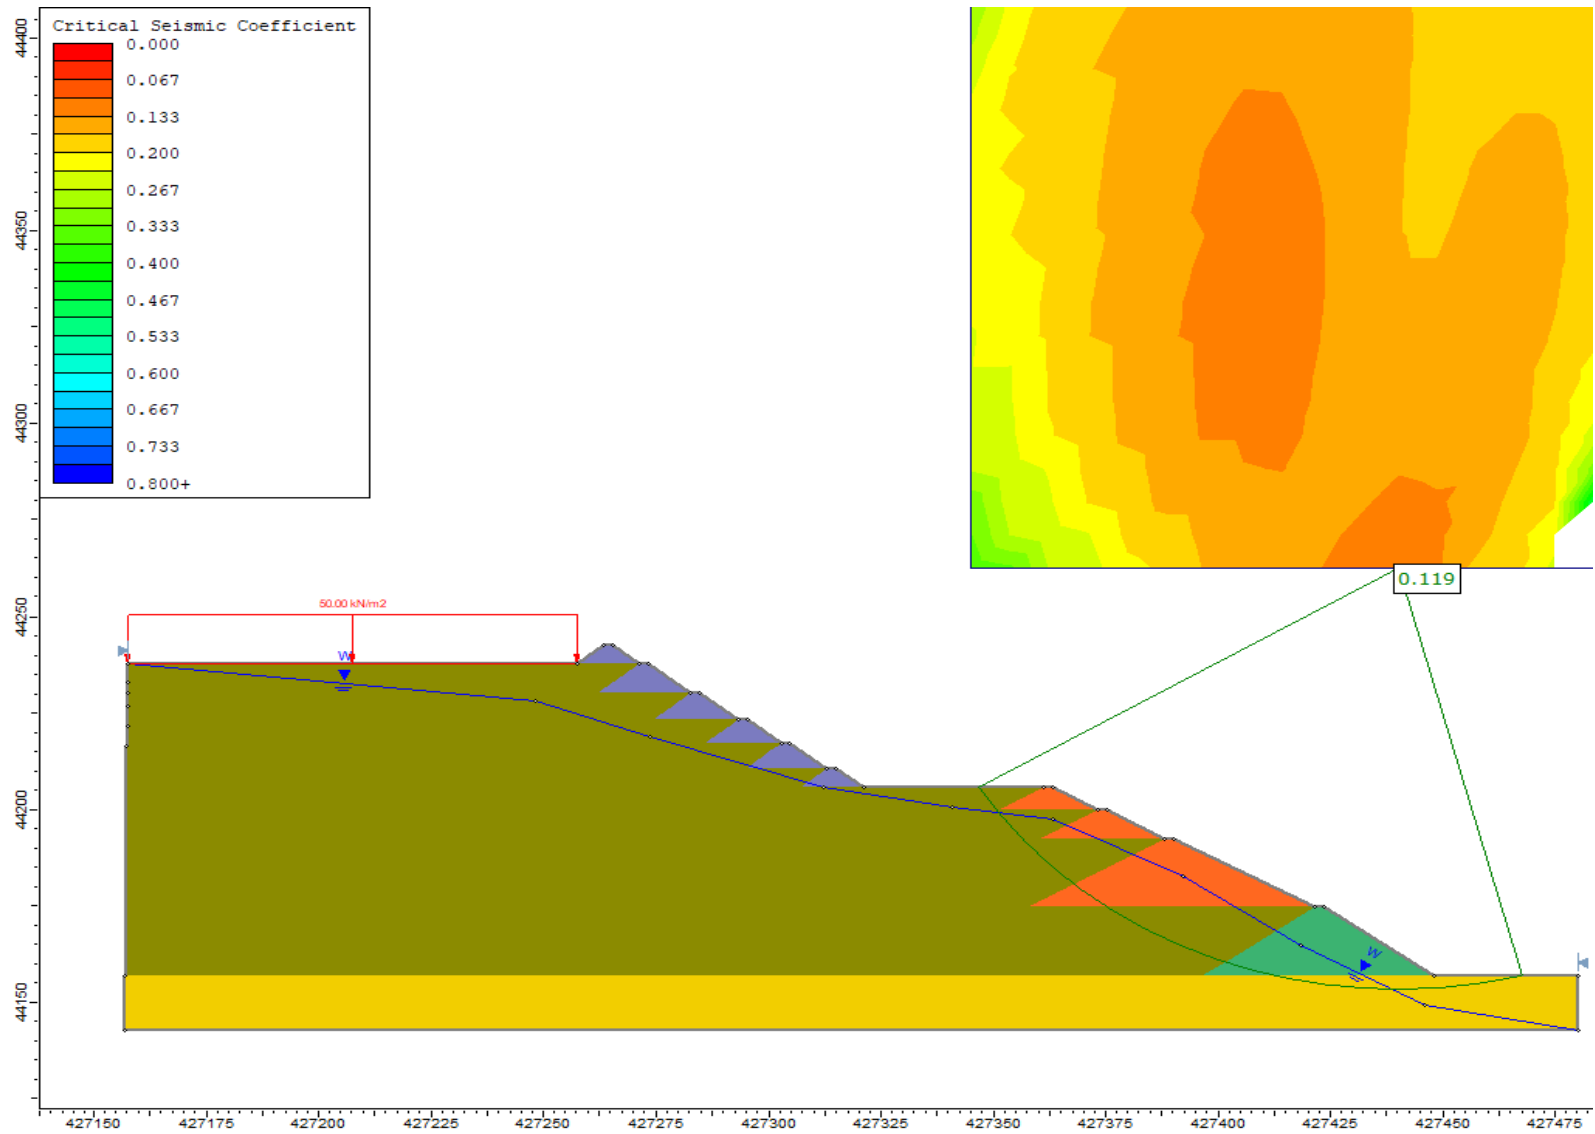
Figure 15 – Critical acceleration simulation

This method falls under the advanced seismic analysis by specifying a horizontal seismic coefficient. The factor of safety that is targeted in this situation is 1. By computing the analysis, the result shows a horizontal seismic coefficient that is equal to 0.199 (Figure 15). It can be identified as a critical coefficient because when it is reached, the factor of safety is 1 and the dam stability is endangered.
