Safety Investigation and Guidance for Work-Zone Devices in Freight Transportation Systems Subjected to Passenger Car and Truck Impacts with New Crash Standards

Report # MATC-UNL: 100

Final Report

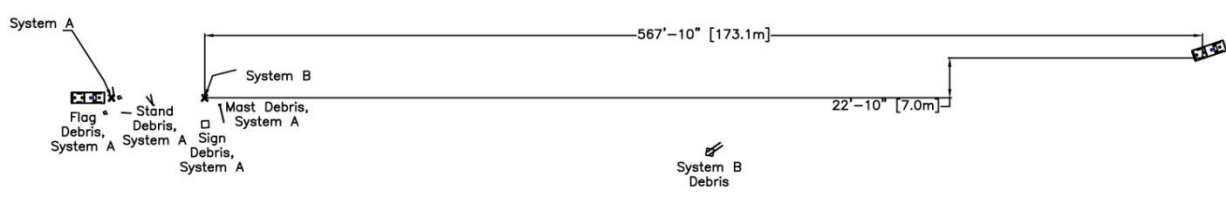
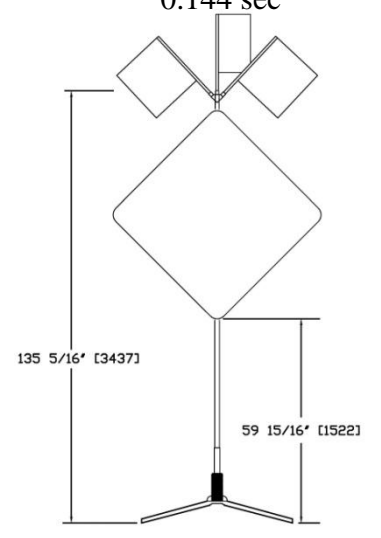
Figure 45. Summary of Test Results and Sequential Photographs, Test No. WZ09-1A

Following test no. WZ09-1, a safety performance evaluation was conducted, and the performance of System No. 1A was determined to be unacceptable according to the MASH criteria. It was deemed unacceptable due to the flag holder penetrating the roof, the sign panel penetrating the windshield, windshield indentation greater than 3 in. (76 mm), and significant windshield cracking. Deformations of, and intrusion into, the occupant compartment did occur as System No. 1A penetrated into the occupant compartment on the right side of the windshield when the corner of the sign panel sliced through the windshield and also when the metal flag holder penetrated the roof into the occupant compartment.

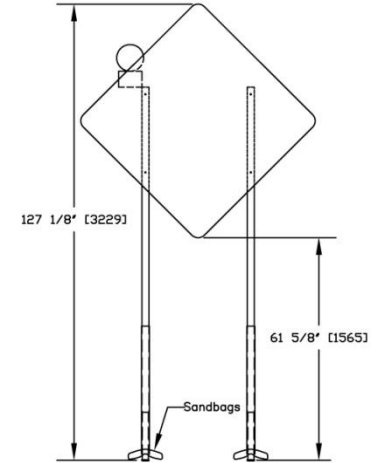
Figure 46. Summary of Test Results and Sequential Photographs, Test No. WZ09-1B

System No. 1B was also determined to be unacceptable according to the MASH criteria due to the light and mast penetrating the windshield, windshield indentation greater than 3 in. (76 mm), and significant windshield cracking, which caused the obstruction of driver visibility and the loss of structure in both glass layers in the windshield. Deformations of, and intrusion into, the occupant compartment did occur as System No. 1B penetrated into the occupant compartment near the upper-center region and upper-left corner of the windshield when the light, mast, and sign panel contacted the windshield. The vehicle's trajectory did not intrude into adjacent traffic lanes.

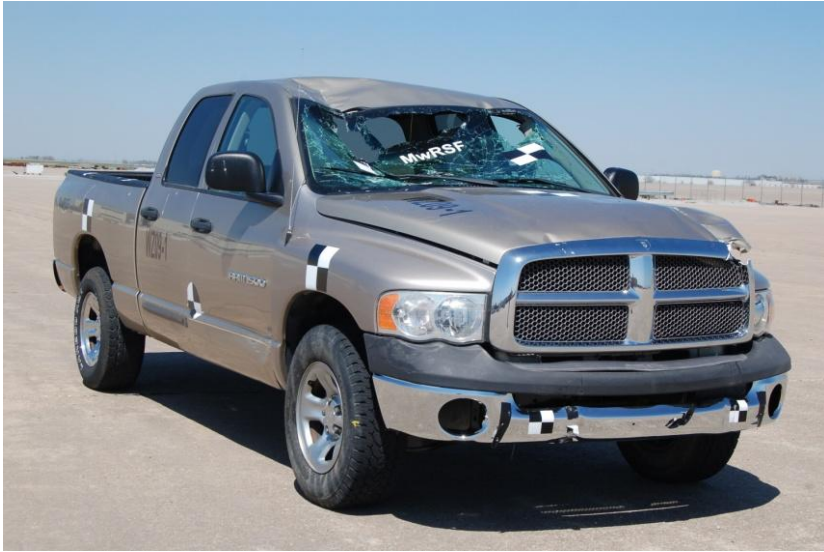
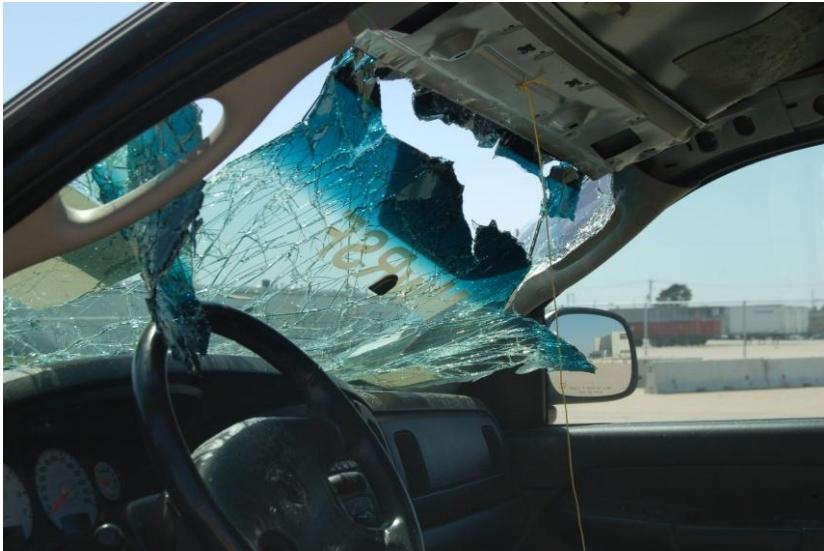
Figure 57. Vehicle Damage, Test No. WZ09-1

Vehicle damage is shown in Figures 57 and 58. The bumper was dented inward where it contacted System Nos. 1A and No. 1B. Small scuffs were found on the plastic bumper on the right side and at both impact locations. The upper-right side of the grill was scratched. The left corner of the grill was broken, and the engine hood sustained a cut at the left-side impact location. The hood was pushed backward and upward at the left-front corner, and the left-front half of the hood was scratched. The windshield was sliced through at the center of the right target where it was contacted by the sign panel from System No. 1A. The upper-center windshield contained a large hole along the roofline where the sign panel of System No. 1B impacted. Another large hole occurred in the upper-left corner of the windshield where the light and mast of System No. 1B impacted. Significant windshield indentation and cracking occurred. The roof was dented and encountered scratches at the right-side impact location. Small dents were found in the front of the roof at the left-side impact location. A small hole was observed in the middle of the roof and slightly off center to the right side where the flag holder of System No. 1B impacted.

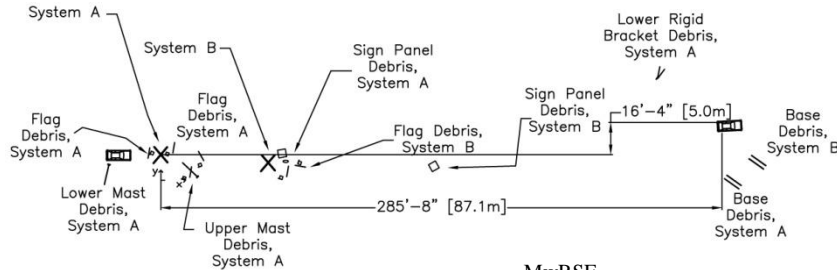
Figure 59. Summary of Test Results and Sequential Photographs, Test No. WZ09-2A

Following test no. WZ09-2, a safety performance evaluation was conducted, and the performance of System No. 2A was determined to be successful according to the MASH criteria. The windshield damage from System Nos. 2A and 2B overlapped at the middle third of the windshield, but the damage to the right third of the windshield was specifically from System No. 2A. A concentrated point of impact from the flash bulb on the lower windshield, and not the test article, occurred in the lower-right corner of the windshield. All other cracking and indentation on the right side of the windshield was from the test article. Detached elements and debris from System No. 2A contacted the windshield, and moderate cracking occurred. A maximum deformation of 2¼ in. (57 mm) occurred on the right side of the windshield, which is below the 3 in. (76 mm) maximum value defined in MASH. There was no penetration of the windshield and no tear in the plastic liner. Moderate windshield cracking also occurred along the upper-right two-thirds of the windshield when the sign panel from System No. 2A released and impacted the windshield, as determined from high-speed video analysis. The cracking appeared to be the same at the upper-middle region of the windshield as well as to the right side. The maximum deformations at the top of the windshield are unknown due to overlapping damage with System No. 2B, but the deformations were less than 3 in. (76 mm). Therefore, the system performance was determined to be acceptable.

- Test Agency MwRSF
- Test Number WZ09-2A
- Date 5/28/09
- MASH Test Designation Number 3-71
- Test Article Portable Sign Support
 - Height to Bottom of Sign 20 1/8 in. (511 mm)
 - Mast Material Aluminum Tubing
- Key Component – X-Footprint Base
 - Length 84 3/4 in. (2,143 mm)
 - Width 32 3/4 in. (832 mm)
- Key Component – Aluminum Sign Panel
 - Dimension 48 in. x 48 in. (1,219 mm x 1,219 mm)
 - Thickness 0.075 in. (1.9 mm)
- Vehicle Make and Model 2002 Kia Rio Sedan
 - Curb 2,309 lb (1,047 kg)
 - Test Inertial 2,404 lb (1,090 kg)
 - Gross Static 2,573 lb (1,167 kg)
- Impact Conditions
 - Speed 64.1 mph (103.2 km/h)
 - Angle 0 deg
 - Impact Location centerline of mast
- Exit Conditions
 - Angle 0 deg

- Vehicle Stability Satisfactory
- Vehicle Stopping Distance (longitudinal) 285 f t- 8 in. (87.1 m) from Impact A
- Vehicle Stopping Distance (lateral) 16 ft - 4 in. (5.0 m) left of Impact A
- Maximum Angular Displacements (DTS)
 - Yaw -2.08 deg
 - Pitch 3.90 deg
 - Roll -1.02 deg
- Vehicle Damage Moderate Windshield Damage
 - VDS^[33] 12-FR-1
 - CDC^[34] 12FZAW1
 - Maximum Interior Deformation NA
- Test Article Damage Severe

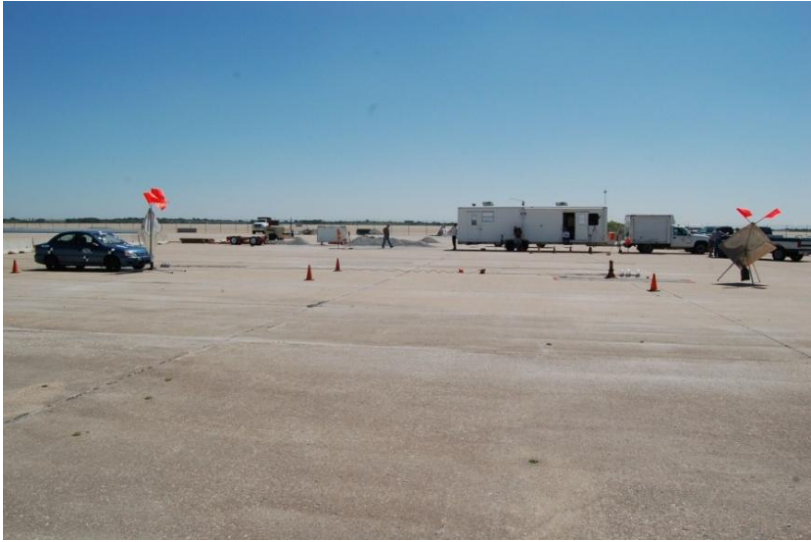
Figure 65. Impact Location, Test No. WZ09-2B

vehicle impact was to occur with the center of the sign panel at the left-side quarter point on the car's bumper, as shown in Figure 65. The actual point of impact was at the left-side quarter point. A sequential description of the impact events for test no. WZ09-2A is shown in Table 17. Approximately 0.678 seconds after the first impact, the second impact occurred. A sequential description of the impact events for test no. WZ09-2B is shown in Table 18. The vehicle came to rest 285 ft – 8 in. (87.1 m) downstream from the first impact and 16 ft – 4 in. (5.0 m) laterally towards the left of the first impact. The vehicle trajectory and final position are shown in Figures 59, 60, and 66.

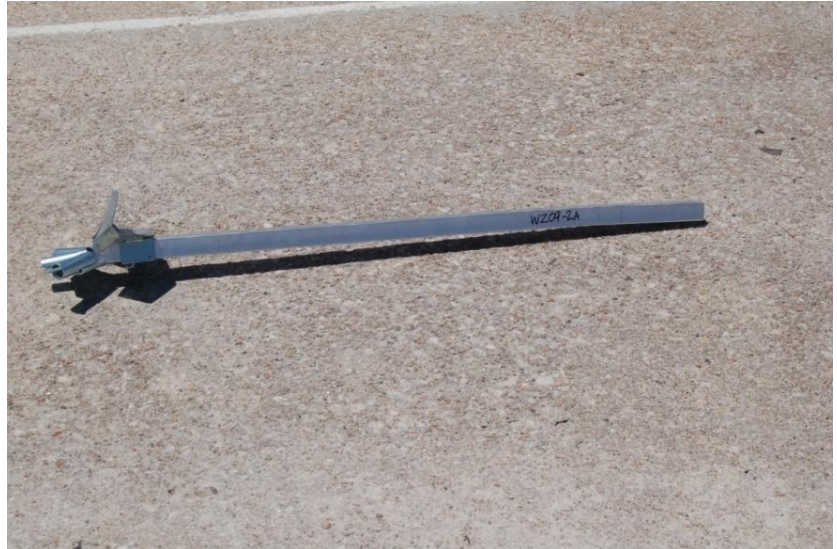
Figure 67. System Damage, Test No. WZ09-2A

Damage to System Nos. 2A and 2B is shown in Figures 67 through 70. System No. 2A encountered severe damage to the sign support stand. The lower mast fractured at the breakaway holes and landed upstream of the impact. The base, with all four legs attached, remained intact under the car. The angled plate attaching two of the legs was bent and torn at one of the bolt holes. The other angled plate's corner was deformed and crushed from dragging. Both coil springs were significantly deformed and bent over. The upper rigid bracket deformed out. The flag holders were slightly bent, and the bottoms of two flag staffs were fractured. The upper mast was bent slightly. The lower rigid bracket was slightly deformed out. The sign panel was deformed out with a crease at the top corner from the rigid panel bracket.

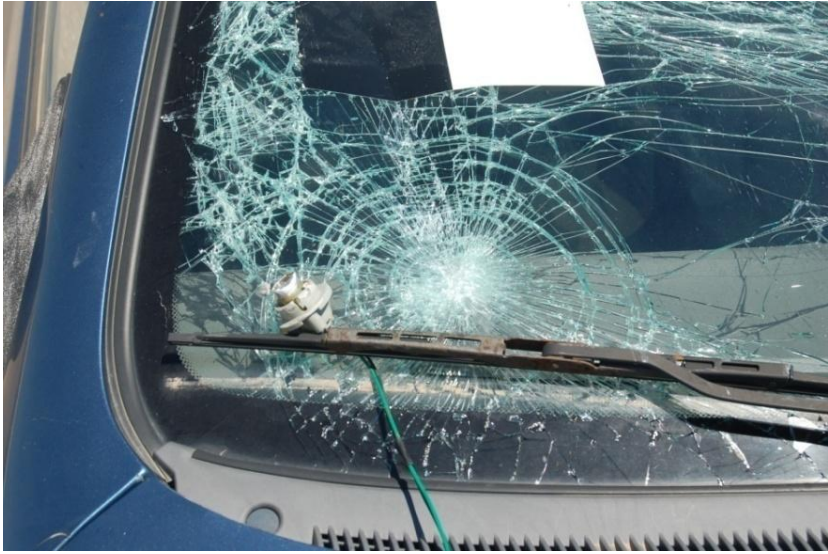
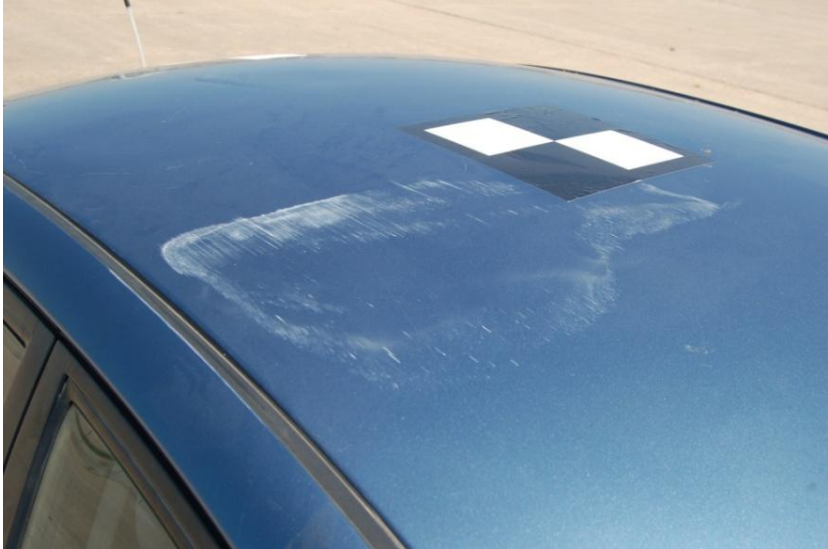
Figure 71. Vehicle Damage, Test No. WZ09-2

Vehicle damage is shown in Figures 71 and 72. The left side of the front plastic bumper was scuffed and cut where it contacted System No. 2B, and it was deformed outward from the left-front quarter panel. The lower-left side of the plastic bumper was deformed backward and torn. The left headlight was fractured. The left-front quarter panel was dented at the front. The left-front corner of the hood was deformed down. The right side of the engine hood and roof were scuffed from the sign panel of System No. 2A. A concentrated point of impact was found at the bottom-right corner of the windshield from the flash bulb deforming into the windshield. A large hole was found at the top of the windshield slightly to the left of center where the upper rigid bracket and mast of System No. 2B impacted. The entire windshield encountered cracking with severe cracking at the upper half of the windshield. The rearview mirror disengaged from the windshield, and glass was found on both the front and back seats.

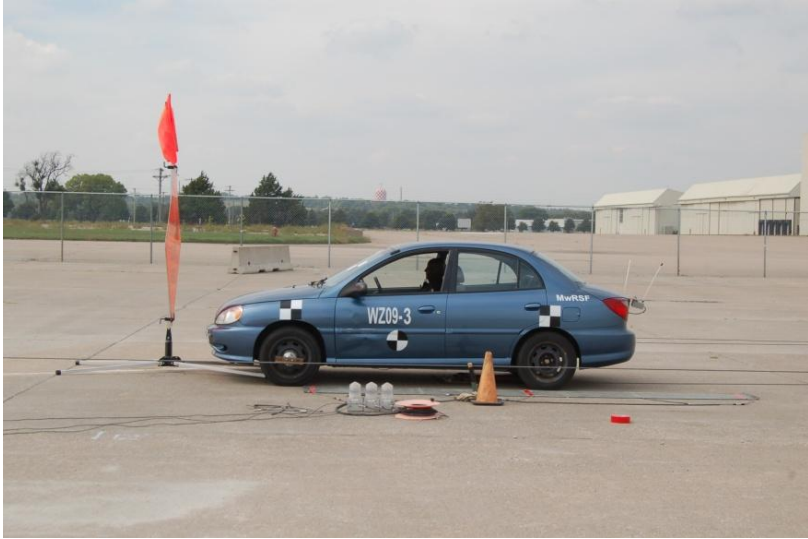
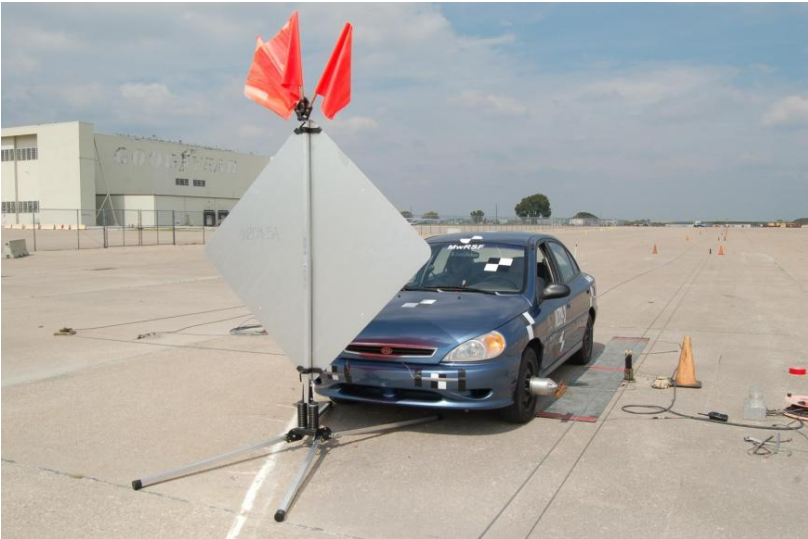
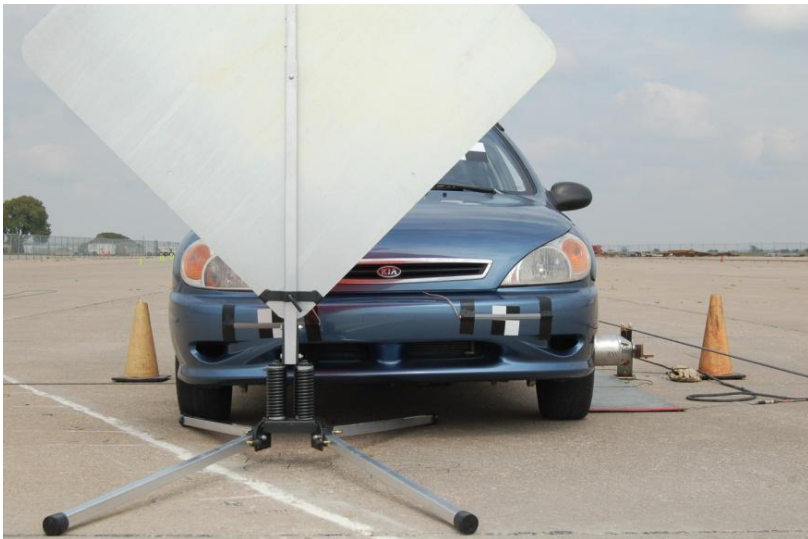
Figure 79. Impact Location, Test No. WZ09-3A

For System No. 3A, initial vehicle impact was to occur with the centerline of the mast at the right-side quarter point on the car's bumper, as shown in Figure 79. The actual point of impact was 1½ in. (38 mm) to the left of the right-side quarter point. For System No. 3B, initial

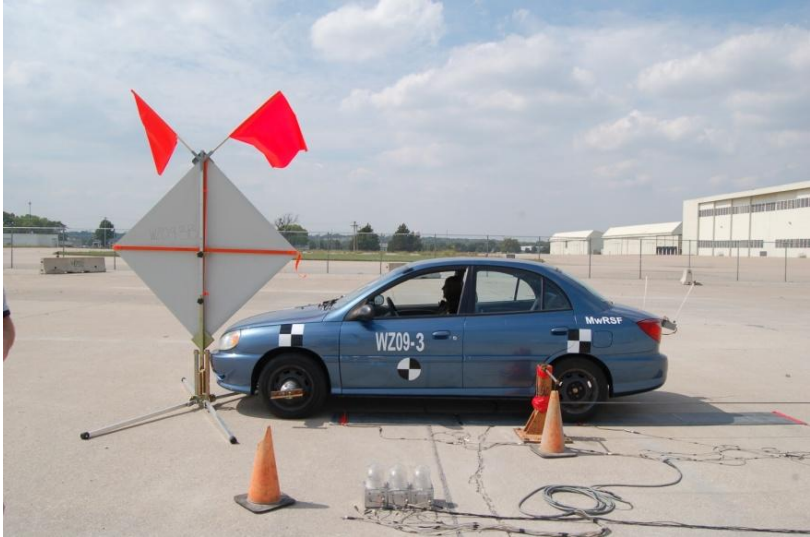
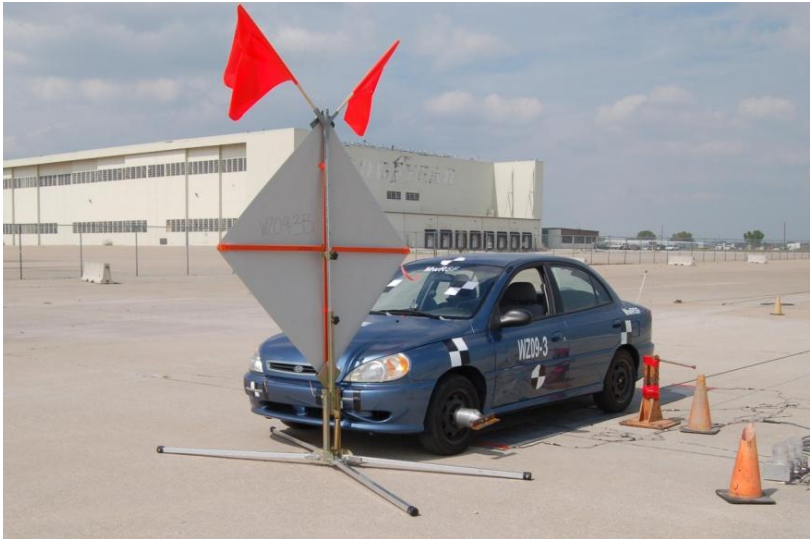
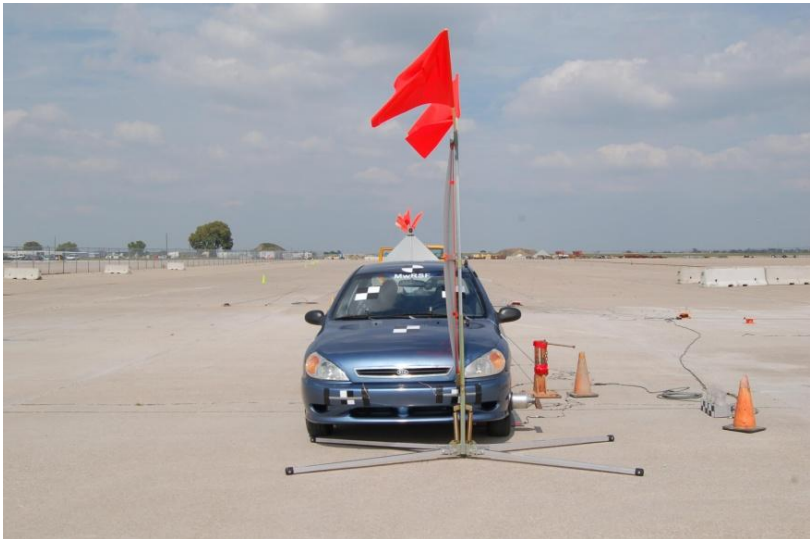
Figure 80. Impact Location, Test No. WZ09-3B

vehicle impact was to occur with the centerline of the mast at the left-side quarter point on the car's bumper, as shown in Figure 80. The actual point of impact was at the left-side quarter point.

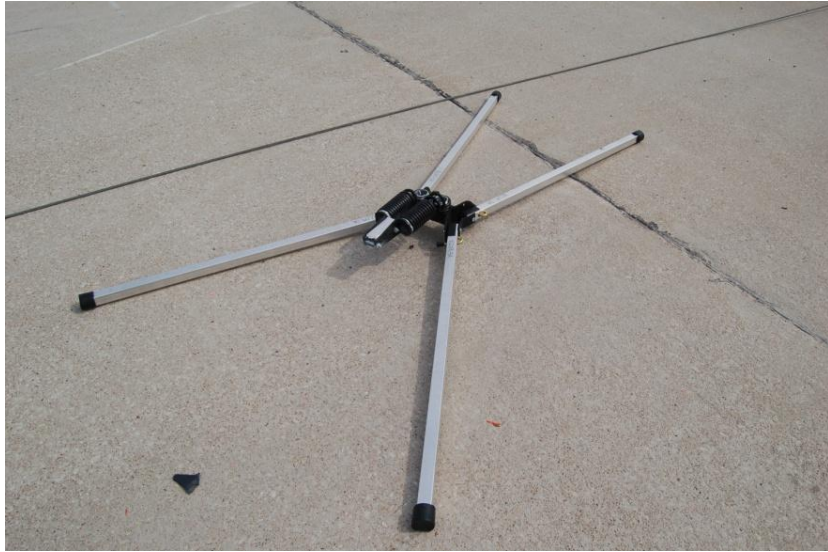
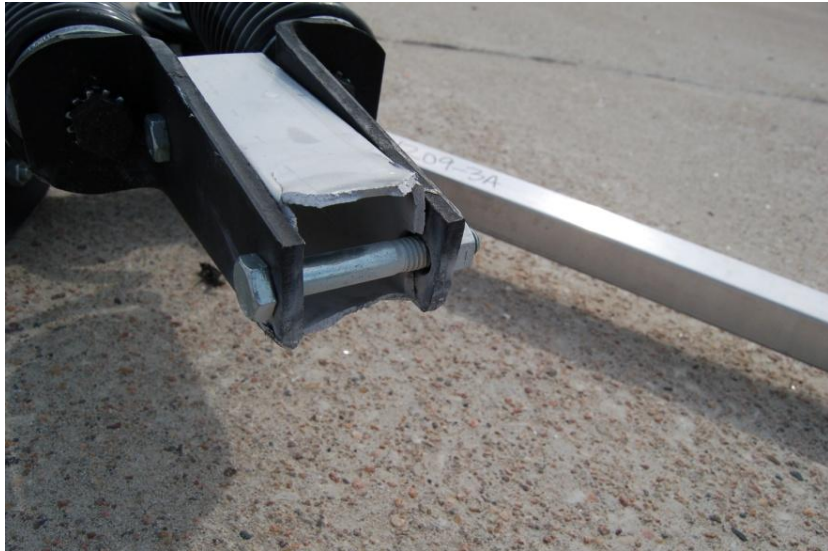
Figure 82. System Damage, Test No. WZ09-3A

Damage to System Nos. 3A and 3B is shown in Figures 82 through 85. System No. 3A encountered moderate damage. The three flags released from the flag holder. Both springs were deformed to a horizontal position. The front of base plate deformed inward, and the front legs were pushed closer together. The lower mast completely fractured at the top of bolt side plates and was crushed at the fracture point. The lower mast aluminum was torn below the fracture point at one corner. The sign panel remained intact with the car, and reflective material was scraped on the front face. The sign panel was also deformed outward with a small hole near the top. Damage to the concrete surface around the original location of System No. 3A included gouges 2½ ft (0.8 m) downstream of the impact, where the bottom part of the lower mast contacted the concrete.

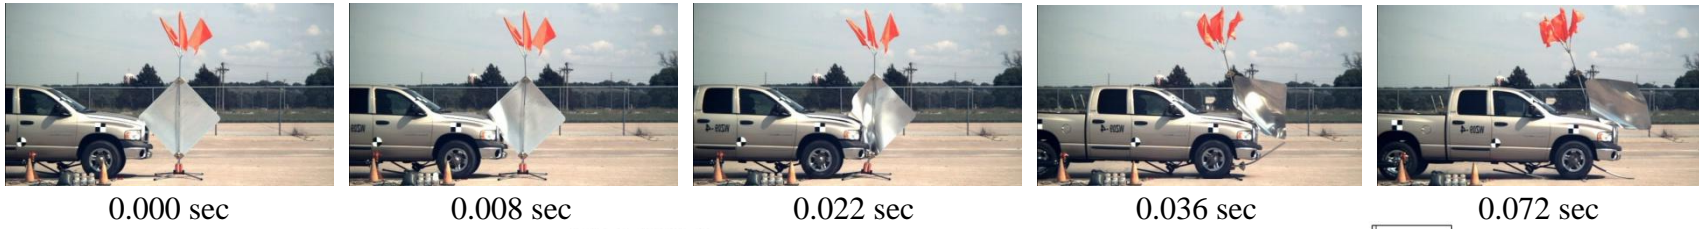
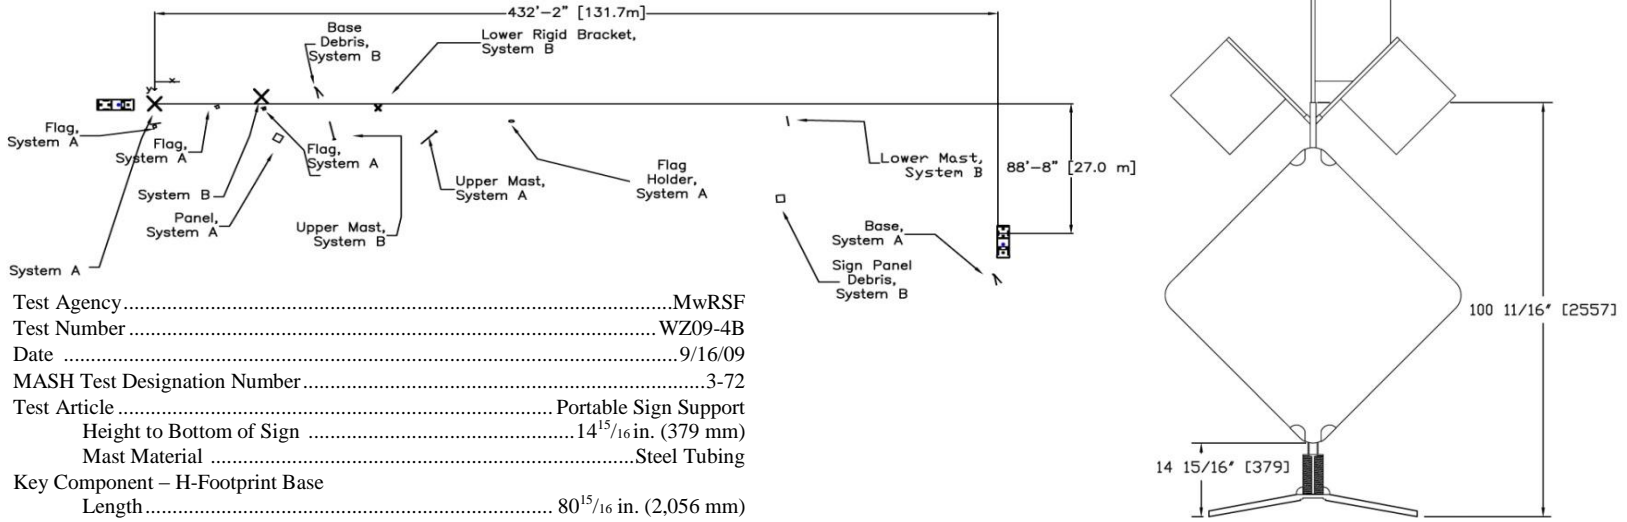
Figure 89. Summary of Test Results and Sequential Photographs, Test No. WZ09-4B

System No. 4B was determined to be acceptable according to the MASH criteria since the components of System No. 4B did not contact the pickup truck's windshield or roof. Deformations of, and intrusion into, the occupant compartment did not occur, and System No. 4B did not show any potential for occupant compartment penetration. The impact with System No. 4B did not affect the vehicle's trajectory.

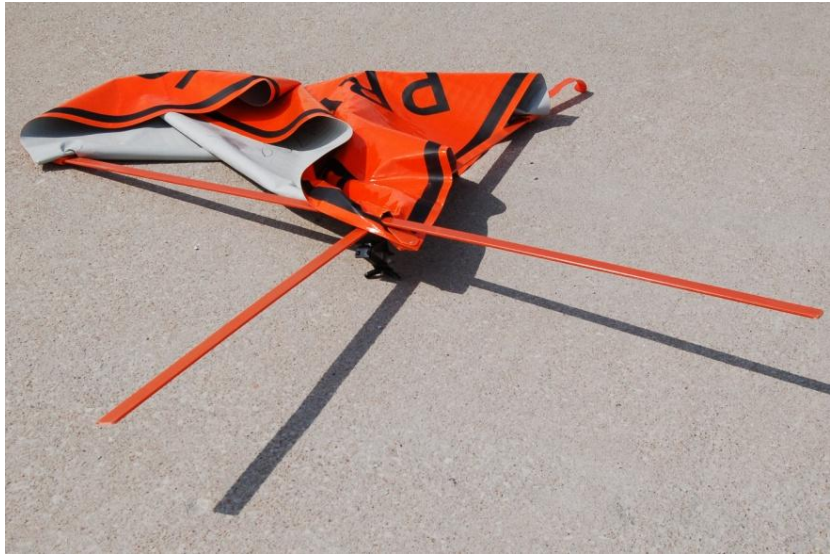
Figure 96. System Damage, Test No. WZ09-4A

Damage to System Nos. 4A and 4B is shown in Figures 96 through 99. System No. 4A encountered severe damage. All three flag staffs fractured at the top of the flag holder, and the ends remained intact with the flag holder. The vertical crossbracing tore through the top of sign panel. The upper mast was bent slightly and separated from the lower mast. The flag holder separated from the upper mast and had scratches and denting on one corner. The base was carried underneath the truck the entire time. One leg penetrated the floorboard and was bent significantly. One leg was wedged behind the right-front wheel and was bent slightly. The lower mast almost completely fractured 1½ in. (38 mm) above the top bent plates. The springs deformed to a horizontal position and were scraped on their sides. All legs released from their original lock positions.

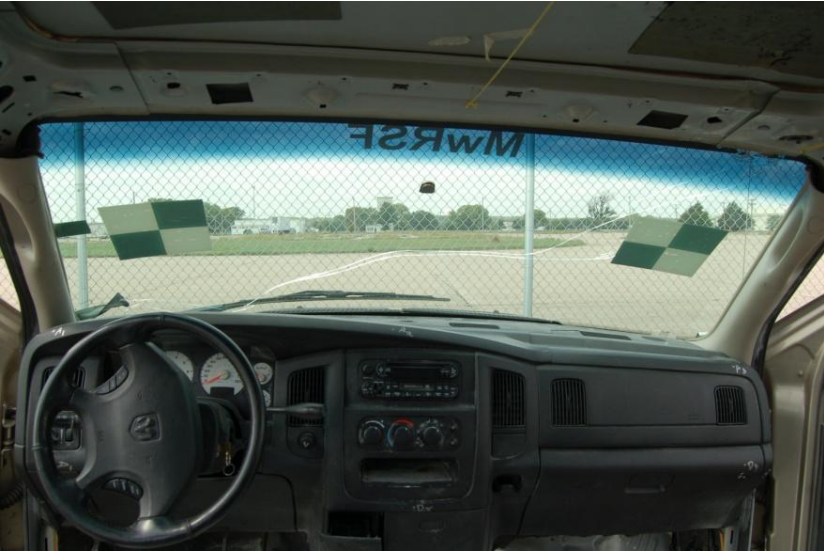
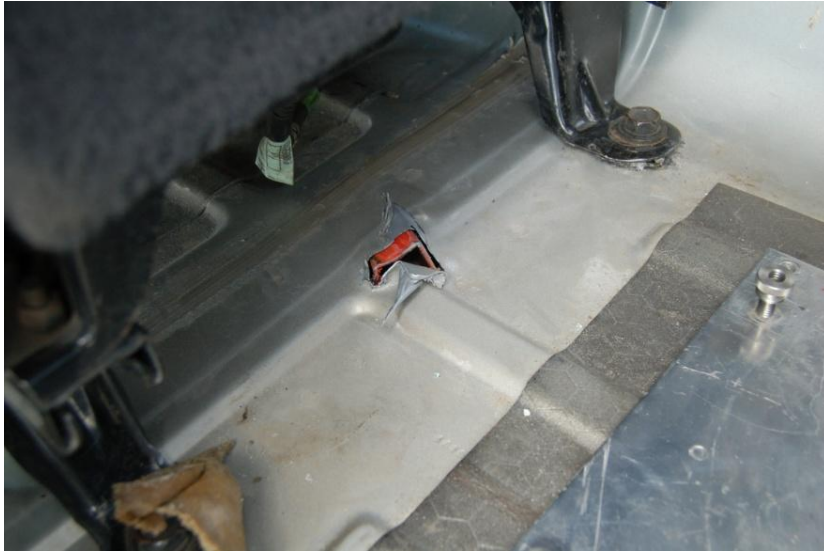
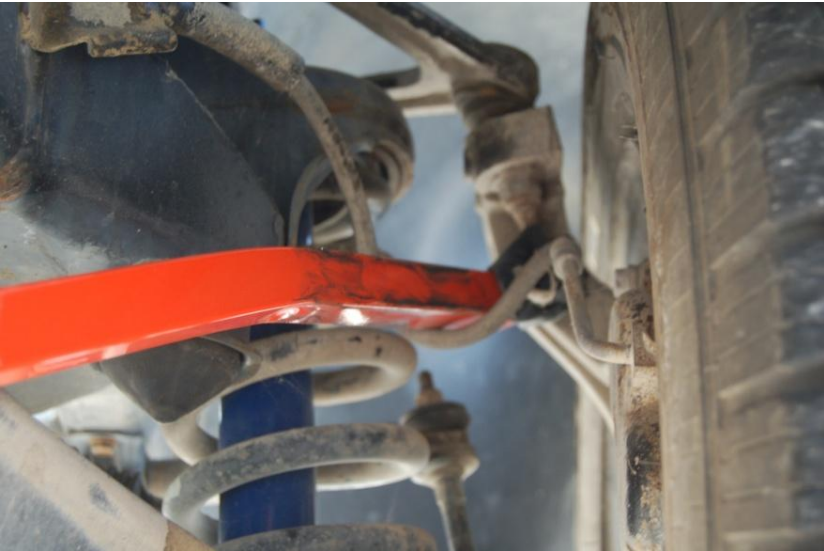
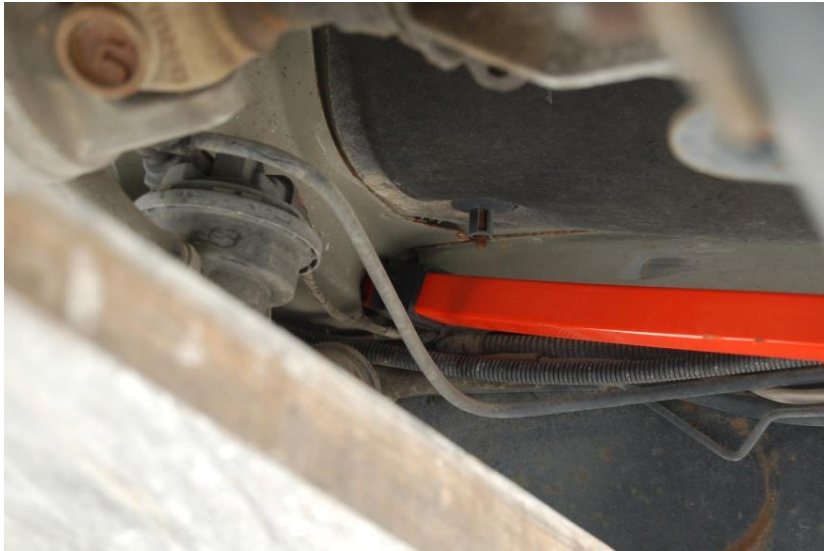
Figure 100. Vehicle Damage, Test No. WZ09-4

Vehicle damage is shown in Figures 100 and 101. The bumper was dented inward where it contacted System No. 4A and where it contacted System No. 4B. The grill was sliced at the upper-left region. The left front of the engine hood was dented inward and sliced. Scraping occurred on the right-front corner of the hood. A small dent was found in the right-front corner of the hood, and a scratch was found down the right side of the hood. A concentrated tear occurred in the upper-right corner of the windshield where it was contacted by the flag holder from System No. 4A. Two hairline cracks were found beginning at the lower-left corner of the windshield and spanning to the upper-right corner of the windshield. A dent and a scratch were found at the right-front region of the roof. A small hole was found in the floorboard on the left side with one of the legs of System No. 4A protruding through it. The right-front tire was deflated, and one leg of System No. 4A was wedged behind the right-front tire. The front bumper was pushed down and scuffed from a secondary impact with a concrete barrier prior to stopping.

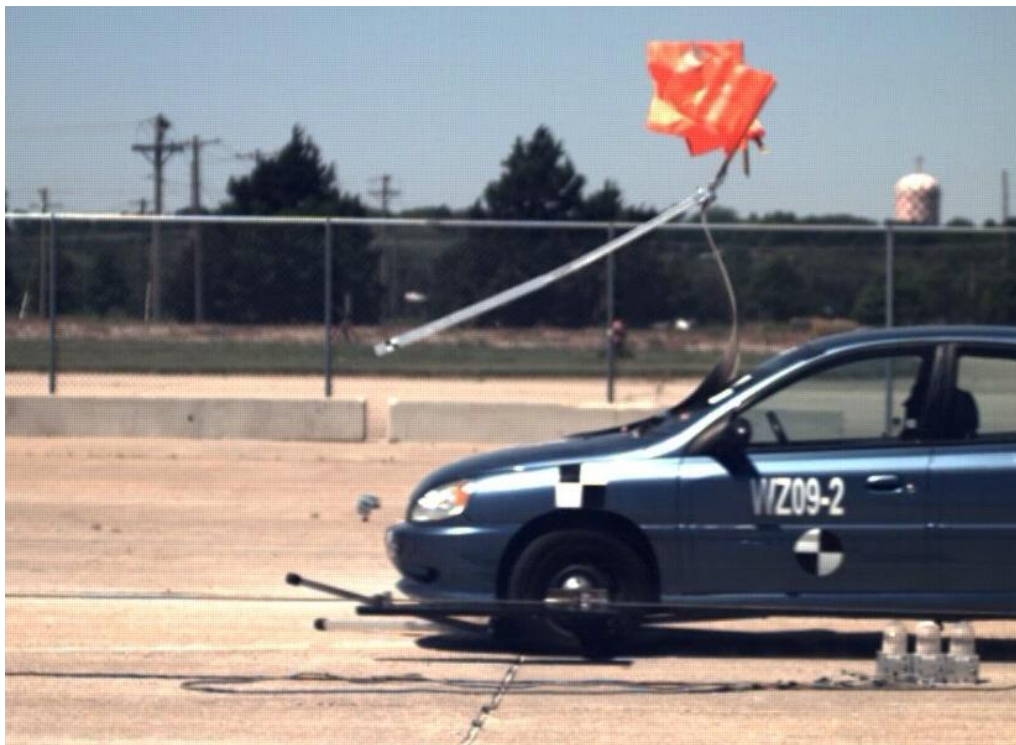
Figure 103. System No. 3A, Frangible Mast

A mast with a frangible base reduces the amount of flex that develops in the sign panel and mast (System Nos. 1A, 2A, 3A, and 4A). This relatively quick release of the mast from the stand allows the sign panel and mast to fall upon the vehicle with little additional force than what normally occurs through the impact event, as shown in Figure 103. However, this force can still be sufficient to cause indentation or penetration of the windshield. On the other hand, when base bending occurs, as shown in Figure 104, the sign panel and the top of mast are accelerated downward into the windshield (System No. 1B). When the mast was unloaded, the sign panel and mast have the tendency to "whip" downward onto the vehicle. In addition, a base-bending

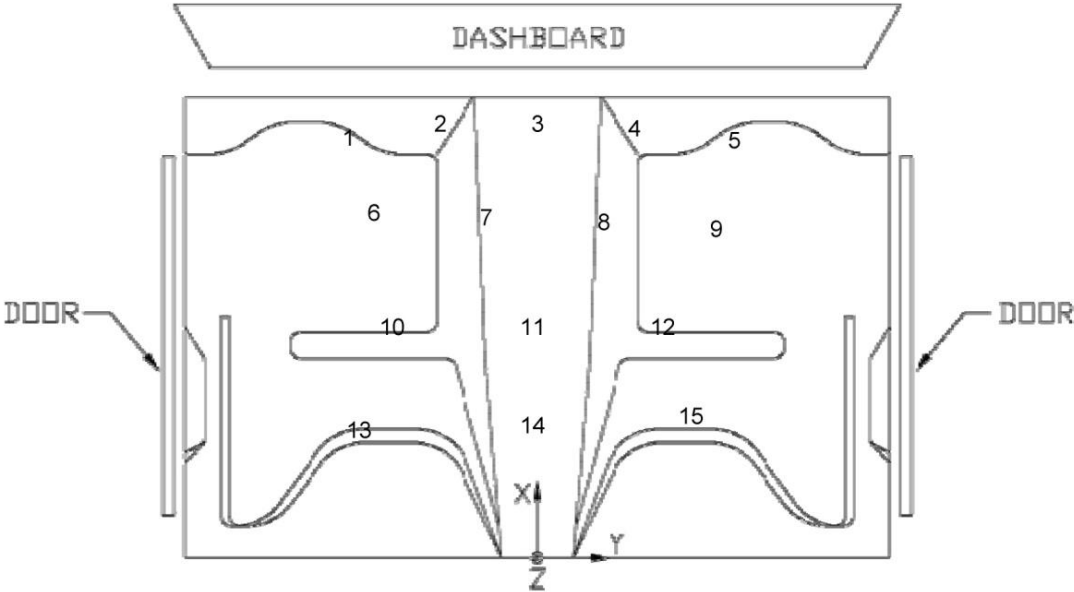
Figure E-1. Roof Deformation Data, Test No. WZ09-1

Max is at roof edge of glass, passenger side, 1.5inches in from roof seam.

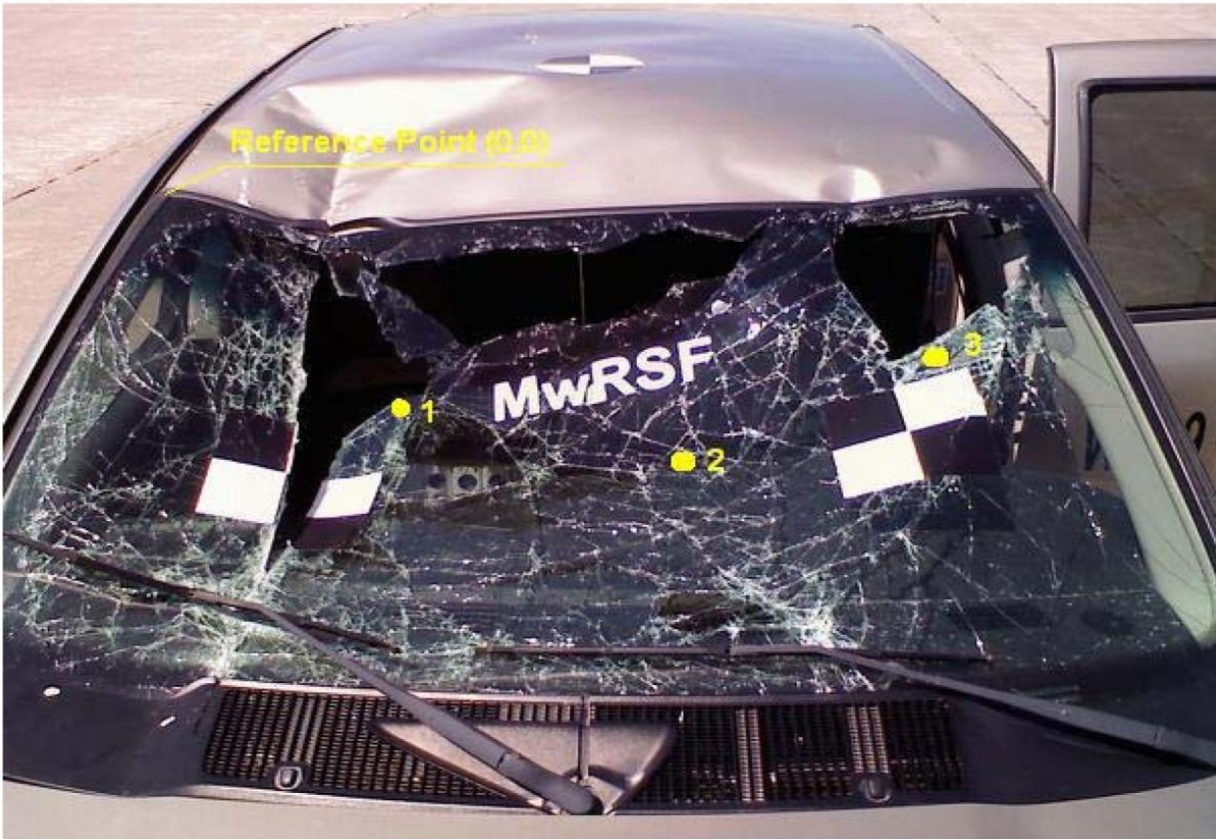
Figure E-2. Windshield Deformation Data, Test No. WZ09-1

Lateral (X)	Longitudinal (Y)	Pre test	Post test	Crush
Point 1	12	7	4	17	13
Point 2	28	14	2.25	11.25	9
Point 3	44	9	4.25	8.5	4.25
Max Crush	12	7	4	17	13

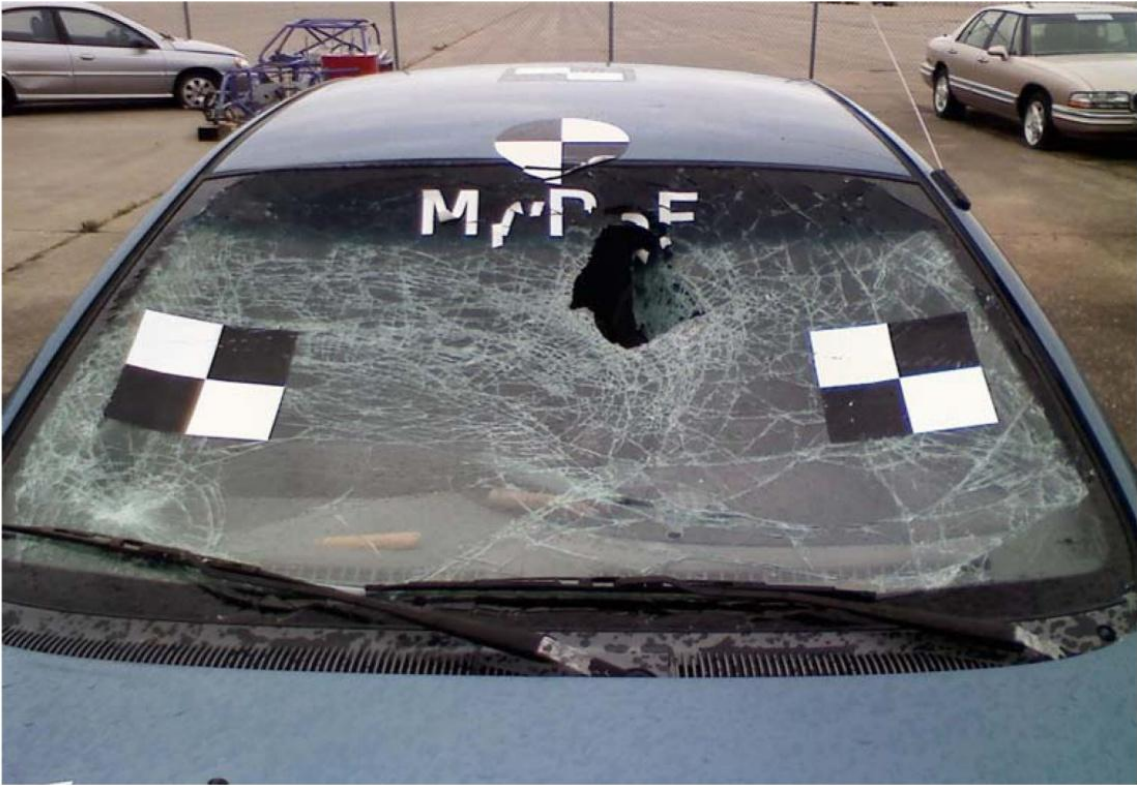
Figure E-4. Windshield Deformation Data, Test No. WZ09-2

Lateral (X)	Longitudinal (Y)	Pre test	Post test	Crush
Point 1	9	11	5.25	7.5	2.25
Point 2	25	9	4.75	9.5	4.75
Point 3	26	13	4.75	12.5	7.75
Max Crush	12	13	4.75	12.5	7.75
