# Purbeck-Southampton Pipeline: Final Report of Botanical, Morphological and Reinstatement Post-Construction Surveys

Project leader: F.H. Dawson  
Report date: July 1992  
Report to: BP Petroleum Development Ltd  
Contract no.: CC/WYT 0015 2.8.91  
IFE report ref.: RL/T04053d1/5  
TFS project no.: T04053d1

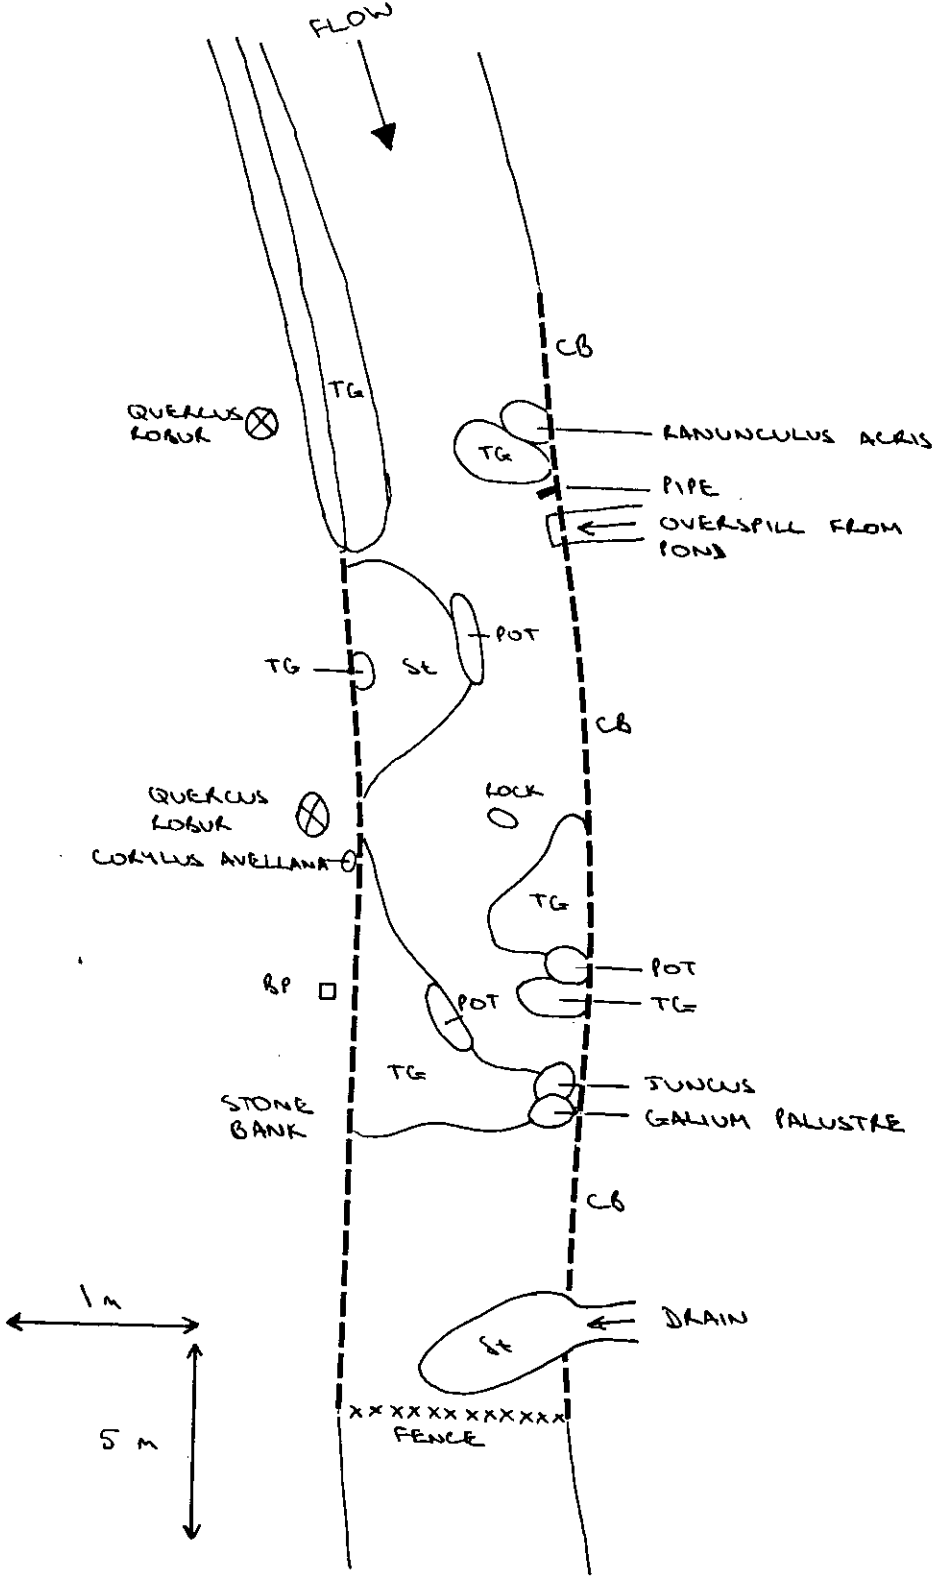
The left artificial bank is constructed from concrete filled bags; the downstream half of this bank is covered with rope mesh, and there is an outflow pipe from the adjacent fishing lake entering through upstream half. The right artificial bank is primarily constructed out of steep stone cladding, but with concrete filled bags on the upstream quarter. Both banks have been constructed to a far greater height than was observed at any of the other pipeline crossing sites; this is apparently so that periodic high flood levels can be accommodated without breaching the banks.

The channel is heavily silted, with large areas of terrestrial grasses etc. growing within the main channel. This accumulation of silt will possibly result in deleterious effects on the downstream flora and fauna.

**FIGURE 5.** Map of Passford Water at the site of the oil pipeline crossing, showing location of major plant populations etc. BP = position of BP pipeline marker post; CB = artificial bank constructed using concrete bags; Pot = *Potamogeton polygonifolius* Pourret; St = stones; TG = terrestrial grasses. Dashed lines indicate position of artificial banks.

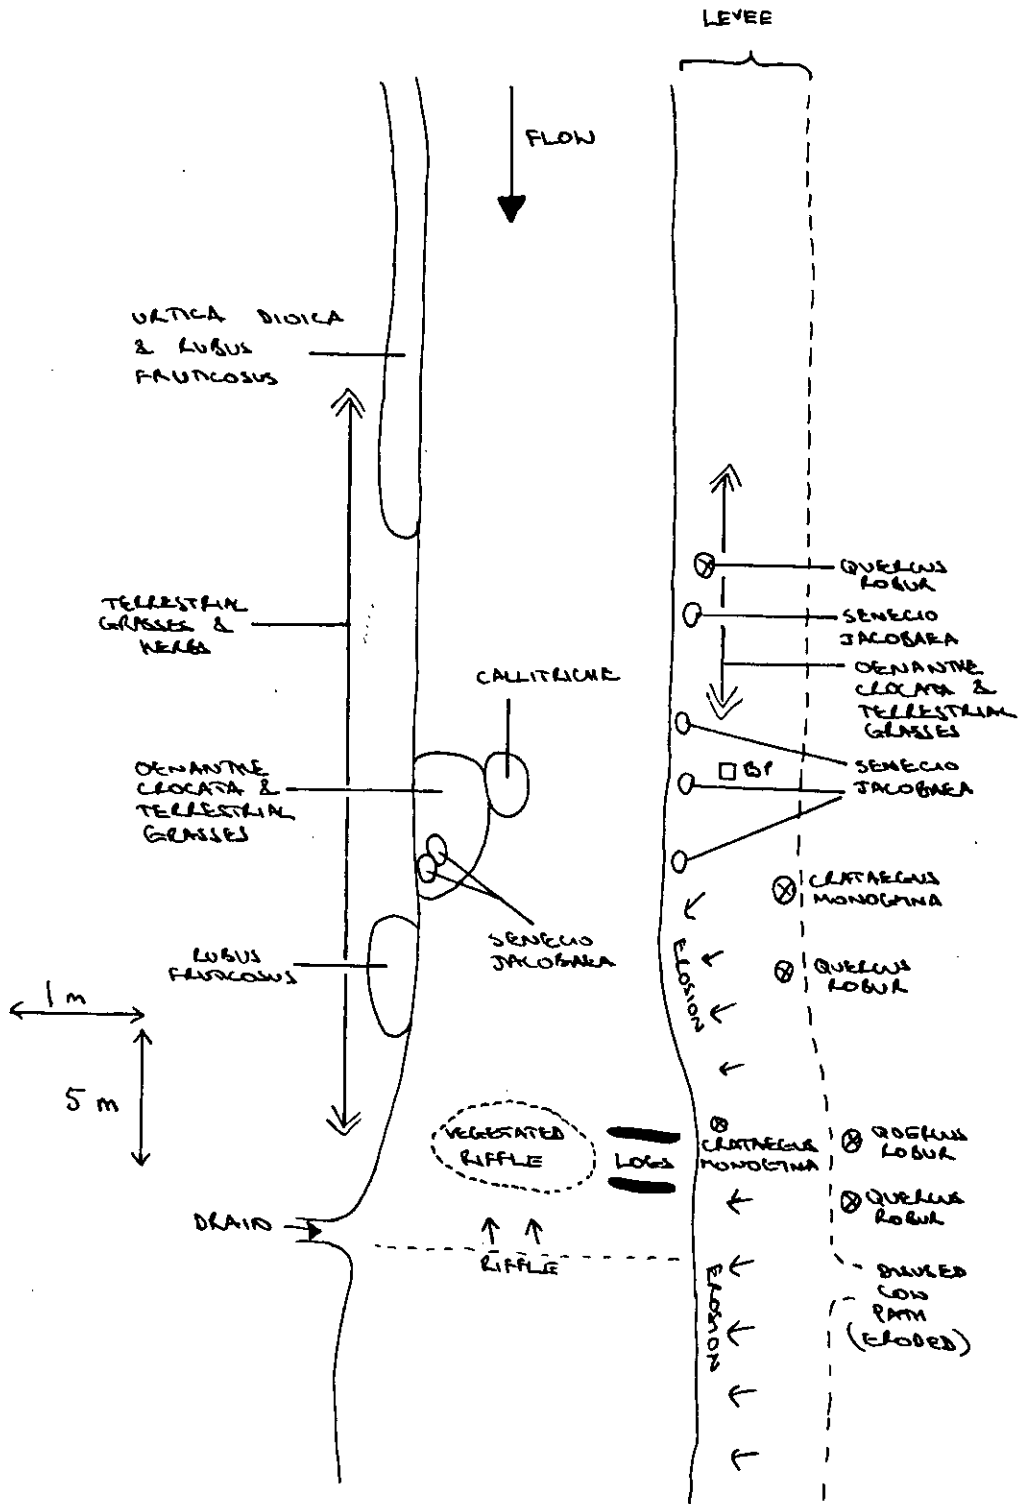
The construction of the pipeline does not appear to have resulted in any deleterious effects downstream such as erosion problems, sedimentation or alteration in water flow rate.

FIGURE 6. Map of Crockford Stream at the site of the oil pipeline crossing, showing location of major plant populations etc. BP = position of BP pipeline marker post; TG = terrestrial grasses. Dashed lines indicate position of artificial banks.

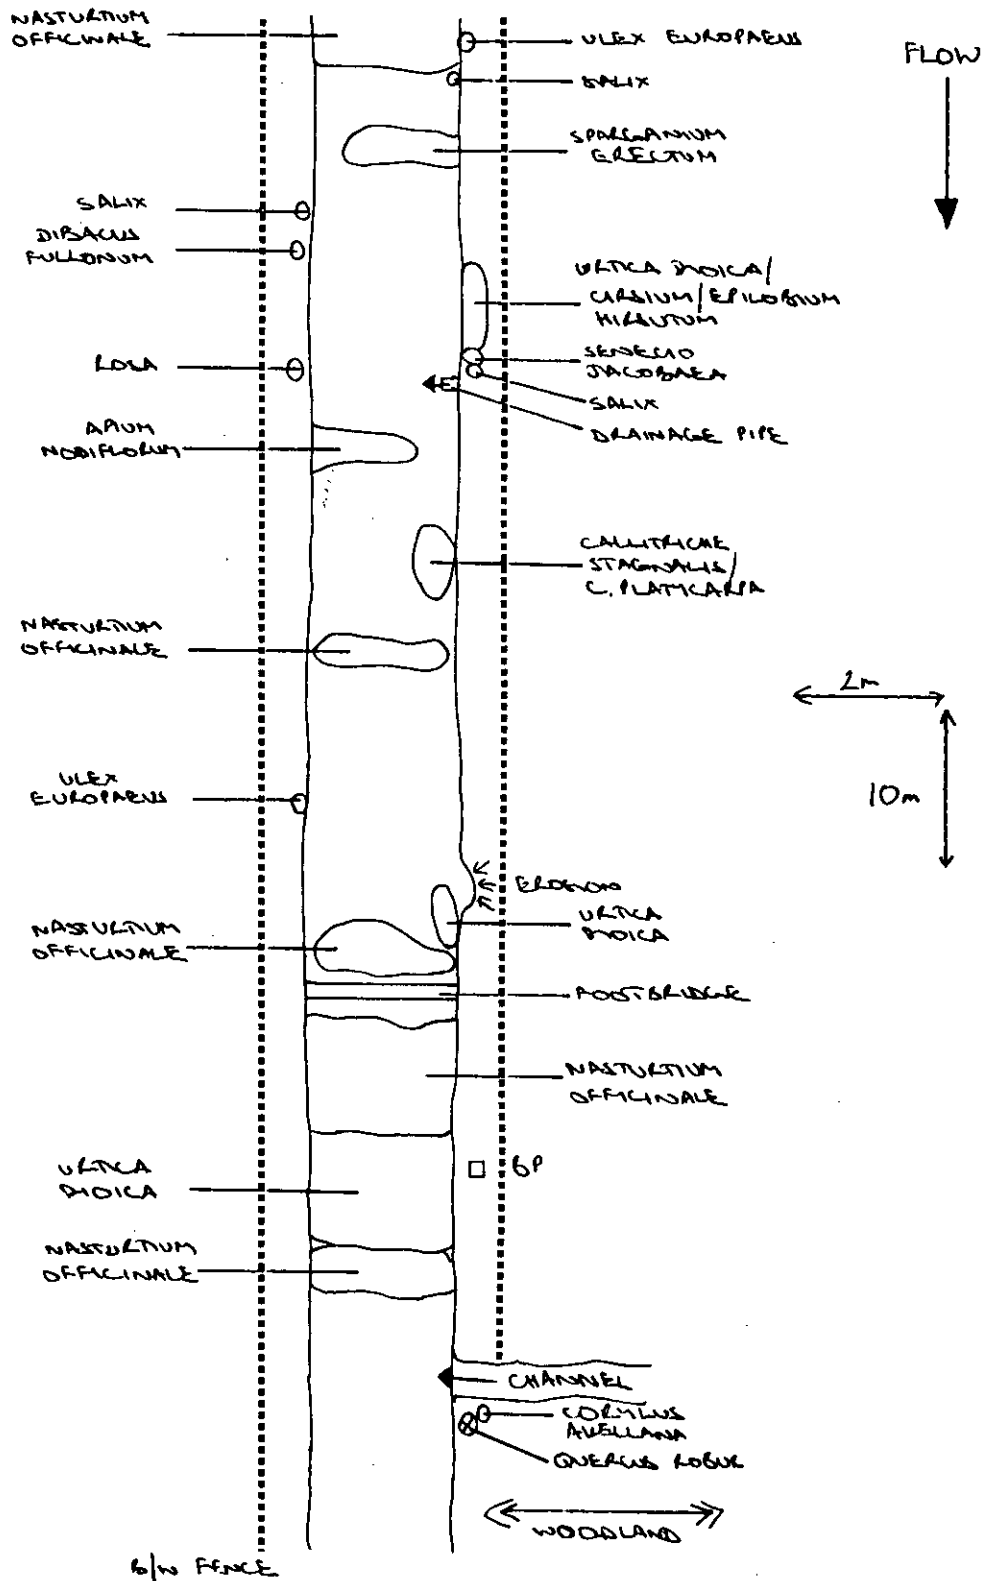
The aquatic vegetation is dominated by *Nasturtium officinale* R. Br., which considerably reduces the water velocity and flow downstream. The riparian flora primarily consists of *N. officinale* and *Oenanthe crocata* L., with other large stands of *Urtica dioica* L., etc. Several small shrubs (including *Salix* L. sp. and *Ulex europaeus* L.) were found growing on the banks of the channel, suggesting that reasonable re-vegetation is occurring.

FIGURE 7. Map of Beck Farm Stream at the site of the oil pipeline crossing, showing location of major plant populations etc. BP = position of BP pipeline marker post; B/W = barbed wire fence. Dashed lines indicate position of artificial banks.

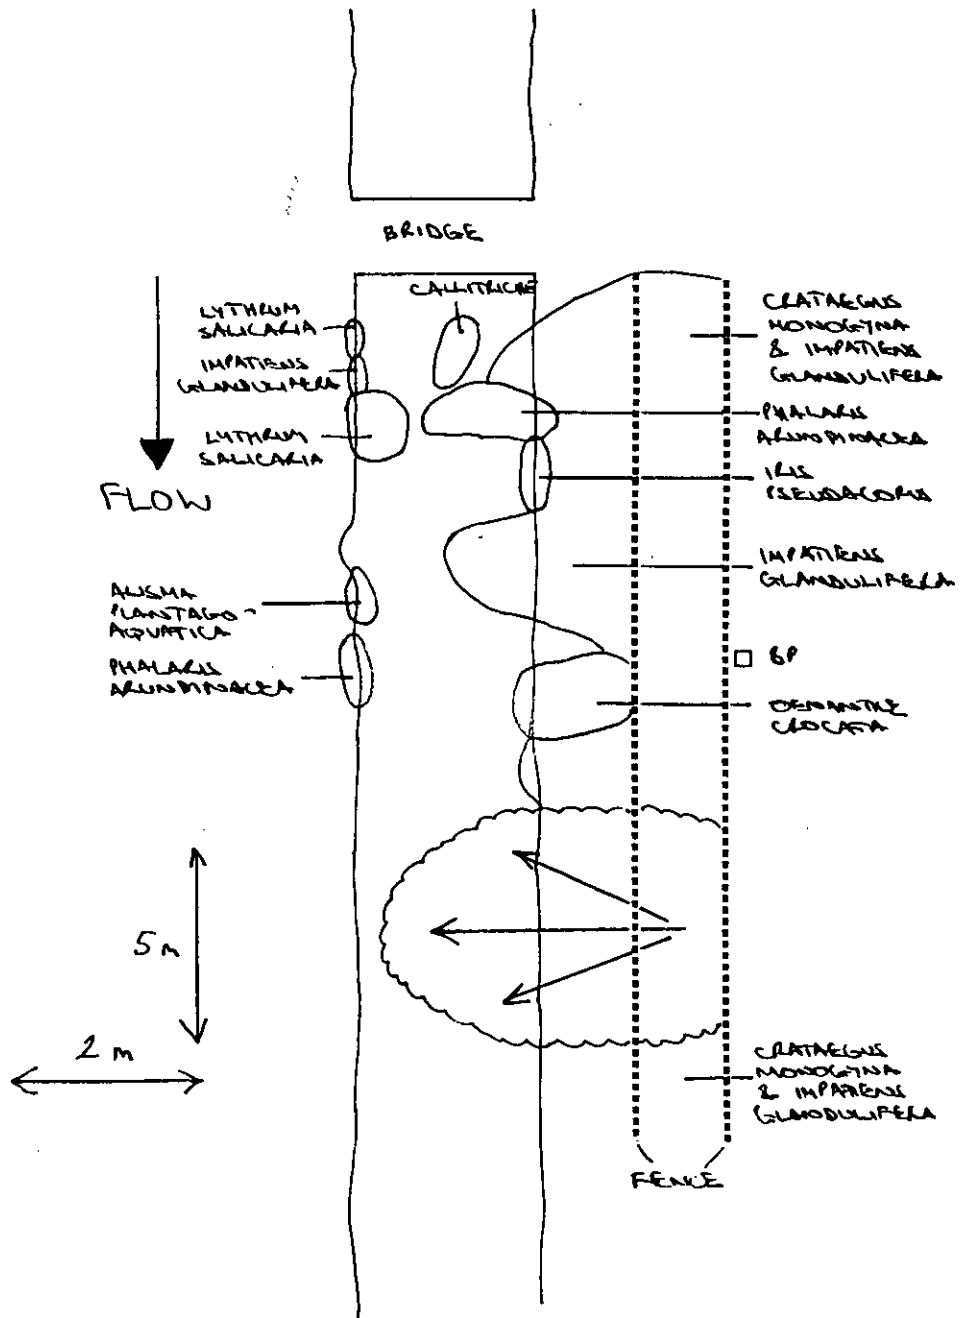
The artificial banks have been constructed from soil (possibly laid over concrete bags, although these are not visible). The banks are highly vegetated with ephemeral weedy species, and mainly *Impatiens glandulifera* Royle and *Rumex* L. sp. The top of the left bank has been replanted with a hawthorn hedgerow (*Crataegus nonogyna* Jacq.), although the area is largely dominated by *Impatiens glandulifera*.

The aquatic vegetation is almost totally dominated by large stands of *Callitriche* L. sp., which is able to grow because of the lack of shading; this will inevitably have affected the flow rate downstream.

**FIGURE 8.** Map of Dark Water at the site of the oil pipeline crossing, showing location of major plant populations etc. BP = position of BP pipeline marker post; TG = terrestrial grasses. Dashed lines indicate position of artificial banks.

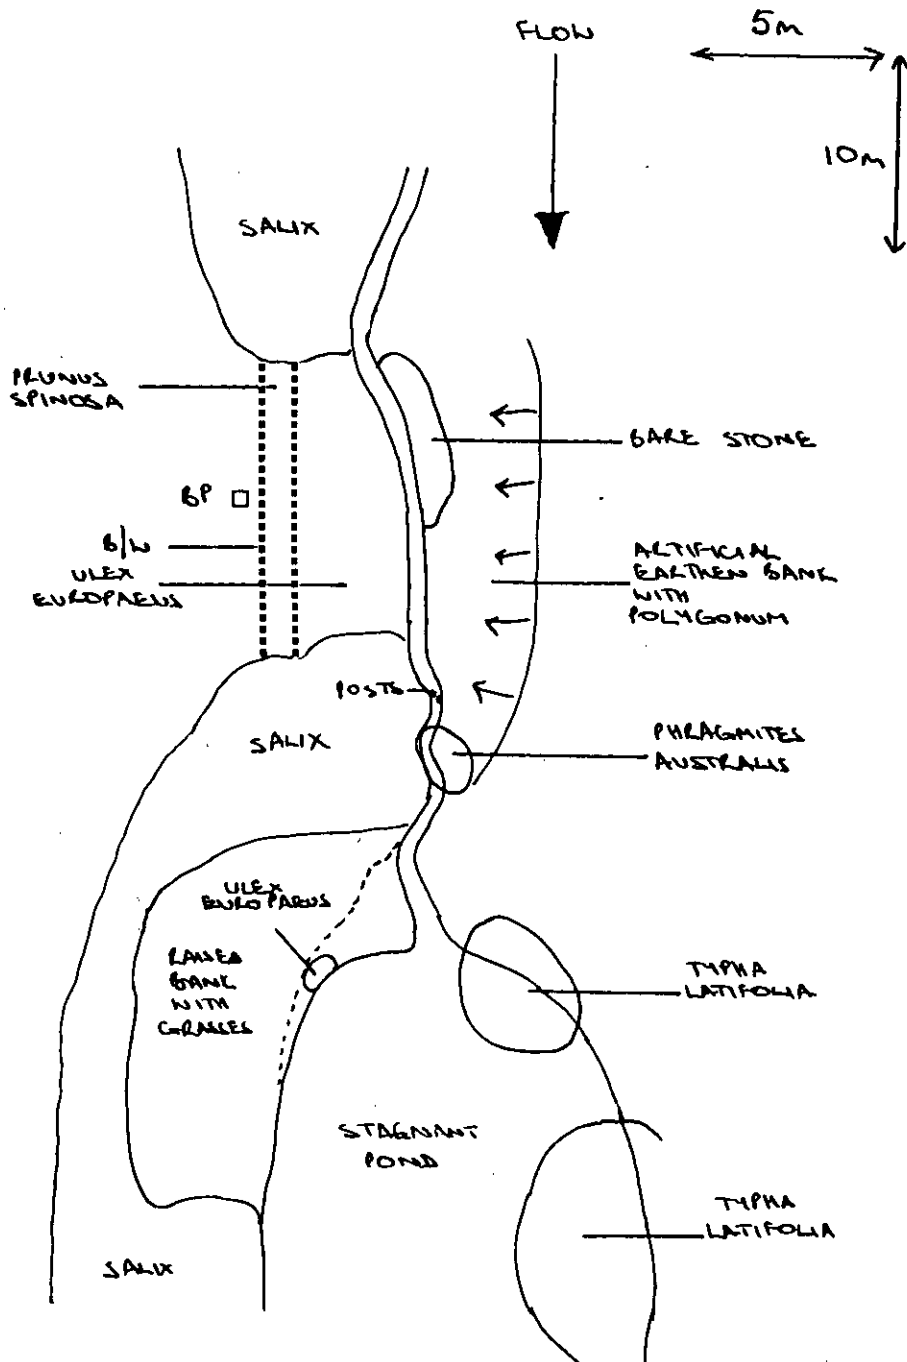
The pond immediately downstream of the crossing point is also very species poor, although a small number of *Callitriche* L. plants were observed. The marginal vegetation was dominated by bulrushes (*Typha latifolia* L.).

The construction of the pipeline does not appear to have resulted in any deleterious effects downstream such as erosion problems, sedimentation or alteration in water flow rate.

FIGURE 9. Map of Mopley Pond Stream at the site of the oil pipeline crossing, showing location of major plant populations etc. BP = position of BP pipeline marker post; B/W = barbed wire fence.
