THE ROYAL CHAPEL OF NATIONAL PALACE OF SINTRA: A STUDY OF TIMBER ELEMENTS

D. F. Henriques^{1,2} and V. Baptista¹

¹ ISEL – Instituto Superior de Engenharia de Lisboa

*The work consisted in the characterization and structural assessment of tribune's first floor beams. Inspections took place between January and May 2018. The wood present in most of the structural and secondary elements is coniferous, most of which has been identified as *Pinus Sylvestris, L.* The work was carried out in situ by visual inspection and by non-destructive and semi-destructive tests. Water content, drill resistance and penetration resistance were measured. Physical-mechanical properties of the timber members were estimated based on the in-situ measurements and the scientific literature. Visual strength grading was also applied to the floor beams. From the results obtained several important information were taken. Report and recommendations were presented as the conclusion of the study.*

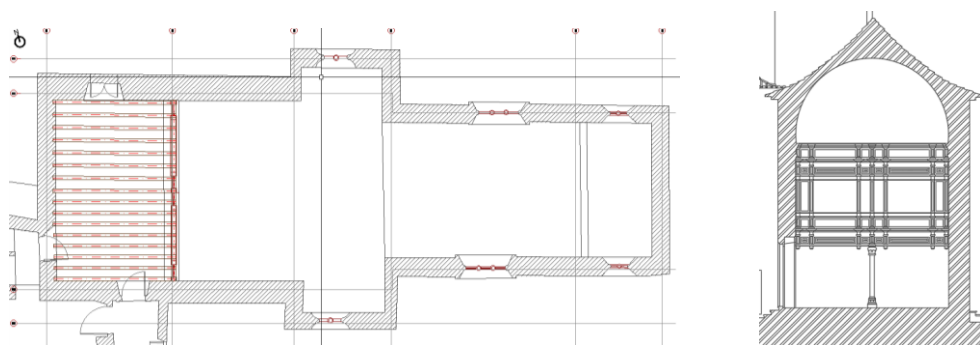
Figure 1: Royal Chapel’s plan and section

The Chapel is constituted by foundations and walls of regular masonry and his plan has a cross shape. The opposite side of the main altar have two floors supported by a timber structure (Figure 1). The first floor was the tribune and nowadays is where pass all visitors. The second floor was the chorus and nowadays is inaccessible to the public. The roof has tree roof slopes, with two hips in the main altar zone, and the other side is adjacent with other part of the building. The roof structure support, and his roof sheathing, formed by collars, purlins, principal rafters and tie-beam are all made in timber. Concerning to the species, considering the date of construction, it is thought to be Maritime Pine or Redwood [20, 21].
