Tornado Damage Assessment in the aftermath of the May 20th 2013 Moore Oklahoma Tornado.

Tornado Damage Assessment in the aftermath of the May 20th 2013 Moore Oklahoma Tornado

March 2014

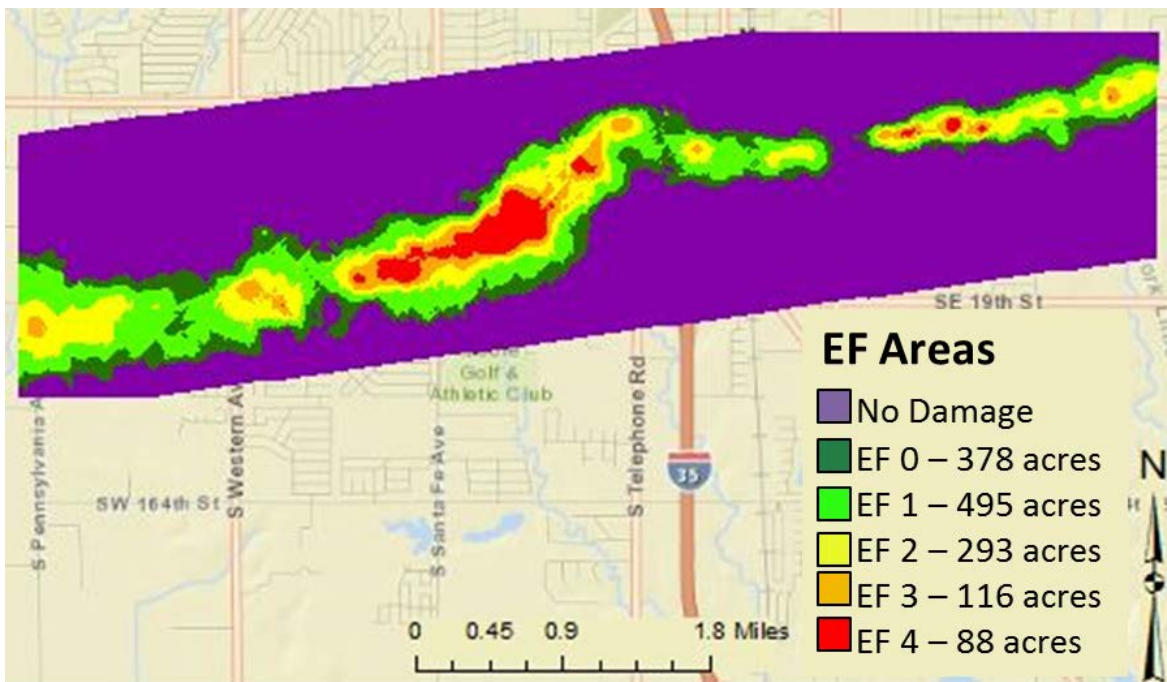
Figure 2.5, Contour map of EF wind speeds based on observed building damage.

It should be noted that the maximum expected wind speed for One- and Two- Family Residencies for a degree of damage rating of 10 “Destruction of engineered and/or well-constructed residence; slab swept clean” is 200 mph. An EF5 rating is over 200 mph; therefore,

by evaluating only wood framed constructed buildings in this study, an EF4 rating is the maximum rated photo and contour that can be achieved as shown on Figures 2.4 and 2.5.

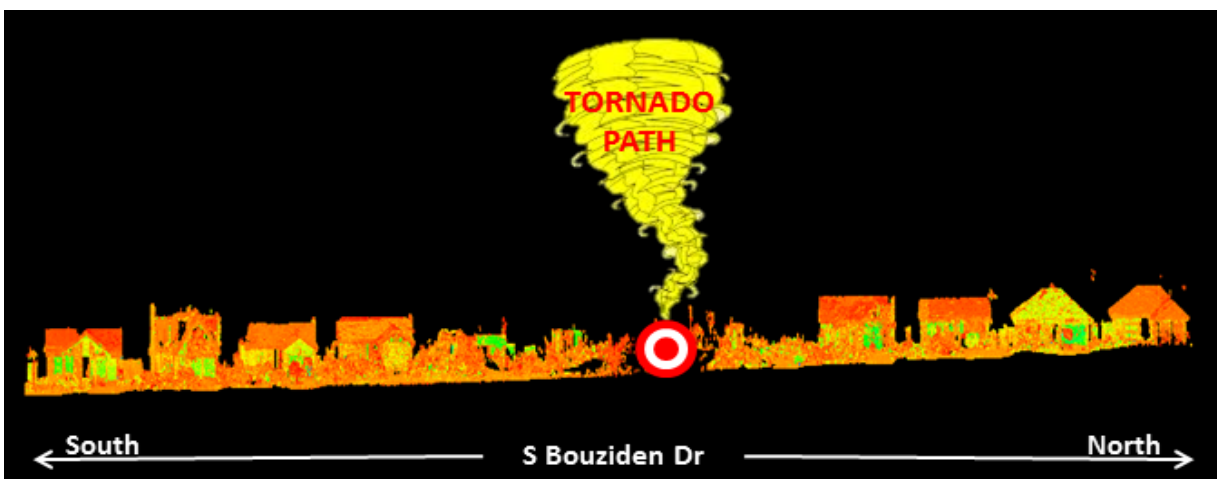
Generated 3D point clouds of the damaged areas were employed to virtually investigate damage of buildings. The 3D nature of the scenes allows the investigator to navigate through the 3D scene, rotate or move the point of view, zoom in, or zoom out. This helps to properly understand the overall condition of the site and identify the location of the tornado path. Figure 2.7 illustrates a cross section of the second point cloud, which shows the damaged buildings on the west side of Bouziden Drive. The figure shows that damage gradually increases from the low damage at either end of the scan (south and north) to the total destruction at the center where the tornado has passed.

Figure 2.7, Point cloud of damaged buildings at west side of the Bouziden Drive and the tornado path.

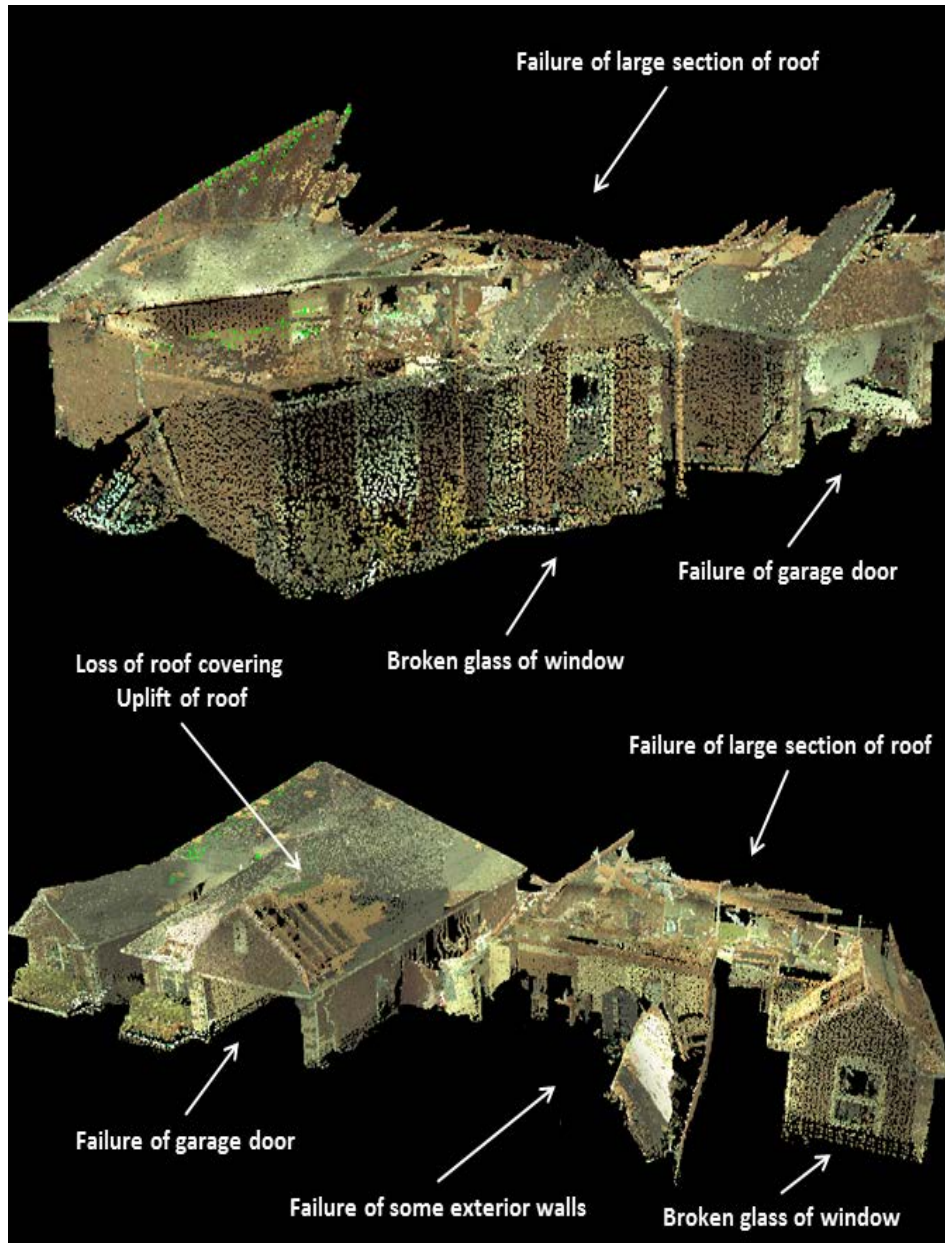
cloud of each building was investigated to detect those damage metrics. Figure 2.8 shows point clouds of three buildings and some detected wind damage metrics. Once the damage of each building was analyzed, an EF rate was assigned to the building based on the EF scale. Figure 2.9 and Figure 2.10 show the aerial view of damaged areas and results of the EF rating. Table A1 in the appendix presents the detailed results of the damage assessment and EF ratings for all individual buildings.

Figure 2.8, Point cloud of three damaged buildings and detected wind damage metrics.

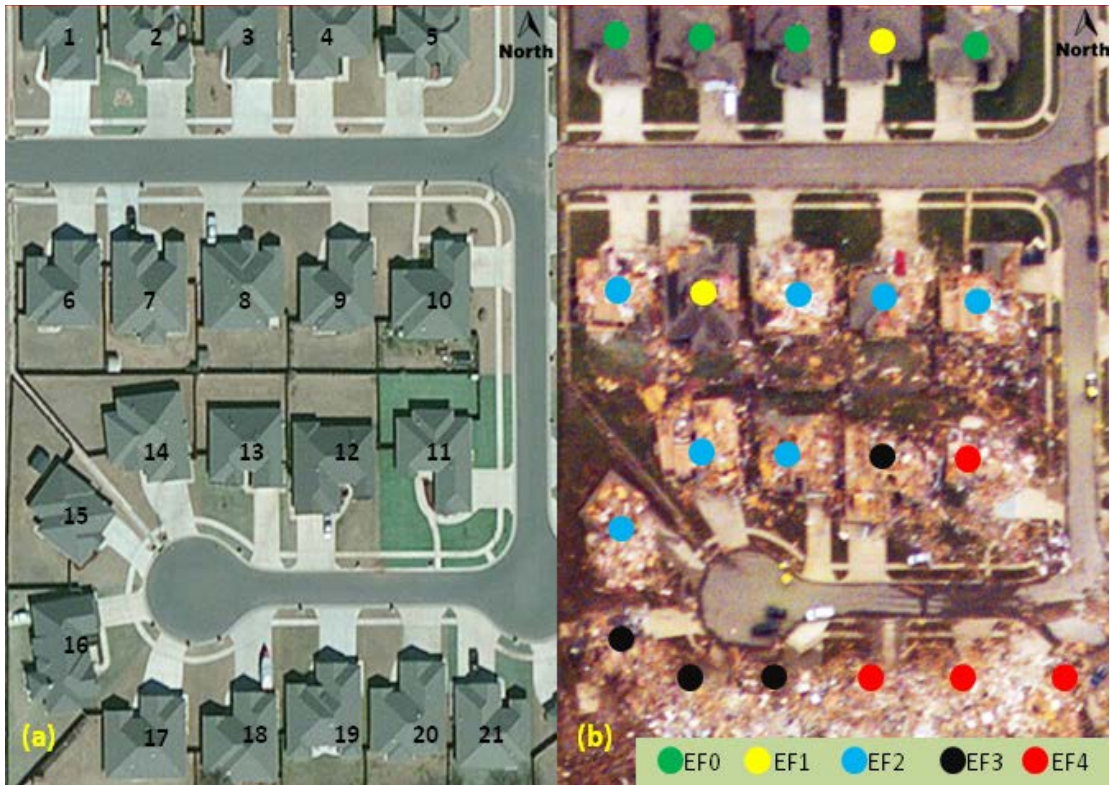
Figure 2.9, Aerial images and EF rates of the area #1: (a) pre-tornado image and building IDs; (b) post-tornado image and EF rates.

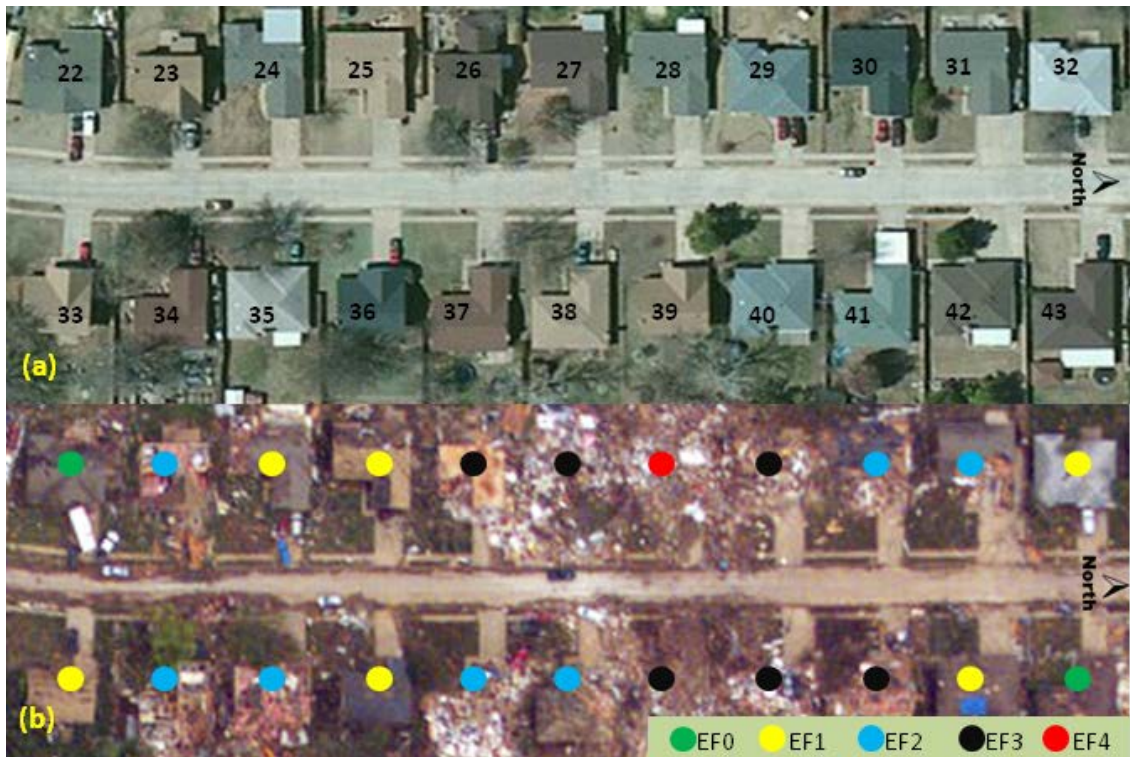
Figure 2.10, Aerial images and EF rates of the area #2: (a) pre-tornado image and building IDs; (b) post-tornado image and EF rates.

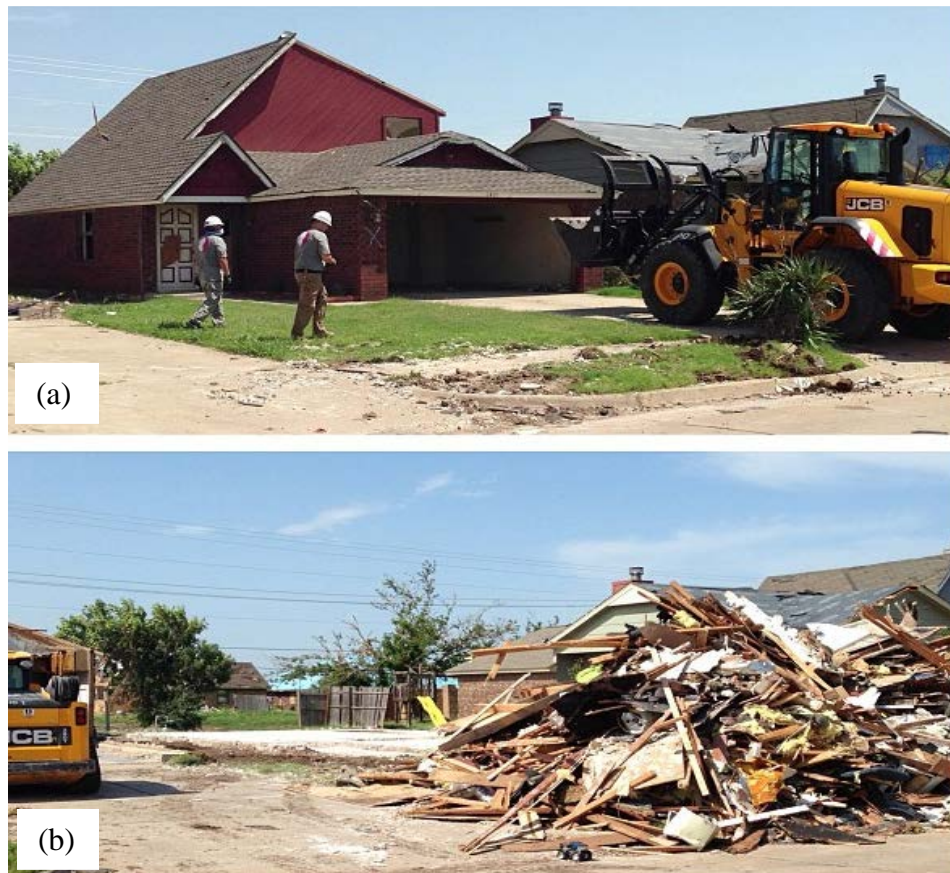
Figure 3.3, Comparison of damaged home (a) pre- and (b) post-demolition

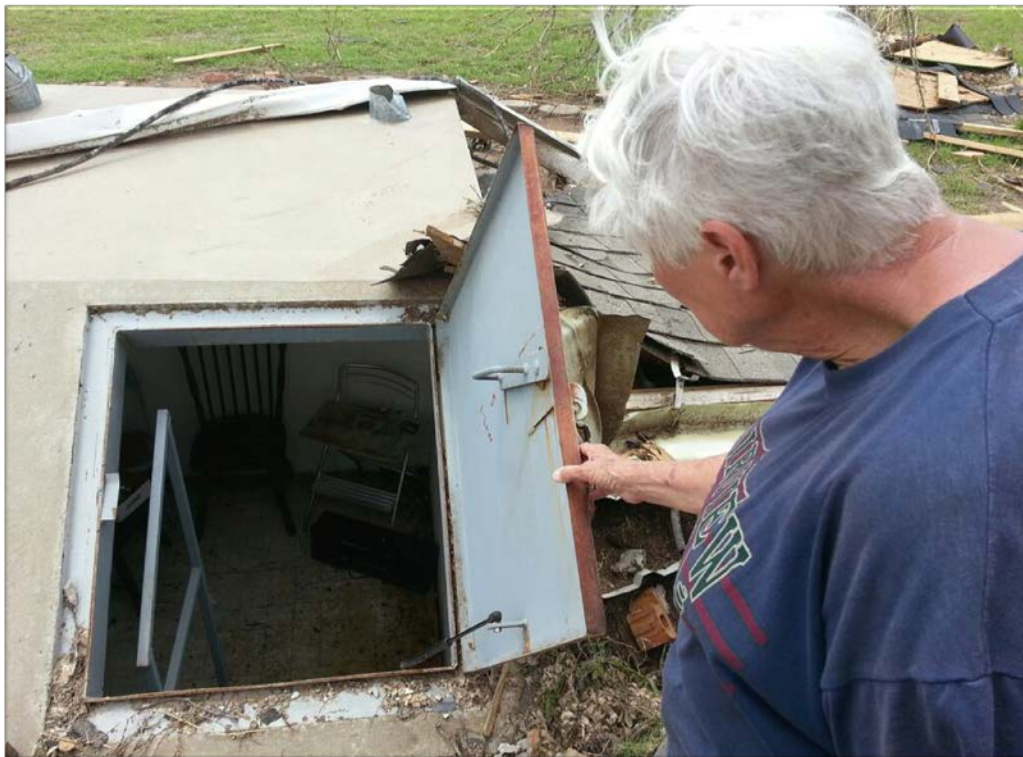
Figure 3.4, Picture of local shelter obtained from active social media data collection.

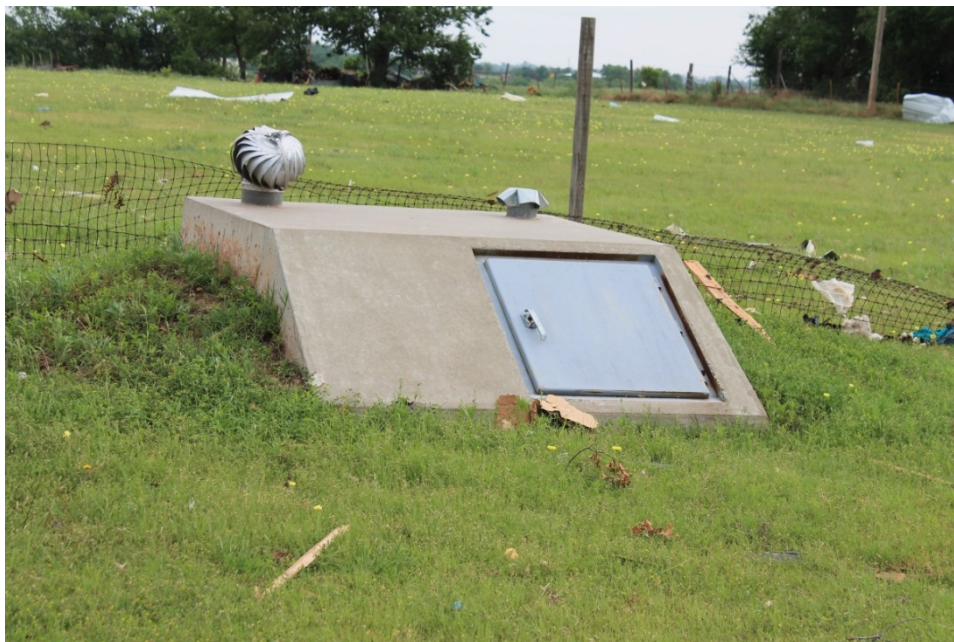
There were 29 documented prefabricated concrete storm shelters within the damage path. These shelters were partially raised from the ground (~1/3 of the total height) and had the majority of the above ground portion covered with soil and vegetation. A steel door and ventilation spout were on the exposed concrete roof. A photo of a prefabricated concrete shelter is shown in Figure 4.2. Since these shelters were found outside homes, the assessment teams documented many instances where the owners would leave the shelter unlocked and open for neighbors to use in case of an emergency as described in more detail below. The second most common type of storm shelters observed were cut into the garage floor slab. There were over 25 garage floor shelters seen during the damage surveys with two door types: a sliding door and a hinged door. An example of a sliding door garage floor shelter is shown in Figure 4.3 which illustrates that this type of shelter was designed so a car could drive over them to preserve garage space. This type of storm shelter is a quick retrofit to an existing home, requiring approximately 12-15 hours to install, and allows occupants to enter the shelter without having to go outside into the elements. Although typically positioned behind a parking space, a car may have to be moved before occupants are able to enter.

Figure 4.2, Example of a prefabricated concrete storm shelter.

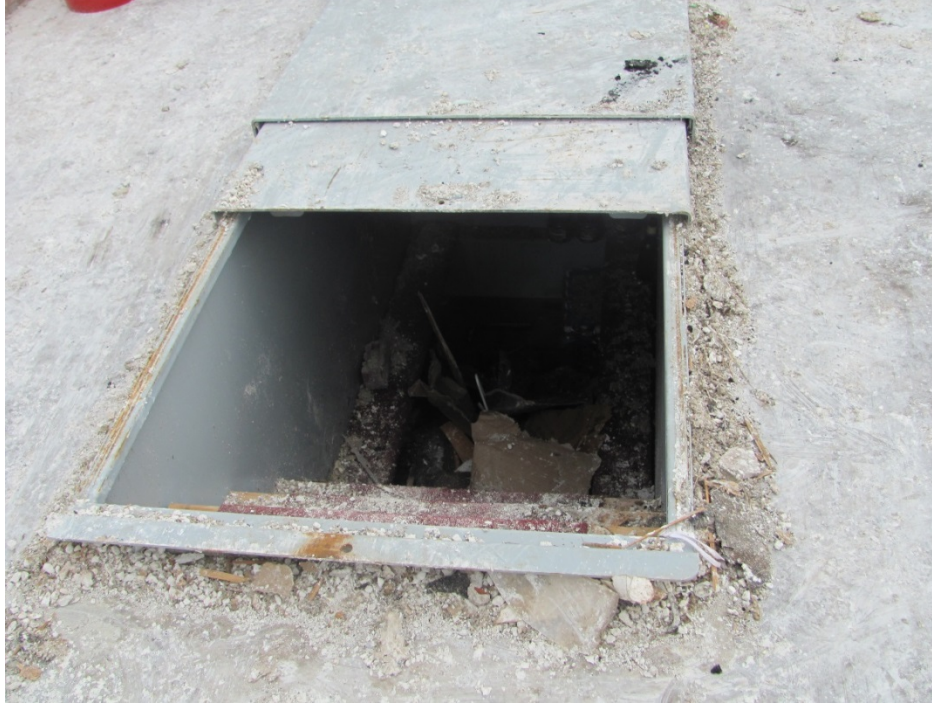
Figure 4.3, Example of a garage slab storm shelter.

While the majority of the garage slab shelters performed very well, there were some issues observed with these shelters. The first was that garage doors and attached garages often fail first during a tornado event (Marshall, 2002). In these instances, large objects and debris can block the doors of garage slab storm shelters. Figure 4.4 illustrates a garage slab storm shelter that was covered by debris after the garage and house collapsed. It should be noted that although debris can cover below ground shelter doors, and occupants may be trapped, first-responders are available very quickly after an event and occupants are typically assisted with in a half hour since the location of registered residential shelters is known. Another observation made was that in some cases the storm shelters were filled with water caused by heavy rains following storm passage or severed water lines in severely damaged homes. This was documented by the team several times with one shelter filling with 0.3 m (1 foot) of water before the occupants were able to safely exit the storm shelter. In the event of debris blocking the exit of the shelter, flooding could prove very dangerous to anyone remaining inside the storm shelter. An example of a flooded storm shelter is shown in Figure 4.5. Floating bottles and bench seats indicate that water had reached the top of the safe room. Another observation, while not directly related to the performance of garage slab storm shelters in the tornado, was that many of these shelters were left open after the occupants exited and were not closed. This is a hazard to first responders and

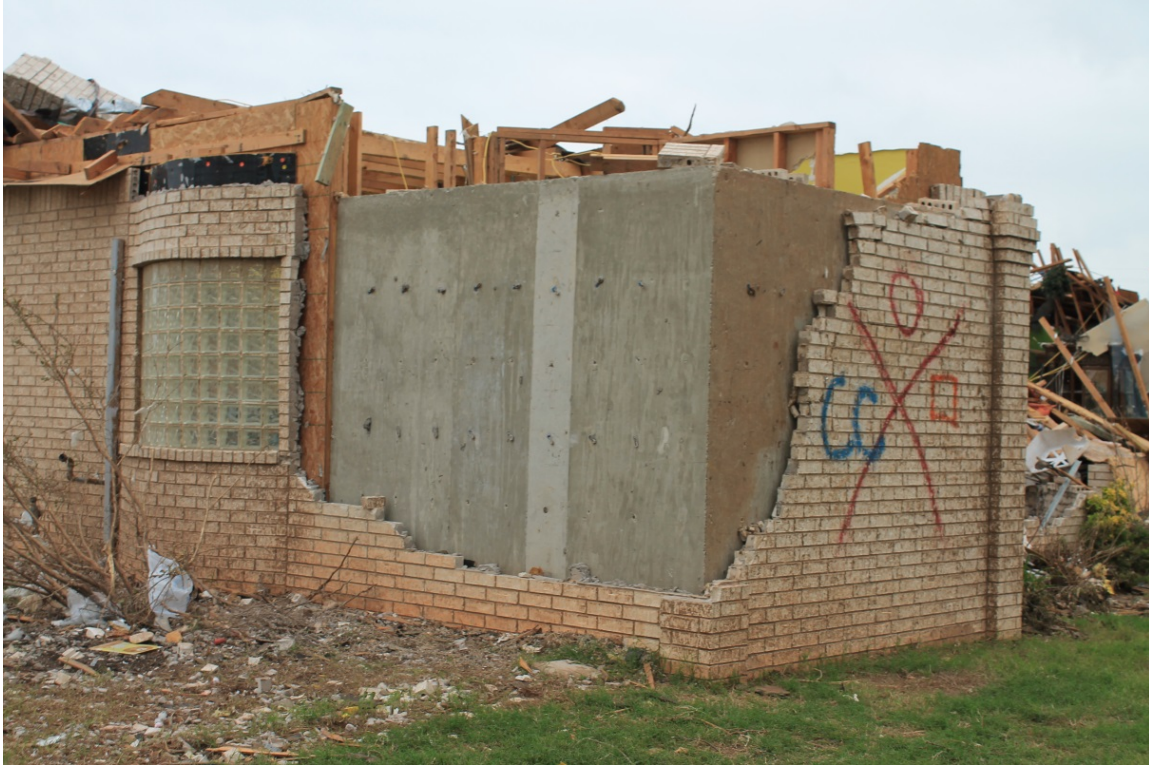
There were two observed instances of concrete or concrete masonry unit (CMU) safe rooms that were used as bedroom closets. Both of these safe rooms were stand alone and had no part of the home attached to the walls or ceilings as prescribed by FEMA 320. The first safe room was in an area that experienced EF3 level damage on Riverside Drive in eastern Moore. The safe room was built on the southwest corner of the home and is pictured in Figure 4.6. Inspection of this safe room indicated that the exterior dimensions were 3 m by 3 m (9.5 feet by 9.5 feet) and 2.5 m (8 feet) tall. The door had the FEMA recommended three dead bolts and three hinges and ventilation was noted at two locations on the ceiling. The second concrete/CMU safe room, shown in Figure 4.7, was found near the intersection of SW 149th St and S. May Ave. The home experienced EF4 damage with complete removal of the roof, second floor, and external walls. This house was near the intersection of the 1999 and 2013 tornado paths. The property also included a pool cabana, tennis courts, stand-alone garage, and greenhouse. The cabana, garage, and greenhouse were all removed from their foundations and blown approximately 45-90 meters (50-100 yards) according to the home owner. Likewise, trees on the property were badly damaged and debarked. The owner informed the team that he built the safe room according to the FEMA 320 specifications current at the time of home construction in 2001. The safe room door did have three dead bolts and hinges and adequate ventilation. Even though the home had an above ground safe room, the owner described to the team that his family felt safer below ground, so they also had an additional below ground garage slab storm shelter installed and were in that shelter when the tornado struck. Both the above and below ground residential shelters at this location performed well.

Figure 4.6, FEMA designed CMU safe room found near Riverside Drive in eastern Moore.

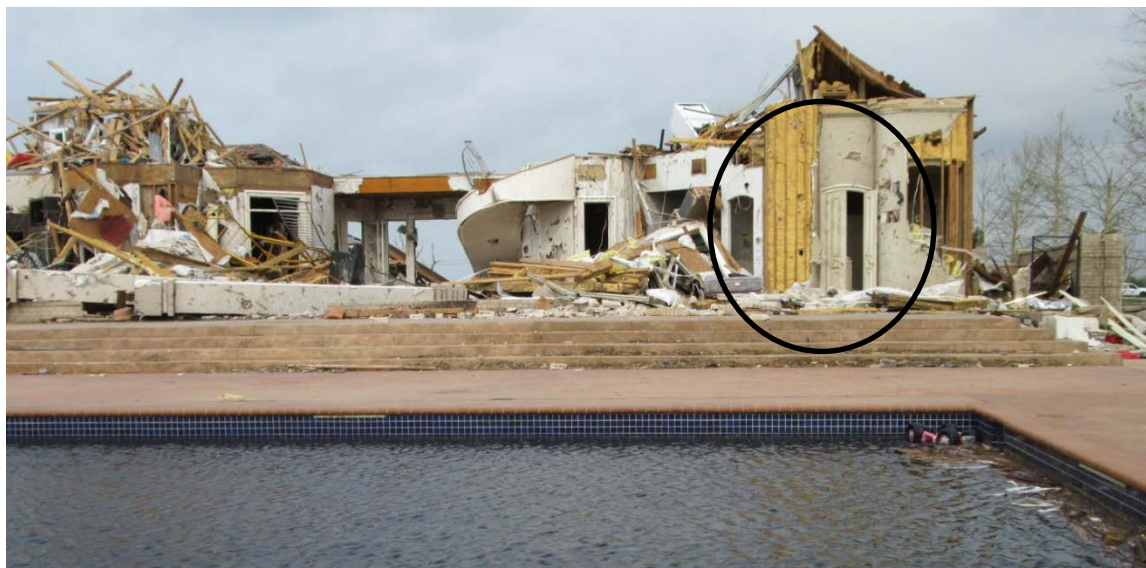
Figure 4.7, FEMA designed CMU safe room found near SW 149th St and S. May Ave. The safe room is centrally located among the remaining rooms and is indicated with the black circle.

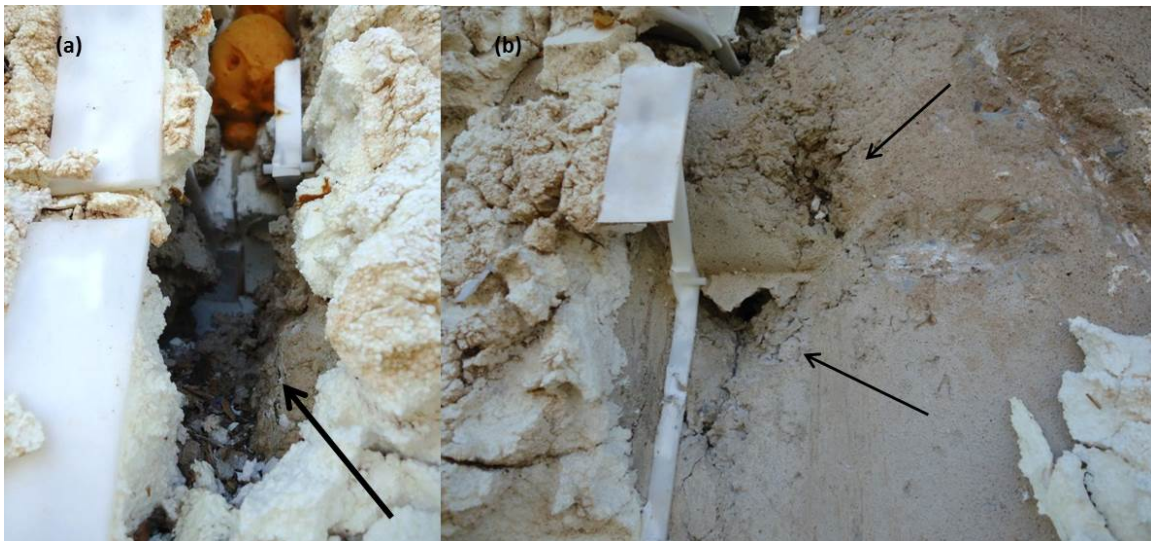
Another likely explanation for the failure was issues with workmanship and construction quality. Several large holes and voids were observed in the concrete at the location of the perforations as shown in Figure 4.11. FEMA 320 states that the compressive strength of concrete used in safe rooms must be at least 20.7 MPa (3000 psi), however, there is no requirement for testing of concrete used in safe room construction. Concrete compressive strength for the safe room that was perforated was estimated using ASTM method C805 (2013) and a Soiltest CT-320 concrete test hammer. The average curves provided with the instrument were used to convert the rebound results to compressive strength. Two locations were examined on both the roof and the west wall of the safe room. Those on the west wall were located directly between the missile impact points and at a location with no damage. For each location, the surface of the concrete was smoothed with a carborundum stone and ten readings were taken spaced at a minimum of 2.5 cm (1 inch). The average of the ten readings was then input into the curves provided with the instrument in order to determine an estimate of compressive strength. Results from the rebound hammer tests indicate a concrete compressive strength of approximately 23.4 MPa (3400 psi) for the walls of the safe room and 15.2 MPa (2200 psi) for the safe room roof. The curves used to convert the rebound values to compressive strength were

based on average concrete mixtures and curing conditions and have a margin of error of $\pm 20\%$. Considering the margin of error, the measured values indicate that the wall concrete had a compressive strength most likely in excess of the 20.7 MPa (3000 psi) specified by FEMA (2008). However, the compressive strength of the safe room roof concrete may have had a compressive strength less than the specified minimum.

Figure 4.11, Inadequate concrete pour indicated by; (a) a large area of poorly consolidated concrete below missile perforation and (b) a large void in the concrete in the thinned area of the waffle grid and in the vicinity of a plastic clip.

In addition, the location and configuration of the plastic cross ties caused concrete flow issues and the actual concrete thickness at the location of missile impact was measured to be approximately 2.5 cm (1 inch). This measurement is less than the FEMA required minimum thickness of 5.1 cm (2 inches). This highlights the point that care must be taken to assure that all areas of safe room walls are properly filled with adequate strength concrete and to avoid plastic cross ties along the thinned portion of ICF waffle grid safe rooms when possible.

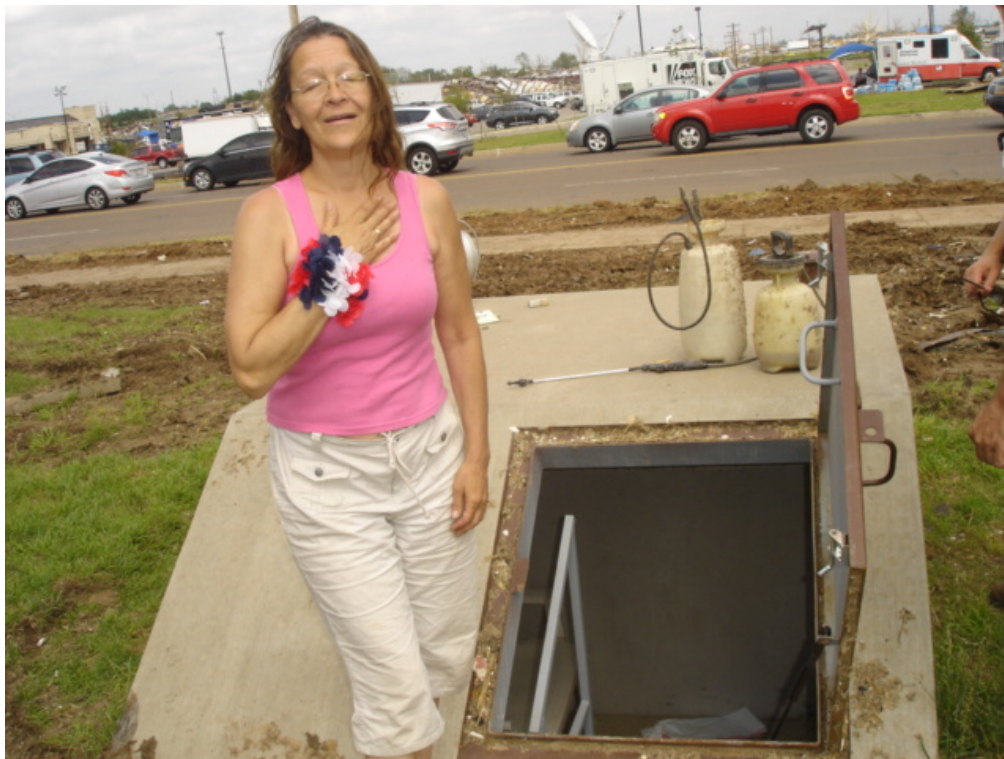
Figure 4.12, This woman's family and neighbors sought protection in her shelter. The woman was not home at the time, but called her friends and family and told them to get into the shelter. This location is about 100 feet west of the Moore Medical Center and the Warren Theatre, where the tornado was at one of its strongest points.

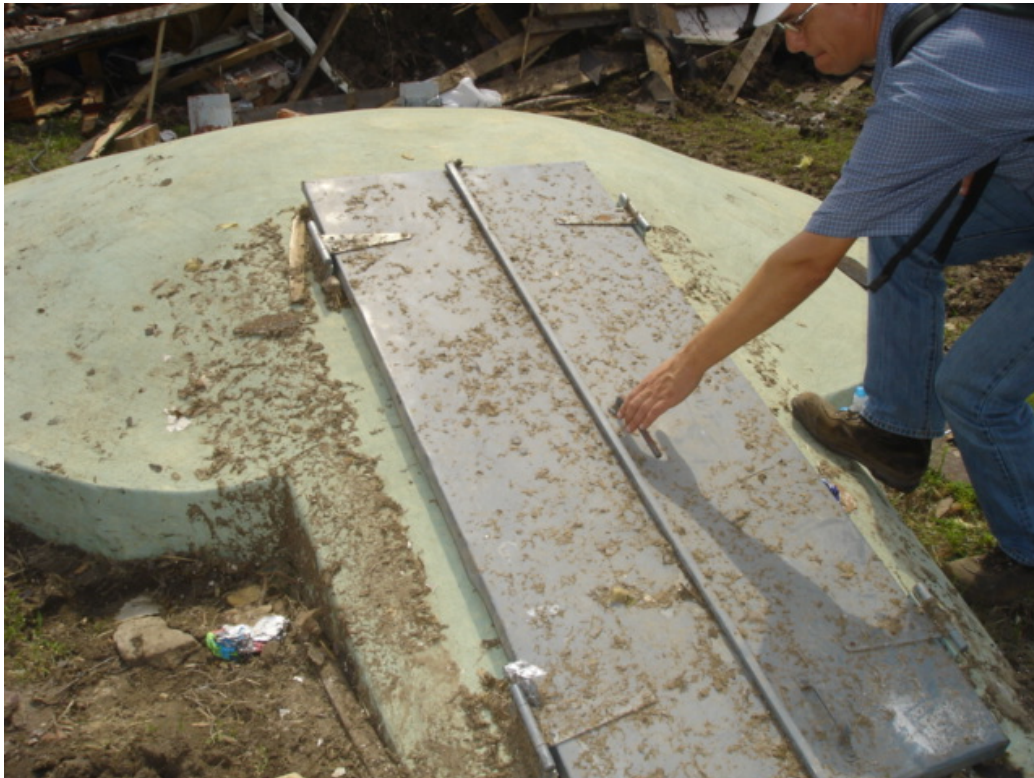
Figure 4.13, This shelter was one of the older observed shelters in the area.

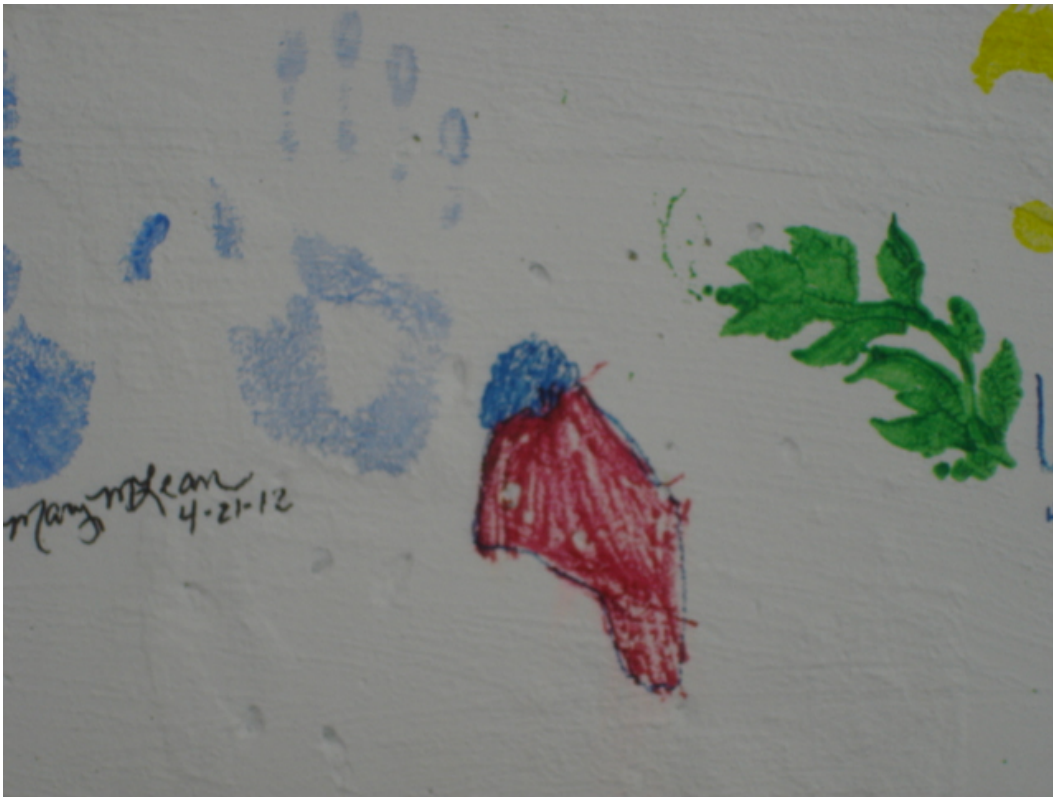
Figure 4.14, Storm shelter with walls decorated by children taking refuge.

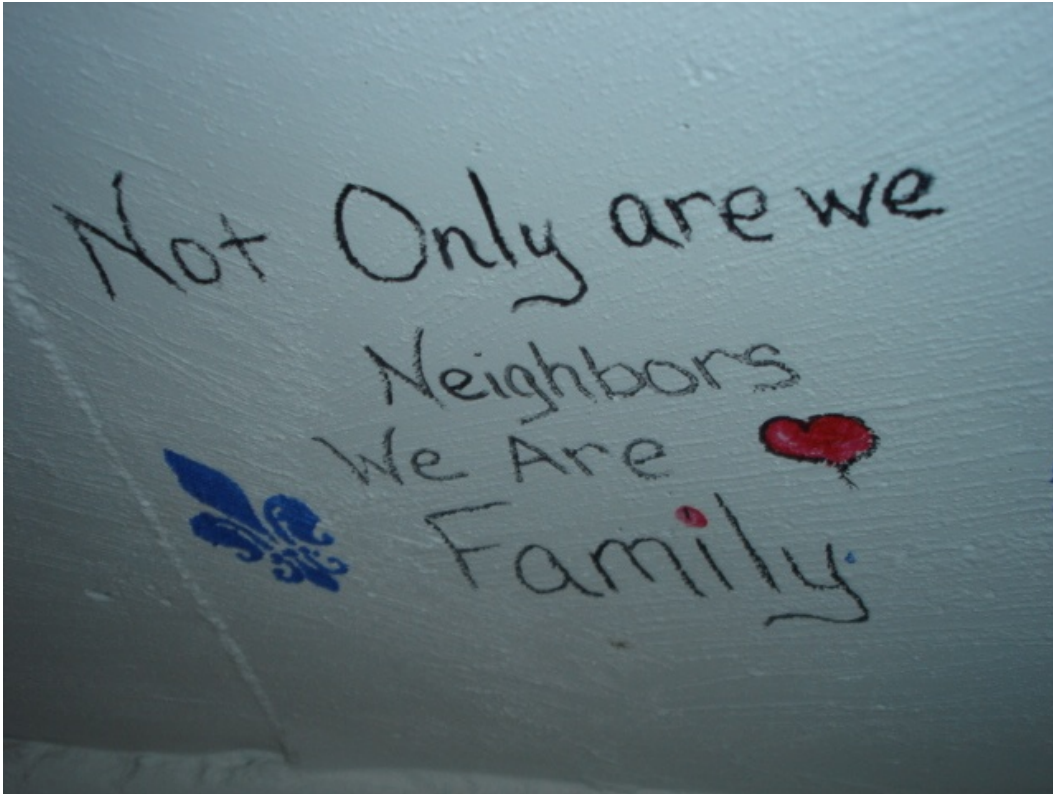
Figure 4.15, Message on interior of storm shelter indicating the informal network of storm shelter shared use.

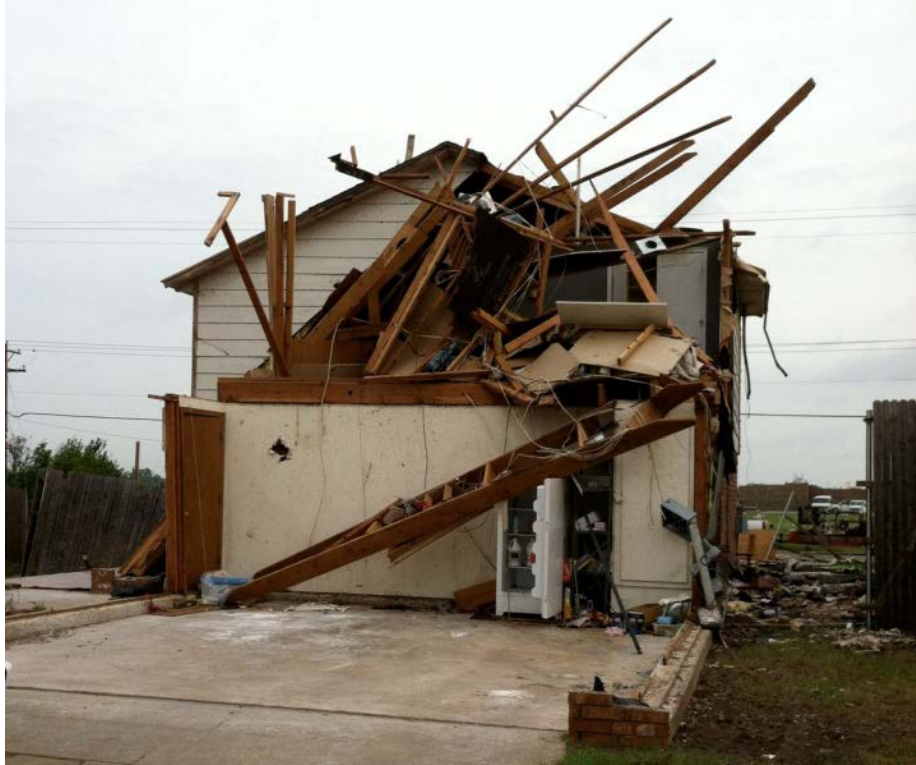
up and off. This resulted in essentially complete loss of lateral support to the tops of the garage walls on either side of the large garage door as shown in Figure 5.2 and Figure 5.3. The short walls adjacent to the garage door opening were typically not sheathed (e.g. with plywood) and therefore had minimal shear stiffness.

Figure 5.3, Missing garage on house with “protruding” garage.

The garage walls in the houses shown in Figures 5.2 and 5.3 had properly anchored sill plates (see Figure 5.4 for example). The anchored sills are effective in resisting uplift, but not torsion (caused by collapsing wall) and uplift.

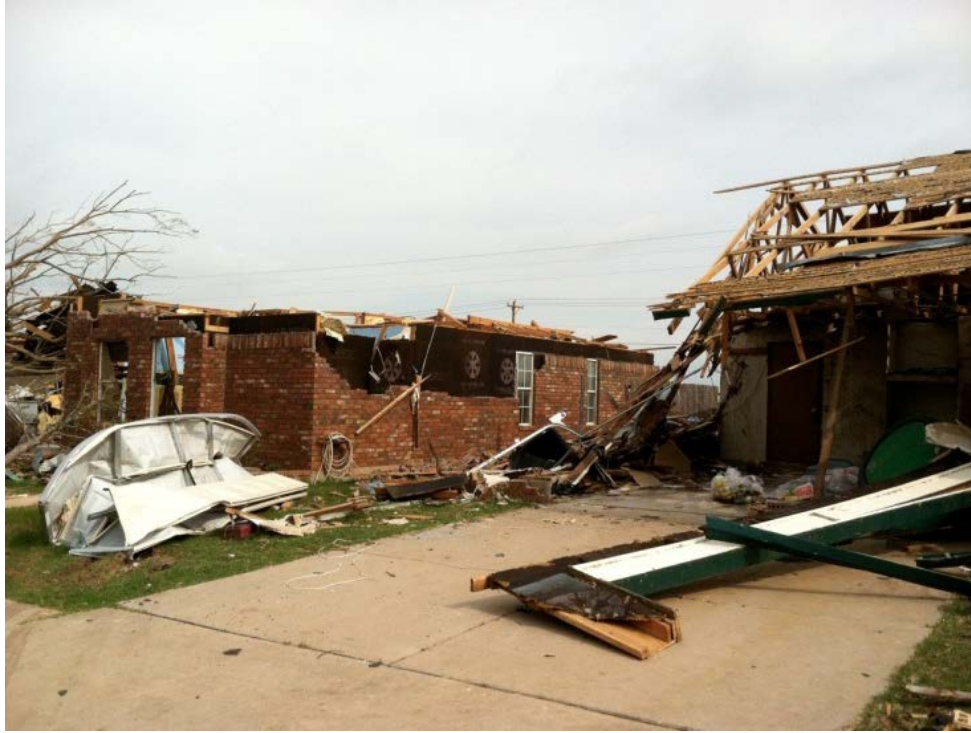
Prefabricated roof trusses resisted uplift better than rafter/ridge beam construction. See Figure 5.5 for a house with rafter/ridge beam roof framing flanking a house with prefabricated wood roof trusses. The prefabricated roof trusses are still intact, but the entire roofs of the rafter/ridge beam roofs have been removed. The better performance of the prefabricated roof trusses is likely due to the better connections (metal truss-plates loaded in shear), and the more web members connecting the top chord to the bottom chord.

Note in Figures 5.5 and 5.6 that although the roofs, ridge beams and rafters are missing, the ceiling joists are still intact. These ceiling joists provide lateral support to the walls. Houses missing prefabricated truss roofs (not shown here) did not have ceiling joists, since the bottom chords of the roof trusses serve as the ceiling joists. This implies that although the prefabricated roof trusses performed better than ridge beam/rafter roofs at one wind speed, at higher wind speeds the situation may be reversed.

Figure 5.5, Missing rafter/ridge beam roof on house to left of house with largely intact prefab truss roof.

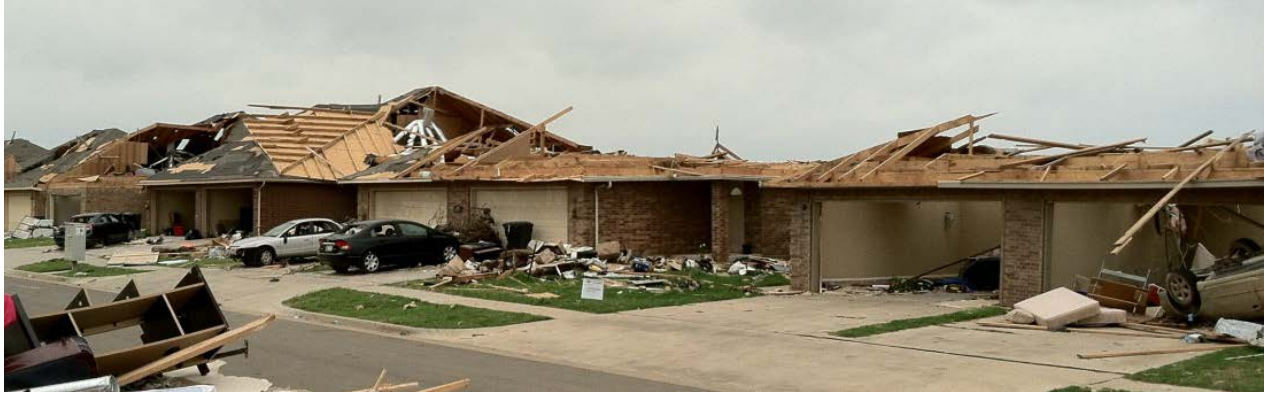
High-profile roofs have a distinctive architectural look but may lack utility. Another weakness of rafter/ridge beam roofs observed and shown in Figures 5.7 and 5.8 is the relatively long unsupported spans of the rafters (see Figure 5.7). The rafter has minimal vertical support to resist gravity loads and also the support to resist uplift loads depends on a weak connection between the rafter and the vertical support. In addition, while ample lateral support is provided to the compression side (top) of the rafter for gravity loads from the sheathing, only one point of lateral support is provided to the compression side (bottom) of the rafter for uplift loads from the purlin. Figure 5.8 shows a house with intact garage doors but completely missing its high-profile roof.

Figure 5.8, Progression of roof damage to “high profile” ridge beam/rafter roofs.

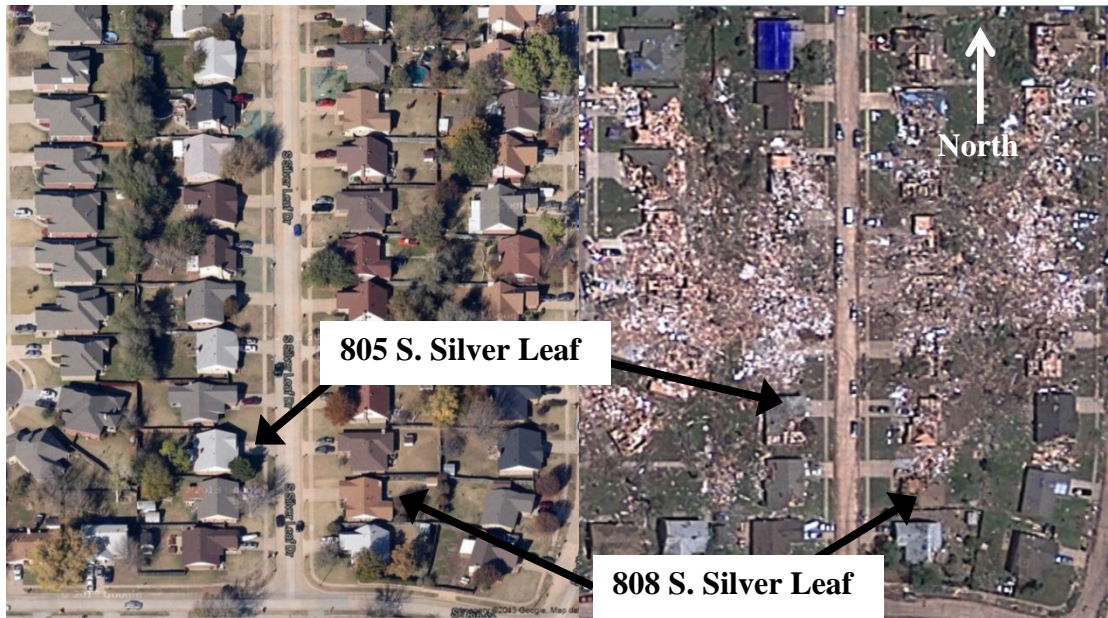
Two homes located diagonally across the street from one another on one of the narrowest sections of the tornado path (i.e. visible damage width was ~200 yd) were compared for performance of the roof trusses. The home at 808 S. Silver Leaf Drive was located approximately 180 ft south of the center of the damage path on the east side of the north-south street and the home at 805 S. Silver Leaf Drive was located approximately 150 ft south of the center of the damage path on the west side of the street. The homes directly to the south of both 808 and 805 S. Silver Leaf sustained substantially less damage, while the homes directly to the north of both were nearly completely destroyed. Locations of the homes in both before and after aerial views are shown in Figure 5.9.

Figure 5.9, Before (left) (Google Maps 2013) and after (right) (Google Crisis Response, 2013) photos showing home locations.

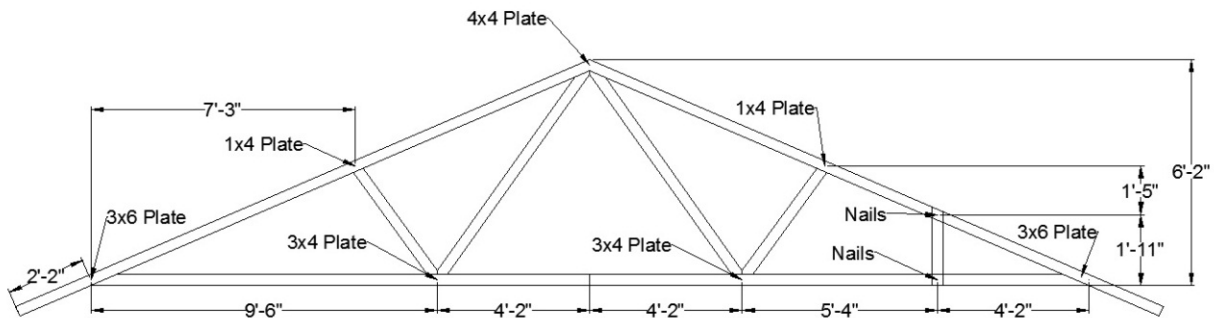
Both homes were single story, wood frame structures with brick veneer, an attached garage, and a fireplace. Both homes had gable roofs consisting of 2×4 trusses spaced at 24 in. connected with press plates and attached to the 2×4 wall plates with two 16d toe-nails at each truss, 1x6 roof sheathing, and asphalt shingle roofing. The roof of 808 S. Silver Leaf had a pitch of 5.5:12 and the truss height was 74 in. The roof of 805 S. Silver leaf had a pitch of 5:12 and the truss height was 97 in. The 2×4 stud walls were connected to the foundation slab using $\frac{1}{2}$ in. anchor bolts for both homes. Walls were sheathed with insulating fiberboard sheathing at all locations except for the corners of the homes, which each had one sheet of plywood sheathing in each direction.

Figure 5.11, Geometry of roof trusses at 808 S. Silver Leaf.

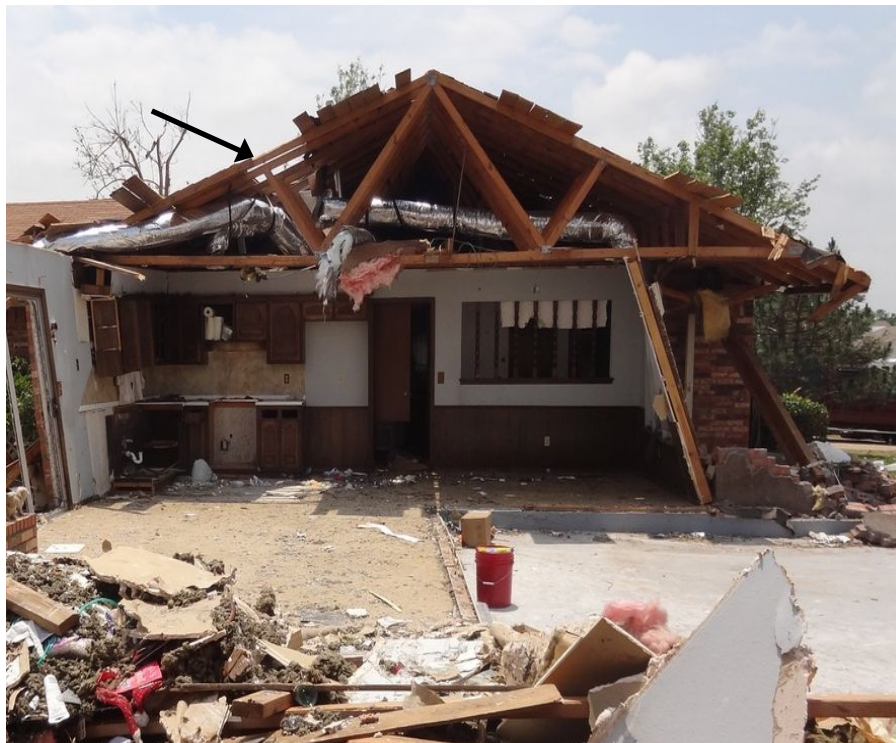
had approximately 32, 3/16 in. points pressed into the wood, distributed across the two members being connected. The failures of these smallest plates in the trusses that remained intact were on the east side, as shown in Figure 5.13, whereas those on the west side did not fail. The connection to the wall top plate was intact on the east side, but not on the west side due to the severe lean of the wall shown in Figure 5.12. Only connectors on two of the intact trusses were broken, but other failures of the 1 in. by 4 in. connector plates were observed in the portions of the roof structure piled in the yard on the east side of the home.

Figure 5.12, Intact roof truss with plate failure location indicated.

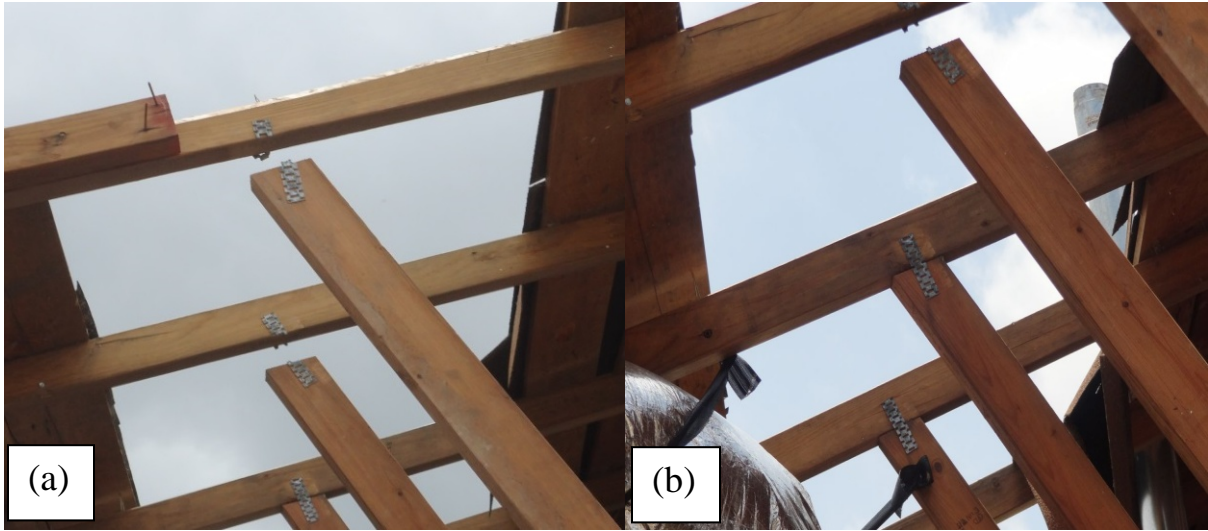
Figure 5.13, Examples of (a) small truss connector plate failures at location indicated and (b) small connector plates that remained intact.

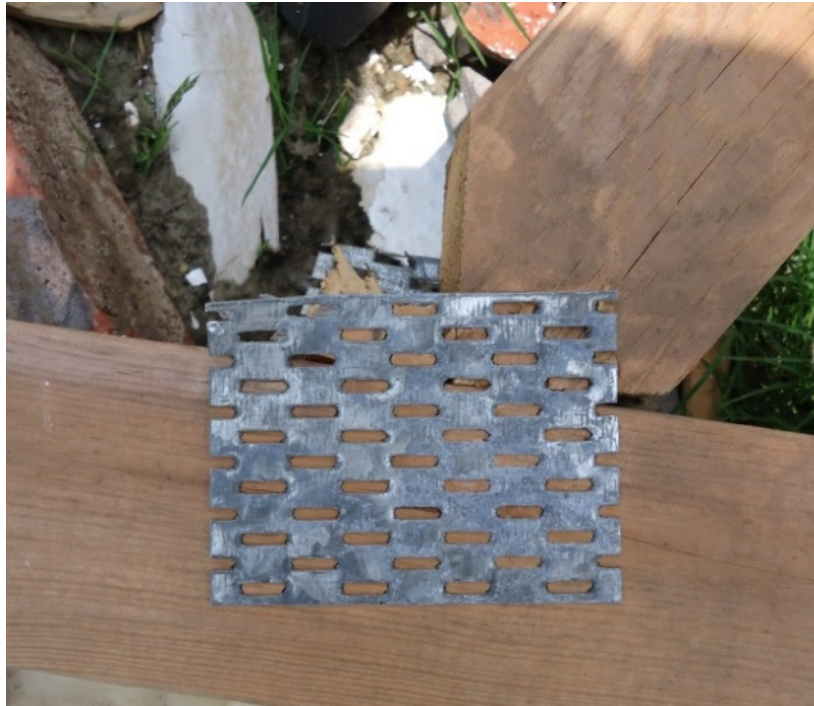
Figure 5.14, Example of connector with unequal overlap of the connector similarly observed in several locations. The gap between the wood members was within the range allowed at the time.

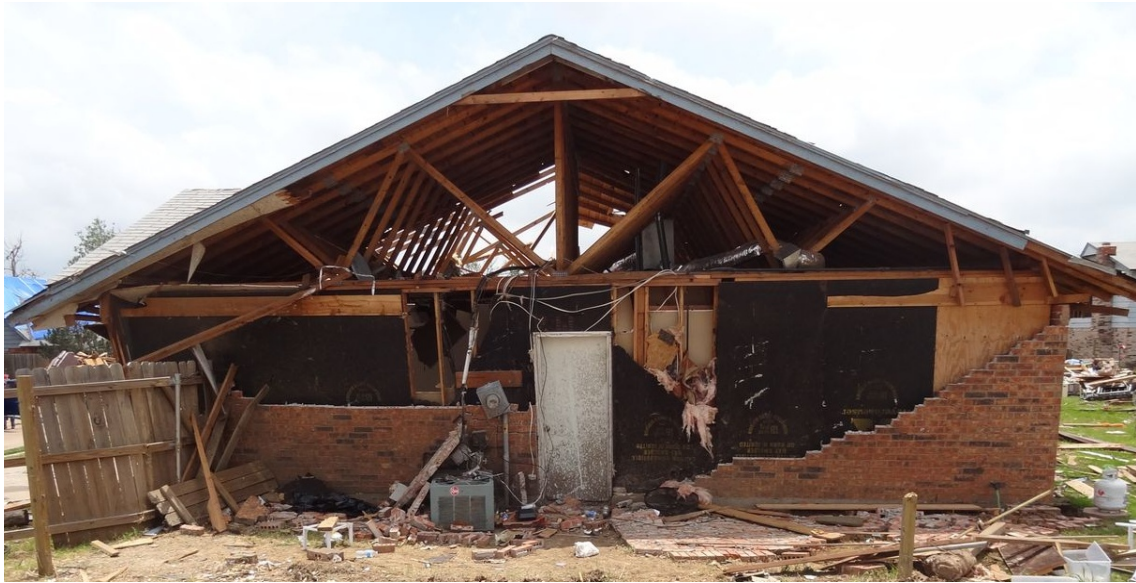
All walls remained intact as seen in Figure 5.16, but the building only had plywood structural sheathing at each corner, probably for intermittent bracing as allowed by the building code. The roof truss pattern and field measured dimensions are shown in Figure 5.17. The truss connector plates had the same thickness, but were more robust in their dimensions and of a different type than those in 808 S. Silver Leaf, as shown in Figure 5.18. The properties of the steel were also not known. The truss members were the same size (2×4) as those in the roof structure of 808 S. Silver Leaf.

Figure 5.16, 808 S. Silver Leaf Drive after the tornado.
