Tornado Damage Assessment in the aftermath of the May 20th 2013 Moore Oklahoma Tornado.

Tornado Damage Assessment in the aftermath of the May 20th 2013 Moore Oklahoma Tornado

March 2014

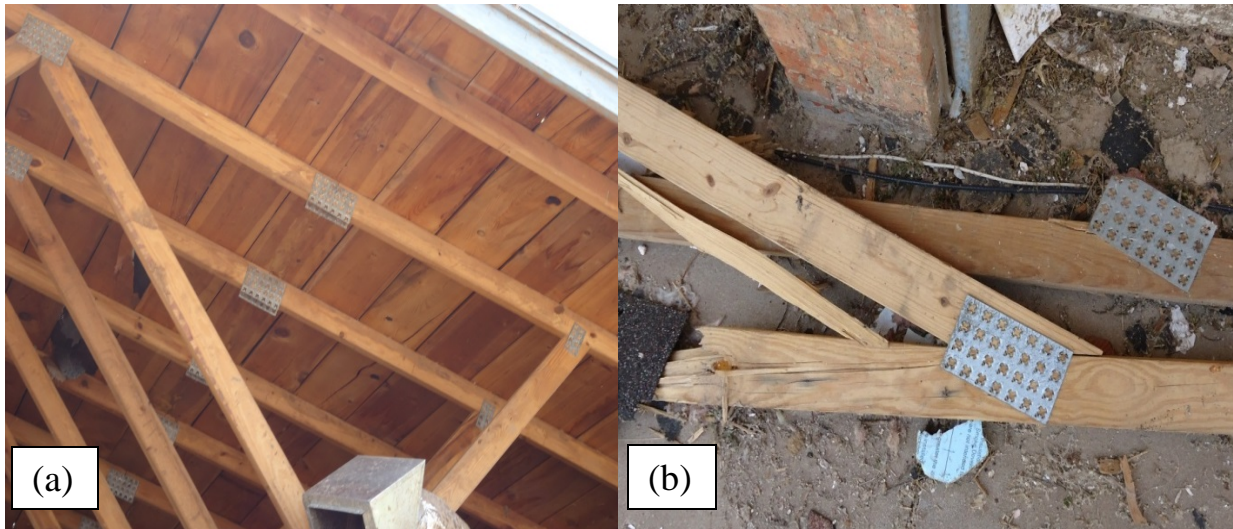
The smallest truss plate connectors were 2 in. by 4 in. instead of the 1 in. by 4 in. connectors observed in 808 S. Silver Leaf and the largest connectors were 5 in. by 8 in. instead of the 3 in. by 6 in. plates observed in 808 S. Silver Leaf. No evidence of connection plate failures was observed in 808 S. Silver Leaf, with all failures located within the truss members similarly to the piece shown in Figure 5.18(b).

Figure 5.18, (a) Larger truss connector plates than for 808 S. Silver Leaf and (b) example of failure within the truss members.

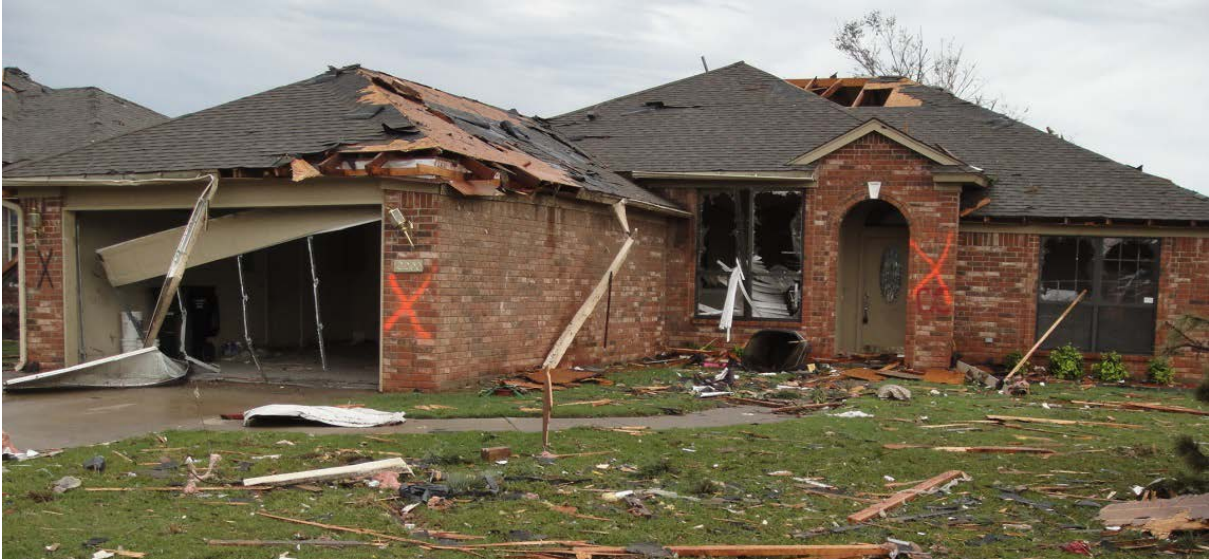
As soon as the garage door has been breached, the shell of the building is no longer intact and immediately begins to function as a “partially enclosed” structure, rather than an “enclosed” one. When the home begins to behave as a partially enclosed structure, ASCE 7-10 dictates that the internal pressure coefficient is boosted from $GC_{pi} = + 0.18$ to $GC_{pi} = + 0.55$. The typical result of this transition to a partially enclosed structure is that the internal wall pressure and uplift within the garage moves to a range far beyond what the wood-frame walls and roof trusses can resist and literally attempts to blow the structure up like a balloon. This also serves to explain why garages that have failed in this manner (such as shown in Figure 5.25 and 5.26) often give the appearance of having “blown up”, rather than simply collapsing. Once the garage has been completely destroyed, the front of the home is left exposed (see Figure 5.27), and the damage progresses into the structure in a similar manner.

Figure 5.25, Stage 3 -- Home Becomes Partially Enclosed Structure; Roof Begins Peeling Off

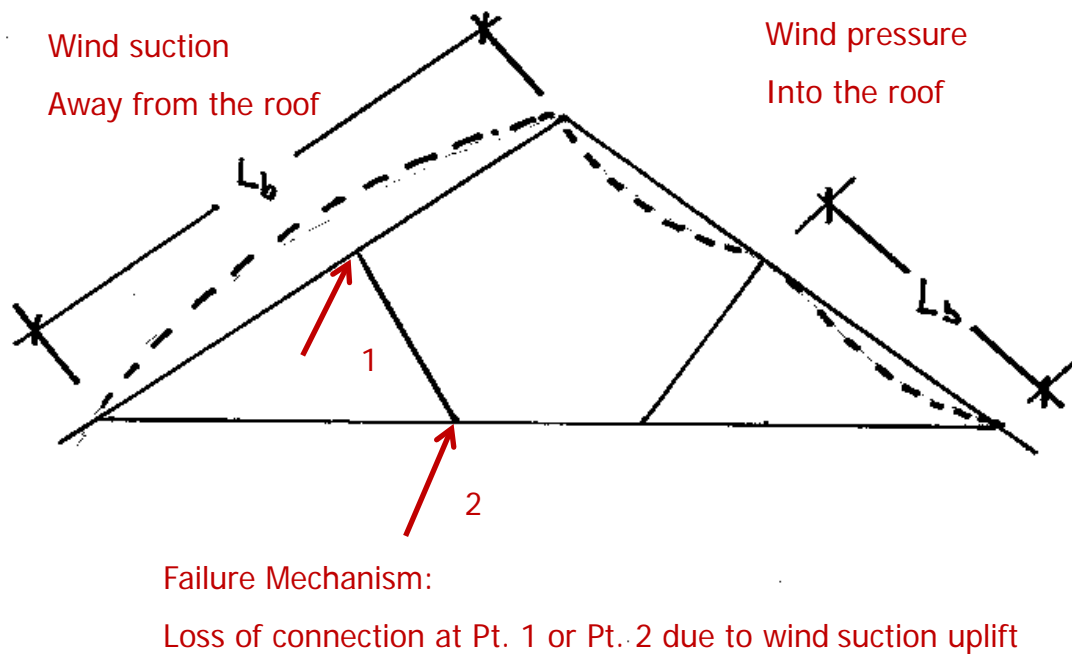
In general, these nailed connections are intended to perform well in compression, but tend to be highly vulnerable to tension forces. Tension is induced when the leeward slope of the roof is subjected to uplift. The resulting failure mechanism is illustrated in Figure 5.30.

Figure 5.30, Roof Truss Failure Mechanism

In the event of a failure as illustrated in Figure 5.30, the following sequence occurs:

1. Due to connection failure, the rafter loses a brace point, effectively becoming twice as long.
2. Doubling the rafter length stresses the rafter beyond design capacity.
3. The rafter fails in flexure, causing a general failure in the roof system on the leeward slope.

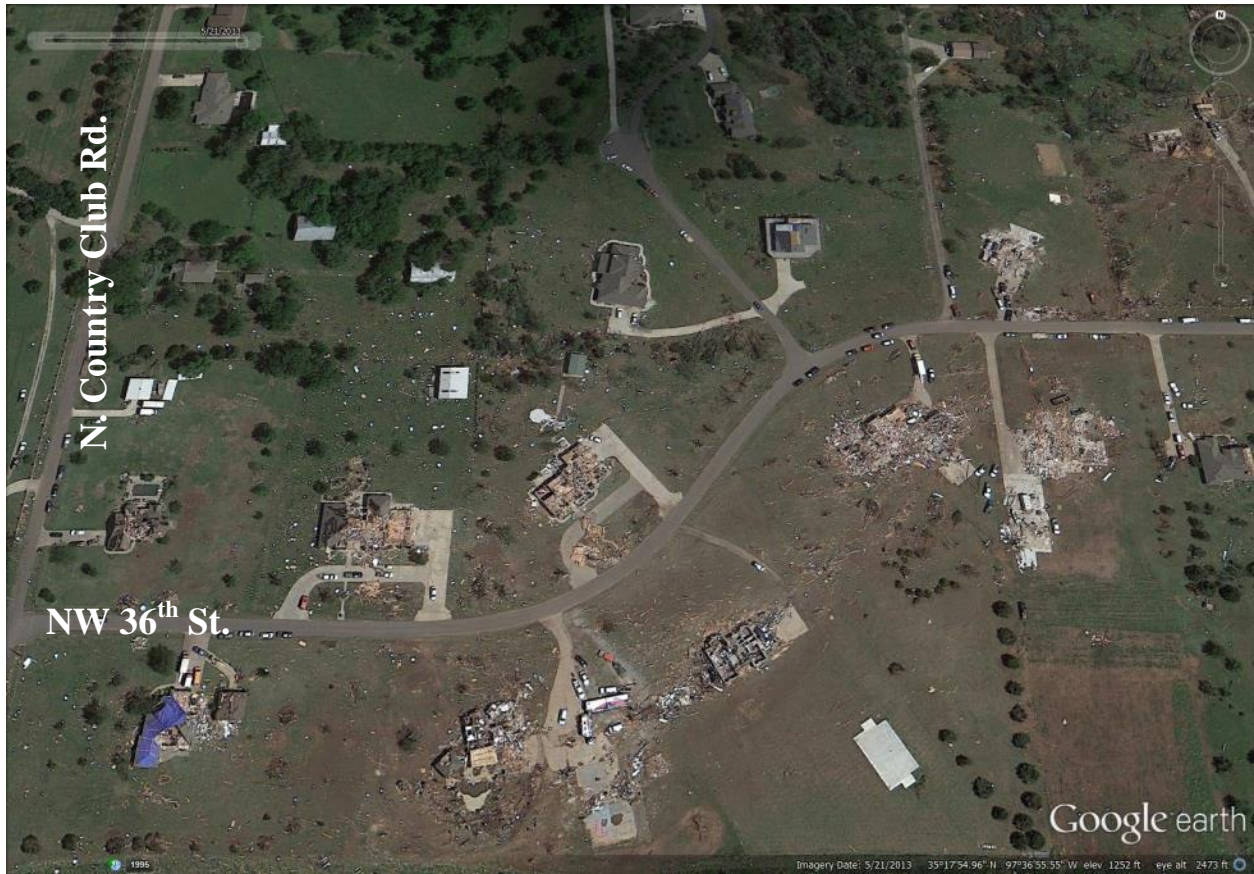
The damage sustained by this neighborhood is shown in Figure 6.3. Although extreme, the tornado did not completely destroy the homes and left many walls still standing. It is interesting to note that the most severely damaged home in the neighborhood (completely leveled) is located very close to a home that was almost undamaged. This observation is illustrated in greater detail in Figure 6.4.

Figure 6.3, Damage in Newcastle neighborhood (NW 36th).

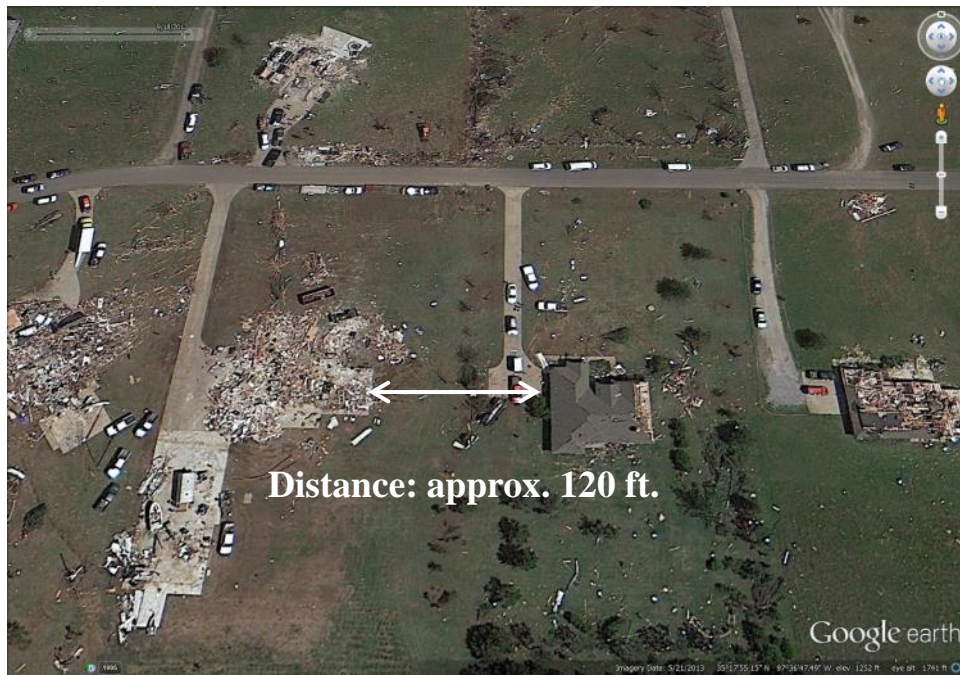
Figure 6.4, Damage Separation in Newcastle neighborhood (NW 36th).

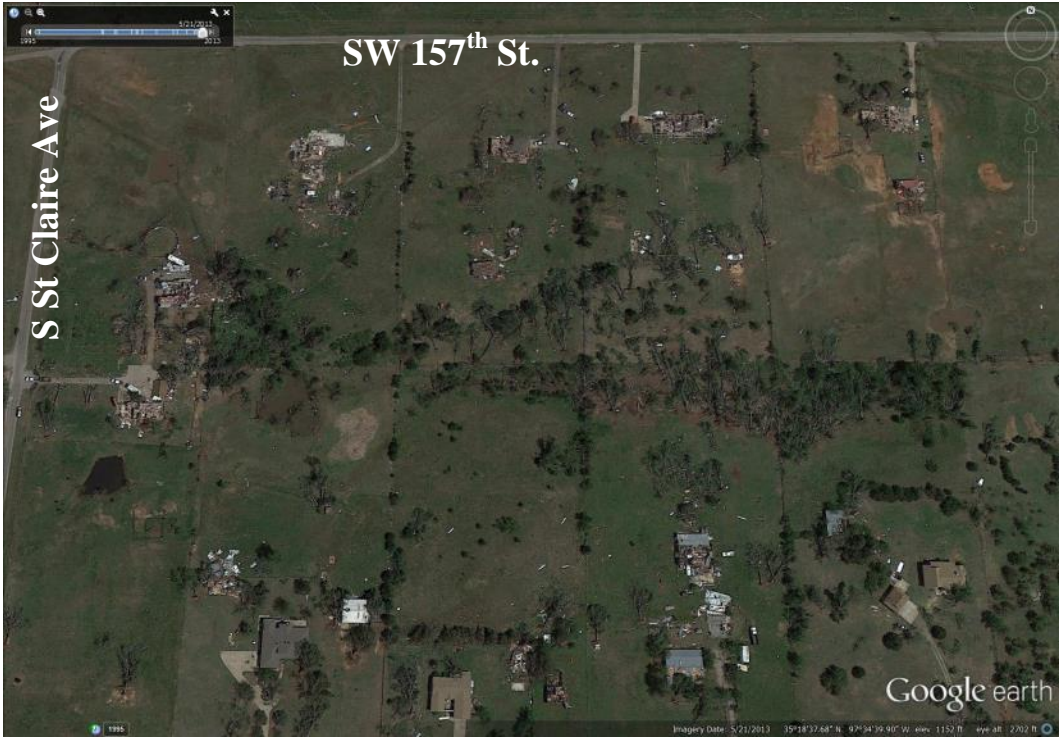
An aerial assessment of Neighborhood #2 indicates that the damage intensity was low compared to areas to the west. A visual inspection of the post-event aerial image indicates that no homes in this neighborhood were completely leveled. The damage was not extreme, as seen in Figure 6.6 and Figure 6.7, in this neighborhood. The only home completely destroyed in this neighborhood was a single-wide mobile home, seen in the upper right-hand corner of Figure 6.6.

Figure 6.6, Neighborhood #2 – Damage 1

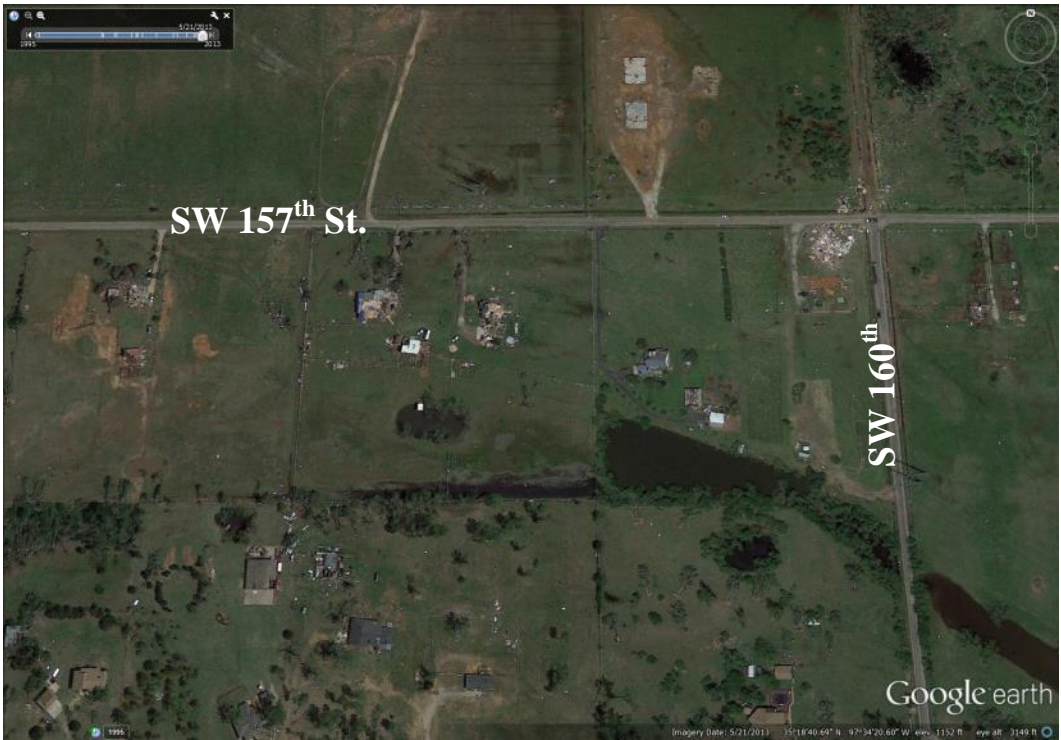
Figure 6.7, Neighborhood #2 – Damage 2

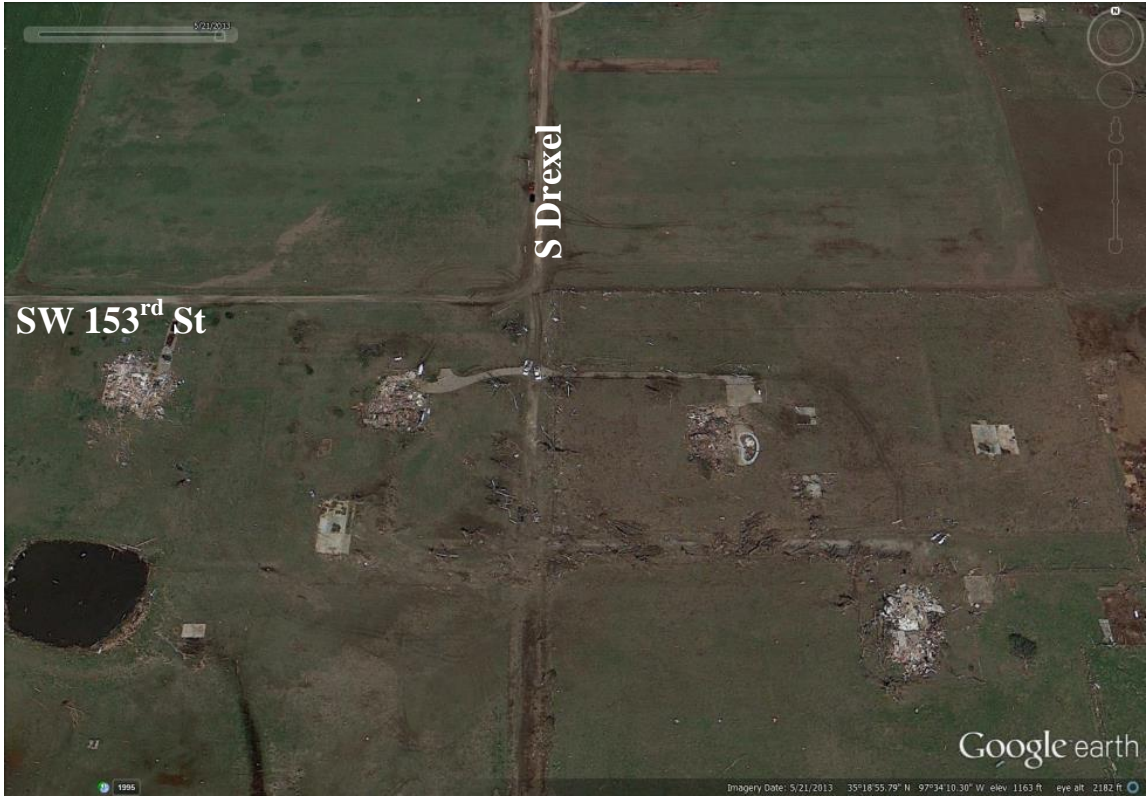
The damage across the width of this neighborhood, which is labeled Neighborhood #3 in Figure 6.1, is shown in Figure 6.10 and Figure 6.11. Notice that at this point in the tornado path, the damage is very severe for most homes. Figures 6.12 and 6.13, 6.14 and 6.15, 6.16 and 6.17, 6.18 and 6.19, and 6.20 and 6.21 show the images before and after the tornado for Neighborhood #4, #5, #6, #7, and #8 shown in Figure 6.1, respectively.

Figure 6.10, Neighborhood #3 – Damage 1

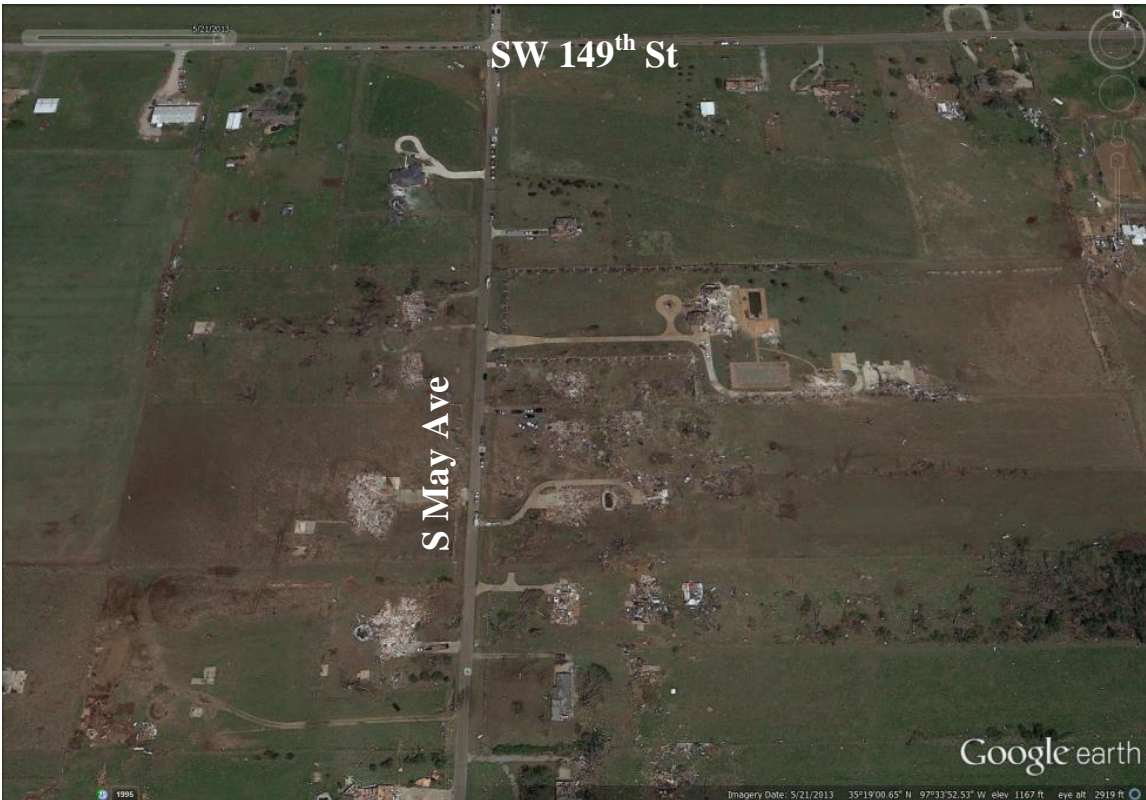
Figure 6.11, Neighborhood #3 – Damage 2

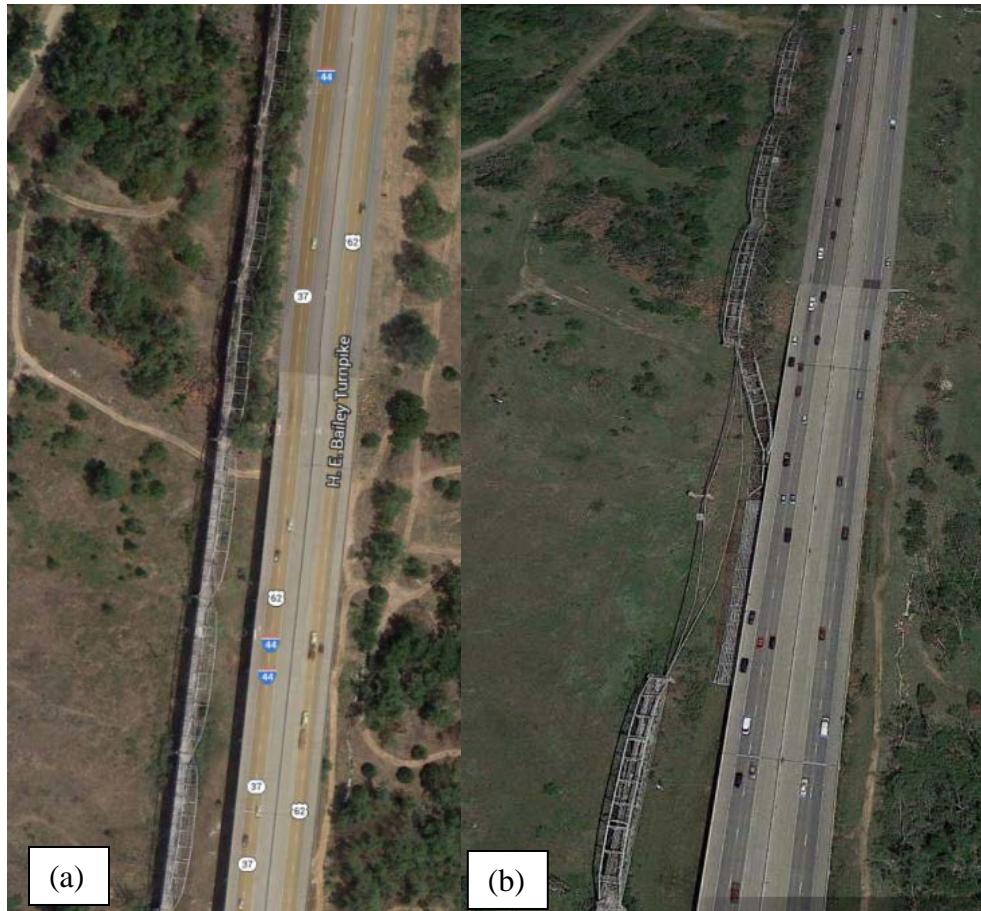
When the tornado passed through this location, it generated sufficient force to destroy two spans of the bridge, knocking them off their piers and shredding the truss structure, as seen by comparing the pre-event photo, Figure 6.26(a), with the post-event photo, Figure 6.26(b).

Figure 6.26, Old US 62 Steel Truss Bridge near I-44, (a) pre-event photo, (b) post-event photo.

The damage shown in Figure 6.26(b) indicates the strength of the tornado in terms of its ability to transport heavy debris. In this case, the power of the tornado is demonstrated by its ability to lift a bridge off of its piers and turn it upside down.

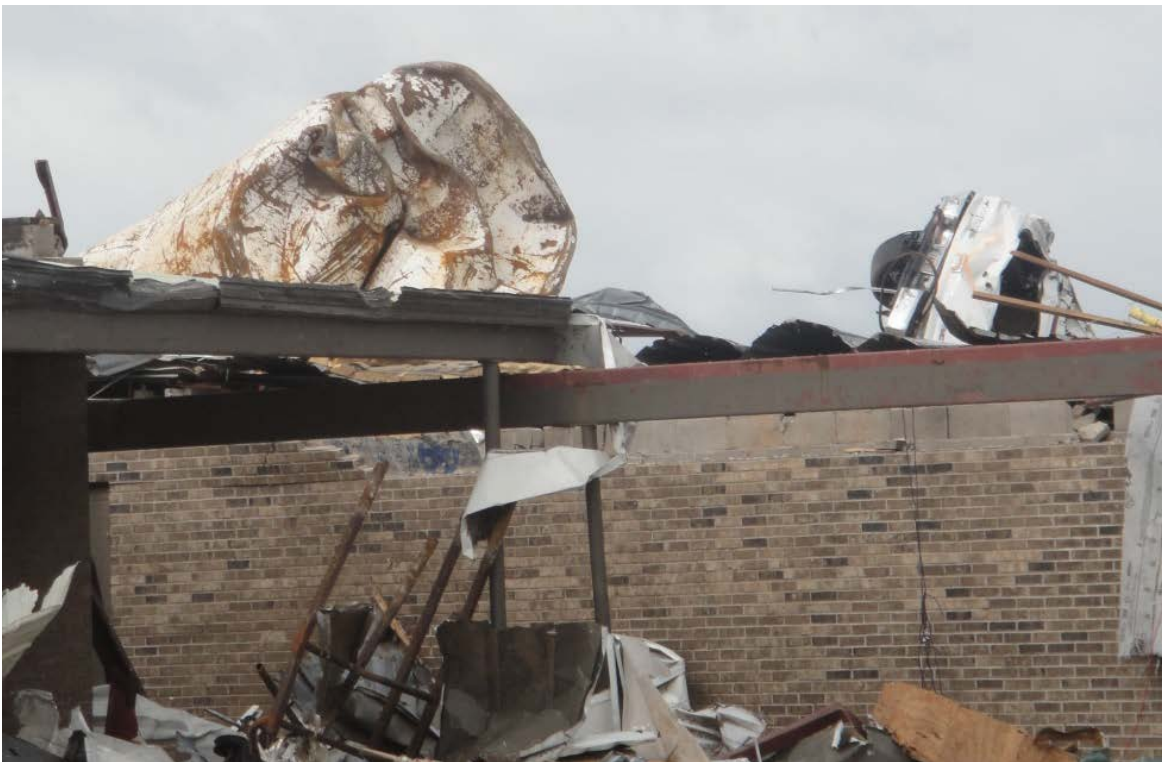
Figure 6.30, Oilfield Tank on Briarwood Elementary School Roof

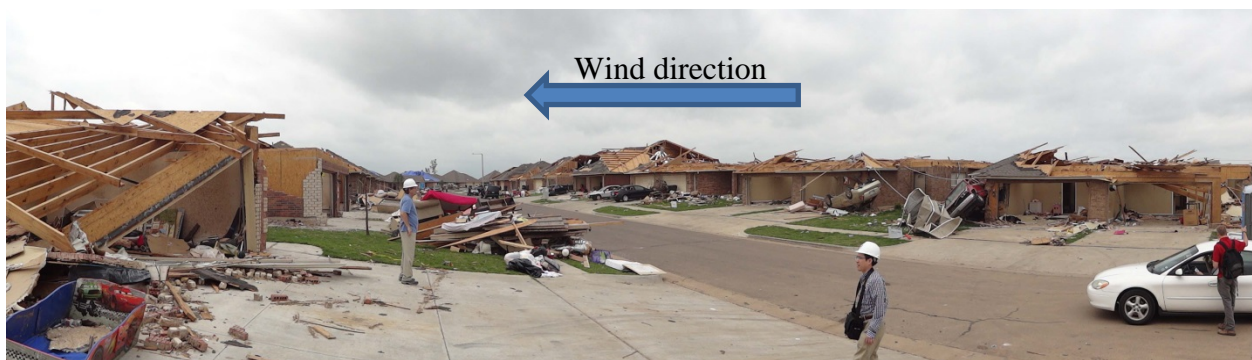
track. This damage pattern is similar to what was observed in the aftermath of Tuscaloosa and Joplin tornadoes. Figure 7.3 shows the damage pattern of houses on the Kyle Dr. in which the camera was pointed to the south looking away from the centerline of the tornado. It should be noted that the tornado vortex was counter-clockwise and this neighborhood was on the south side of the tornado center line. Therefore, the houses on the south edge of the damage area experienced west-to-east winds, which is right-to-left in Figure 7.3. In Figure 7.3, the houses on the right side (west) near the middle of the street had the roof fail before the garage door failed. Failure of the roof happened on the leeward side of the roof and the roof was intact on the windward side. The garage doors, on the leeward side, were not damaged on these homes. Similar damage was observed on the roof of the houses on the left side (east) of the street (failure happened on the leeward roof, intact on the windward roof), but the garage doors on the left side of the street all failed. This is because roof sheathing panels are weaker in uplift and stronger in compression due to nail withdrawal capacity. This failure pattern indicated that these houses experienced higher wind speed than at the edge of damage area and mainly in one direction of horizontal winds. It can also be seen in Figure 7.3 that garage doors and roofs failed on both sides of Kyle Dr. to the north where the photo was taken and several walls were collapsed in the house on the north-east end of Kyle Dr., far left in Figure 7.3.

Figure 7.3, Damage pattern on Kyle Dr., Moore, Oklahoma (Camera pointed to the south).

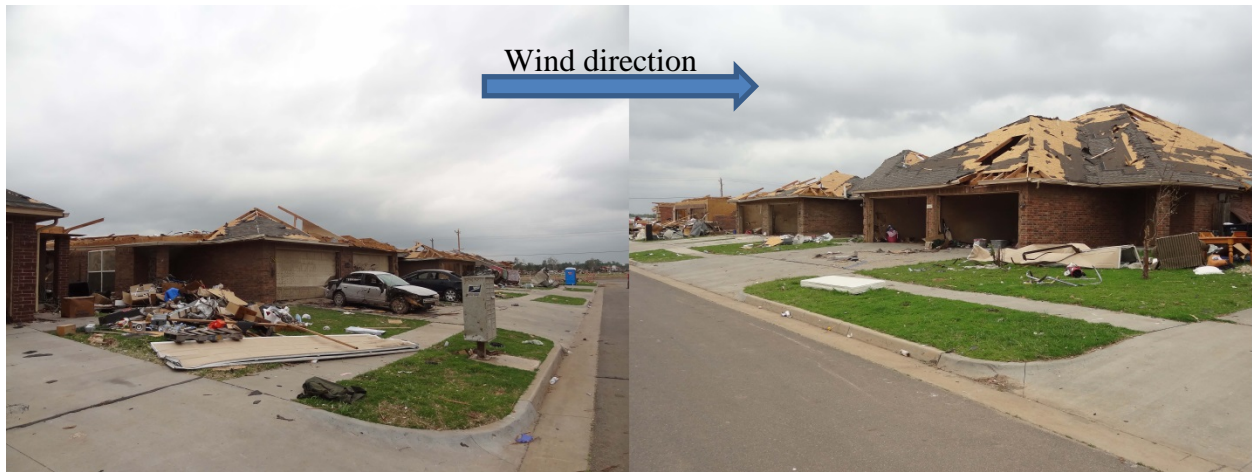
A closer inspection near the northern segment of Kyle Dr. indicated that the homes in this area experienced wind in one direction, as shown in Figure 7.4. Again, the house on the left had roof failure and the garage door survived, while the house on the right had the garage door blown in and only a minimal amount of sheathing panels failed.

Figure 7.4, Failure of roofs and garage doors on (a) west side and (b) east side of Kyle Dr.

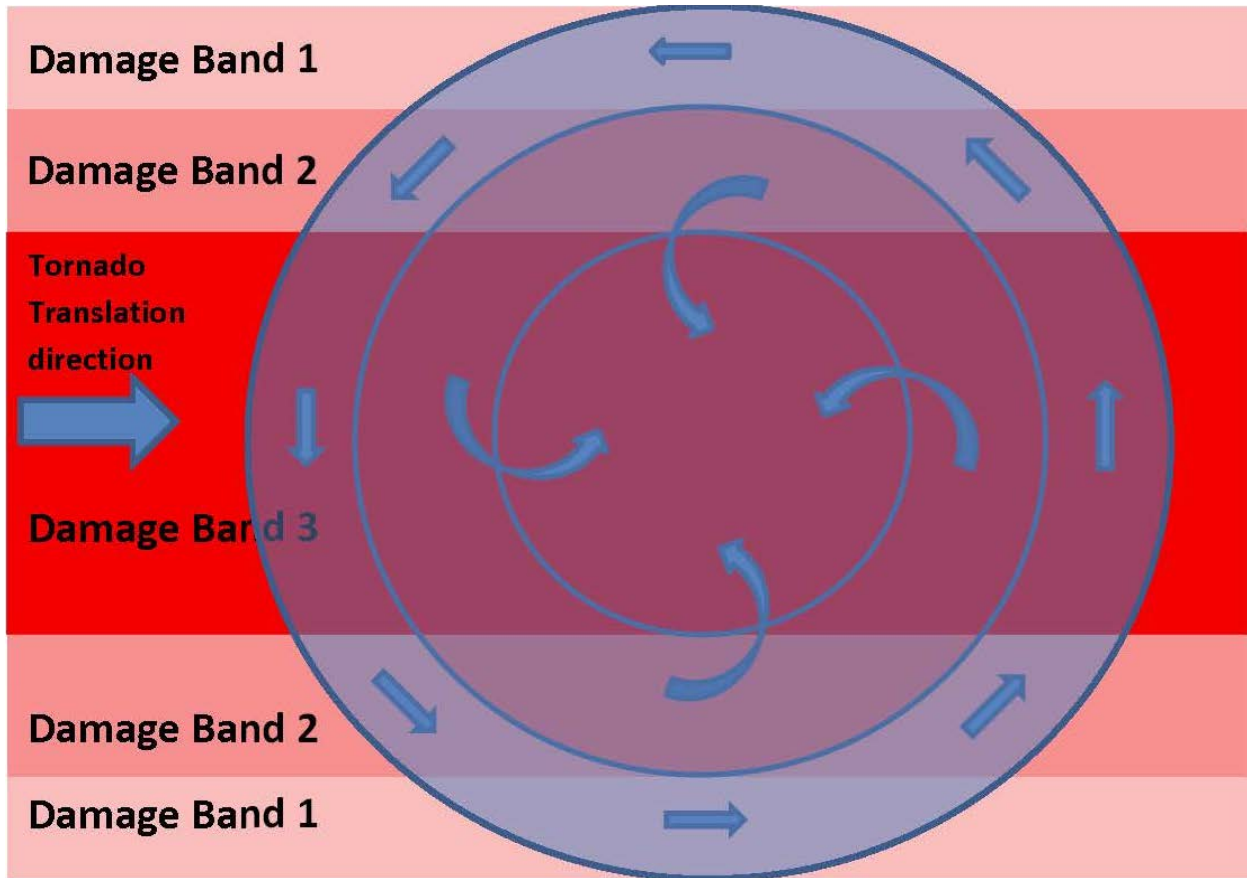
To explain the different types of structural failure observed within a tornado wind field, a sketch of a tornado wind field is introduced in Figure 7.5. This sketch is based on the residential building damage that was observed in the aftermath of several tornadoes. In large tornados, the damage area along the tornado track can be divided into three bands. In Figure 7.5, Band 1 is the area right outside of the tornado core, in this area, buildings often experience straight winds in one direction, and the damage to residential structures is similar to what was observed in hurricane winds: garage doors fail on the windward side and some roof sheathing fails on the leeward side, as seen in Figure 7.2. In Band 1, the wind velocity has a much larger horizontal than vertical component. Band 2 is where the wind field in a tornado has significant vertical wind and the horizontal wind is also strong. A building in Band 2 experiences horizontal winds in two different directions as the tornado moves over the building. As can be seen in Figure 7.5, buildings in Band 2 also experience straight line wind before transitioning into a horizontal plus vertical wind field. Therefore, buildings in Band 2 often have failure of garage doors on the windward side and the roof damage on both windward and leeward sides. This failure pattern is because uplift occurs on both sides of a roof as seen in Figure 7.4. Buildings in Band 3 often have higher damage levels not only due to higher wind speeds at the core, but also because the building experiences winds from all directions. As the tornado passes over a building, horizontal winds will go in two opposite directions. In addition, buildings in Band 3 also experience large uplift wind suction. Damage to buildings in Band 3 is extreme and often consists of roof loss, exterior wall loss, interior wall loss, and even total destruction of the structure.

Figure 7.5, Damage zone on a large tornado track.

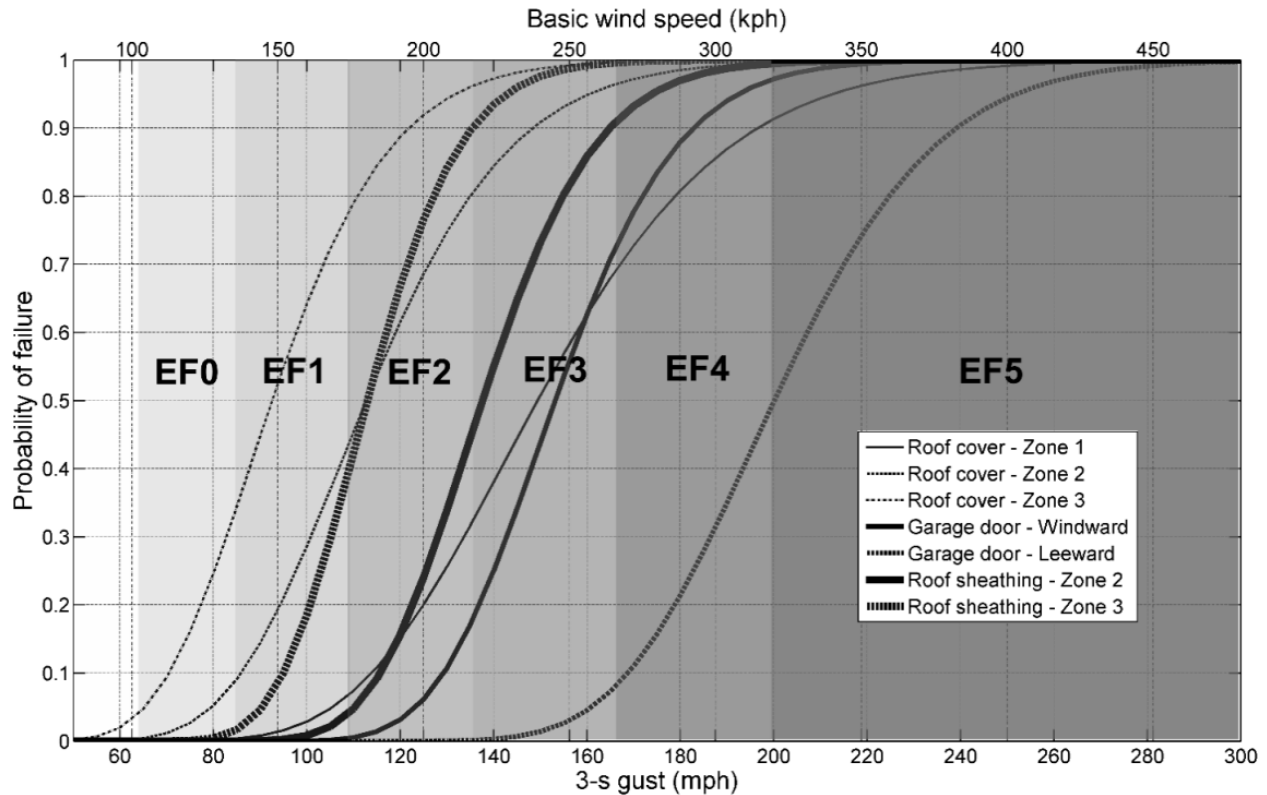
Figure 7.6 presents fragility functions for different components of a building in damage Band 1, shown in Figure 7.5. The fragility functions of these building components were calculated with the condition that the building had no windward window broken or garage door failure (the internal pressure does not change and the building remains partially enclosed). It was also assume that in damage Band 1, the vertical component of wind velocity was small and the wind load applied on the building components is similar to straight wind. The wind load was calculated based on Equation (7.2). From the fragility functions shown in Figure 7.6, it can be seen that roof cover (asphalt shingles) often fail first. If one looks at the median value, 50% roof cover loss in roof zone 3 (corner, defined by ASCE7 for C&C) occurs around EF1 wind speed and 50% roof cover loss in roof zone 2 (roof edge, defined by ASCE7 for C&C) occurs around EF2 wind speed. In partially enclosed buildings, roof sheathing panels in roof zone 3 often starts to come off in EF1 to EF2 wind speeds.

Figure 7.6, Component fragility in damage Band 1, partially close building.

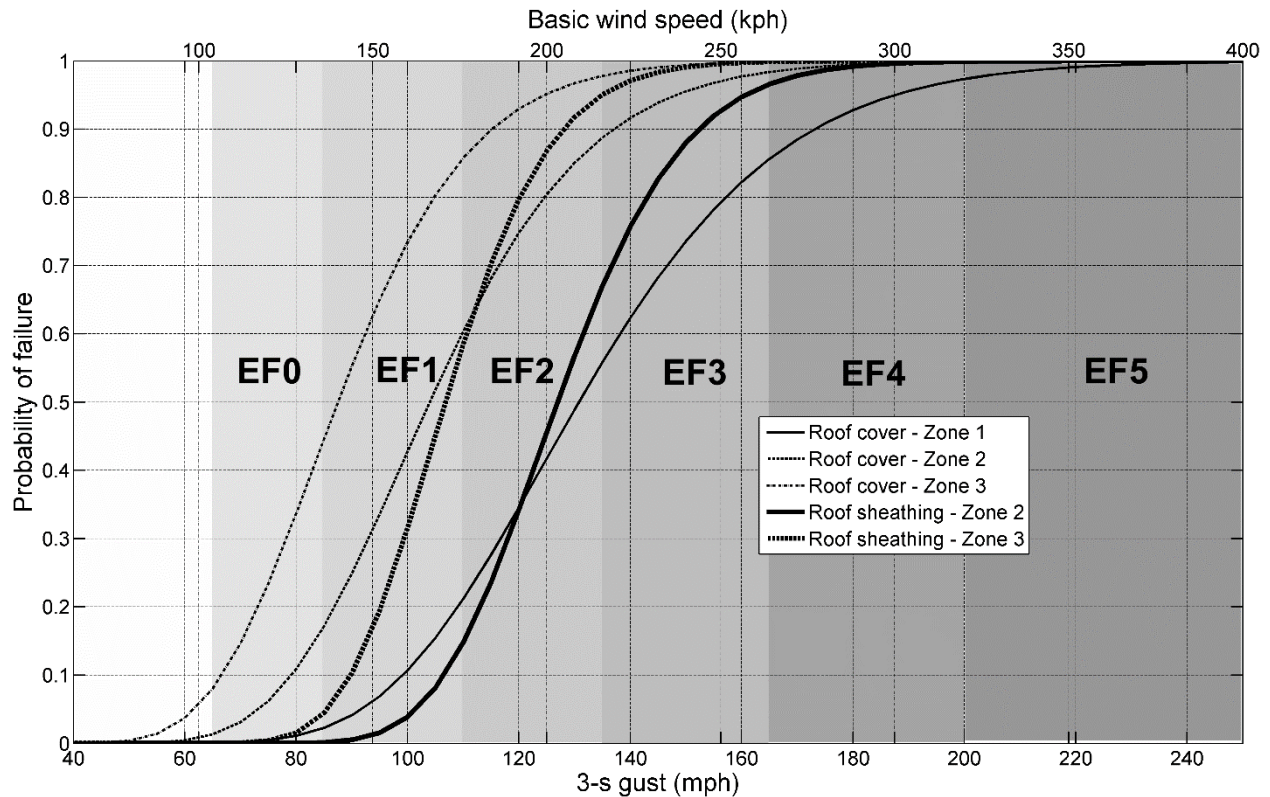
Broken windows and garage door failures were observed in many buildings in damage Band 1, which has a major impact on the internal building pressure. Figure 7.7 shows the fragility of roof cover and roof sheathing panels in partially open buildings, in which the mean value of internal pressure coefficient changes from 0.15 to 0.46 (Table 7.2). In partially open buildings in damage Band 1, 50% of the roof cover in zone 3 and zone 2 often fails around EF1, and 50% of roof sheathing panels in zone 3 and zone 2 fails around EF2 wind speeds. Recall that in damage Band 1, the wind load does not include the effect of vertical wind velocity pressure increases.

Figure 7.7, Component fragility in damage Band 1, partially open building.

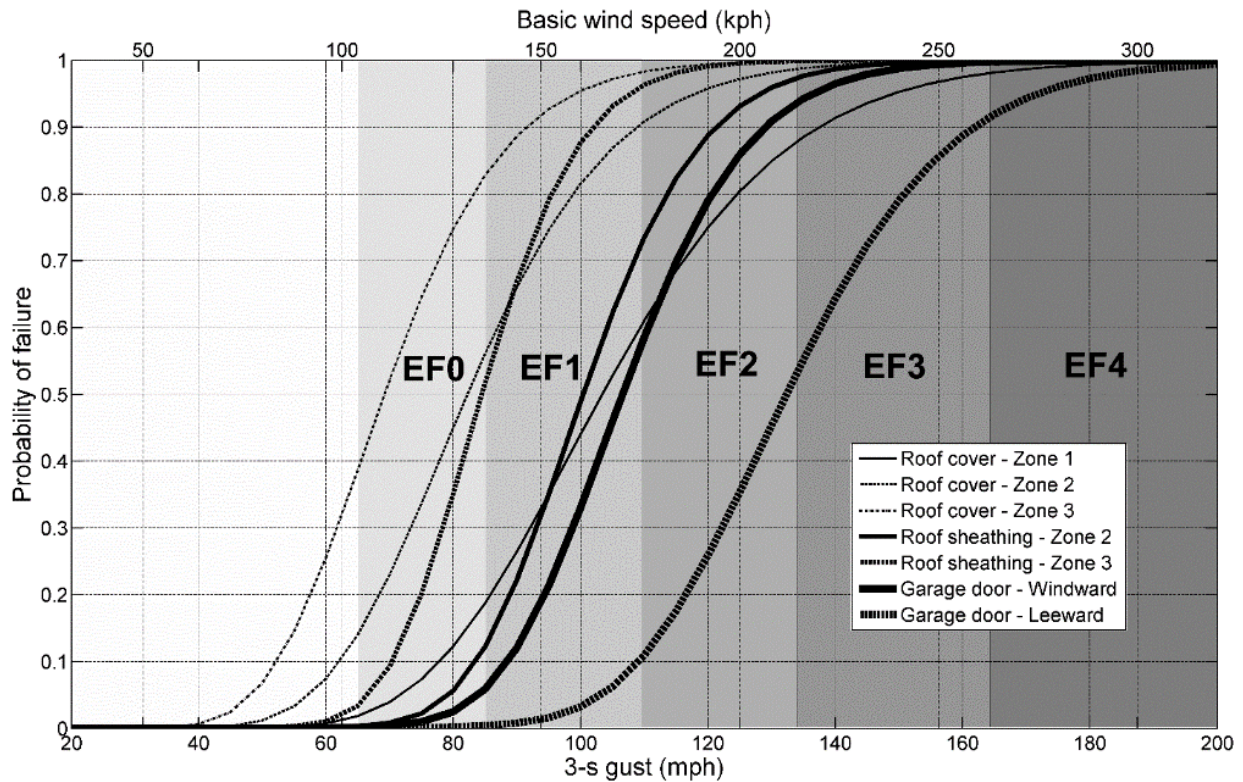
In damage Band 2, broken windows and garage door failures were observed in most of the buildings. The fragility functions in Figure 7.8 are presented for roof cover and roof sheathing panels in roof zone 2 and 3, and garage door windward and leeward walls in partially open building in damage Band 2. Recall that in damage Band 2, calculated wind load includes the effect of vertical wind velocity pressure as a result of the high vertical component of wind speed in a tornado. It can be observed from this figure that up to 96% of roof sheathing panels in roof zone 3 and 72% of roof sheathing panels in roof zone 2 fail at wind speed EF1 range, much higher than 60% of roof sheathing panels in roof zone 3 and 15% roof sheathing panels in roof zone 3 in buildings in damage Band 1. For wind load in damage Band 2, the factor K_c was taken as a uniformly distributed random variable range from 1.4 to 1.8.

Figure 7.8, Component fragility in damage Band 2, partially open building.

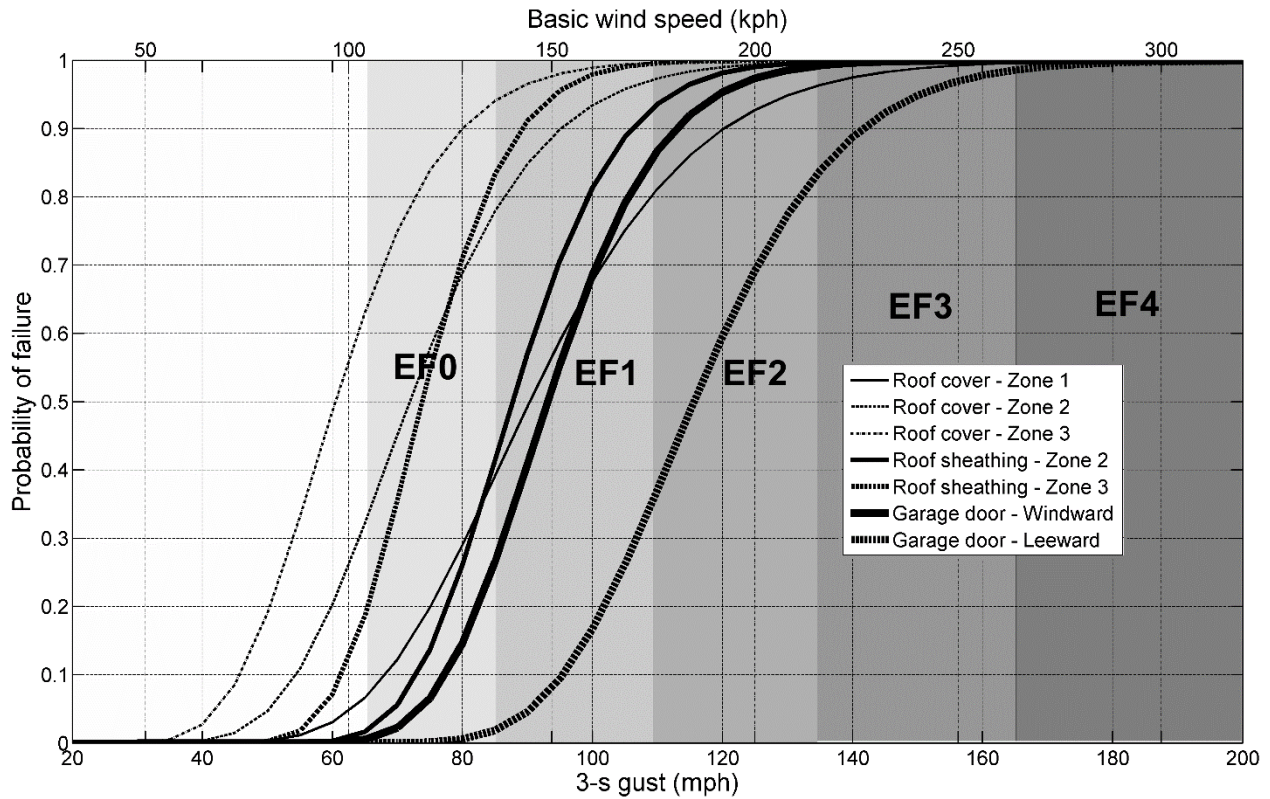
Because of the higher vertical wind speed component in damage Band 3, in wind load calculations, the factor K_c was taken as a uniformly distributed random variable with a range from 1.8 to 2.4. Figure 7.9 shows the fragility function for components of partially open buildings in damage Band 3. It can be seen in Figure 7.9 that at EF1, almost 100% of roof sheathing panels in roof zone 3, and up to 93% of roof sheathing panels in roof zone 2 failed. These values were also higher than those of buildings in damage Band 2. It should be noted that garage doors designed for straight wind speed of 140 mph (Figure 7.6) would fail at tornado wind speed of EF1 to EF2.

Figure 7.9, Component fragility in damage Band 3, partially open building.

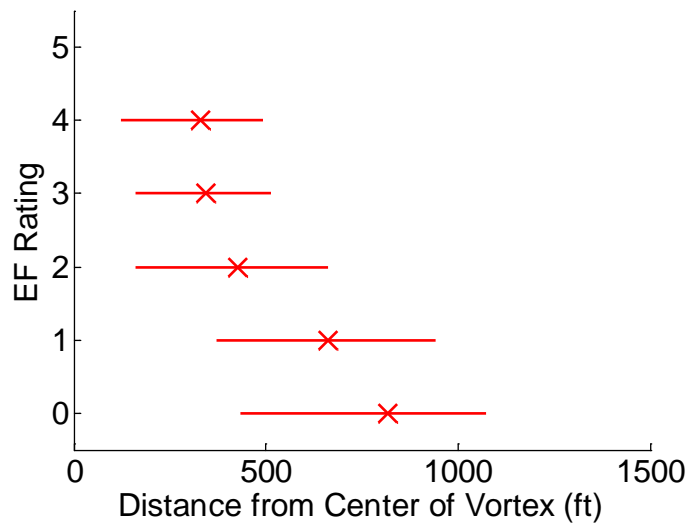
EF ratings from the 20 May 2013 Moore tornado were plotted as a function of distance from the center of the vortex. These ratings are shown in Figure 7.16. To compare force prediction data sets (such as the example shown in Figure 7.15) with the EF ratings assessed from the Moore damage surveys, some data reduction was conducted to make sense of the comparison. First, statistics were computed for each distance from the vortex center—specifically, from all 10 runs of the simulator, the mean, 25th percentile, and 75th percentile forces were calculated.

Figure 7.16, EF ratings from 20 May 2013, Moore tornado plotted against distance from vortex center. The symbols represent the mean distance for a given rating while the left and right ends of the lines represent 25th and 75th percentile distances.

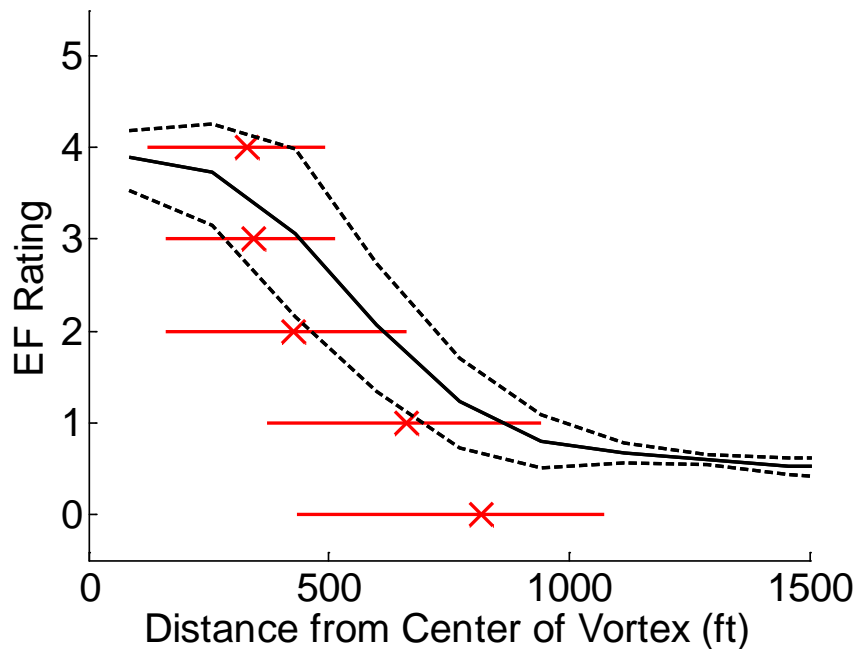
The comparison is shown in Figure 7.17. The laboratory prediction does not decay quite as quickly as the field data, but the comparison is reasonable. The lab predictions shown are from a V55 vortex rather than the V15 vortex. The V55 vortex has a higher swirl ratio than V15, and therefore the V55 vortex has a two-celled structure while the V15 is single-celled. The fact that the comparison between Moore and V55 was better than the comparison between Moore and V15 might be an indication that the Moore tornado vortex was a two-celled or multi-celled vortex. Confirmation of this typically requires mobile radar data from the storm and some extra analysis. Unfortunately, these are not available for Moore.

Figure 7.17, Comparison of Moore damage assessments (in red) with laboratory predictions (in black) from a V55 type vortex. The red symbols represent the mean distance for a given rating while the left and right ends of the red lines represent 25th and 75th percentile distances. The solid black line represents the mean EF prediction for each distance while the upper and lower dashed lines represent the 75th and 25th percentiles of these predictions.
