# JOINT TRANSPORTATION RESEARCH PROGRAM

# Concrete Box Beam Risk Assessment and Mitigation:

Volume 1 — Evolution and Performance

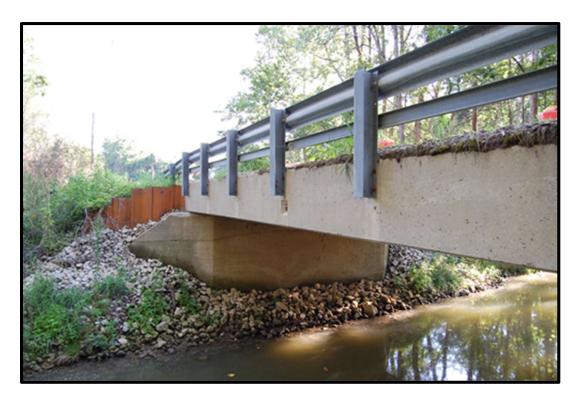
Figure 4.3 Pond creek bridge.

Pond Creek (35-00013) is a single-span bridge located in Huntington County, initially built in 1930 ("year built") and then reconstructed with seven adjacent box beams in 1960 (Figure 4.3). The beams span 34.6 ft. and have a depth of 21 in. All beams are 4 ft. wide, resulting in an overall bridge width of 21.1 ft. The bridge carries CR 500W over Pond Creek. The bridge has an 8-in. thick gravel wearing surface with no membrane and a single tie rod at midspan.

From visual observations made on July 27, 2016, the exterior beam on the east side of the bridge has cracking, spalling, and exposed strands toward midspan (Figure 4.3). Longitudinal cracking in the bottom flange was also noted in one of the middle beams and the first interior beam on the west side (Figure 4.4). Efflorescence covered a majority of the first interior beam on the

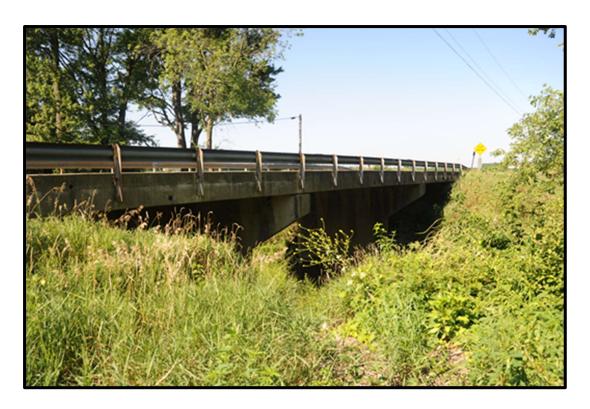
Figure 4.8 Rock creek bridge.

The most deteriorated span was on the east end of the bridge. One of the exterior beams has a large region of spalling with two exposed stirrups and signs of water leakage around the shear key (Figure 4.8). The other exterior beam has a longitudinal crack in the bottom flange and a hole in the top flange (Figure 4.9). The hole revealed standing water in the void of the box beam. The middle span has one beam with a longitudinal crack in the bottom flange and signs of water leakage at the shear key (Figure 4.10). The complete map is provided in Figure 4.11.

For the Rock Creek (90-00079) Bridge, damage in the form of a hole in the top flange of the exterior beam in the east span was discovered. This damage was not found in the box shown in Figure 4.8, but rather observed in the top flange in the other exterior beam on the south side of the same span. The damage was so significant that the void of the box beam could be observed. Standing water, spalled concrete, and small wildlife were found in the void. A longitudinal bar and stirrups were also exposed (Figure 4.46).

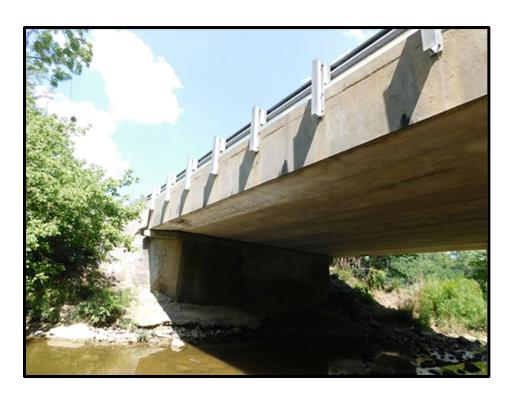
Figure 4.13 Clear creek bridge.

The bottom of the superstructure is in good condition compared to the Pond Creek and Rock Creek bridges. Spalling at the bottom corners of two adjacent beams with two exposed strands in the middle of the span was noted (Figure 4.13). Between Beam 3 and Beam 4, rust staining was observed towards midspan (Figure 4.14). Corrosion and two exposed stirrups were also observed at the southeast corner of the bridge (Figure 4.15). The complete deterioration map is provided in Figure 4.16.

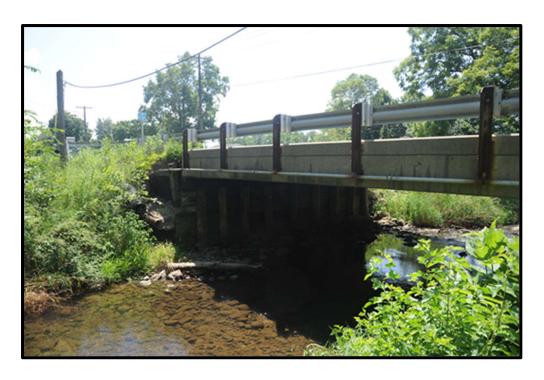
Figure 4.18 Yellow Creek Bridge.

The underside of the Yellow Creek Bridge has small regions of spalling at the edges of the first interior beams along with an exposed strand (Figures 4.18 and 4.19). An exposed stirrup was observed on the exterior face of the exterior beam on the east side (Figure 4.20). Patched potholes were scattered across the concrete wearing surface and were filled with asphalt (Figure 4.21). A correlation was made between the location of the patches and the location of the longitudinal joints of the box beams. A complete map of the deterioration is provided in Figure 4.22.

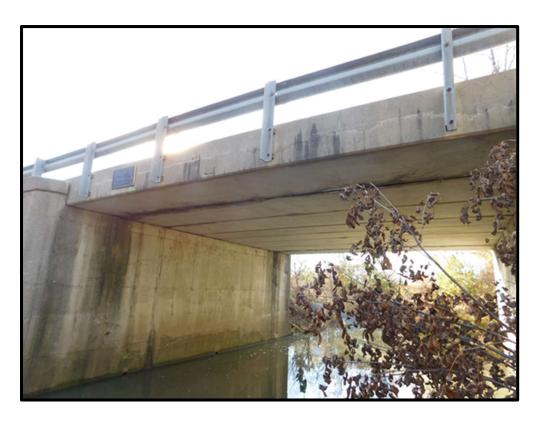
Figure 4.24 Beal-Taylor Ditch Bridge.

Beal-Taylor Ditch (02-00221) is a single-span bridge located in Allen County and carries West Hamilton Road over Beal-Taylor Drain (Figure 4.23). The bridge was built in 1967 and consists of eight adjacent box beams that span 23.9 ft. and have depths of 12 in. The two box beams in the middle of the bridge are 3 ft. wide, while the remainder of the beams are 4 ft. wide. The bridge has a bituminous wearing surface with no membrane and a single tie rod at midspan. The bituminous wearing surface, however, does not extend to the curbs. Instead, the bituminous wearing surface only covers the roadway while the shoulders of the bridge appear to be covered with gravel (Figure 4.24).

The only problems observed on this bridge were located at the longitudinal joints. On November 3, 2016, which was a relatively dry day, five of the seven longitudinal joints showed leakage. The most moisture along with efflorescence was observed at the exterior joints and extended the full length of the span. In addition, spalling and corrosion were observed at the exterior joint on the east side (Figure 4.25). Moisture was also observed at the interior joints, generally near midspan (Figure 4.26). Leakage was observed near the abutments between Beams 6 and 7. The complete deterioration map is provided in Figure 4.27.

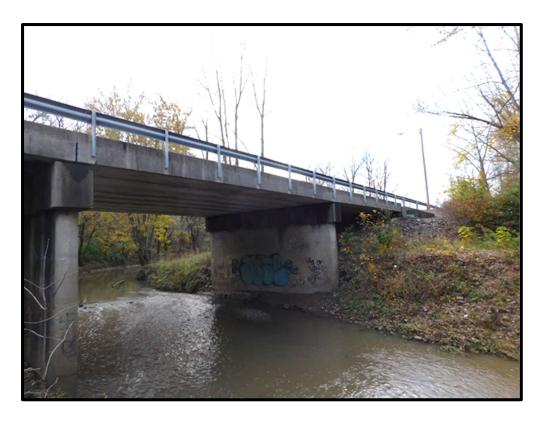
Figure 4.29 Main Street Bridge.

This bridge was noted to be in the worst condition compared to the other five bridges inspected. The end spans have multiple regions of spalling with exposed stirrups and strands (Figure 4.29). Corrosion on the west span was so severe that prestressing strands had fractured and debonded from the concrete (Figure 4.30). Strands were observed hanging from the underside of the superstructure. Spalling initiated near the longitudinal joints and, over time, moved closer to the center of the beams. For one particular beam, 24 exposed stirrups and four exposed prestressing strands were noted. The middle span appeared in better condition with only three locations of spalling, each region having three exposed stirrups (Figure 4.31). A complete deterioration map is provided in Figure 4.32.
