A Survey of Physical Parameters and Natural Radioactivity in the Wooden Church of “Archangels Mihail and Gavril,” Draghia

Ancuța Țenter, Marin Cotetiu, Alexandra Cucos, Bety Burghеле, Kinga Szacsvai and Verginica Schroder

Abstract

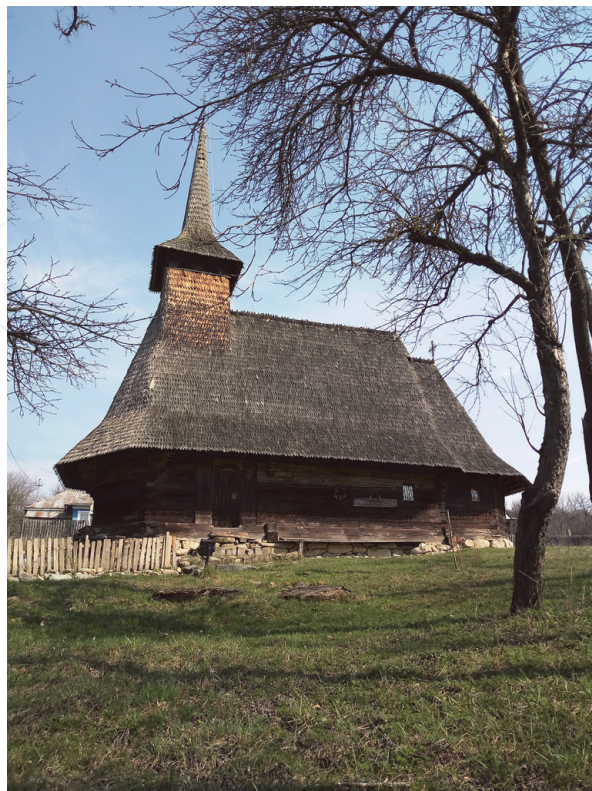
Figure 2.
The church “Archangels Mihail and Gavril,” Draghia.

The church is 12.40 m long, 4.45 m wide, 7.50 m high at the ridge, and 15.50 m high at the tower's spire. The base and the walls are all made of oak beams placed on a dry laid stone foundation [21] (**Figure 2**).

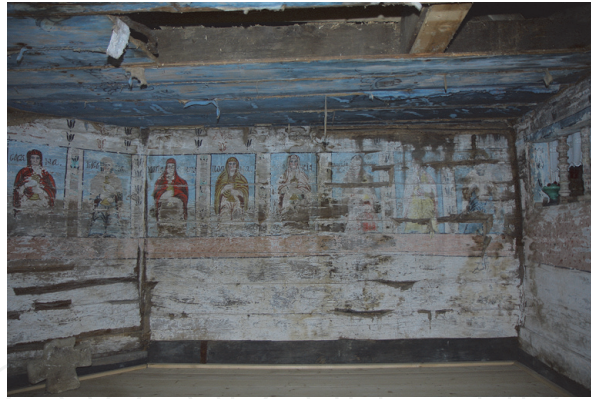
Figure 3.
Holy women with cups in their hands.

The building plan is similar to others found throughout the area; the church being divided into a narthex, nave, and altar [22]. The narthex has a polygonal shape, covered with a straight ceiling, above which the bell tower is situated. The ceiling is painted with cherubs, and the walls are painted with images of the Myrrhbearers, and of wise and foolish virgins from the Gospel of Mathew. The narthex was where the women would attend mass (**Figure 3**).

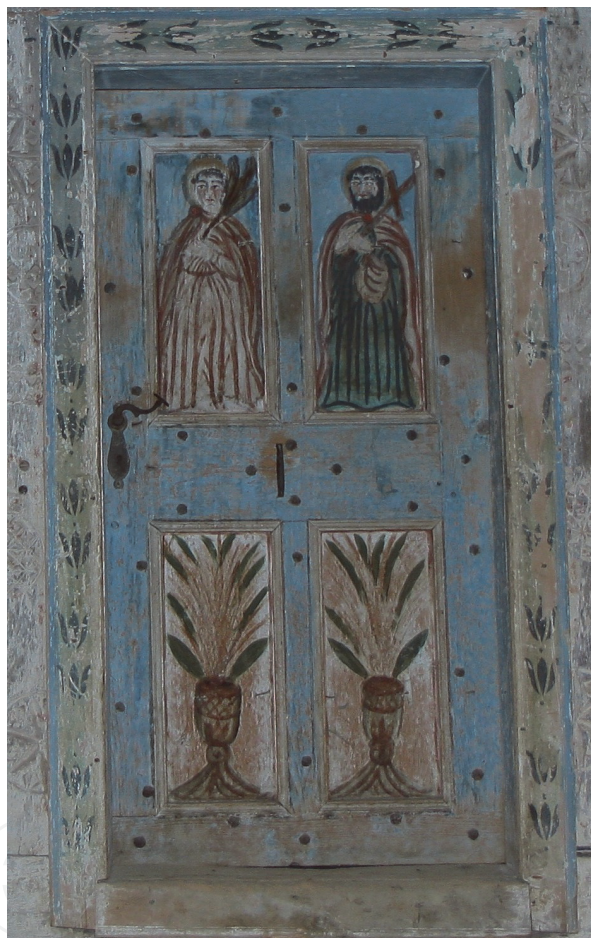
Figure 4.
The door with two saints.

According to the requirements of the Orthodox church construction, the nave is rectangular, with a large dome and separated from the rest of the area by a wall with a door [23]. This wooden door is painted on with two saints (**Figure 4**).

The lower half of the door is painted with the tree of life in a pot. The door frame is engraved with area-specific symbols and historical times rosette with six petals, honeycombs, and wolf teeth. The opening is provided with slightly turned columns

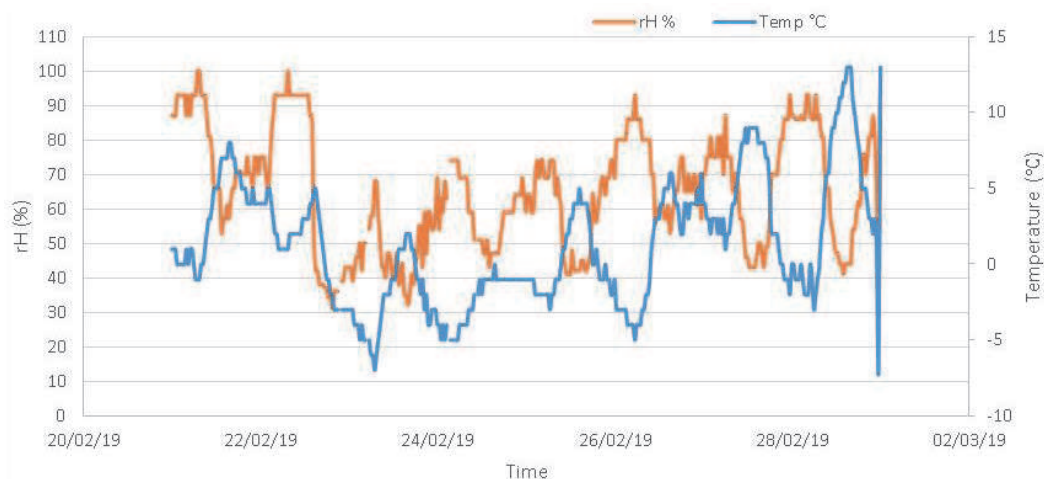
Figure 8. Weather conditions in the area at the time of study (February 2019).

The data provided by the Baia Mare weather station for the time interval of interest showed the following outdoor conditions: an average temperature of 1.27°C, with a minimum of -7°C and a maximum of 13°C (**Figure 8**). This fact explains the naturally low temperatures recorded inside the church, which is not equipped with a heating system.

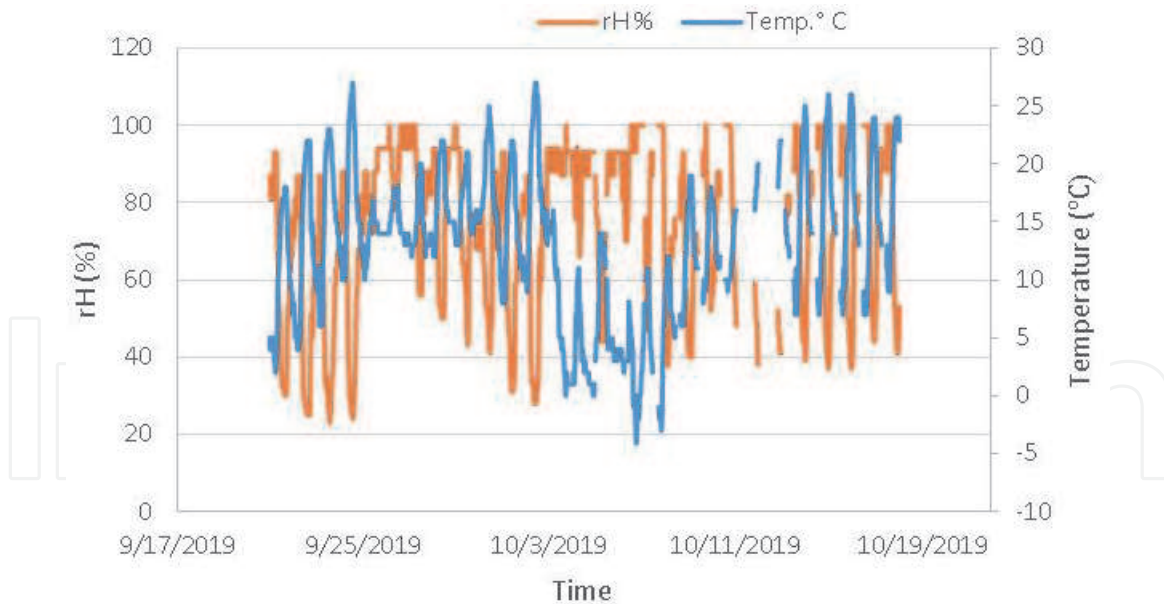
Figure 11.
Weather conditions in the area at the time of study (September–October 2019).

The data provided by the Baia Mare weather station for the time interval of the second measuring campaign showed an average temperature of 13°C, with a minimum of –4°C and a maximum of 27°C. On the other hand, the values of the relative humidity of the outdoor air had very high values during this period, with an average of 73%, which may have caused and maintained the high humidity inside the church (**Figure 11**).

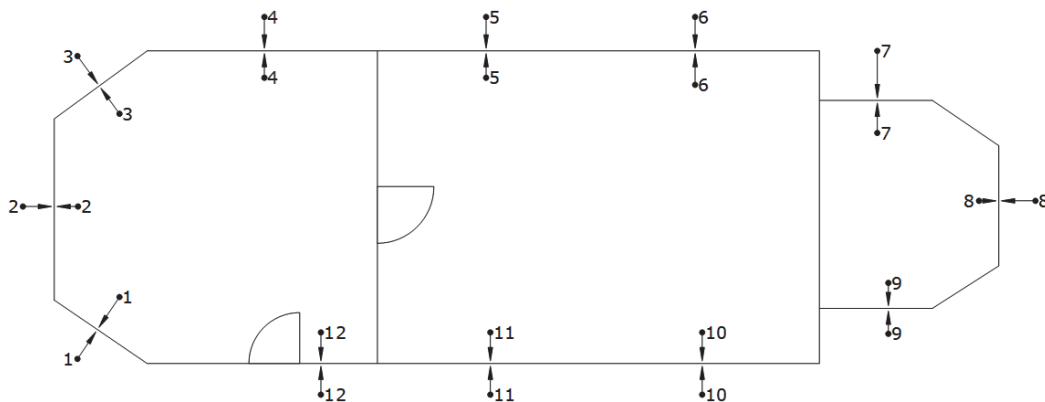
Figure 12.
Drawing plan of the wooden church with markings of the 12 indoor and outdoor sampling points.

operated particle measuring device (Trotec GmbH, Germany) was used to record important climate data such as the relative humidity and the air temperature. The measurements were performed every day between 19 and 19.30 p.m. The 12 points on the outside and inside the church were set at the ground level (Figure 12). The recorded data allowed the observation of relevant variations in the values of rH, between the outer and the inner points of the wood surface.

The highest average values (80.30, 80.90, and 80.30%) were recorded in sampling points 10, 11, and 12, behind the door of the church. This may explain the state of advanced degradation, the painting being almost completely obliterated, more so than in other areas inside the church (Figures 13 and 14).

dehumidifier with a setting function allowing the relative humidity of the indoor air to be decreased between 50 and 60%.

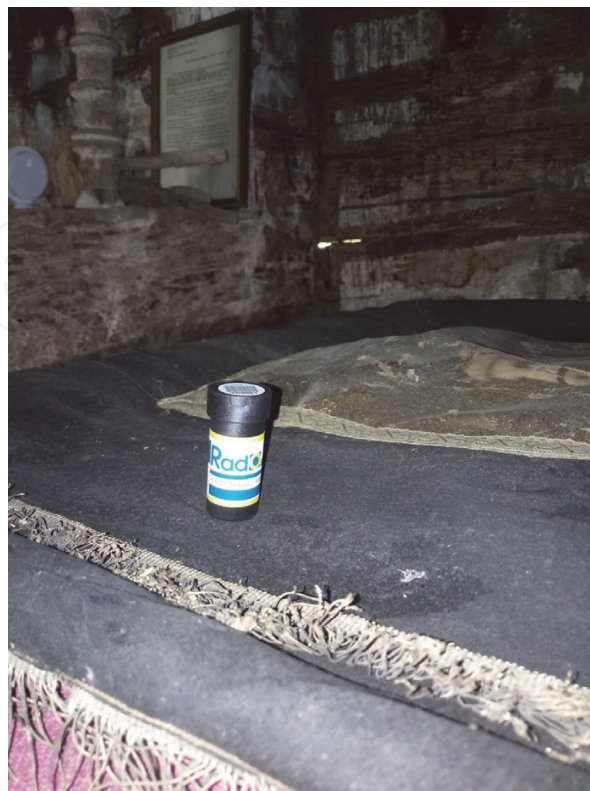
Figure 15.
CR-39 detector.

At the time of the second campaign, passive radon detectors were installed along the active monitoring system. Indoor passive radon measurements were performed by using CR-39 track detectors exposed for 1 month, in all three rooms of the wooden church (**Figure 15**), according to the NRPB Measurement Protocol [36].

Following the laboratory analyzes performed at the Constantin Cosma Radon Laboratory of Babeş-Bolyai University, an average concentration of 107 Bq m⁻³ was obtained for the monitored period. Taking into consideration the seasonal correction factors implemented through national regulations, the annual indoor radon activity concentration for the investigated public building was calculated to be 140 Bq m⁻³,

well within the limits allowed by both the European Union, WHO, and by the Romania law regarding the exposure of the population in public spaces [37–39].
