Full Length Article

Experimental investigations on the chlorine-induced corrosion of HVOF thermal sprayed Stellite-6 and NiAl coatings with fluidised bed biomass/anthracite combustion systems

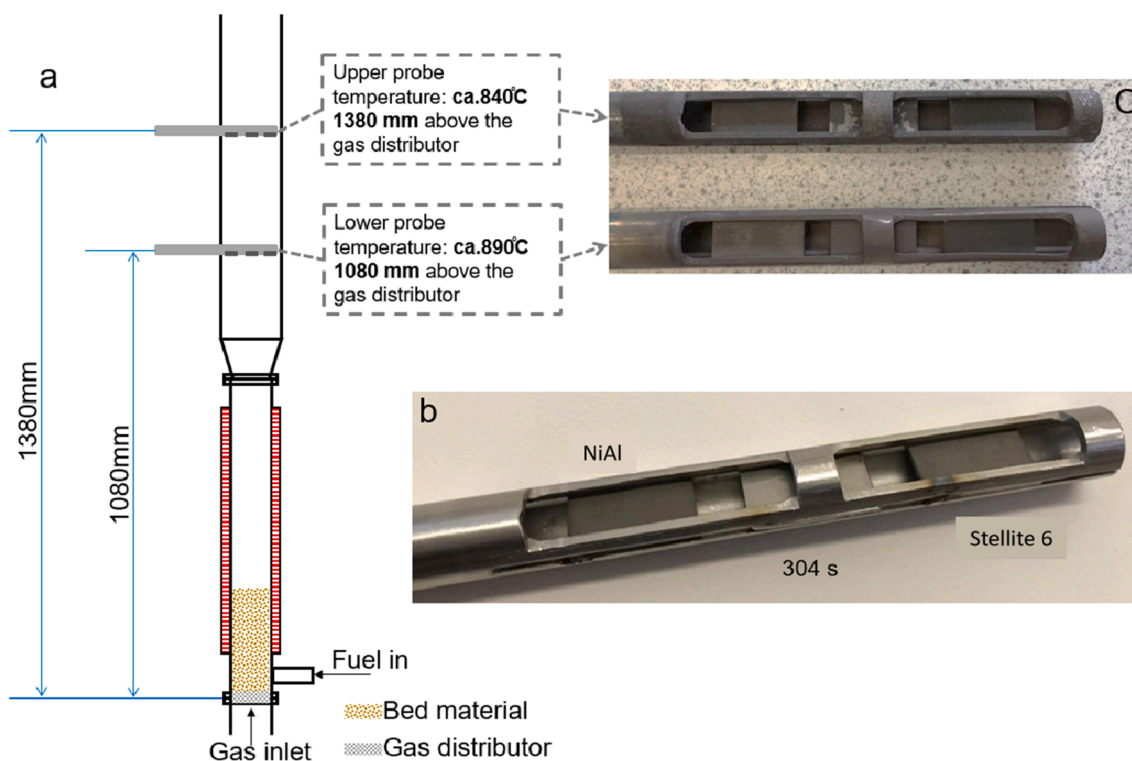
Fig. 1. Simplified schematics of the 20kWth BFB with the coating material probes installation mechanism: a) Coating material probes mounting positions in the 20kWth BFB combustor; b) Coating materials installation in a 310 stainless steel probe; c) The two coating sample probes after tests.

Fig. 1b shows the mounting mechanism of the coating materials which were welded inside a 310 stainless steel tube (o.d. 19 mm; i.d. 14 mm) with the “window” width of 12 mm. The NiAl and Stellite-6 coating specimens were located symmetrically aside by the 304 SS substrate. Two identical sets of the coating material probes were prepared and inserted into the freeboard zone of the 20kWth BFB combustor facing towards the upcoming fluidisation gas stream. After 20 h high

temperature test, the two probes (Fig. 1c) were taken out for further characterisation.

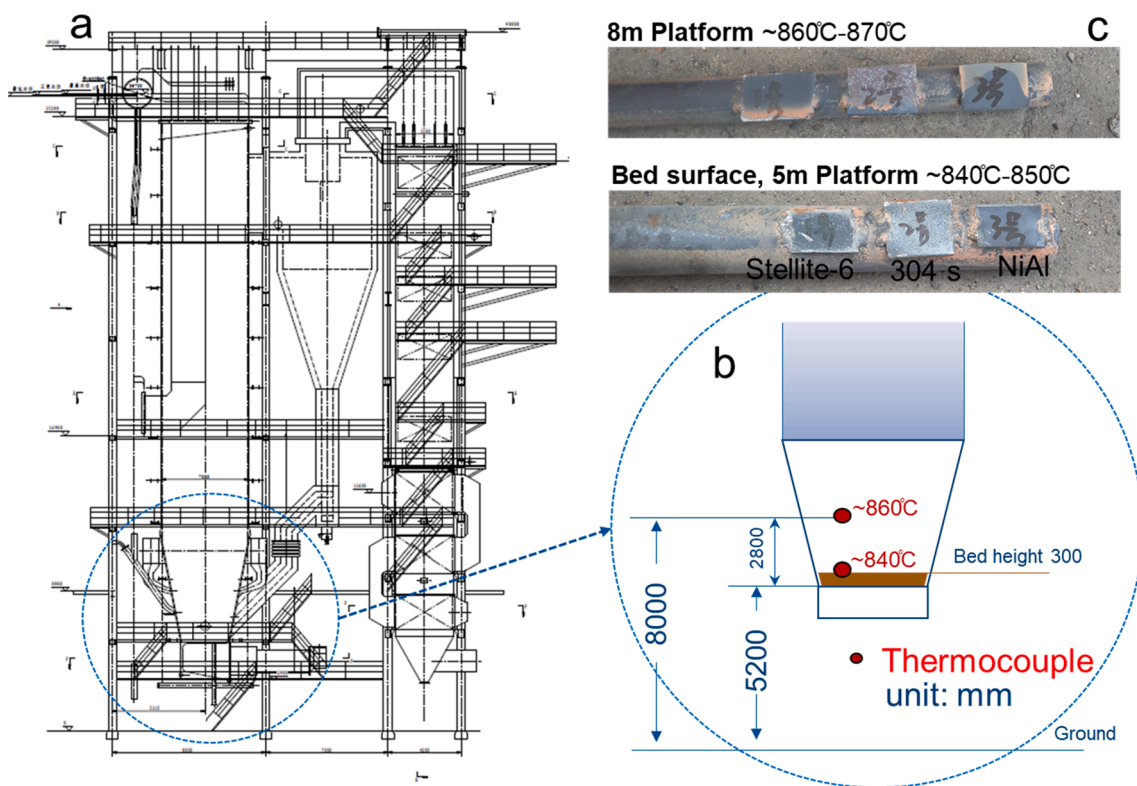
The coating materials were welded on the thermocouple probes and inserted into the boiler at the 5 m and 8 m operational platforms facing towards the upcoming fluidisation gas flow (Fig. 3b). Worth noting that the actual height to ground of the lower probe is 5.5 m and hereinafter, 5 m platform is used for simplicity. The average local temperatures were about 840 °C and 860 °C for the 5 m and 8 m installation positions, respectively, during the test. The measurement campaign lasts ca. 1630 h based on the power plant scheduled shut down program. After the test campaign, the samples (Fig. 3c) were retrieved for further analysis and characterisation.

Fig. 3. Schematics of the industrial CFB in Qinhuangdao Lihua Starch Co., Ltd with the coating materials installation mechanism: a) The schematics of the CFB boiler; b) Details of the coating samples installation position; c) Photos of the two thermocouples with welded coating samples after tests.
