# Observations about the seismic response of RC buildings in Mexico City

Over 2000 buildings were surveyed by members of the Colegio de Ingenieros (CICM) and Sociedad Mexicana de Ingenieria Estructural (SMIE) in Mexico City following the Puebla-Morelos Earthquake of 2017. This inventory of surveyed buildings included nearly 40 collapses and over 600 buildings deemed to have structural damage. Correlation of damage with peak ground acceleration (PGA), peak ground velocity (PGV), predominant spectral period, building location, and building properties including height, estimated stiffness, and presence of walls or retrofits was investigated for the surveyed buildings. The evidence available suggests that (1) ground motion intensity (PGV) drove the occurrence of damage and (2) buildings with more infill and stiff retrofit systems did better than other buildings.

Reinforced concrete, earthquake damage, 2017 Puebla-Morelos Earthquake, structural damage, seismic response

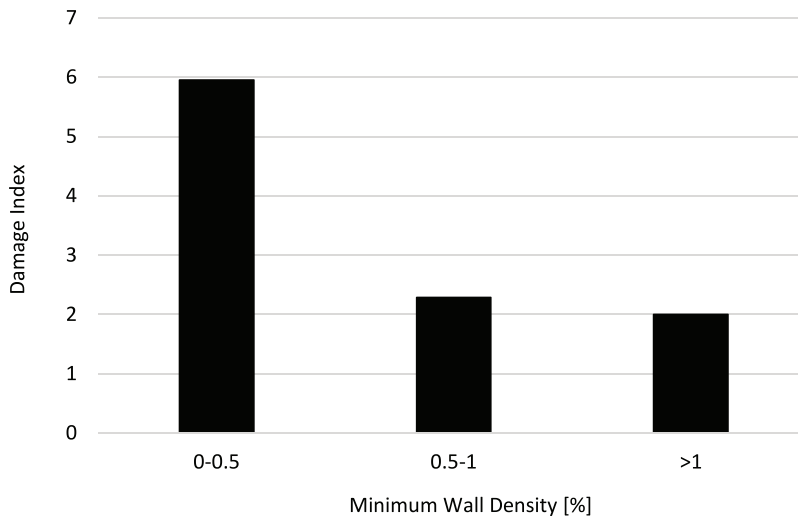
**Figure 19.** Average damage index versus wall density.

Figure 19 shows the mean damage index assigned by the writers based on data collected on-site plotted versus wall density (measured as the ratio of cross-sectional area of infill wall<sup>1</sup> to floor plan area). The damage index was chosen to be 1 for little or no structural damage, 5 for moderate damage, and 10 for building collapse and structural failures (Appendix 1). Figure 19 shows that the buildings with larger wall densities performed better despite the modest drift capacity of infill.<sup>2</sup> In addition, it was clear that buildings retrofitted following the 1985 event by adding stiffening elements (often RC infill walls) performed quite well in 2017 (Roselin et al., 2019).

Note: Data used to produce this plot are available at <https://datacenterhub.org/resources/14746> and Design Safe (PRJ-1800 and PRJ-2285). Most walls were masonry infill. RC walls were present in isolated cases. They were treated as being equivalent to produce Figure 19.
