Learning from failure: Damage and Failure of Masonry Structures, after the 2017 Lesvos Earthquake (Greece)

Abstract - On the 12th of June 2017 an earthquake of Mw=6.3 struck SSE of Lesvos Island, causing one human fatality and severe damage to the built environment. The traditional settlement of Vrissa was the most affected area, having masonry structures as the majority of its building stock. The objective of the present study is two-fold: to present the structural damage and failure patterns induced by the Lesvos earthquake to masonry structures; to highlight the causes and weaknesses that led to damage, or the factors that prevented it. Particular attention is paid to traditional construction techniques and architectural features that contributed to the seismic response of the structures, either having beneficial or detrimental effect. To this end, a field reconnaissance has been conducted and meaningful technical conclusions are drawn by the observations. Structural systems of both unreinforced and timber-reinforced masonry are inspected. Besides the identification of frequent cases of local, out-of-plane and in-plane mechanisms, combined global mechanisms are also pointed out

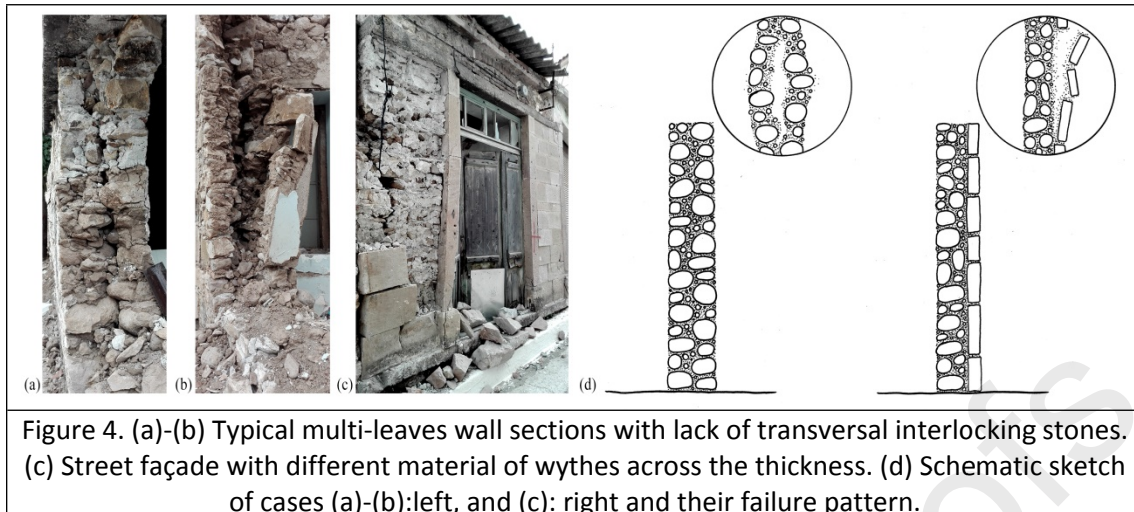
175 In some structures built at the central part of the settlement, a different kind of building
 176 material was used between the parallel leaves. Perfectly cut stones were employed for the
 177 outer leaf of the façade in order to demonstrate wealth and solidity, while rubble stones
 178 were used for the rest of the section (Figure 4 (c), (d)). Once again, no mechanical
 179 connection between the leaves was ensured, while the different stiffness of the masonry
 180 across the section increased its vulnerability.

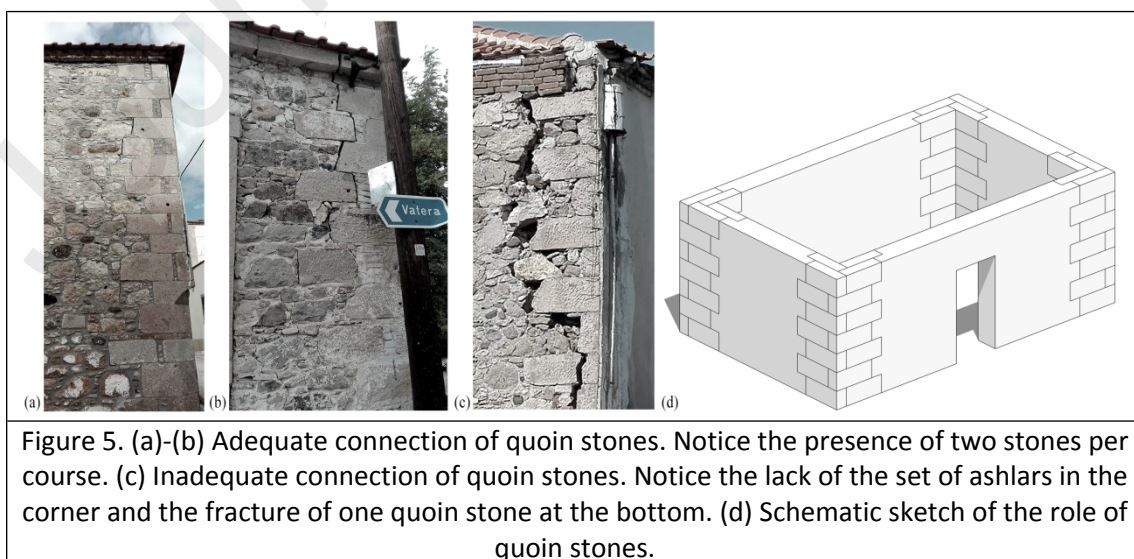
182 The corners of URM buildings were usually constructed with quoin-stones. Well-shaped and
 183 in most cases, being made with more than a single stone in the course, quoins helped the
 184 connection of transversal walls, preventing local or global failures (Figure 5 (a), (b), (d)), as
 185 shown below. Still, quoins were often insufficient to prevent the development of corner
 186 cracks, especially when an additional set of ashlar stones was poorly constructed or missing
 187 (Figure 5 (c)). The use of ashlar stones was also adopted for the stones in the frames around
 188 building openings. Often, monolithic squared stones were used for posts and lintels around
 189 the openings, as a local architectural feature. The lack of proper interlocking of these
 190 elements with the rest of the masonry, leads to the assumption that these are decorative,
 191 non-structural elements.

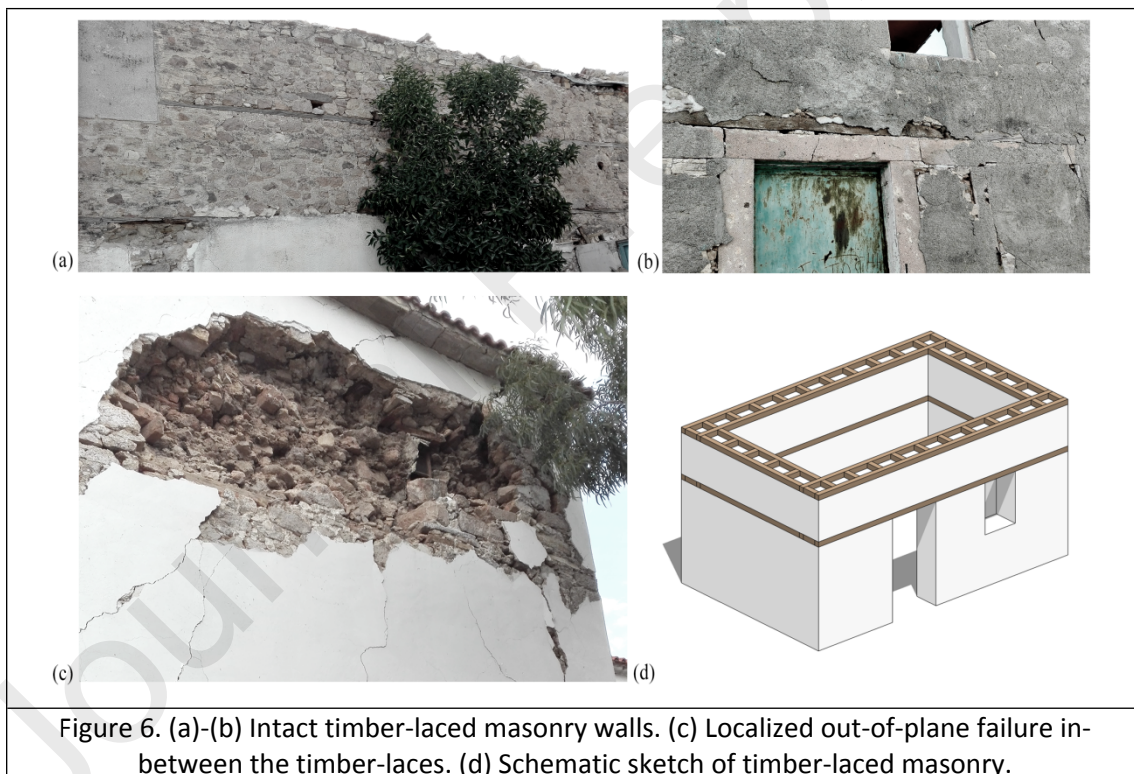
203 *Timber-laced masonry* consists of timber ring beams placed at regular spacing across the
 204 height and as a pair across the thickness of the walls (Figure 6). Such a technique, as
 205 described in [41–44] and references therein, improves the seismic performance of the
 206 building in its inelastic range, by providing horizontal slip planes, dissipating energy and
 207 enhancing the masonry In-Plane (IP) and Out-Of-Plane (OOP) strength by confining portions
 208 of the walls. In addition, this technique enhances the connection between transversal walls
 209 and helps to tie the leaves of a wall together and avoid disintegration. During the
 210 reconnaissance campaign, the damage that was observed in timber-laced masonry
 211 structures was limited in-between the ring-beams across the height, demonstrating the
 212 adequacy of the system (Figure 6 (c)).
