# Geological challenges and geohazard monitoring of a mega engineering hydropower project in Iceland

Fjola G. Sigtryggisdóttir<sup>a,\*</sup>, Jónas Thór Snæbjörnsson<sup>b,c</sup>

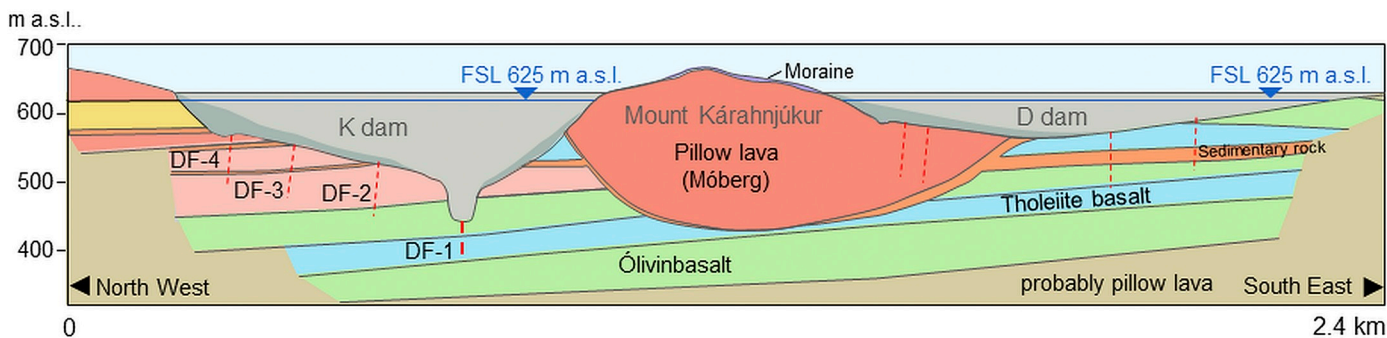
**Fig. 4.** Geological section through the ridge Mount Kárahnjúkur at the site of the Kárahnjúkar (K) and Desjarár (D) Dams (see Fig. 5 for dam location). The dashed red lines represent the approximate location of the main faults encountered in the foundation of the K Dam during the construction phase. In the foundation of the K Dam the faults are labelled DF-1 to DF-4. (Based on Gudmundsson and Helgason (2004)). (For interpretation of the references to colour in this figure legend, the reader is referred to the web version of this article.)

During the excavation of the foundation of the Kárahnjúkar (K) and Desjarár (D) Dams a complex fault system was encountered (Gudmundsson and Helgason, 2004) (see Figs. 4, 5, 6 and 8). Of special concern was a fault encountered in the foundation of the K Dam (Figs. 5, 6 and 7), which was judged to be of strike-slip nature. This fault, trending N20–22°E, labelled DF-1 is also referred to as the Toe-wall Fault and has been considered particularly important due its location in the canyon directly under the K Dam (see Figs. 4, 5, 6 and 7). Fig. 8a shows the Toe-wall Fault, DF-1, as it crosses a ledge west of the

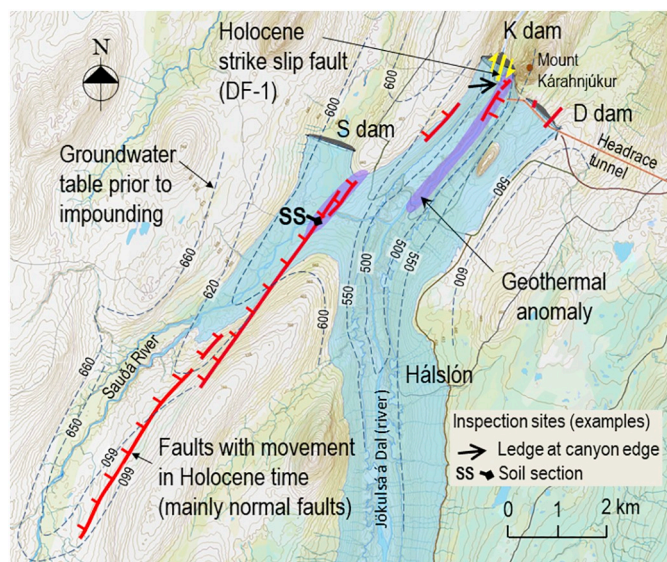
The debate was intensified by the fact that during the construction phase, active faults were encountered in the foundations of the K and D Dam (Figs. 5 and 6). Only a month prior to the reservoir impoundment concerns regarding the safety of the dams were highlighted in public debate. This included apprehension concerning potential excessive leakage and large movements on faults in the dam foundation induced by water pressure from the reservoir. For instance, a question was raised regarding how much the fault (DF-1) underneath the K Dam would open after the impounding. The question was illustrated with a schematic figure, adopted in Fig. 7.

**Fig. 5.** The dam site and the reservoir, along with groundwater contour lines prior to inundation and Holocene faults identified during the construction phase. The inspection sites pointed out here are further shown in Fig. 8. (Based on a map made by Landsvirkjun and Iceland GeoSurvey).

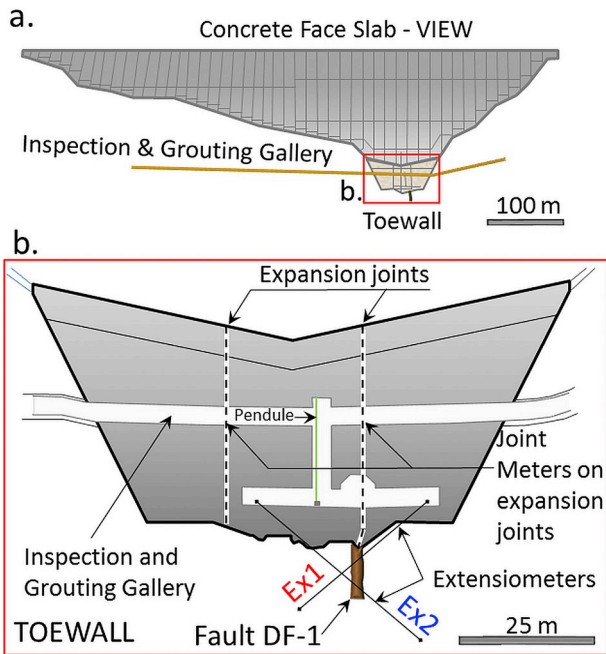
- (iv) Instruments were installed on or near each fault in the foundation of the K Dam to monitor potential movements, whereas only the most prominent fault in the foundation of the D Dam is monitored downstream of the dam. Joint meters and/or crack meters in the foundation of the K Dam are accessible in the grouting gallery underneath the main dam. The Toe-wall Fault or fault DF-1 (Figs. 6 and 7) is monitored by extensometers in boreholes crossing the fault (Fig. 13) but with different alignment in the horizontal plane.

Fig. 13. Extension meters crossing the Toe-wall Fault, DF-1, in the foundation of the Kárahnjúkar Dam (K Dam) where the dam is highest (in the canyon). (a) Longitudinal view of the K Dam upstream face. (b) Instrumentation in the Toewall. (Dam instrumentation specified by the designer, Kárahnjúkar Engineering Joint Venture).

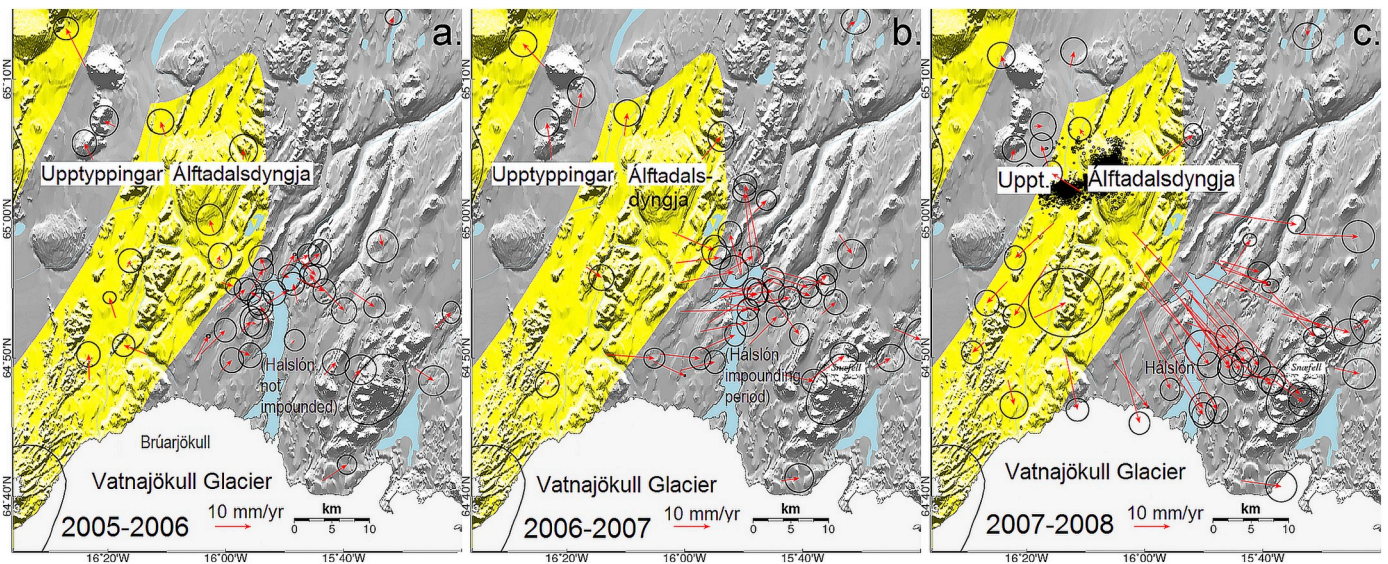
The earthquake activity continued into 2008 while the reservoir elevation decreased, and thus the similarity between the curves in Fig. 16 was lost, and the discussion expired. Furthermore, in early 2008 after processing data from a surveying campaign to monitor crustal displacements of benchmark points, the activity (within the marked boundary in Fig. 10) was explained as a geophysical process unrelated to the reservoir filling. The micro seismicity recorded had to be interpreted in connection with the monitoring of crustal movements to fully understand the ongoing processes.

Fig. 17. Horizontal velocities derived from yearly GPS campaigns on the Reservoir Network between 2005 and 2008 (Ófeigsson et al., 2009). (Courtesy of Benedikt Ófeigsson).
