HAM, MARIE SHARPE. The Renovation and Partial Restoration of the North Carolina Executive Mansion (1974-1976). (1977) Directed by: Dr. Mary Miller. Pp. 213

THE RENOVATION AND PARTIAL RESTORATION
OF THE NORTH CAROLINA
EXECUTIVE MANSION
(1974-1976)

Marie Sharpe Ham

A Thesis Submitted to
the Faculty of the Graduate School at
The University of North Carolina at Greensboro
in Partial Fulfillment
of the Requirements for the Degree
Master of Science in Home Economics

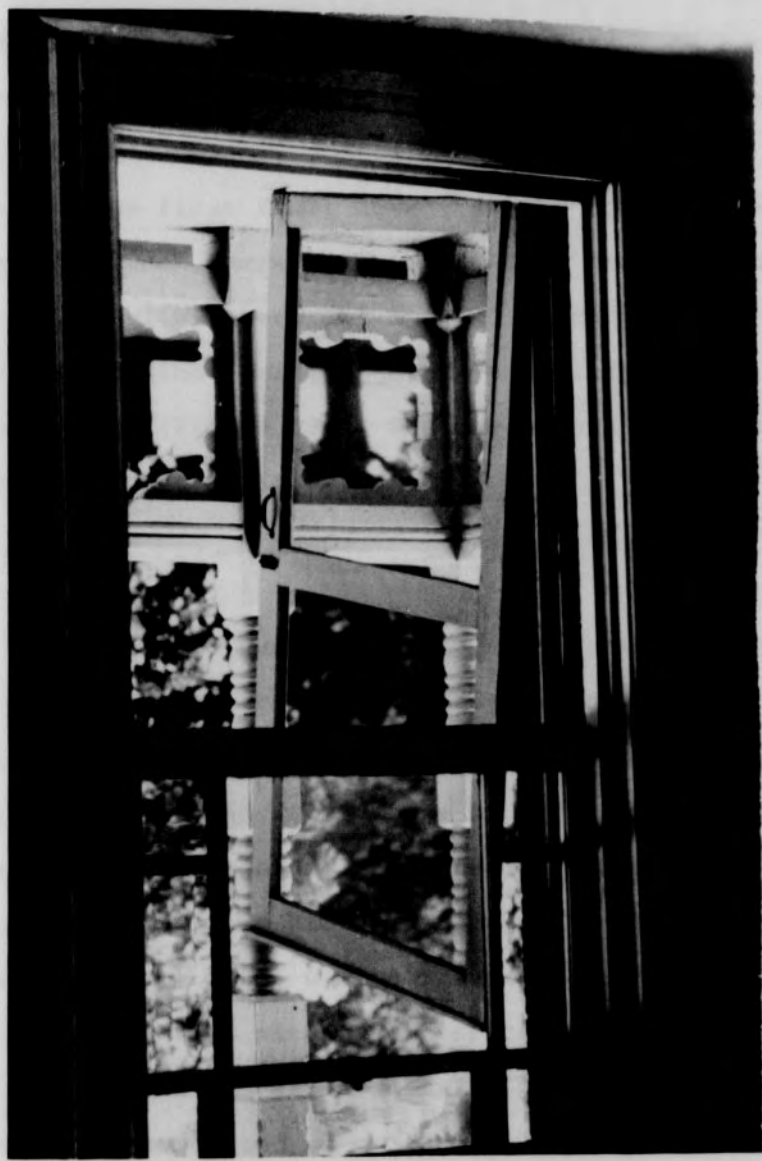
the opening is high enough (6 feet) to be used as an exit. Close examination of the windows on the second floor revealed that the screens for these windows were hinged on the side (Figure 12). This hinging allowed use of the windows as an access to the second floor balconies. Wire screen fabric for the East porch windows was not purchased because of inadequate funds. While these screens were not replaced by the 1973-75 funding, they will be included in a future procurement program.

Figure 12. Second Floor Balcony Window and Hinged Screen

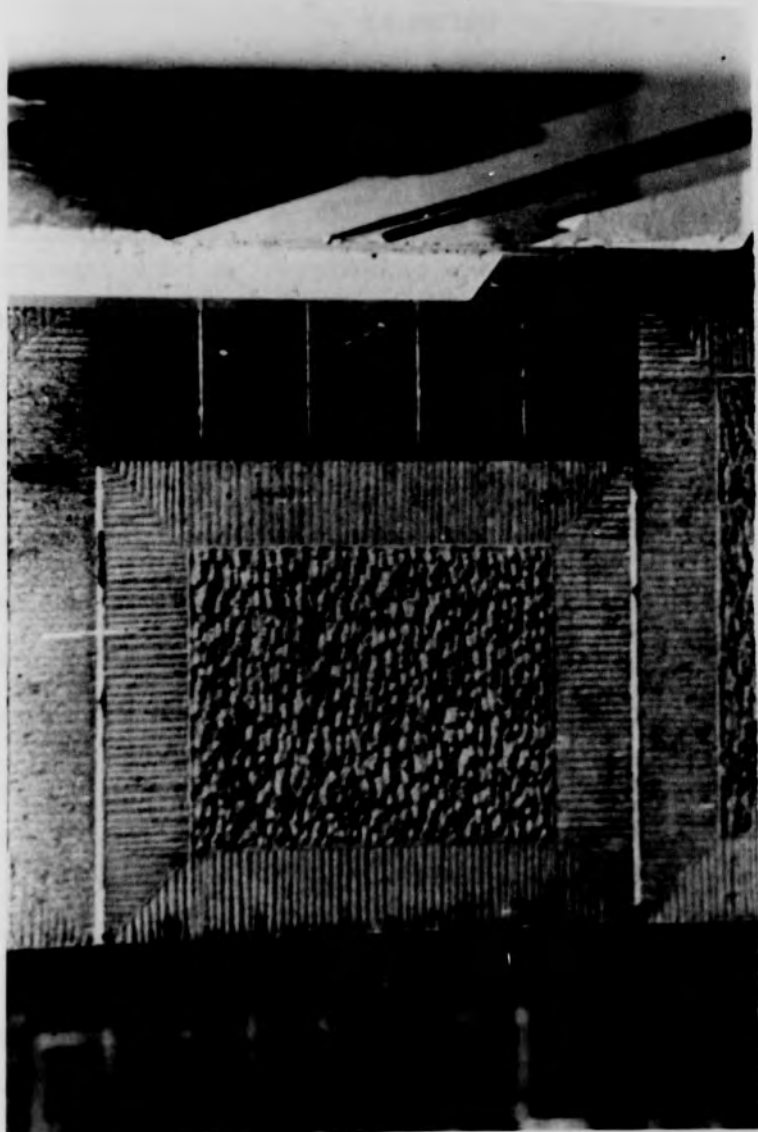
Figure 15. Handmade Brick Facade, Anson County Red Sandstone Quions and Cornerstones with Masonry Joints

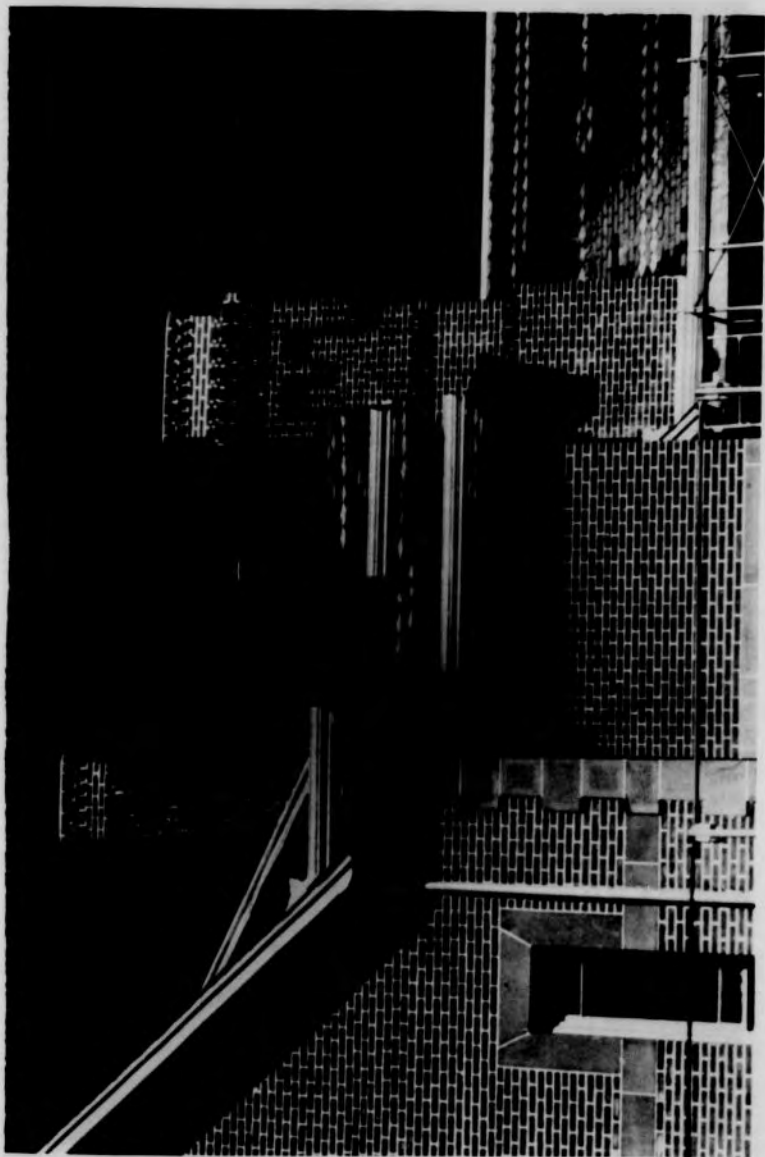
Figure 18. After View of Southeast Corner (South) and Stair Tower/
Fire Escape

The new fire tower is supported by a reinforced concrete foundation rising through the South porch in the Southeast corner. The tower is constructed with a rating for hours of safety, and thus would provide a safe means of egress before it would be consumed by fire. The interior of the existing fire tower is reinforced with cinder blocks, brick, mortar combined to 24" thickness (Figures 20, 21). The stairs are steel, concrete, and aluminum with a rating of 3 hours. Interior doors are of steel with compression panic bars, which release upon impact. According to the initial plan, the interior walls, staircase frame, and doors were to be painted, but because of insufficient funds, this improvement was delayed. Lighting is provided by alternating current/direct current emergency pack lights, which change over from one power source to another within a few seconds in case of a power failure.

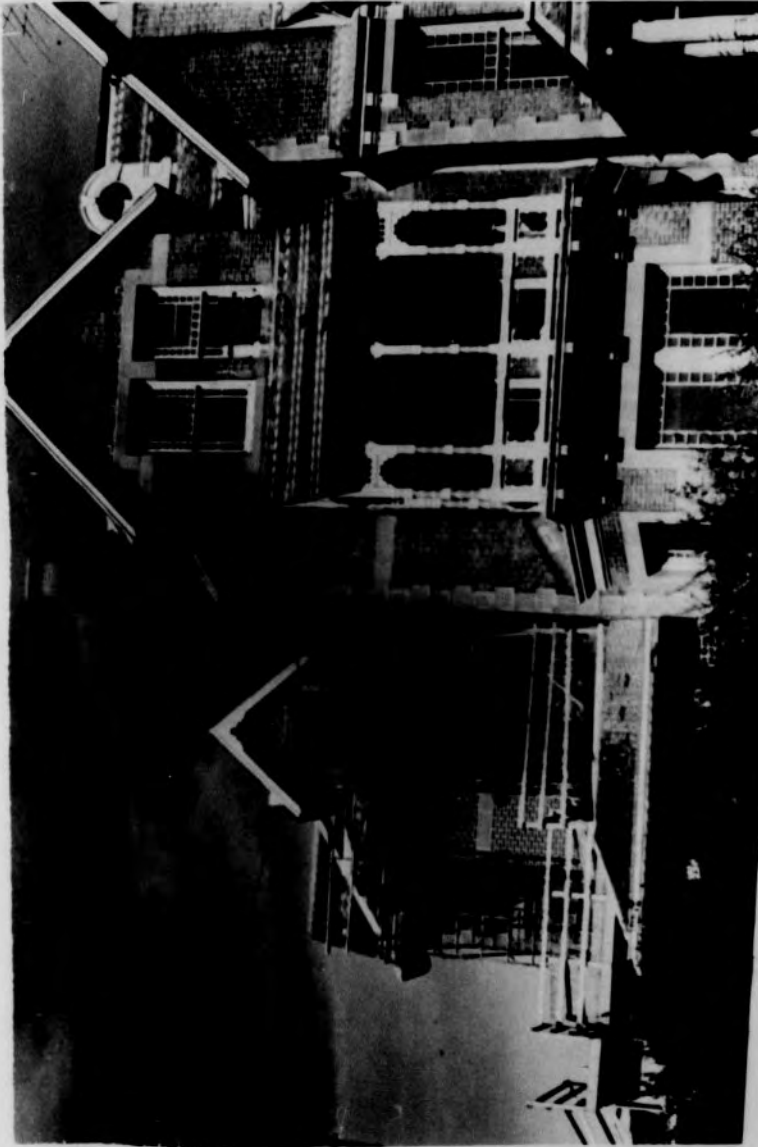
Figure 19. After View of Southeast Corner (East) and Stair Tower/
Fire Escape

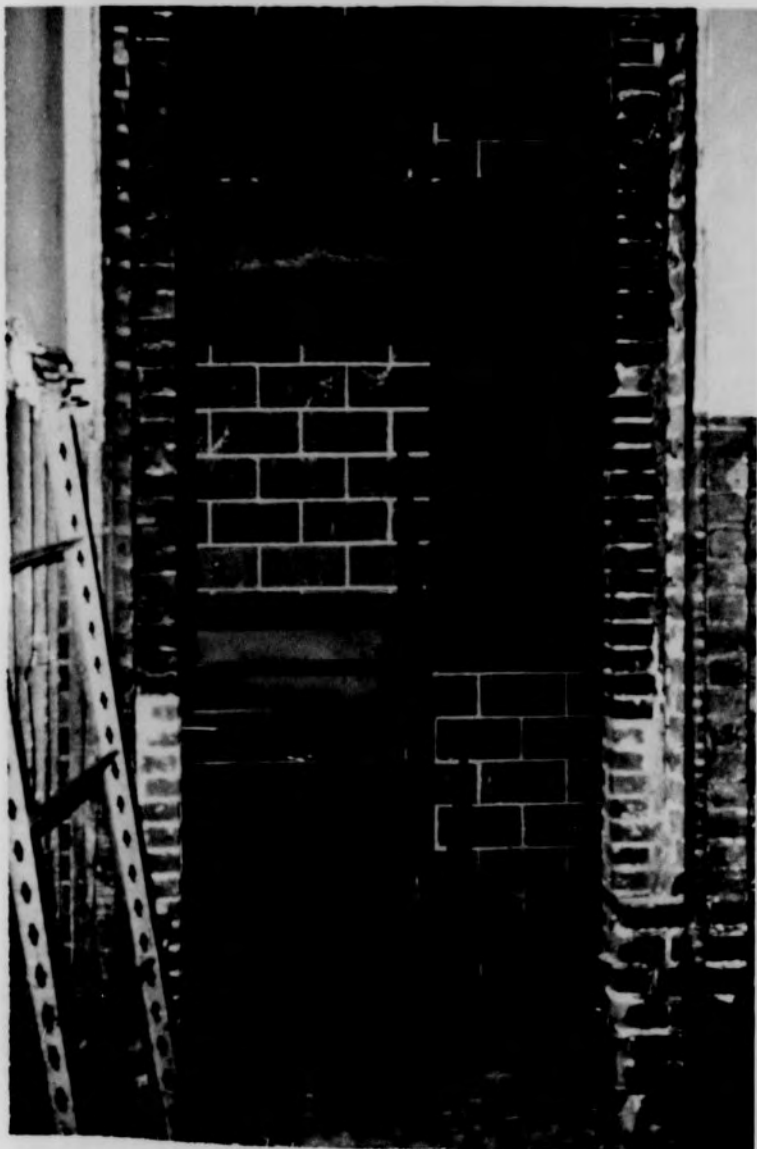
Figure 20. Interior Entrance on the Second Floor
to the Stair Tower/Fire Escape

The Bathroom adjacent to the Southeast Corner Bedroom was converted into a storage area and entrance to the fire tower (see Figure 20). A large closet across the hall was converted into a bathroom for occupants of this bedroom.

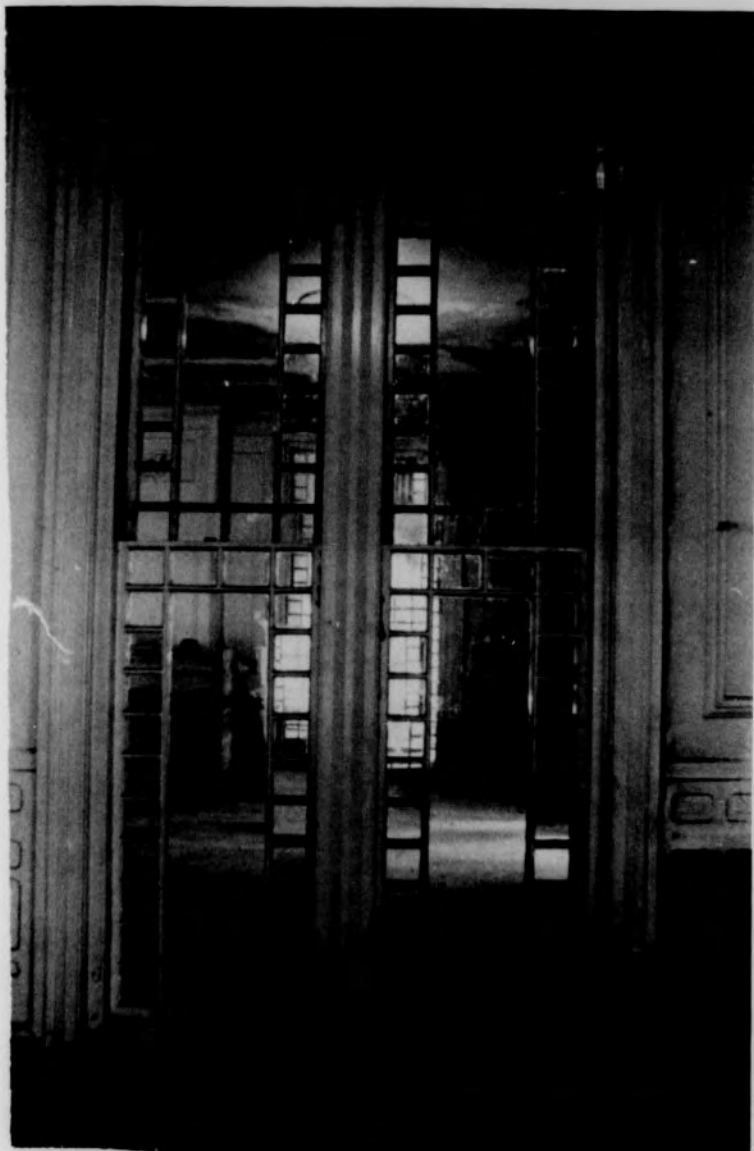
Figure 22. Ballroom Double Window on East Wall
with Silver Mirror Replacement

Several windows and a bathroom were lost because of this addition. On the first floor a double window in the Ballroom was closed off and the glass replaced by a silvered mirror installed in the original wood window frame (Figure 22). A single window in the Library, which was also closed off, was treated in a similar fashion with smoked gray mirror (Figure 23). Many other proposals, such as louvers, shelves, and closing off were considered for these two areas. However,

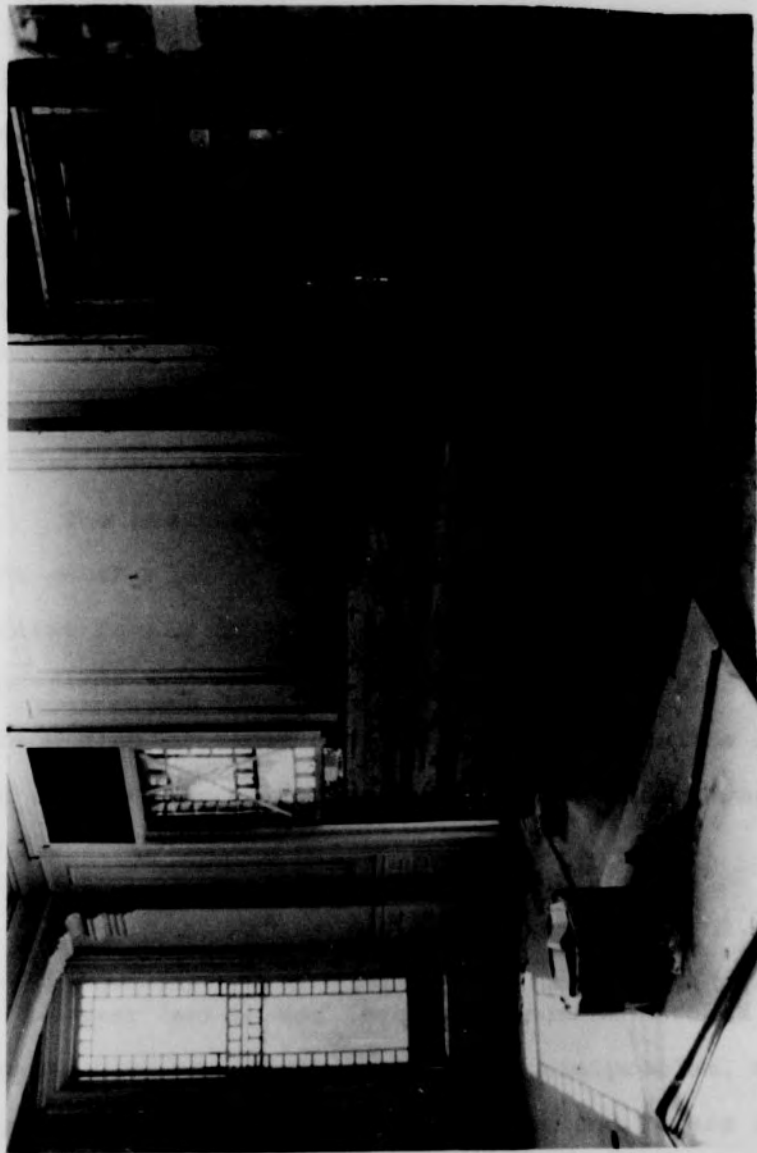
Figure 23. Library Single Window on South Wall with Smoked Grey Mirror Replacement

the use of mirrors seemed to be the least expensive and least controversial. This solution also permits flexibility for possible alternatives in the future. A double window in the second floor, South Central Bedroom was closed off (Figure 24). In this instance, window space was closed off to increase wall space and give more flexibility in possible room arrangements.

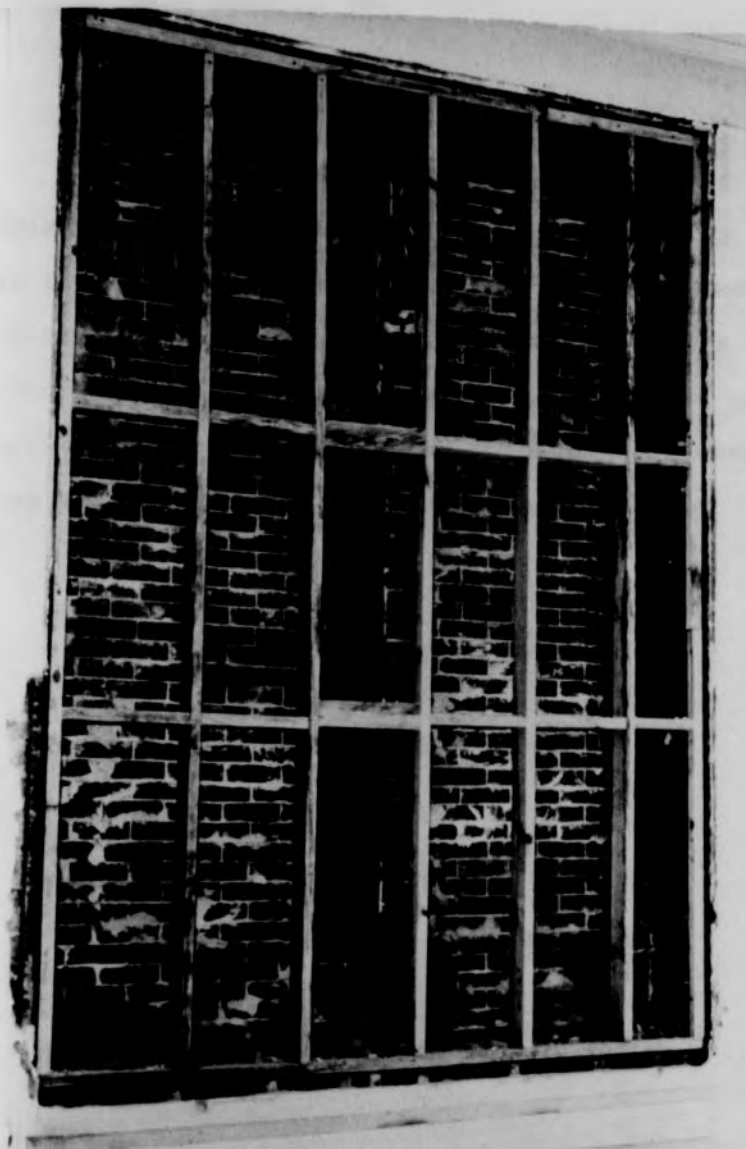
Figure 24. South Central Bedroom on East Wall
with Double Window Closed Off

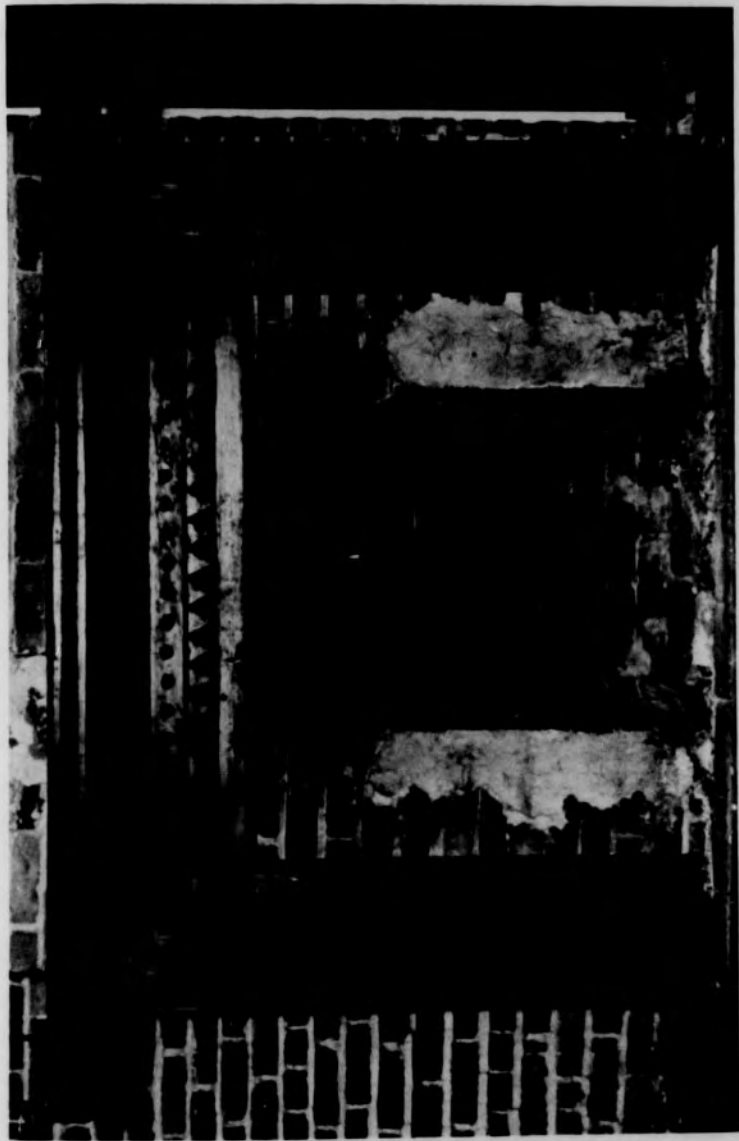
Figure 37. Wooden Mantelpiece from the Third Floor with Original Finish

provided a model of the original finish (Figure 37). The staircase was stripped of its layers of paint with a water soluble paint remover and with the use of jewelers' and carvers' tools (Figure 38). A similar stain and sealer were used to restore the original appearance (Figure 39). A slight modification in the back of the staircase was made to allow for a heating, ventilating, and air conditioning return air grill (Figures 40, 41).

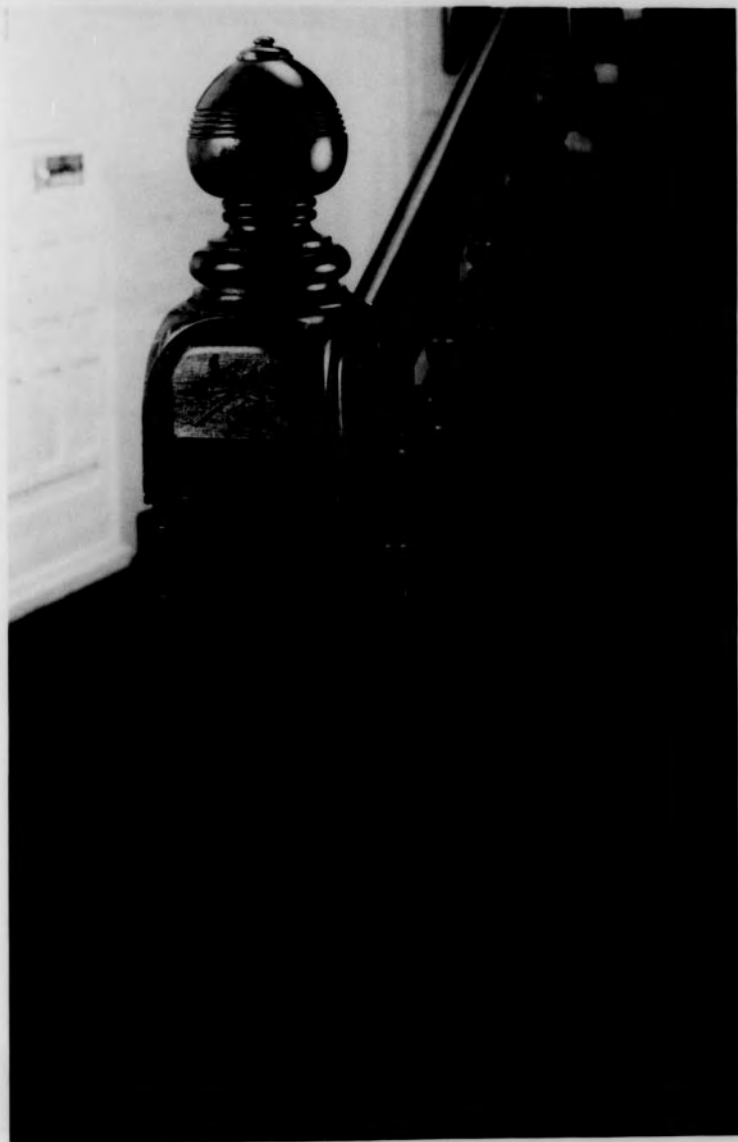
Figure 39. Staircase Newel Post after Paint Removal and with New Finish

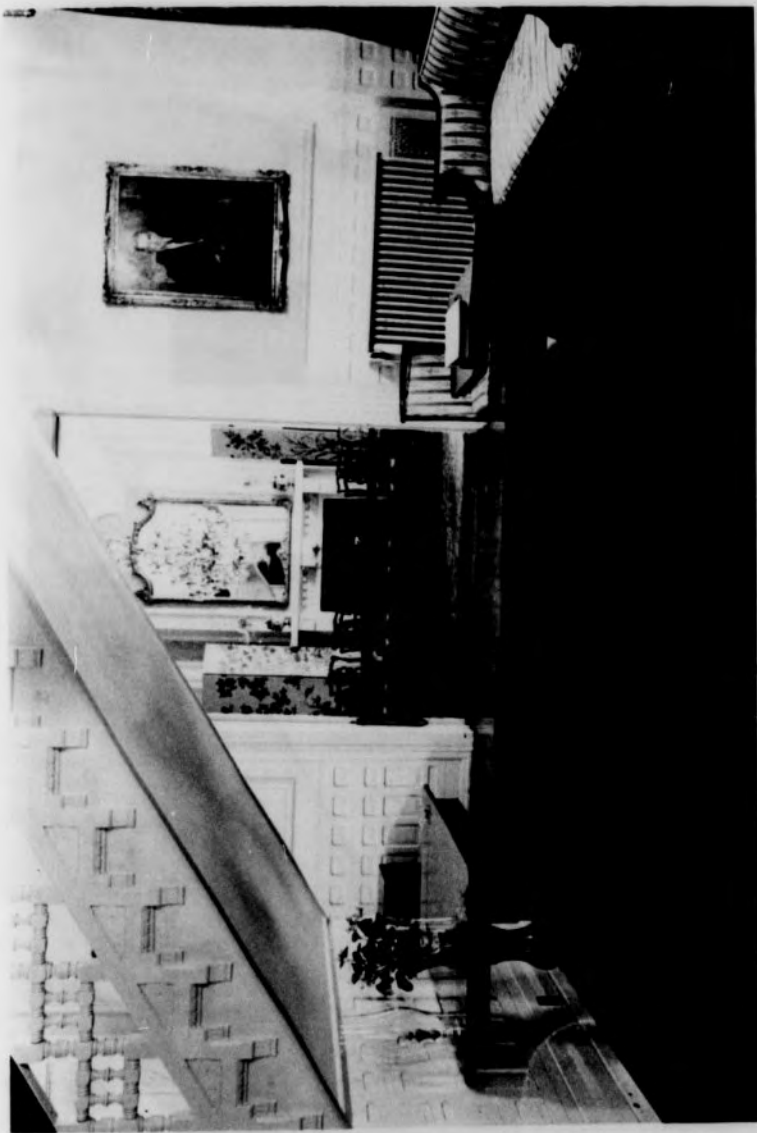
Figure 40. Before View of the Area Behind the Staircase

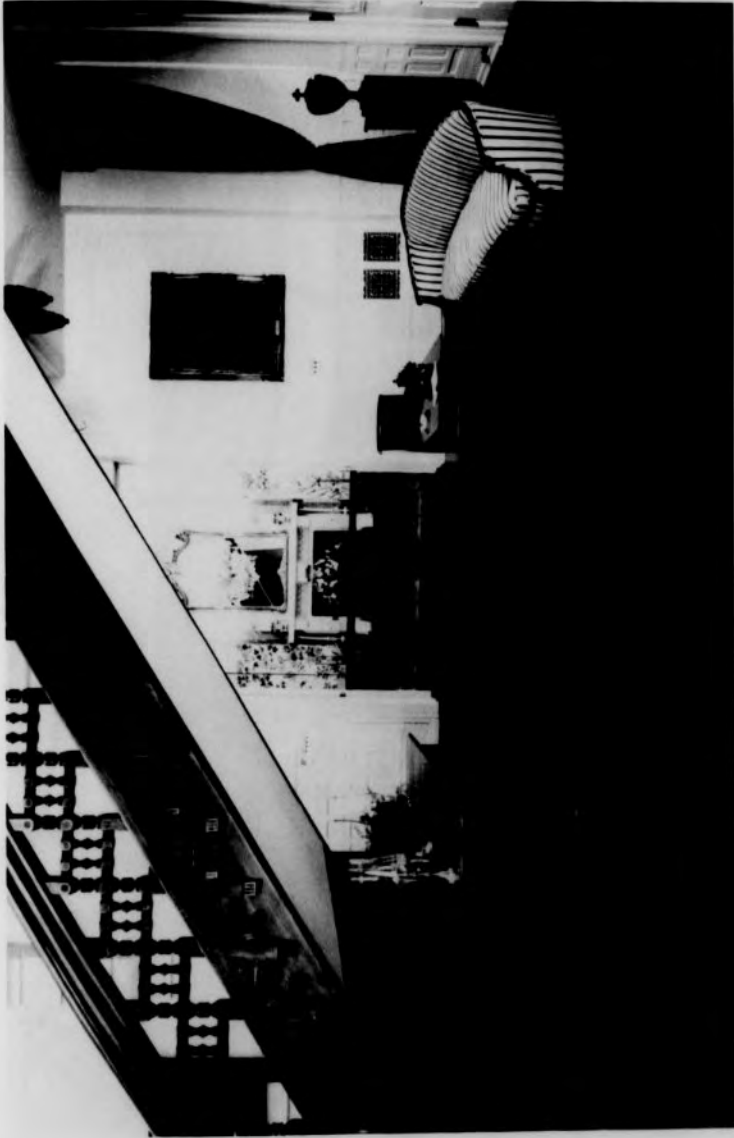
Figure 41. After View of the Area Behind the Staircase Showing the Grill for the Heating, Ventilation, and Air Conditioning Systems

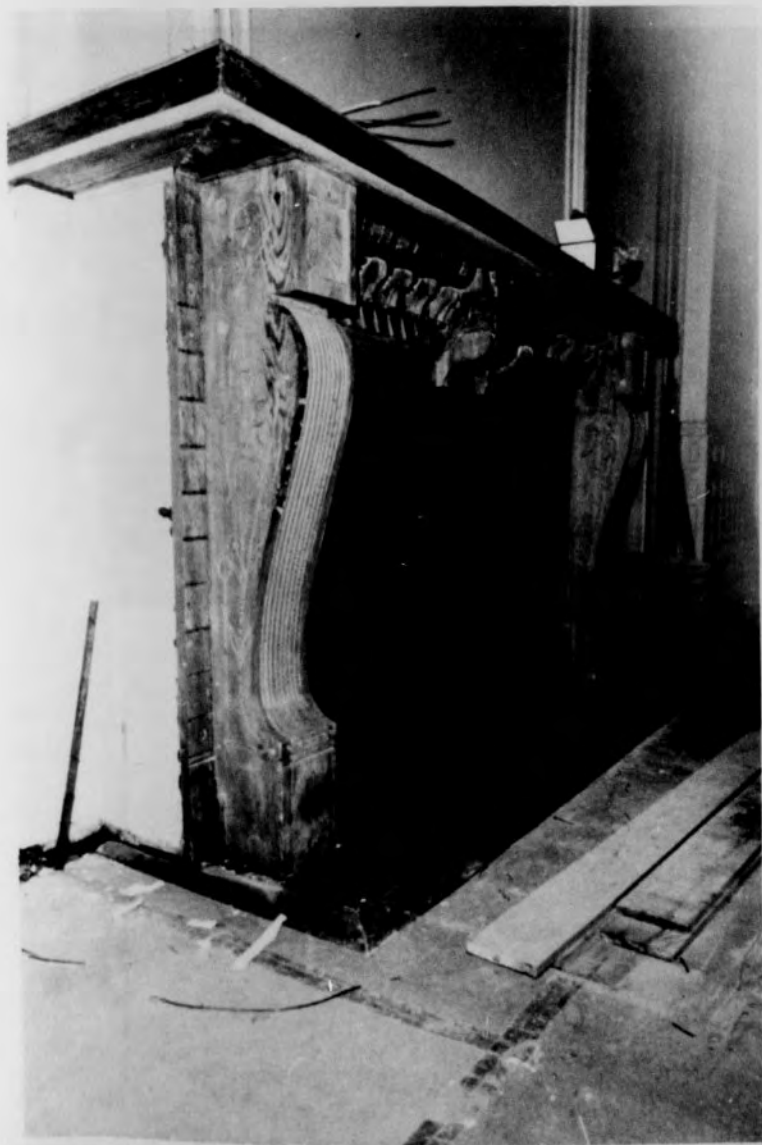
Figure 42. Fireplace Mantel Stripped of Paint
and Reset in Wall

Other wood details. First floor doors, wood molding, wainscoat paneling, and fireplace mantels which could be removed were taken off site and vat dipped to remove the paint (Figure 42). The mantelpieces were of special concern because they had been scorched and were separating from the plastered walls. After stripping the paint off, these mantels were reset with the marble facing. The wood was then painted to a smooth finish in the same tone as the plaster. Unfortunately, because of insufficient funds, this restoration could be done only on the first floor.

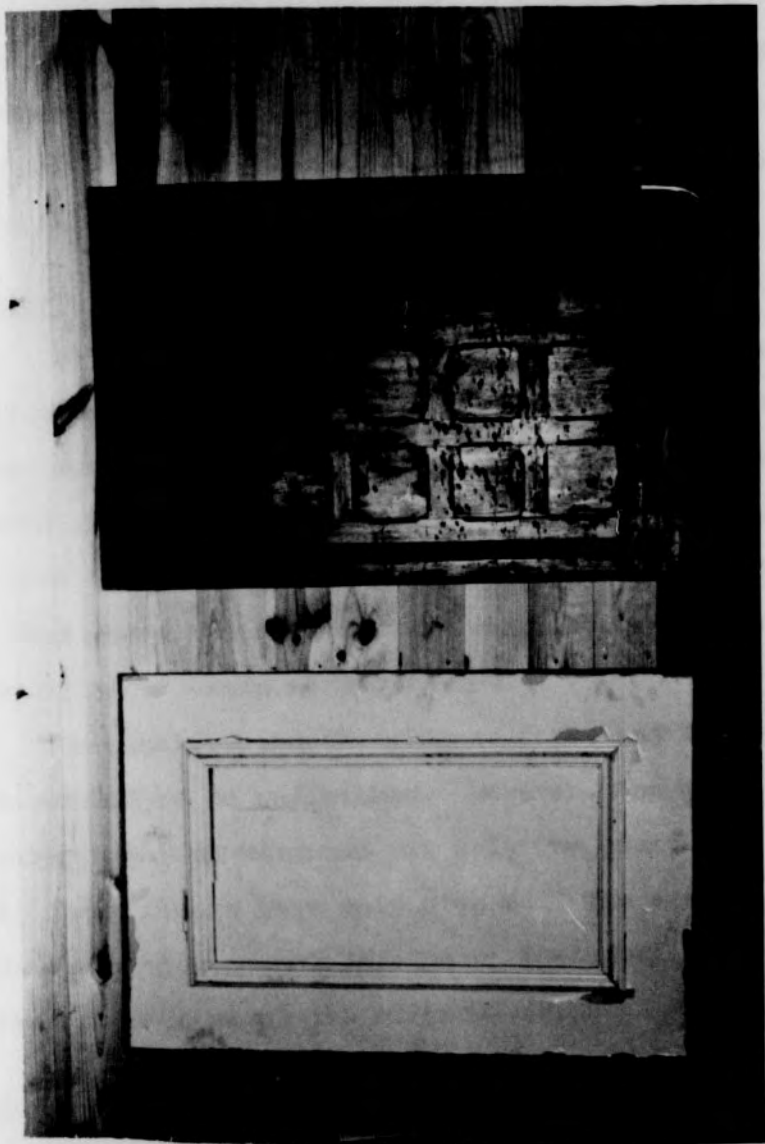
Wood panels. Coffered wood panels above all doors and above and/or below windows had been covered by particle board panels (Figure 43). These panels were removed and the coffered panels were painted to match the plaster.

Figure 43. Discovered Wooden Panel

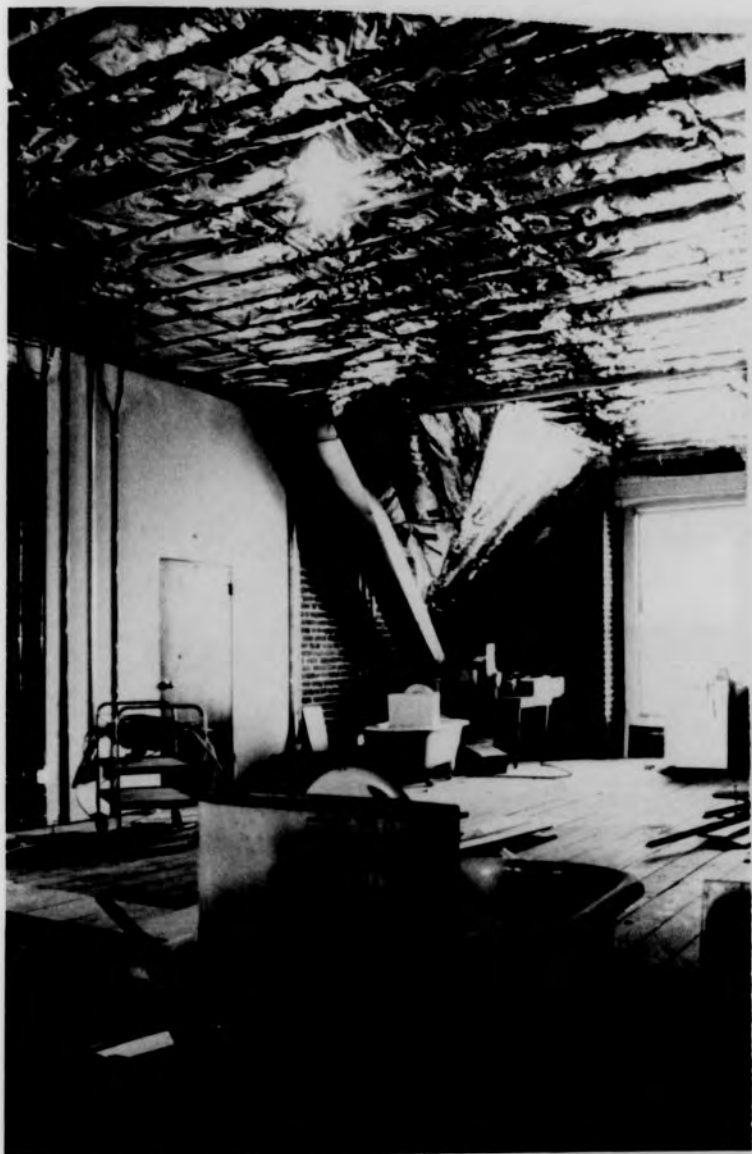
Figure 44. Insulation of the Third Floor in an Unfinished Area

However, in order to maximize the insulation qualities of the brick walls and in anticipation of the expanded use of the third floor, fiberglass bats, and loose fibers were placed between the third floor ceiling and the attic floor, and between attic ceiling beams (Figure 44). Prior to installation of the fiberglass, a fireproofing spray was also applied to all exposed wood.

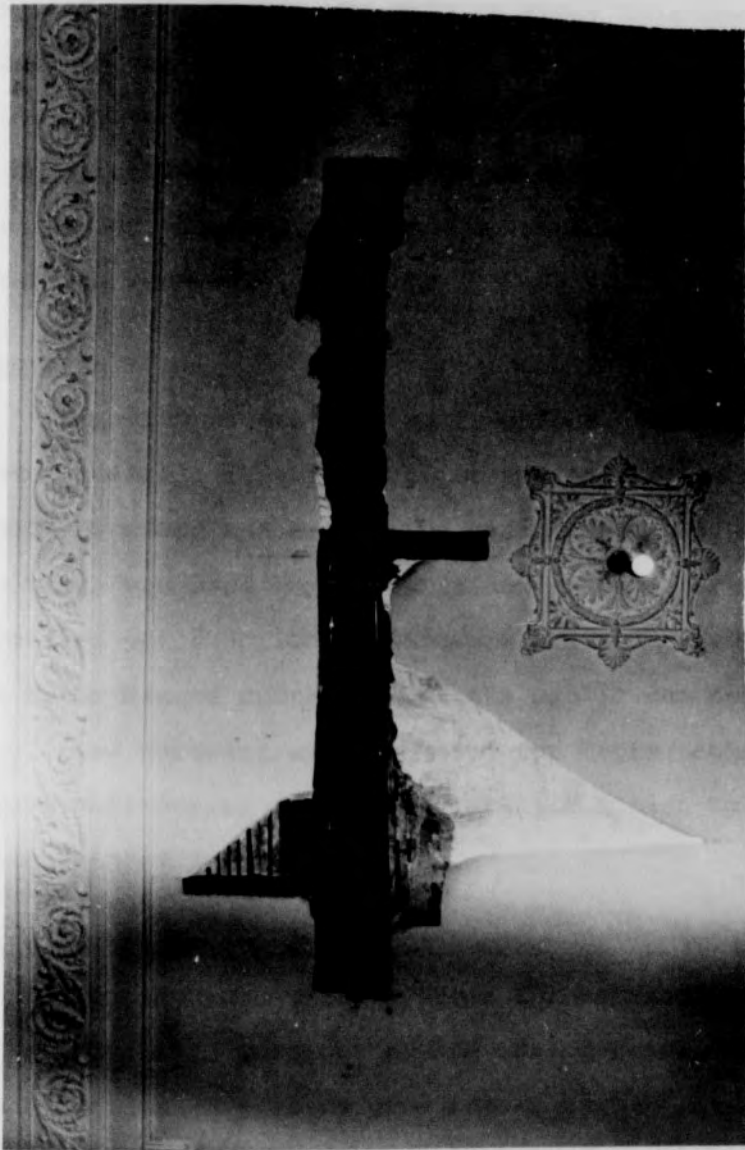
Examination of the original plaster revealed that a base coat had been covered with a canvas impregnated with plaster (Figure 47). In most areas the canvas was removed and replaced with a textured wallpaper similar to the original canvas.

Figure 47. Ceiling in the Ballroom Showing the Plaster and Canvas Finish and the Chasing for the Electrical Conduits

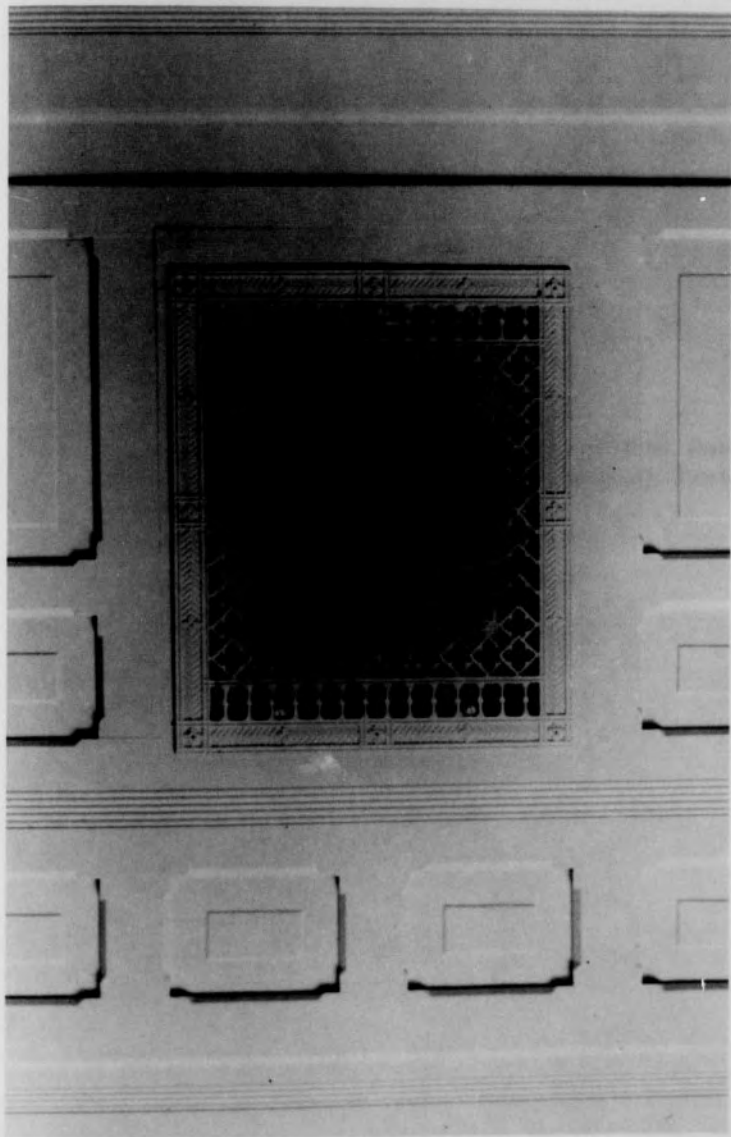
Figure 49. Decorative Grill from Old Forced Air System of Heating

from the basement to the first-floor decorative grills (Figure 49). However, these grills had been blocked off and radiators for circulating steam heat installed many years ago. This system had one thermostat, which was ineffective in providing even temperatures throughout the Mansion. The radiators were also noisy, leaked, and limited flexibility in room arrangements.

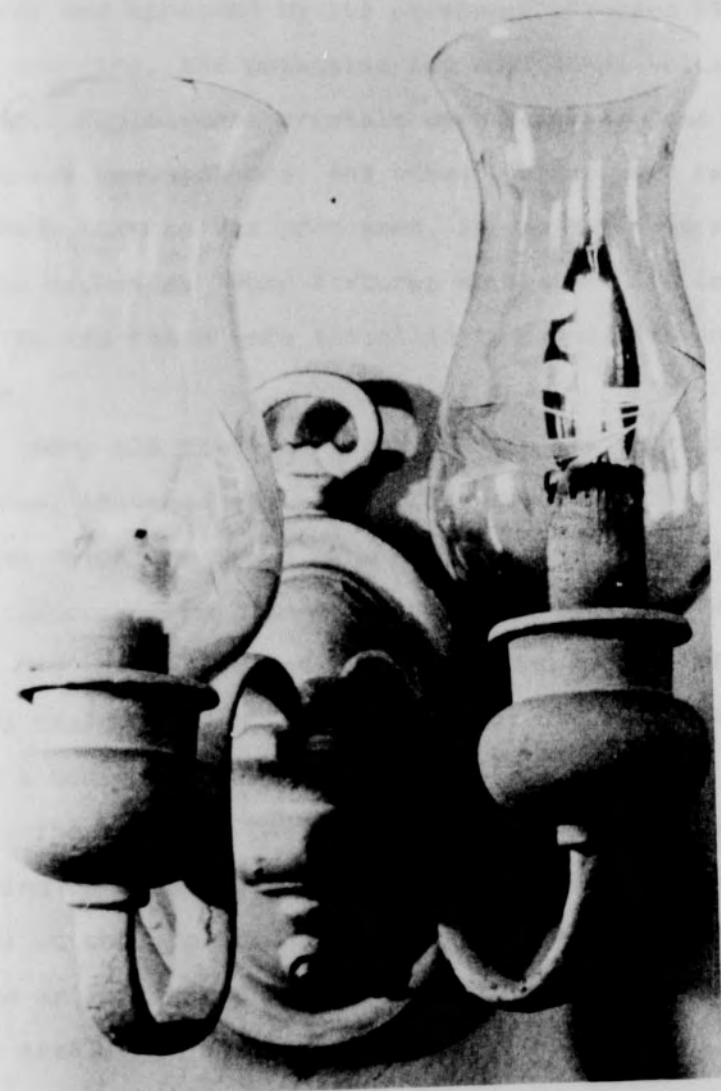
Figure 57. Painted Solid Brass Wall Sconce

Light fixtures. After the existing light fixtures were taken down and examined, it became evident that additional work would be required. The metal plating was peeling and tarnishing. Many fixtures had been painted (Figure 57).

As a result, fixtures were replated or buffed and sealed with a protective coating (Figure 58).

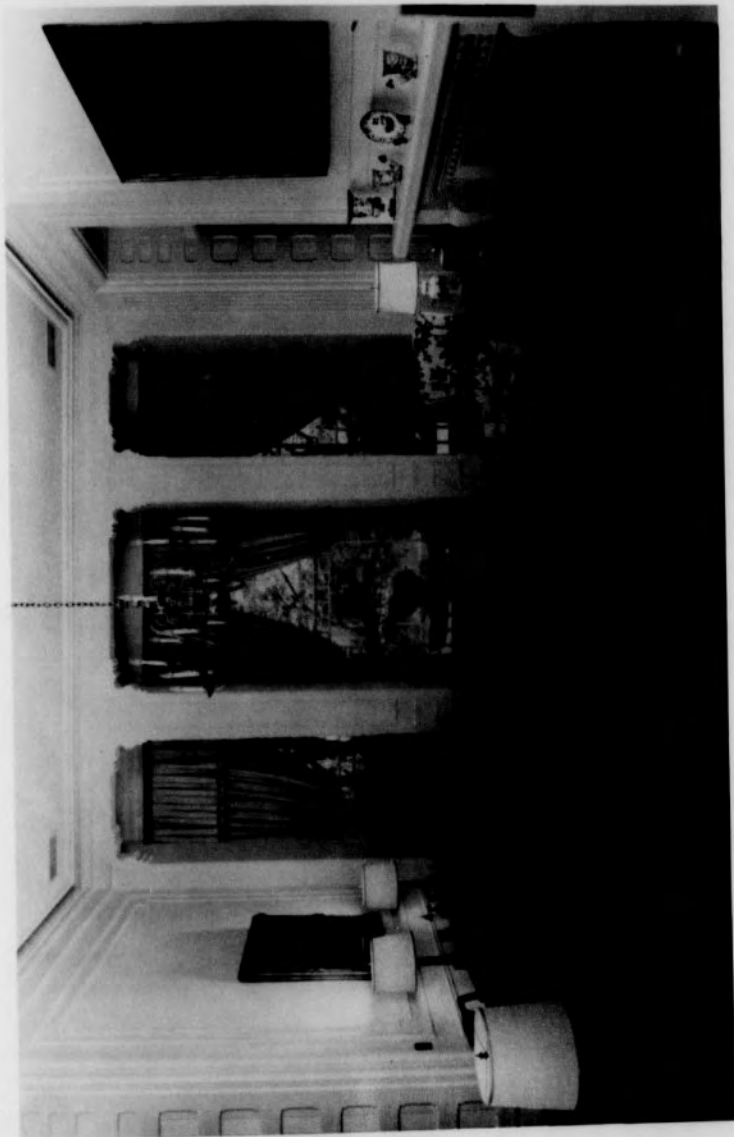
Figure 84. Governor's Study After 1974-76 Renovation and Partial Restoration

Governor's study. The existing cream wool hand crewel draperies and valances were rehung, and the domestic oriental design rug was also reused (Figure 84).
