Operational Evaluation Test Report on Beaver Micro-Vegetation Cutter

**Operational Evaluation Test Report
on
Micro-Vegetation Cutter**

March 2005

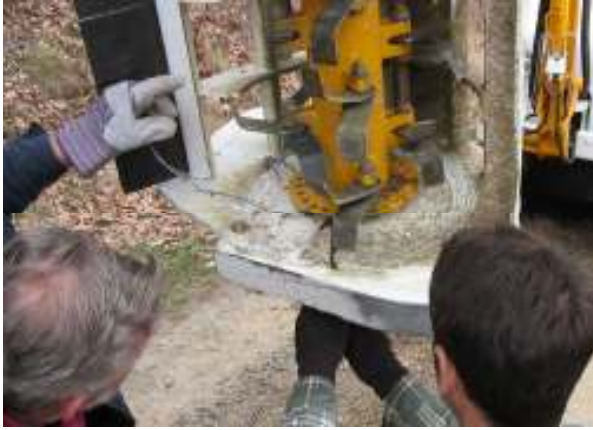
Figure 3: Pre-Test Cutters

- **Vegetation Cutter:** The vegetation cutter was designed and fabricated in the Humanitarian Demining Program's fabrication shop at Ft. Belvoir. A second hydraulic pump is mounted in the Beaver to power the cutter. As a result of the high failure rate of the commercially procured cutting blades used during the pre-evaluation test, new cutters were designed and manufactured in the fabrication shop and used throughout the operational evaluation test. Figures 3 and 4 show the damage sustained by the two-piece cutters used during the pre-evaluation test (wt. = 434 grams); Figure 5 shows the pre-test cutters (left) and the T-1 steel machined cutter (right) used during the

operational evaluation test (wt. = 634 grams); and Figure 6 shows the machined cutter (left) and the 4130 heat-treated cast alloy cutter (right) that will be used on future fabricated vegetation cutters (wt. = 756 grams). The weights and materials are shown for each of the cutters as an indicator of each cutter's strength and durability.

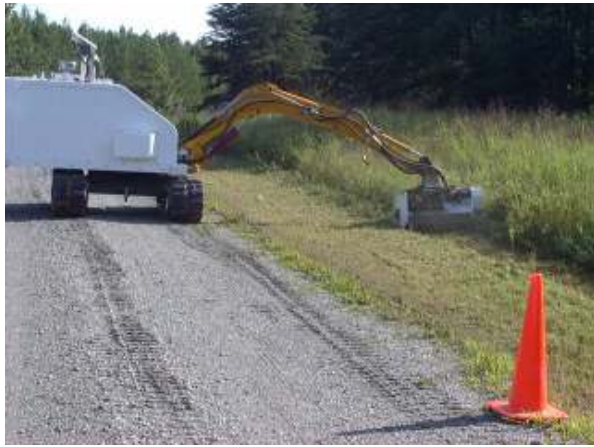
Figure 11: Category 1 Cutting

Throughout the cut, the control vehicle, the Duck, was behind and off to one side of the Beaver, which allowed the operator a clear line of sight of the position of the cutter head.

The Duck never entered the area being cut. The operator said that the Beaver-mounted camera was very useful in lining up the cuts.

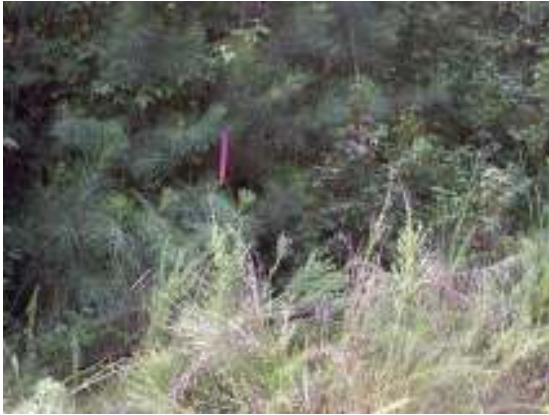
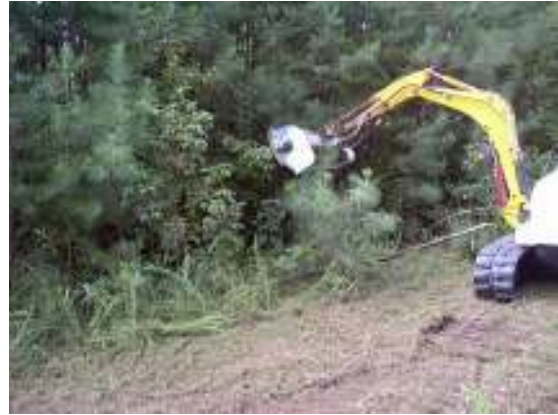
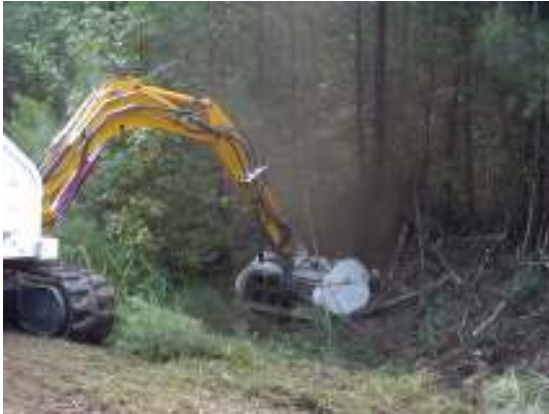
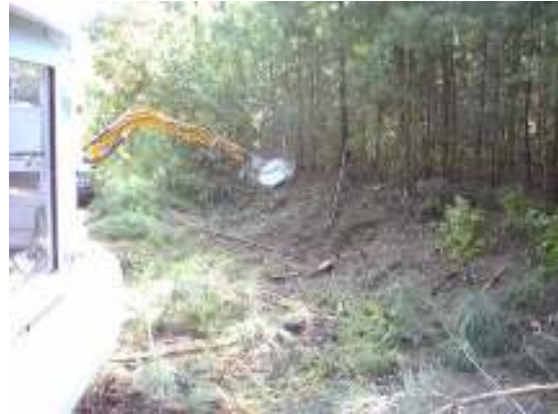
Two larger Category 3 size trees, each measuring 7.5 cm in diameter, were removed in the following manner. The cutter was used to put a cut into the front side (side facing road) of the tree trunks at a height of about 3 meters. The cutter was placed behind the trees, above the cut, and used to pull the trees back toward the road, snapping the trees off at the point of the front cut. The cutter was then used to chew the standing stumps down to ground level and to mulch the tops.

The area cut measured 16 meters by 4.5 meters, an area of 72 m² cleared in 1 hour.

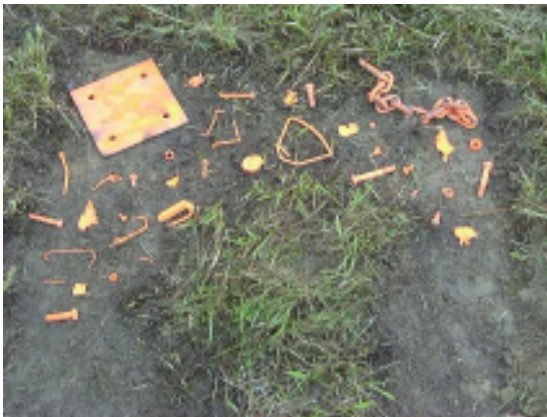
Figure 18: Ferrous Scrap

A Category 1 area, 25 meters by 9 meters, was mowed with the cutter. Thirty-nine pieces of ferrous scrap of various sizes, painted bright orange, were placed randomly throughout the mowed area under the debris from the cutting (see Figure 18). The electromagnet was passed over the area, sweeping the total area in a series of 13 passes. On each pass, the operator kept the magnet as close to the ground as possible without dragging the magnet over the cut vegetation. The magnet was turned off to collect retrieved scrap after every two passes (down and back). A total of 36 pieces of scrap were recovered. A visual search of the area found one more piece. The remaining two pieces were never recovered. However, a metal link from an ammunition belt, not part of the test scrap, was also recovered by the electromagnet. The operator could not guarantee that 100% of the area had been covered since the magnet left no visual tracks of previous passes.

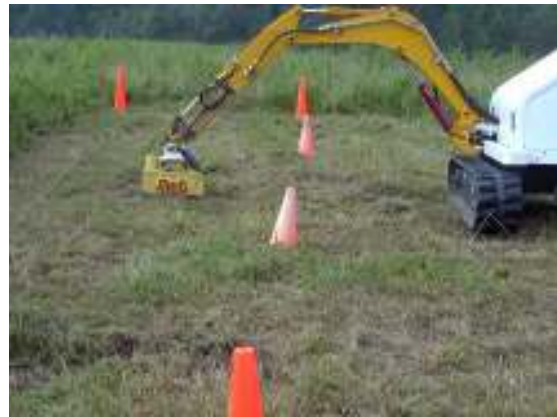
Figure 19: Magnet Sweep

To test the effectiveness of the magnet, seven various pieces of the scrap were selected and placed on a flat area of ground. The magnet was raised above the scrap, turned on, and slowly lowered until the first piece of scrap was picked up. The distance was measured. The lowering of the magnet was continued until all pieces were picked up, with measurements being made as each piece was pulled to the magnet. The test was run twice. The results are presented in Table 6. The difference in pickup height for the same object in the two trials is attributed to the attitude of the electromagnet presenting a changed magnetic field. Figure 19.

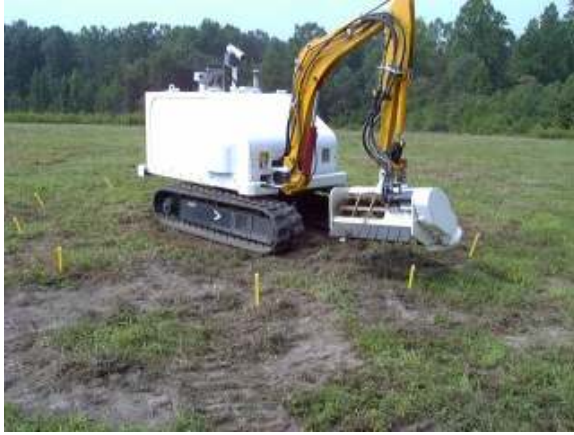
Figure 22: Beaver Turning Radius

Since both vehicles are tracked vehicles, the minimum turning radius will be that achieved by pivoting in a “zero-radius turn,” that is, turning by having one track move forward while the other track moves backwards. By so doing, a tracked vehicle will turn on a point midway between the vehicle’s track system. The minimum turning radius measured for the Beaver was 16.25 feet (4.96 meters) and for the Duck was 8.8 feet (2.69 meters). See Figures 22 and 23.

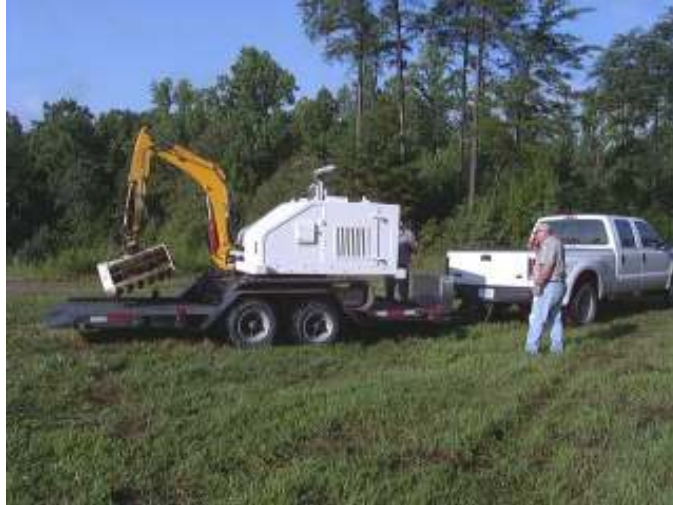
Figure 24: Beaver on Trailer

Local transporting (to and from a staging area) of the Beaver and Duck vehicles, as well as the three attachments (cutter, electromagnet, and bucket shovel), is most easily accomplished with two four-wheel automobile trailers each pulled by a pickup truck. Since the Beaver weighs almost 8,000 pounds (3,629 kg), a heavy truck capable of towing 8,000 pounds will be needed. The Duck, with attachments and tools, weighs about 5,000 pounds (2,268 kg), and may permit the use of a truck with a lower towing capacity. However, if any off-road or unimproved secondary road travel is anticipated, a truck with a towing capacity similar to that used for the Beaver is recommended. Figure 24 is a picture of the Beaver being loaded for movement at the test site.
