EEA Conference & Exhibition 2008

An investigation of excessive corona on a new 275kV line

Dr. Stewart Hardie, Dr. Alan Wood and Prof. Pat Bodger Electric Power Engineering Centre (EPECentre), University of Canterbury, Christchurch, New Zealand

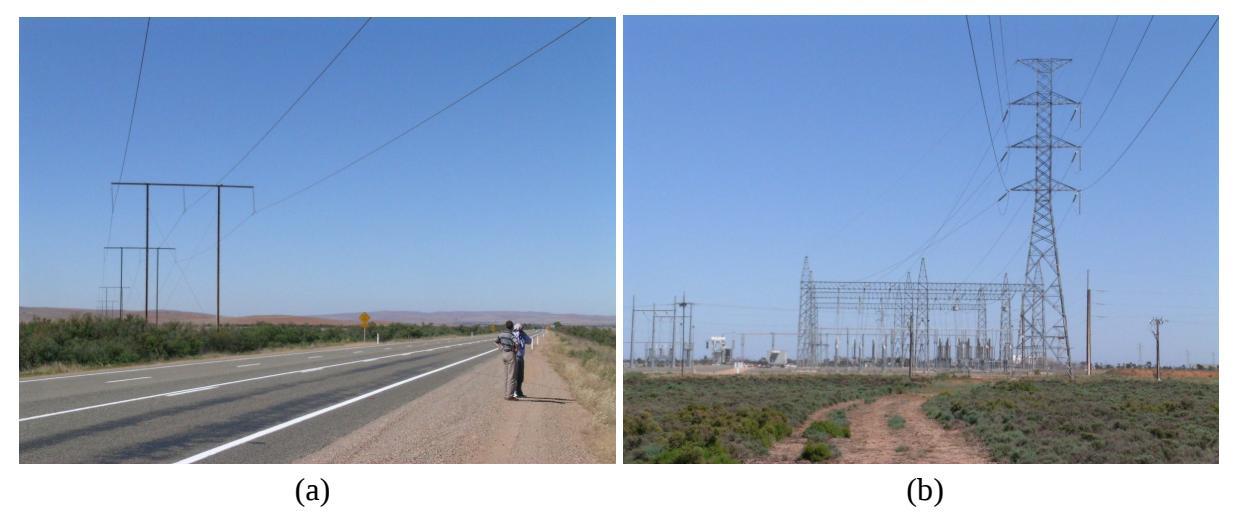
The established Davenport-Para line (300km length) is PI construction with a flat conductor configuration using single olive conductor, shown in Figure 1(a). In 2006, the 275kV network was extended to Bungama substation near Port Pirie. A 7km double circuit transmission line was constructed to connect the existing Davenport-Para circuit to Bungama substation, using DT2/6 (strain) and DS2/10 (suspension or tangent) towers with 3 phase single conductors arranged vertically on each side, shown in Figure 1(b). Initially, one span was energised and excessive corona activity was observed from the new conductor, twice the level of the existing line, and other 275kV lines of the same construction elsewhere. Audible noise tests, conducted in March and April 2006, showed excessive noise levels of up to 51-52 dB(A) whereas the existing line noise levels were 43 dB(A).

Figure 1 – (a) Davenport-Para line, (b) new Bungama line connecting to Bungama substation.

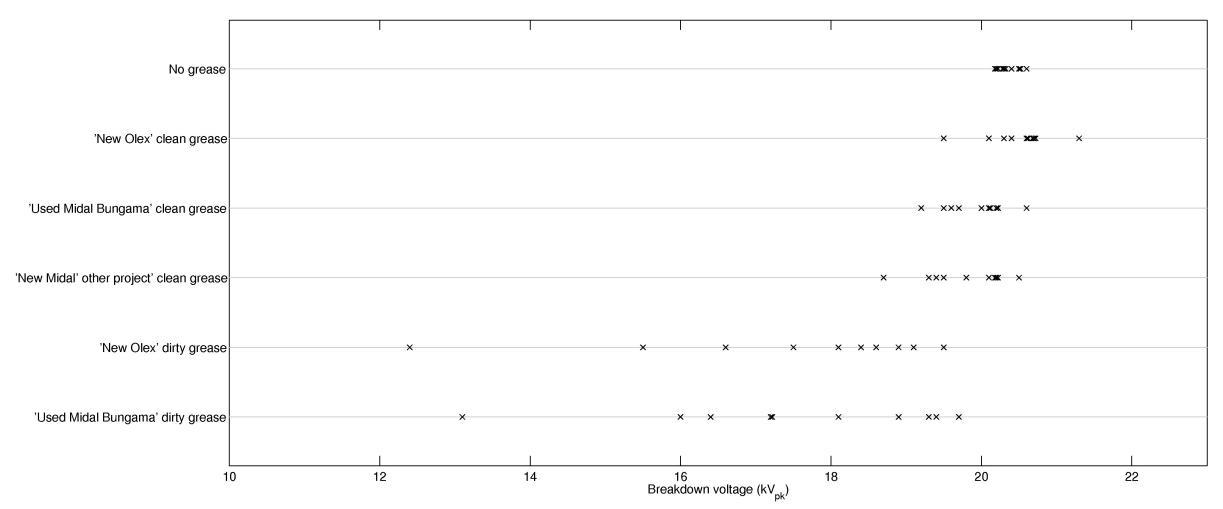
Figure 6 – Breakdown voltages across sphere gaps with various conductor greases applied to one sphere.

The primary conclusion is that clean conductor grease that is present on the exterior of a conductor is unlikely to cause a significant corona problem. Unfortunately, when clean grease is initially present on the conductor exterior, it is highly likely to become contaminated with dirt or other similar material, either during conductor installation on the transmission line or later when wind blown dust is deposited on the conductor. Then, when grease is contaminated, the chances of corona will significantly increase.

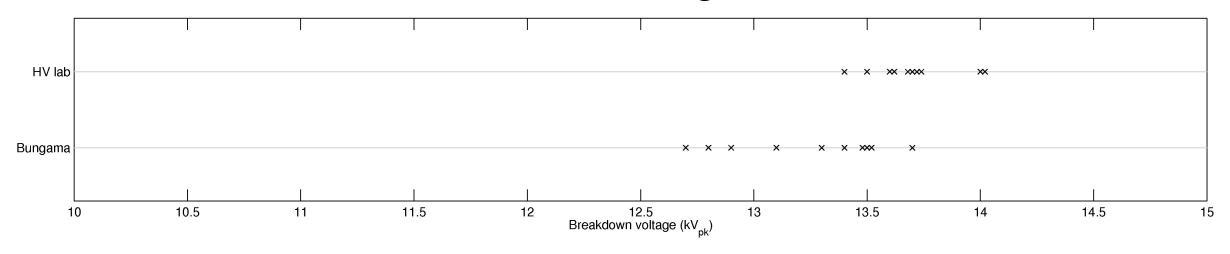
It is unknown why the atmospheric breakdown conditions are slightly lower at Bungama. However, this result means that corona is more likely to start at lower voltages at Bungama.
