# HALT Evaluation of SJ BIST Technology for Electronic Prognostics

James P. Hofmeister, Sonia Vohnout, Christopher Mitchell

**Abstract**—This paper presents the design, test, and results of a highly accelerated life test (HALT) evaluation of a soft-core called Solder Joint Built-in Self-Test™ (SJ BIST™), a method for detecting faults caused by solder-joint fractures in monitored input/output (I/O) pins of field programmable gate array (FPGA) devices, especially those in ball grid array (BGA) type of packages. Modern electronics utilize large FPGAs packages attached to electronic boards by means of solder joints, such as solder balls, between the package and the board. Thermo-mechanical stresses – primarily heat and vibration – cause fatigue damage and eventual fracture failure of one or more balls, which causes intermittent operational faults leading to catastrophic failures in critical systems. Such intermittent faults are difficult to reproduce on a test bench and many field returns of electronic modules with intermittently failing solder balls are diagnosed with code "no trouble found/could not reproduce." The SJ BIST soft-core offers a solution because it detects faults in mo

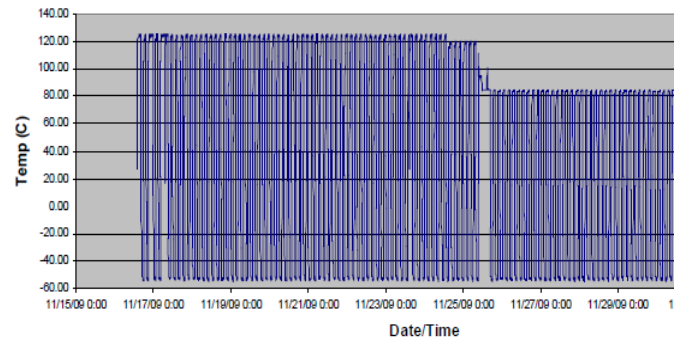
Figure 12. Partial profile of the chamber temperature.

On 25 November, it was noticed the 5A 5VDC power supply was going into current-limiting mode. We decided to reduce the oven temperature to 85°C (see Fig. 12) until we could replace the original with a larger power supply. When we examined the logged data records, and we determined the previous damage to boards 2 and 6 had increased as shown in Table III, Table IV, and Fig. 13:
