Arenosa Creek Surface Water Quality Monitoring Report

Texas Water Resources Institute TR-482
October 2015

Segment: 2453C

Texas Water Resources Institute Technical Report 482

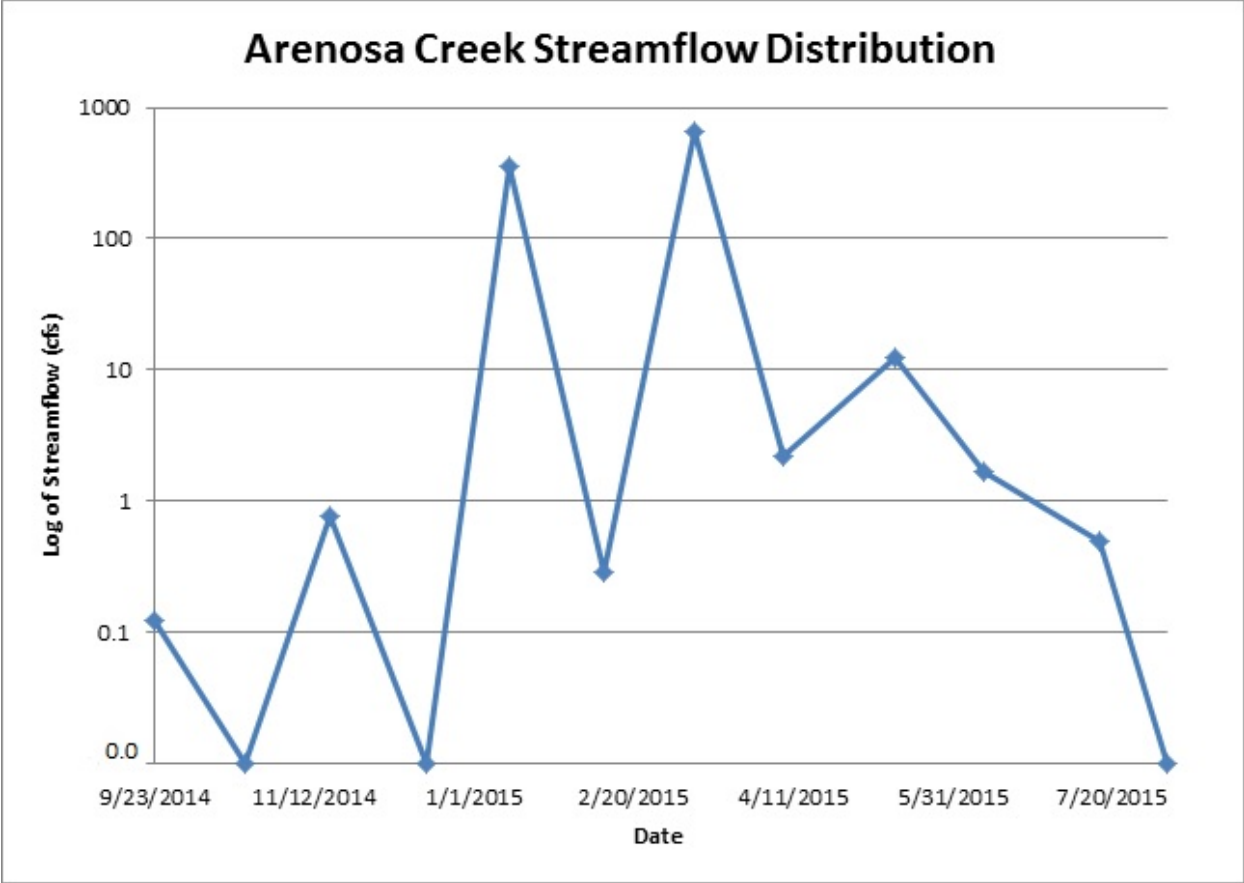
Figure 2. Arenosa Creek streamflow distribution.

Flow ranged from 0 to 647.4 cubic feet per second (cfs) during the sampling period. The highest flow was recorded in March as a result of 4.17 inches of rain falling across the watershed during the 7 days prior to the sampling event. During January, no flow measurements were taken due to unsafe conditions. However, this flow was estimated using the Velocity-Area method. The stream was assumed to be an ellipsoid shape, with an area calculated using the equation-

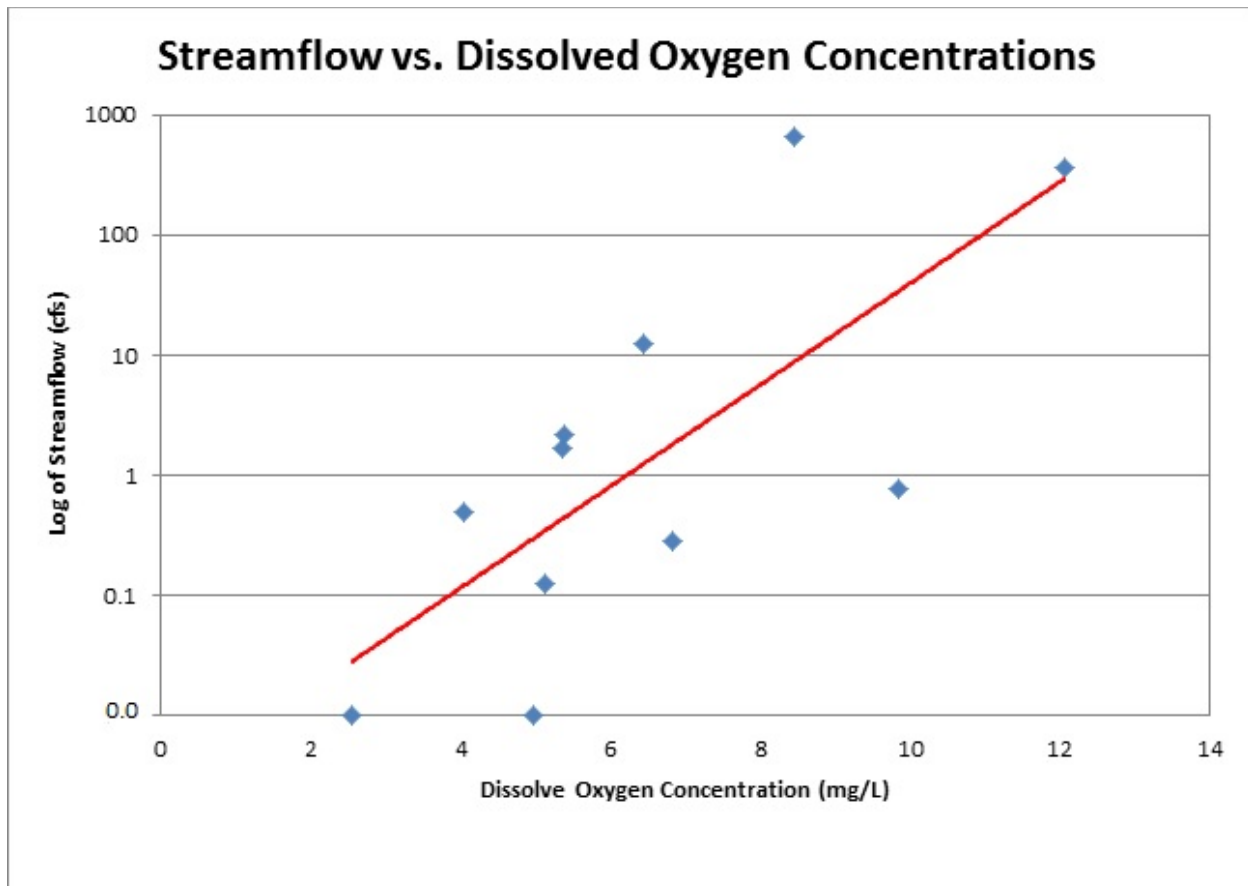
Figure 4. Streamflow vs. DO concentrations in Arenosa Creek.

The average DO recording was 6.5 mg/L with a maximum value of 12.0 mg/L and a minimum recording of 2.6 mg/L (Figure 3). The minimum value fell below the TCEQ minimum value standard. This reading occurred during a monitoring trip with no flow. There were no statistically significant correlations between streamflow and DO readings ($r= 0.56$; $p=0.07$), or *E. coli* concentrations ($r=0.52$; $p=0.10$). No DO reading was taken during the December 17, 2014 monitoring trip due to incorrect calibration of the YSI EXO1 multiprobe.

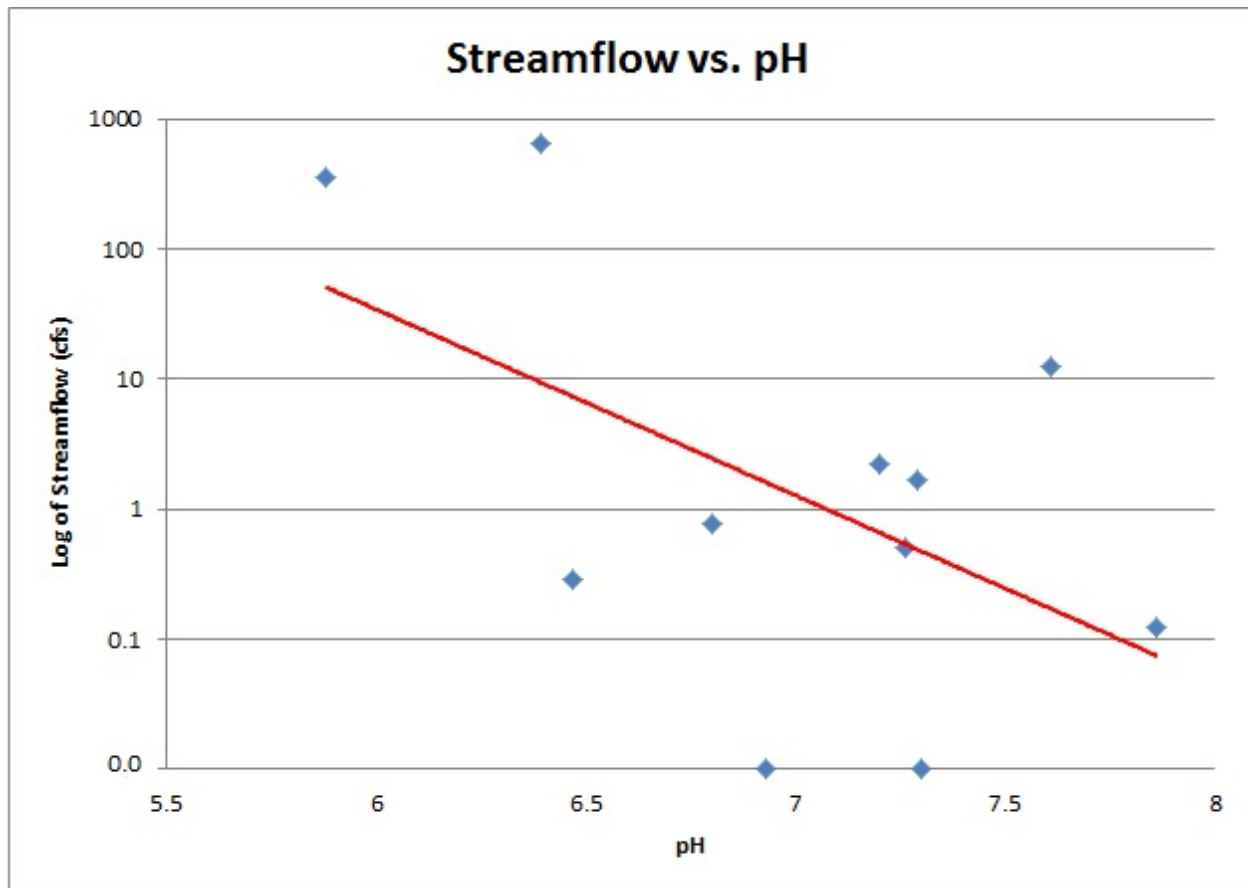
Figure 6. Streamflow vs pH of Arenosa Creek.

Three pH measurements fell below the acceptable pH range of 6.5 to 9.0 between January and March 2015 (Figure 5). pH measurements ranged between 5.9 and 7.9 with a mean of 7.0. There was a statistically significant correlation between pH and streamflow ($r=0.63$, $p=0.03$), but no statistically significant correlation between pH and *E. coli* ($r=0.31$, $p=0.36$). The low pH measurements that were below the TCEQ minimum standard for pH were collected after significant rainfall events. These events could lower the pH of Arenosa Creek due to rainwater having a pH of around 5-6, thus being the likely cause of this minor exceedance. No pH reading was taken during the December 17, 2014 monitoring trip due to incorrect calibration of the YSI EXO1 multiprobe.

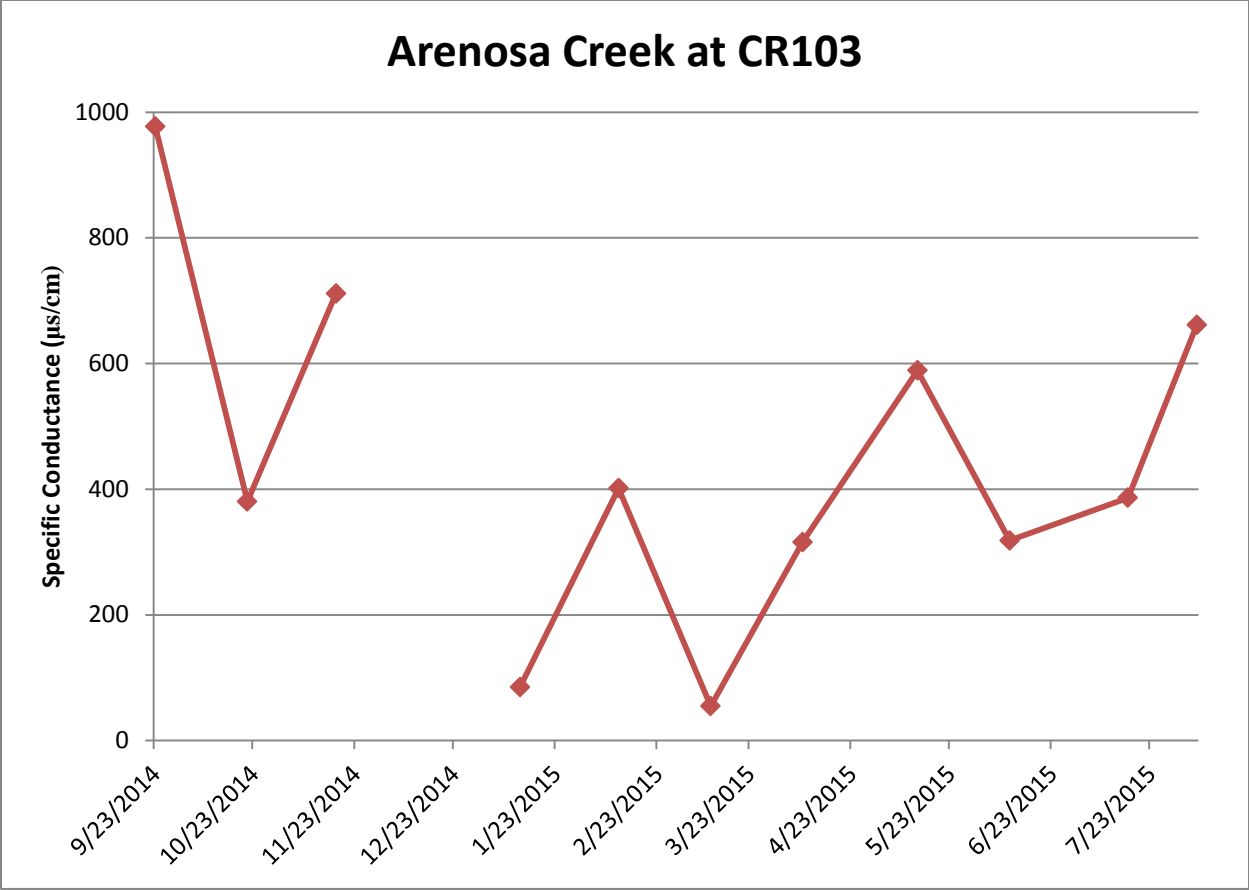
Figure 7. Specific Conductance distribution of Arenosa Creek.

Specific conductance ranged from 55 $\mu\text{s}/\text{L}$ to 977 $\mu\text{s}/\text{L}$, with an average of 444 $\mu\text{s}/\text{L}$ (Figure 7). Unlike many of the previous water quality parameters, there was a significant correlation between specific conductance and streamflow ($r = -0.65$; $p = 0.03$). However, the correlation between *E. coli* and specific conductance was not statistically significant ($r = -0.32$; $p = 0.33$). No specific conductance reading was taken during the December 17, 2014 monitoring trip due to incorrect calibration of the YSI EXO1 multiprobe.

Values collected previously by the GBRA had lower minimum (39 $\mu\text{s}/\text{L}$), median (369.5 $\mu\text{s}/\text{L}$) and mean (427.66 $\mu\text{s}/\text{L}$) specific conductance values than this study; however, data collected by TWRI were not significantly different than the data collected by GBRA ($p = 0.87$).

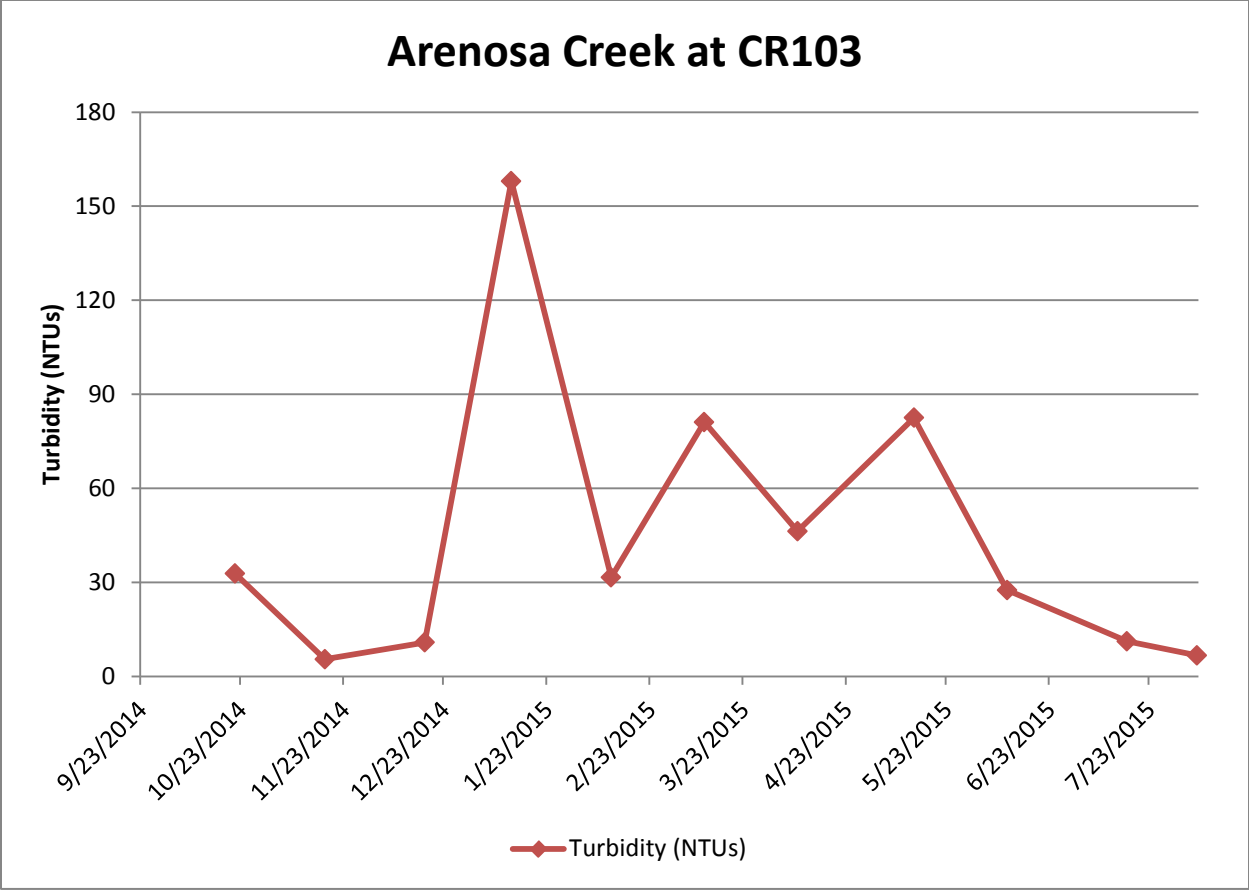
Figure 9. Turbidity distribution of Arenosa Creek.

Turbidity in Arenosa Creek averaged 45 NTU, with a range between 5 NTU and 158 NTU (Figure 9). Turbidity had the strongest correlation of all parameters with *E. coli* ($r=0.83$; $p=0.03$). Streamflow was also correlated with turbidity ($r= 0.65$, $p=0.001$).

Turbidity values collected by GBRA showed minimum (2.8 NTU), median (20 NTU), mean (25 NTU) and maximum (98 NTU) values that were lower than values collected during this study. However, the mean of the data collected by TWRI was not significantly different than data collected by GBRA ($p=0.19$). No turbidity was taken on September 23rd due to not having the turbidity meter.

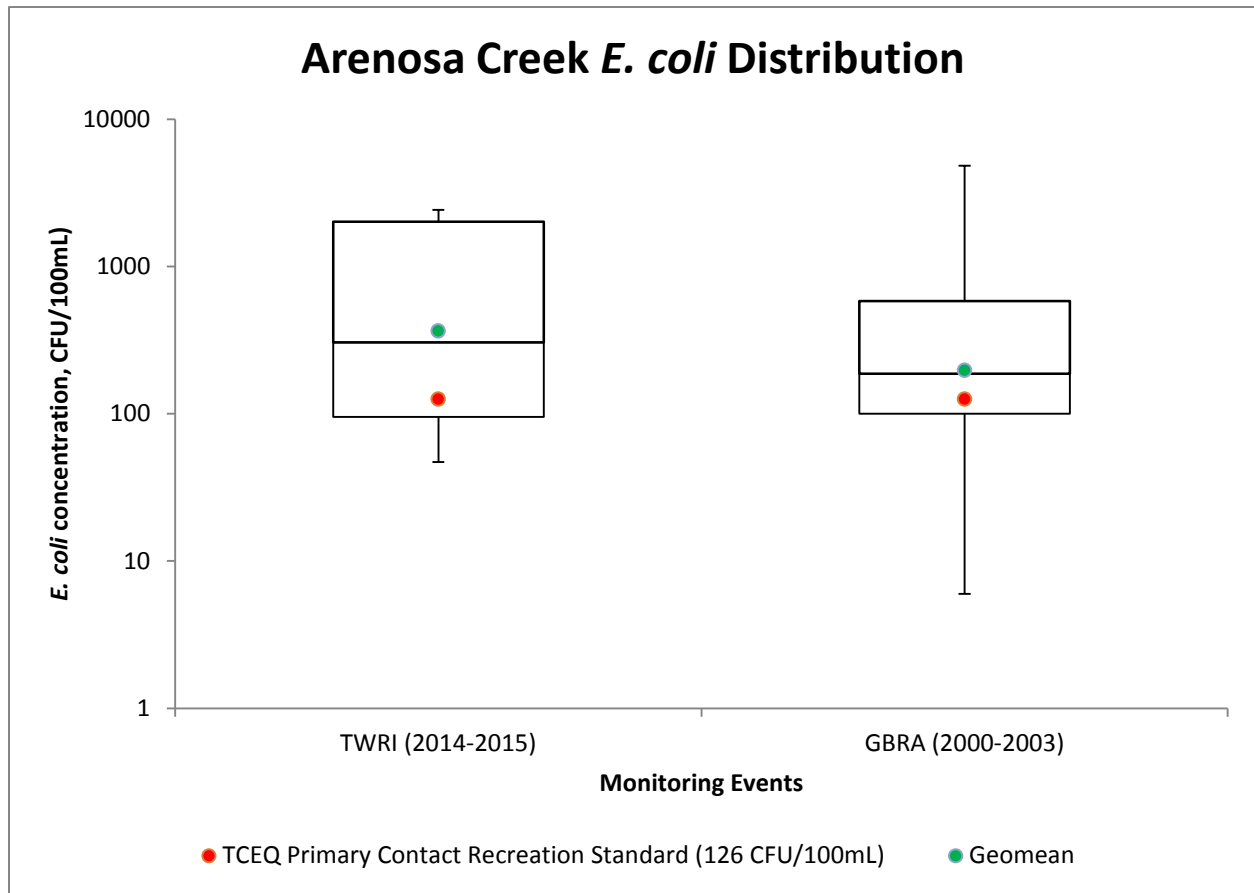
Figure 12. *E. coli* distribution comparison of TWRI and GBRA monitoring of Arenosa Creek.

Minimum, median, and geomean *E. coli* concentrations found during this study were higher than values found during the GBRA study (Figure 12). However the means of both studies were not significantly different (p= 0.32). While it appears that the spread of the GBRA study is greater than this study, half of the *E. coli* samples were analyzed using the MTEC method which does not have maximum values.
