# RECTANGULAR RC WALLS UNDER BI-DIRECTIONAL LOADING: RECENT EXPERIMENTAL AND NUMERICAL FINDINGS

ABSTRACT: Following the recent earthquakes in Chile (2010) and New Zealand (2010/2011), peculiar failure modes were observed in Reinforced Concrete (RC) walls. These observations have raised a global concern on the contribution of bi-directional loading to these failure mechanisms. One of the failure modes that could potentially result from bidirectional excitations is out-of-plane shear failure. In this paper an overview of the recent experimental and numerical findings regarding out-of-plane shear failure in RC walls are presented. The numerical study presents the Finite Element (FE) simulation of wall D5-6 from the Grand Chancellor Hotel that failed in shear in the out-of-plane direction in the February 2011 Christchurch earthquake. The main objective of the numerical study was to investigate the reasons for this failure mode. The experimental campaign includes the recent experiments conducted in the Structural Engineering Laboratory of the University of Canterbury. The experimental study included three rectangular slender RC walls designed based on NZS3101: 2006-A3 (2017) for three

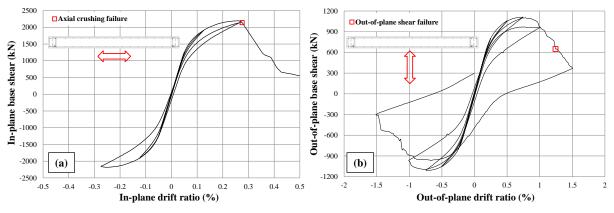
Figure 5 Base shear-drift ratio curve of wall D5-6 under (a) in-plane uni-directional and (b) out-of-plane uni-directional loadings

Figure 5 shows the base shear vs drift ratio as well as the failure point of the wall when it is under in-plane uni-directional (Figure 5a) and out-of-plane uni-directional loadings (Figure 5b). It was assumed that the wall had a cantilever deformation in the in-plane direction when it's under in-plane loading and a double bending deformation in the out-of-plane direction when it is under out-of-plane loading. Therefore, the in-plane shear span of the wall was

assumed 16375 mm (equal to the in-plane effective height of the wall) while the out-of-plane shear span of the wall was 2675mm (equal to half the height of the first storey). As can be seen in Figure 5b, the wall had a 42% strength reduction when out-of-plane shear failure occurred. This strength degradation of the wall when it was under out-of-plane loading was due to out-of-plane shear cracks which did not happen when the wall was under in-plane unidirectional loading only.

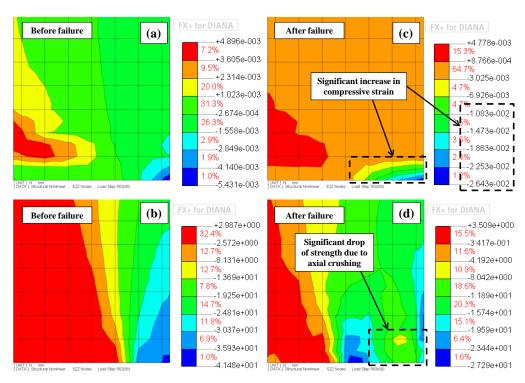
Figure 6 Wall D5-6 under in-plane uni-directional loading (a & b) axial strain and stress before failure, and (c & d) axial strain and stress after failure

Figure 6 and Figure 7 show the behaviour of the wall under in-plane uni-directional loading before and after failure. As the axial strain and stress contours as well as the crack pattern show, the wall under in-plane loading failed in axial crushing resulted from high axial load and lack of confinement. It should be noted that in Figure 7, cracks are filtered to only show the major cracks and neglect the minor ones. However, when the wall was under out-of-plane loading, it failed in shear in the out-of-plane direction (Figure 8). Out-of-plane shear failure was defined as the point that out-of-plane shear cracks forms along the wall's length. Figure 9 compares the crack pattern resulted from FE analysis with the earthquake observations.

High axial load on the deformed wall acted as vertical shear along the wall and led to the outof-plane shear failure of the wall. Low longitudinal reinforcement ratio and lack of sufficient out-of-plane ties were two of the important parameters that led to the final failure of the wall.

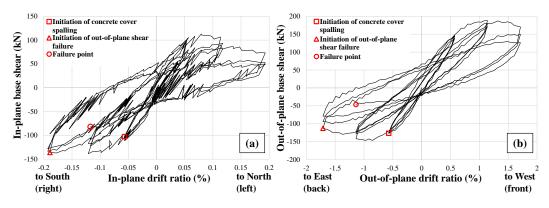
Figure 16 Base shear - drift ratio of SP2-ND in the (a) in-plane and (b) out-of-plane directions

Figure 16 shows the base shear vs drift ratio of the specimen SP2-ND in the in-plane and out-of-plane directions. Initiation of concrete cover spalling, out-of-plane shear failure and final failure point are shown in Figure 16. Initiation of out-of-plane shear failure was considered when shear cracks formed transverse to the wall (see Figure 13). The specimen had 33% out-of-plane strength reduction from its left side and 46% from its right face before failure.
