EVALUATION OF NEW TECHNOLOGIES TO SUPPORT ASSET MANAGEMENT OF METRO SYSTEMS

GUNASINGAM RAVINDRAN

**A thesis submitted in partial fulfilment of the requirements for the award
of the degree Doctor of Engineering (Eng.D) at the
University of College London**

August 2020

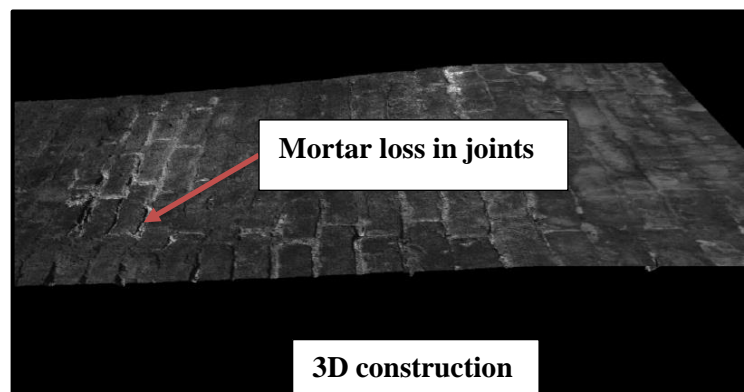
Figure 3-21 Mortar loss in joints- 3D segment re-construction

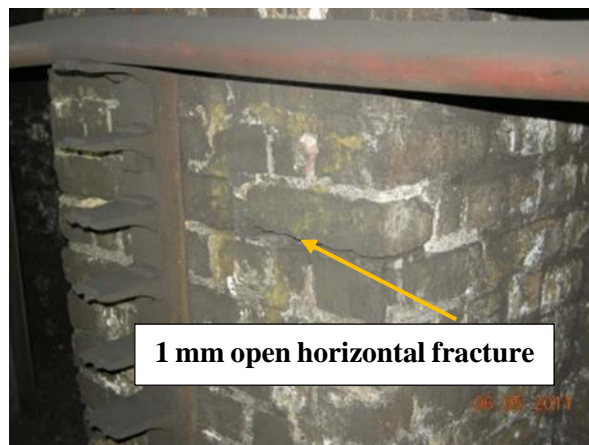
**Figure 3-31 North abutment 1mm open horizontal fracture
(LUL, 2011)**

Figure 3-31 shows the north abutment, with a minor 1mm open horizontal fracture between girders 13 and 14. This defect was not identified by the laser survey due to it being out of line of sight between the laser and the object. Furthermore, other defects mentioned in the visual inspection report for this asset could not be compared with the laser inspection because of the two different referencing systems mentioned above.

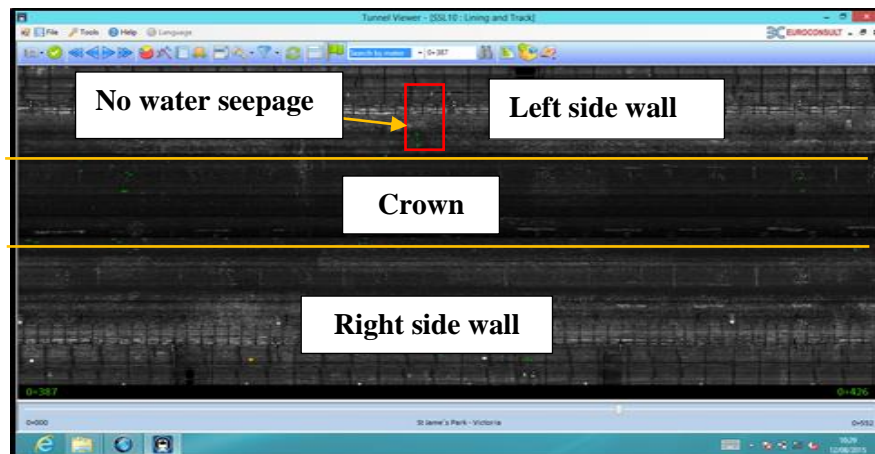
Figure 3-33 Laser inspection water seepage -TL17

TL17 is located between Victoria and St James Park stations; the tunnel is 196m in length. Active water seepage at chainage 60 from the arch springer to track the level on the left side wall (see Figure 3-34) was identified during the visual inspection. However, this water seepage was not identified by the laser inspection and was not seen in the “Tunnel Viewer” software (see Figure 3-33). This seepage may have been inactive during the laser inspection.

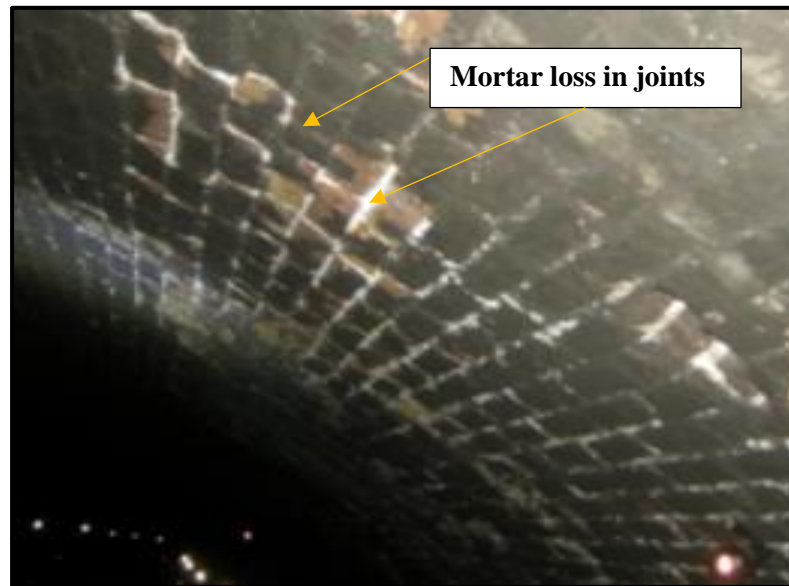
Figure 3-36 Visual inspection Mortar loss in joints – TL17, LUL 2013

The view of typical spalling and mortar loss in joints in the arch soffit at chainage 65 of tunnel 17 (left side) is shown in Figure 3-35 and Figure 3-36 and was identified by both inspection methods.

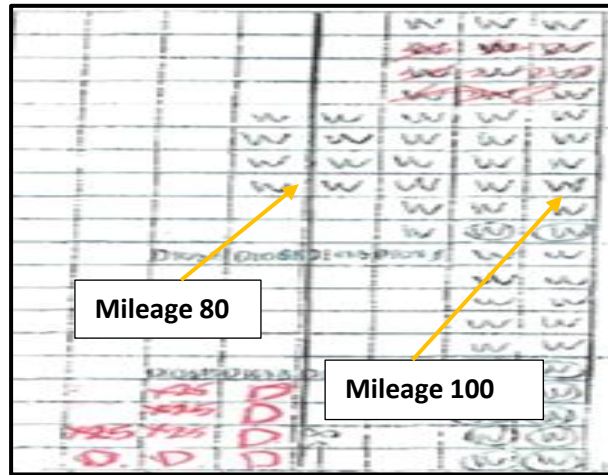
Figure 3-38 Visual inspection water seepage tunnel chart TL-17 (LUL, 2011)

The active water seepages between chainage 80 and 100 were identified as damp patches in the laser survey shown as a blue rectangle in Figure 3-37. The visual inspection tunnel chart (see Figure 3-38) shows this defect using standard defect notification “w” (wet and damp area) at the left sidewall.

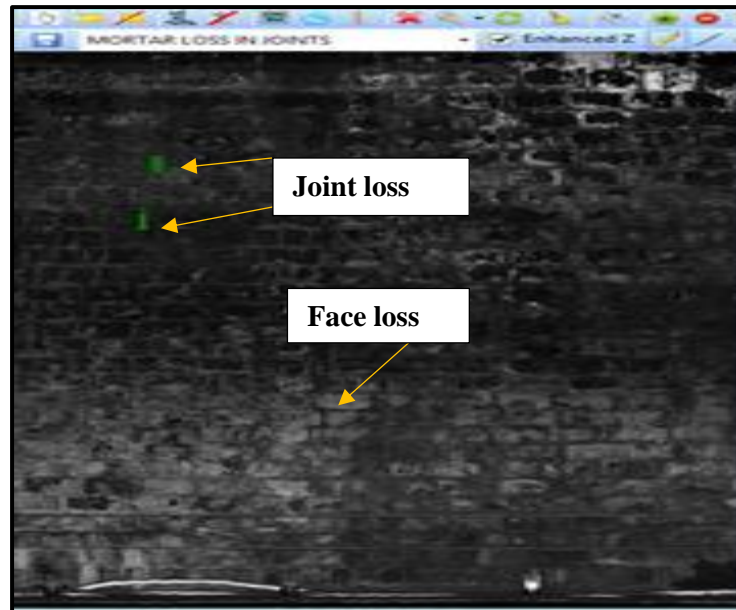
Figure 3-43 Laser Inspection Face and Joint loss- TL56

Figure 3-43 shows face loss and joint loss of the south side wall of TL56 at chainage 100 identified by the laser inspection. At the same time, Figure 3-44 shows joint loss and spalling (visual inspection called face loss as spalling). According to the inspector's comment, drumminess was also identified by the inspector in this area. The laser survey cannot identify drumminess and this seems to be one of the major limitations of this method.

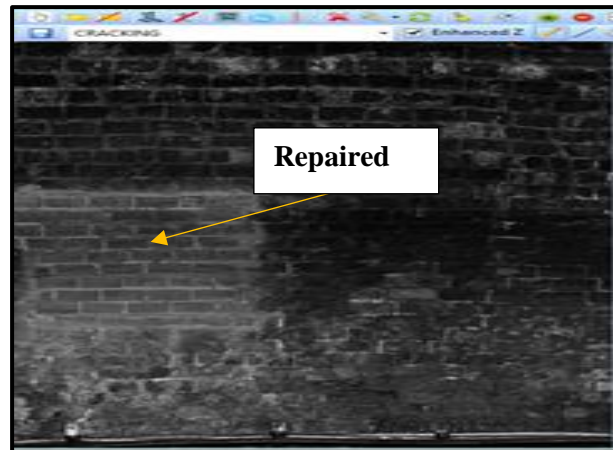
Figure 3-45 Laser inspection Repaired area-TL56

Figure 3-45 shows the repaired area of the Northside haunching at chainage 38 which was clearly captured by the laser survey. According to the visual inspector's comment, the area suffered a 50mm depth spalling of the brickwork and was repaired (see Figure 3-46). According to the Engineering standard S1060, repaired areas and re-pointing works should be clearly shown in the photographs with a clear description of previous defects.

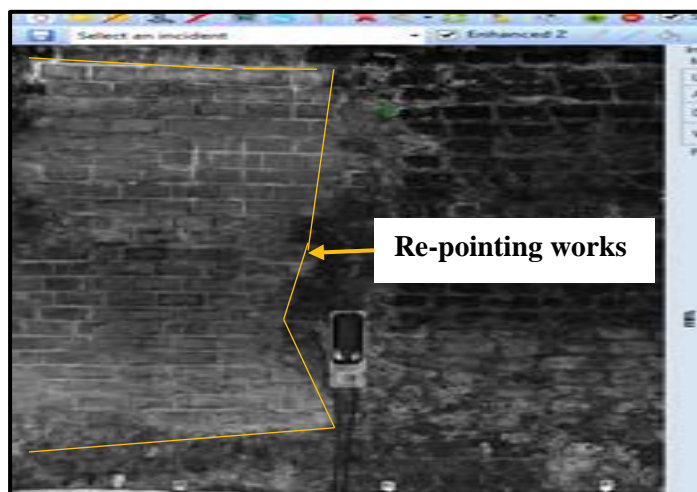
Figure 3-47 Laser Inspection Re-pointing work - TL56

Figure 3-47 shows re-pointing work at the Northsides haunching (between chainage 55 and 60) which was captured by the laser survey using the radiometric property of the laser. This work was noted by the visual inspection as well (see Figure 3-48).

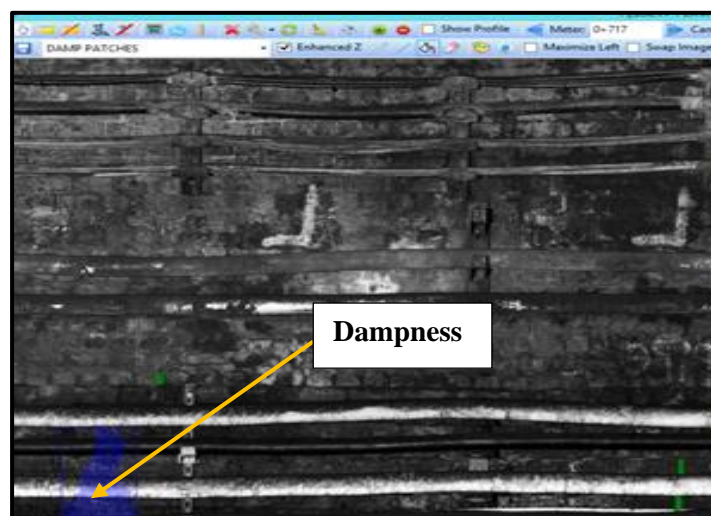
Figure 3-52 Laser inspection Dampness- TL60

Figure 3-52 shows dampness at chainage 3m on the right side of tunnel 60. This defect was identified by the visual inspection as active water seepage (see Figure 3-53).

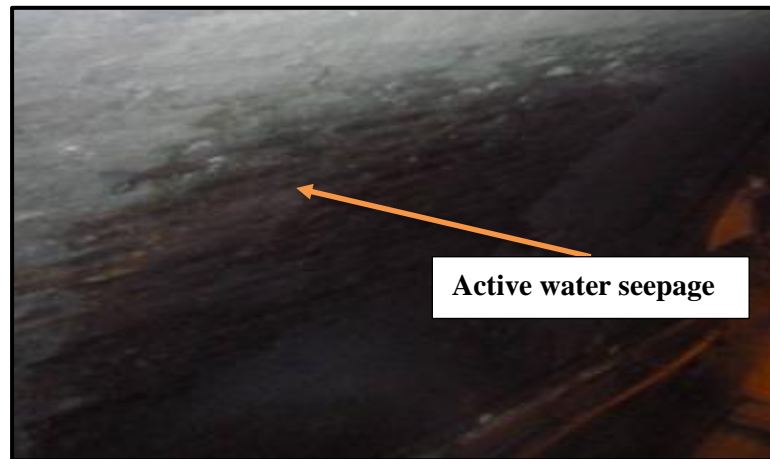
Figure 3-53 Visual inspection Water Seepage -TL60 (LUL, 2011)

The lowest score of 59.38% (see Table 3-21) from the sidewall was obtained as the condition score of this asset. Active water seepage at various locations and different areas of drummy brickwork influenced the lower score.

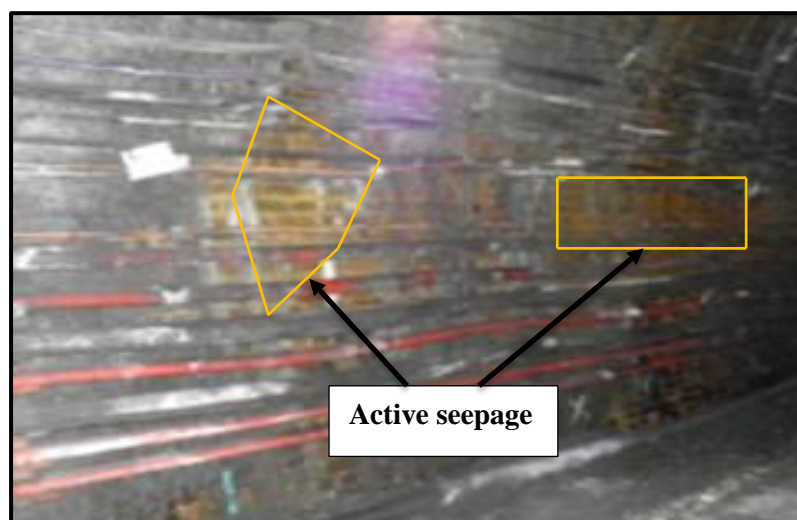
Figure 3-57 Visual Inspection Active Seepage- TL53 (LUL, 2011)

Table 3-25 shows the lowest score of 46.88% (from superstructure), obtained as the condition score of this asset. Heavy spalling, fracture, active seepages and leaching reduced the general surface score to D3 (Extent D, Severity 3 and item score 2).

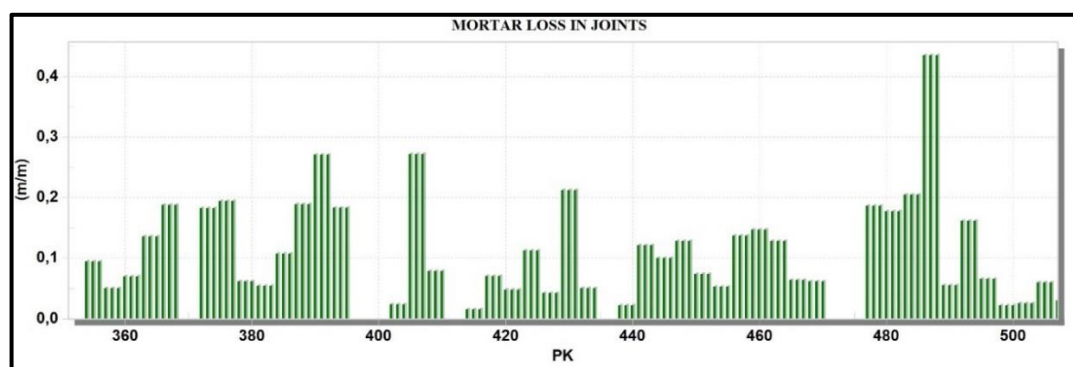
**Figure 3-63 Joint loss identified by the Laser Survey 2014
(Euroconsult, 2016)**

Joint loss, in the Inspection Tunnel Chart, is marked by the letters JL followed by the depth of the joint loss, measured on-site, in millimetres, for example, JL10, JL15 and JL20 were found in the inspection report, indicating joint loss depths of 10, 15 and 20mm respectively. In order to calculate the total joint loss for a particular meter of chainage, from the data in the Inspection Tunnel Chart, the different joint loss per metre of chainage were added and divided by 16 (the length of the circumference of the tunnel), therefore the variation would be between zero, or no joint loss, to 1, indicating that the whole wall on that particular chainage suffered from joint loss. In this method, the depth of the joint loss was not taken into account as it was not clear if the depth corresponded to the deepest value measured or an average. The total Joint loss identified by the Laser inspection in 2014 was directly extracted from the Euroconsult's report (Euroconsult, 2016) show in Figure 3-63 and the chainage mentioned in the X-axis as "PK" was converted into tunnel chainage, used by LUL and mentioned in all Inspection reports.

Joint loss occurs when there is mortar loss in the brick joints. This is a very common defect in old masonry, but it can also be caused by frost damage. If left unattended, it can result in weakened and loose bricks. The mortar can be easily replaced by a maintenance process called repointing, where the new mortar is added to the joints. It is a major concern having loose bricks within a tunnel carrying up to 33 trains per hour. LUL has a contract to repair any joint loss required for a year, but to do this, it must be identified correctly.

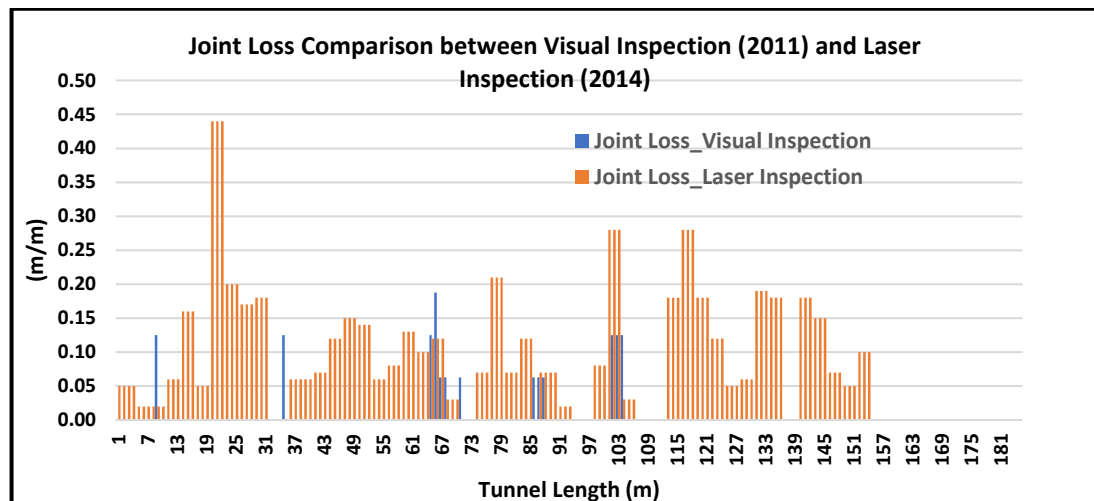
Figure 3-64 Joint Loss comparison between visual inspection and Laser Inspection

Figure 3-64 shows the joint loss comparison between the visual inspection (2011) and the laser inspection (2014). The laser inspection identified more locations of joint loss in tunnel 17 (TL17) compared to the visual inspection. Laser scanner systems are excellent at determining even very small mortar loss given that the measurements are made with an accuracy of 0.5mm, far better than the human eye, particularly in a tunnel environment where there are low levels of light. On the other hand, both inspections were performed in two different periods; the visual inspection in 2011 and the laser inspection in 2014, therefore, it is possible that part of the discrepancy could be due to the appearance of new joint losses. To understand this discrepancy, a visual inspection must be performed in a small length of tunnel, immediately after the laser scanner so a visual check of the mortar loss can then be performed.

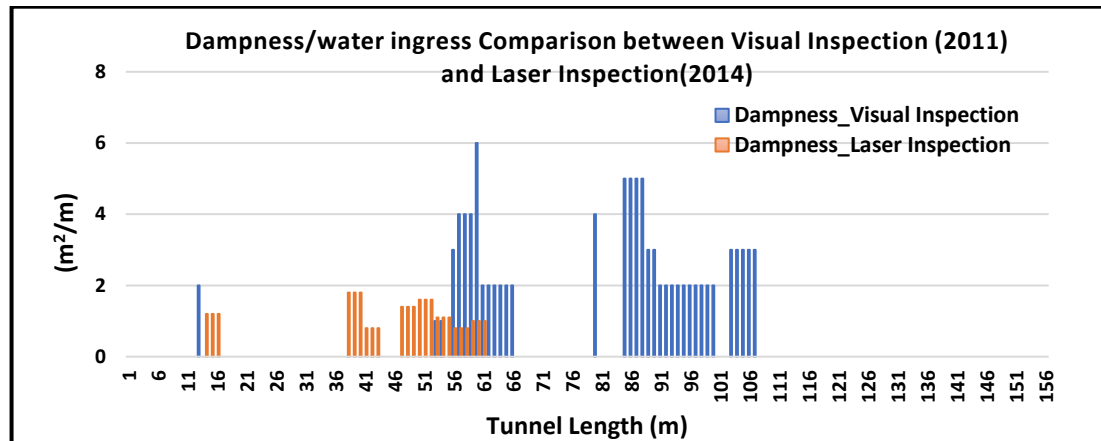
Figure 3-65 Dampness Comparison between Visual Inspection and Laser inspection

Figure 3-65 shows dampness/water ingress detected by the visual inspection in 2011, where the number of square meters of dampness corresponds to a

simple count of the squares marked with the seepage symbol. One major drawback of this calculation is that the area affected in each square is not known, therefore the whole area (1m^2) needs to be considered. This figure did not show any correlation between the two methods to identify dampness/water ingress. This may be due to the different inspection periods (visual inspection in 2011 and laser inspection in 2014), as the moisture areas identified by the laser scanner system were checked visually in the software.

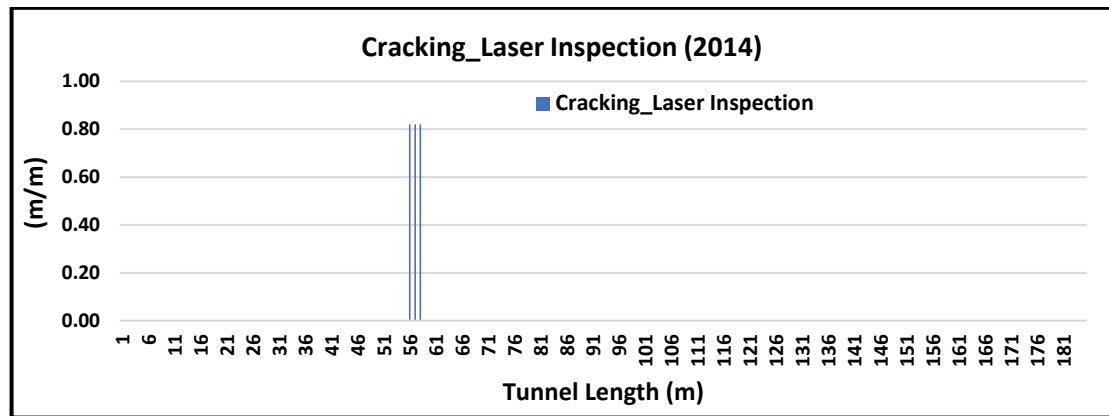
Figure 3-67 Cracking Laser Inspection

Cracks/Fractures can present enormous safety hazards within tunnels and have several causes, the most common being movements within the tunnel. There is often an underlying problem with the tunnel when cracks/fractures occur. Fractures can lead to loosened brickwork and equipment, which could result in the train service becoming affected. Traverse cracks/fractures present a more serious defect than longitudinal cracks/fractures as they indicate flattening of the arch and possible rotation of the tunnel. However, longitudinal fractures are more common and related to the lack of load distribution. Figure 3-67 show cracks identified by the laser inspection in 2014 and these are in a small area of the tunnel. However, cracks have not been identified by the inspector during the visual inspection in 2011.

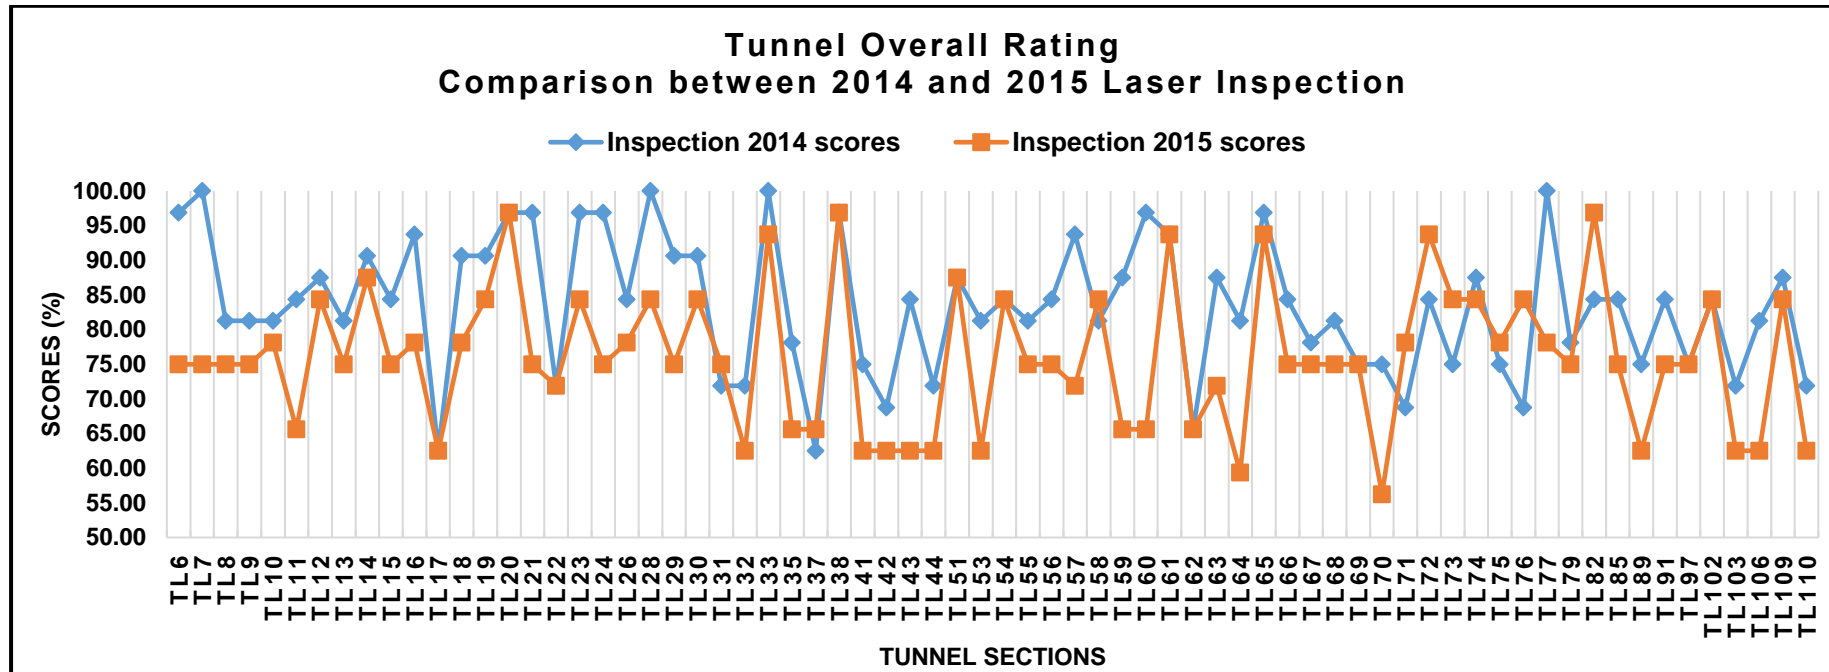
Figure 3-71 Comparison of tunnel scores between 2014 and 2015 Laser inspection

Figure 3-71 shows the comparison of the overall rating of 72 tunnel sections between the two inspections. Compared to the inspection of 2014, the overall scores of the 2015 inspection decreased in most of the tunnel sections (e.g., TL6, TL7, TL8, TL9, TL10, TL11, and TL12). However, in some places, both inspections achieved similar (e.g. TL17, TL22, TL38, TL51, TL54, TL61, TL62, TL69 and TL102) scores. To understand the factors, influencing this score variation throughout the tunnel sections, each defect type was analysed separately.

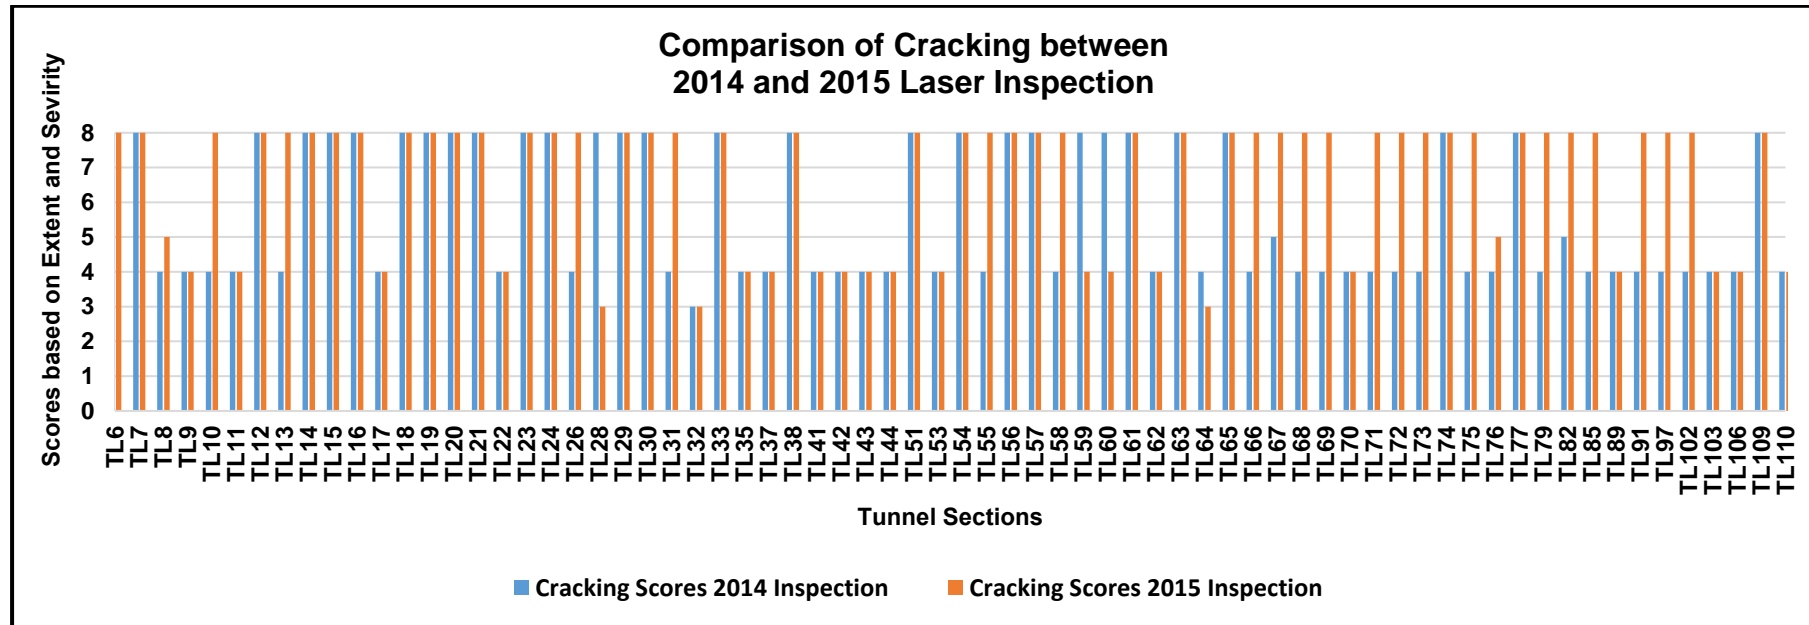
Figure 3-72 Comparison of cracking between 2014 and 2015 Laser inspection

Figure 3-72 shows a comparison of cracking of 72 sections of tunnels between the 2014 and 2015 laser inspection. In most of the tunnels' sections, there were no changes in cracking between the two inspections. However, tunnel sections TLS' 10,13, 26, 31, 55, 58, 66, 68, 69, 71, 72, 73, 75, 79, 85, 91, 97 and 102 were significantly improved from score 4 in the 2014 inspection, to score 8 in the 2015 inspection. This indicates repairs for cracking were performed in between two inspections and this was confirmed with a completed works order. For tunnel sections TLS' 28, 59 and 60, the overall scores had decreased from 8 to 4 between the 2014 and 2015 inspections. This indicates that new cracks appeared between the 2014 and 2015 laser inspection and confirmed with the route inspector. The newly appeared cracks, therefore, reduced the overall scores.

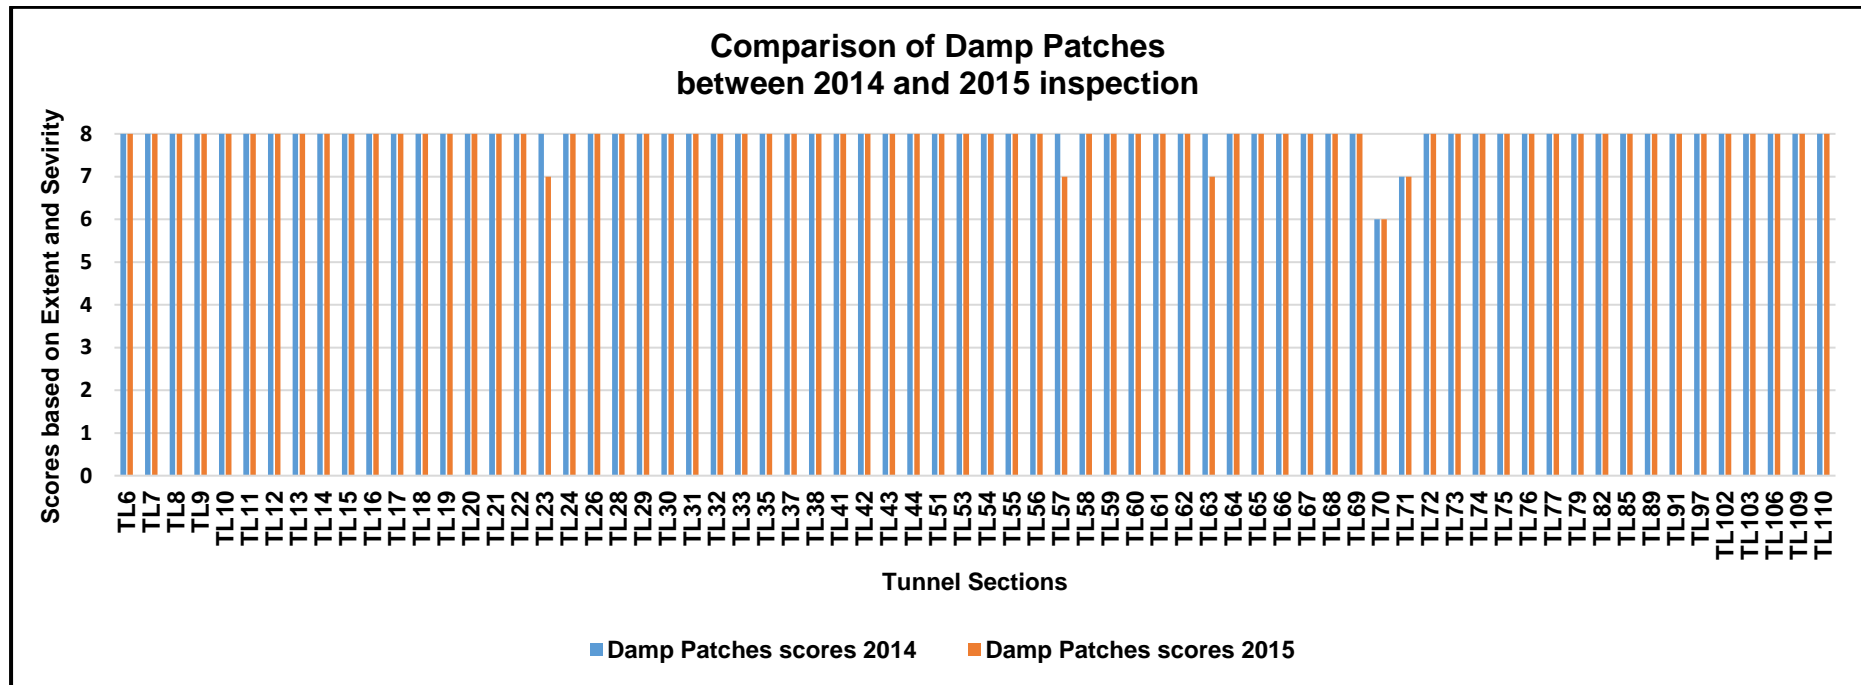
Figure 3-73 Comparison of damp patches between 2014 and 2015 Laser inspection

Figure 3-73 shows a comparison of damp patches of 72 sections of tunnels between 2014 and 2015 laser inspection. In most of the tunnel's sections, there were no significant changes in damp patches between two inspections. Tunnel sections, TL23, TL57 and TL63 scores were slightly reduced from 8 to 7 between the 2014 and 2015 inspections. This indicates that water seepage/damp patches did not much influence the overall inspection scores between 2014 and 2015.

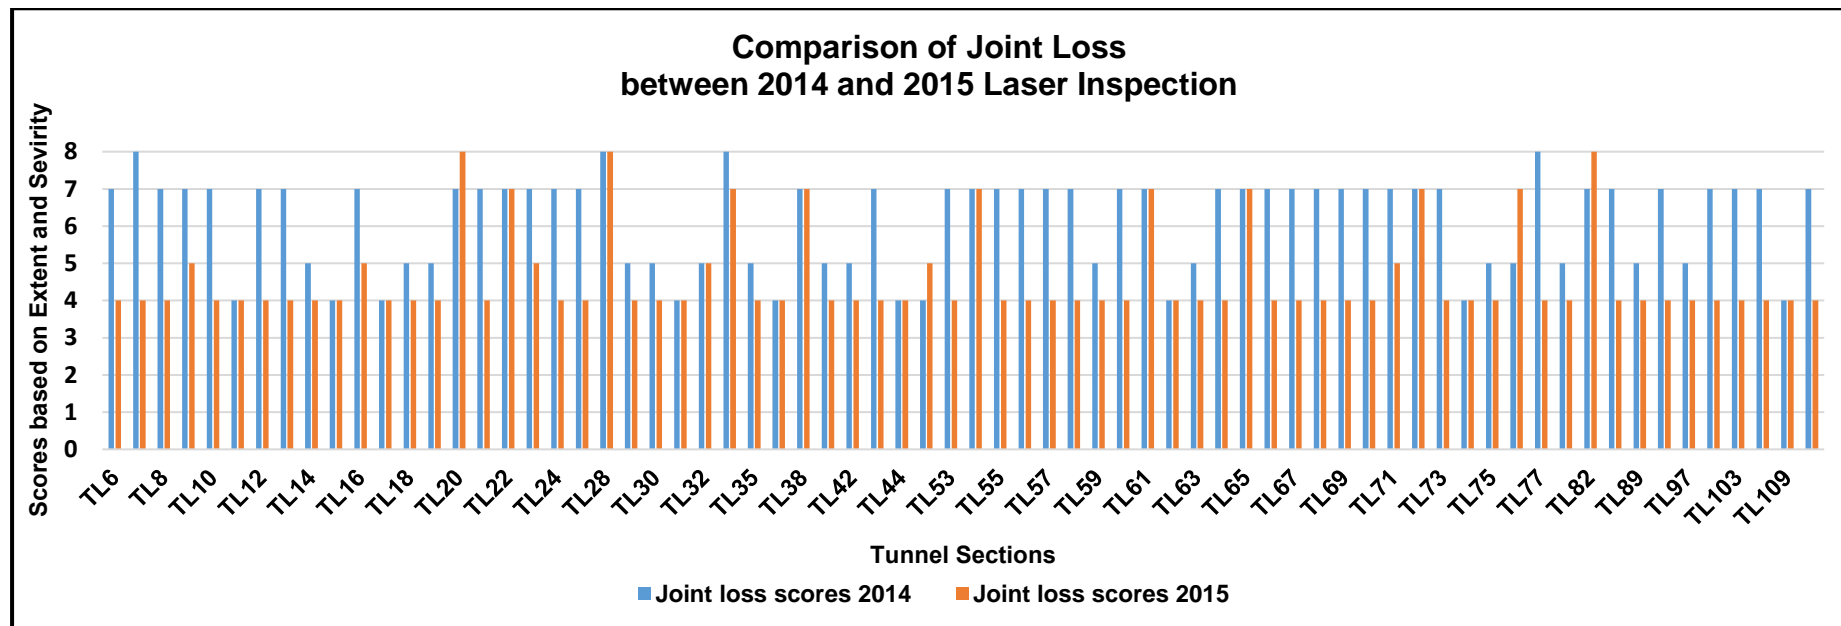
Figure 3-74 Comparison of Joint Loss between 2014 and 2015 Laser inspection

Figure 3-74 shows a comparison of joint loss for 72 sections of tunnels between the 2014 and 2015 laser inspections. In 29 tunnel sections, the overall score for joint loss was reduced from 7 to 4 between the 2014 and 2015 inspection. At the same time, TL20 and TL82 scores were increased from 7 to 8. Eight tunnel sections (e.g., TL11 and TL15) have the same score of 4 in both inspections. The joint loss score for tunnel section TL76 increased from 5 to 7, indicating that new joint losses appeared between the 2014 and 2015 inspections. Therefore, remedial (e.g., repointing) works should be carried out to improve the scores before the December 2016 inspection and also avoiding falling bricks from the tunnel.

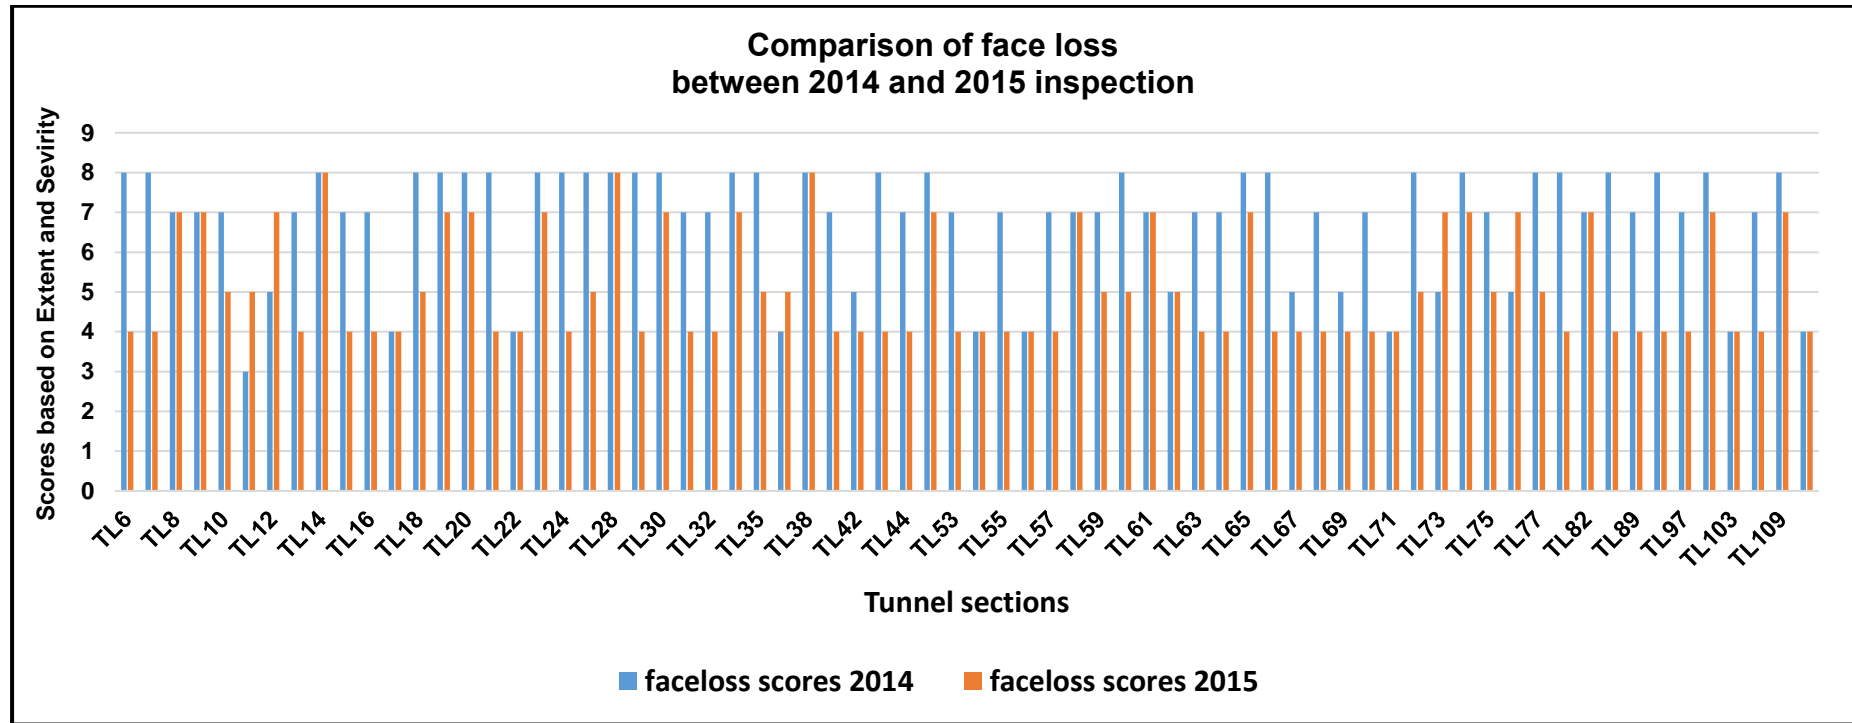
Figure 3-75 Comparison of face loss between 2014 and 2015 Laser inspection

Figure 3-75 shows a comparison of face loss for 72 sections of tunnels between 2014 and 2015 laser inspections. Seven tunnel sections (e.g. TL54, TL56) have the same score of 4 in both inspections. Seventeen (e.g. TL13, TL15), seven (e.g. TL6, TL7) and three (e.g. TL42, TL67) tunnel sections decreased scores from 7 to 4, 8 to 4 and 5 to 4, respectively. At the same time, seven tunnel sections (e.g. TL54, TL56) and another three tunnel sections (e.g. TL58, TL61) have the same score of 4 and 7 respectively for both inspections. Tunnel sections TL12, TL76 and TL76 scores were increased from 5 to 7. These scores indicate remedial works (brickworks) have to be carried out before the next laser inspection to fix the defects and improve the face loss scores.

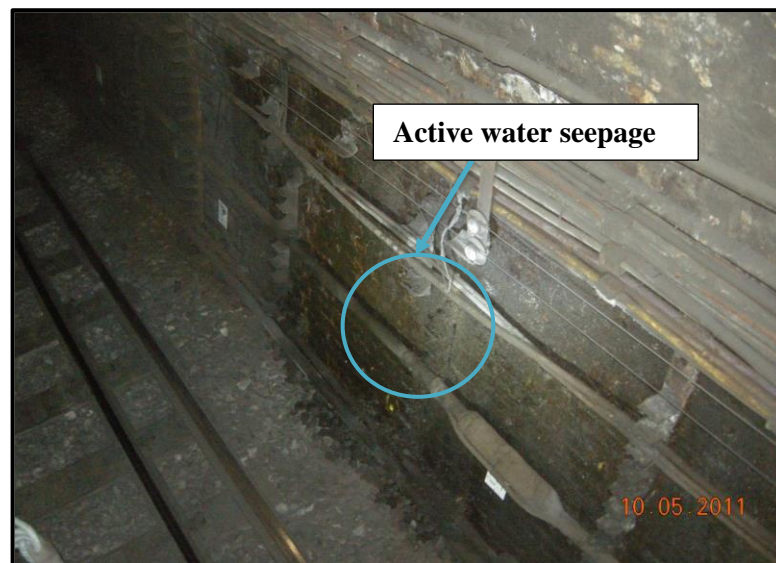
Figure 3-78 TL17- active water seepage at chainage 77, from the arch springer to track level- visual inspection 2013

Figure 3-78 shows that active water seepage at chainage 77 from the arch springer to the track level. The darker areas seen on the ballast was caused by the seepage; this was identified by the visual inspection in 2013. Figure 3-79 indicates that the same defect was identified by the laser inspection in 2015. However, this defect was not determined by the laser inspection in 2014(see Figure 3-80). This indicates that water seepage at this location was not permanent and may due to seasonal variations.

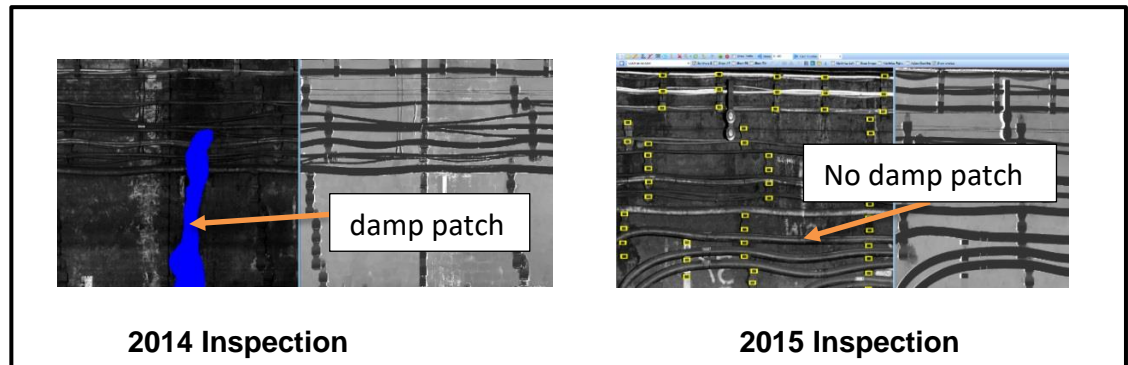
**Figure 3-82 TL 17 area of damp patch at chainage 164
2014 and 2015 Laser Inspection**

Table 3-33 shows that a damp patch at chainage 164 appeared in the 2014 inspection with an area of 0.358m² and did not appear in the 2015 inspection. Figure 3-82 shows that in 2015, the damp patch did not appear, and any repair work also did not take place at that location. This indicates a temporary defect of water seepage at chainage 164 and this may be connected to a seasonal effect (a seepage that appears when a certain rainfall occurs).

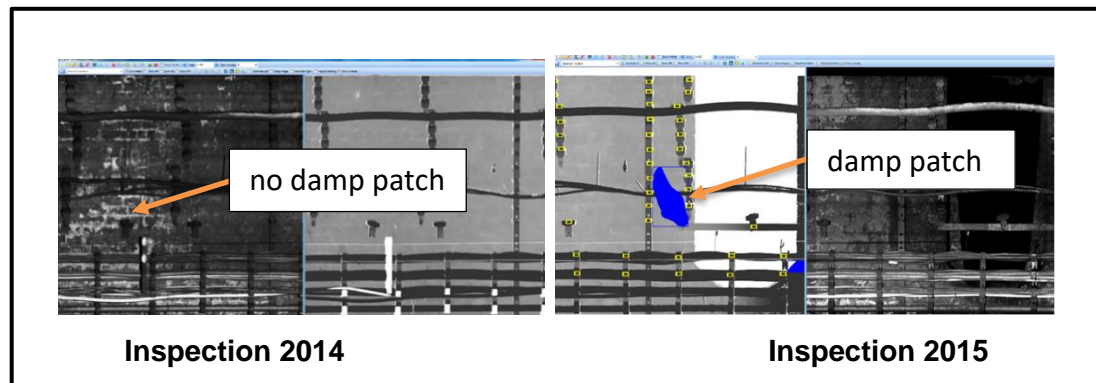
**Figure 3-83 TL 17 area of a damp patch at chainage 87
2014 and 2015 Laser Inspection**

Table 3:35 shows that the damp patch at chainage 87 appeared in the 2015 inspection with an area of 0.130m² but it did not appear in the 2014 inspection.

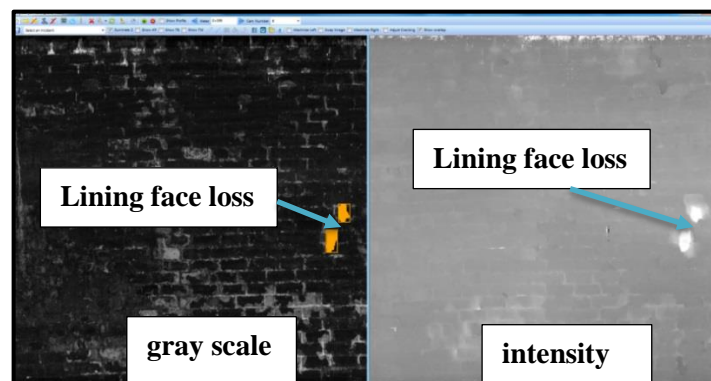
**Figure 3-86 TL17 lining face loss at chainage100
2014 Laser inspection**

Table 3-36 shows a comparison of lining face loss between chainage 86 and 111 of the 2014 and the 2015 laser inspection. In 2014, laser inspection lining face loss was identified at two locations with depths of 52.06mm and 39.43mm (see Figure 3-76). However, in the 2015 laser inspection, these defects had disappeared at those places, and another two-new lining face loss defects appeared with depths of 104mm and 42mm (see Figure 3-87). This may highlight the problem of the odometer not being able to identify the location of defects precisely in between two epochs of observation.

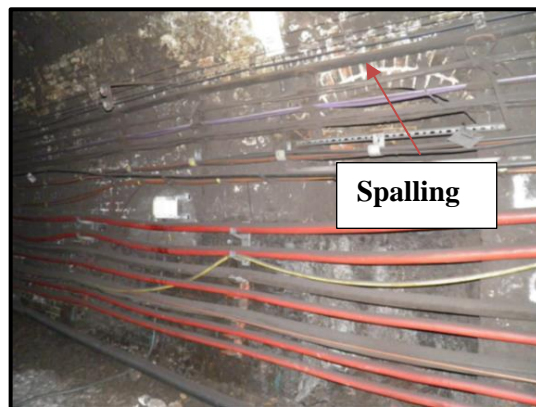
**Figure 3-88 Spalling North abutment at chainage 513m from West
Visual Inspection-2013**

Figure 3-88 shows spalling of the brickwork around the recess area. This was identified by visual inspection at the North abutment 513m from the west. However, this defect was not identified in both laser inspections because remedial work was previously done. Figure 3-89 shows a screen shot of the laser scan software indicating that nothing was found.

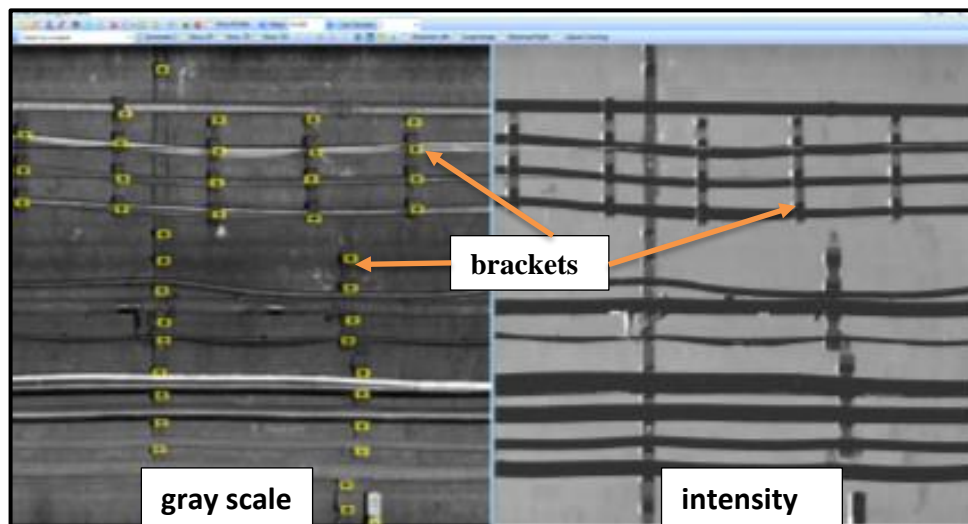
Figure 3-91 Cable brackets

Cable brackets (see Figure 3-91) used for securing cables were detected by Euroconsult's automatic algorithm to identify and locate these data and store them in the database. However, to confirm the algorithm has the capacity to detect automatically, part of this detection was manually conducted by Euroconsult.

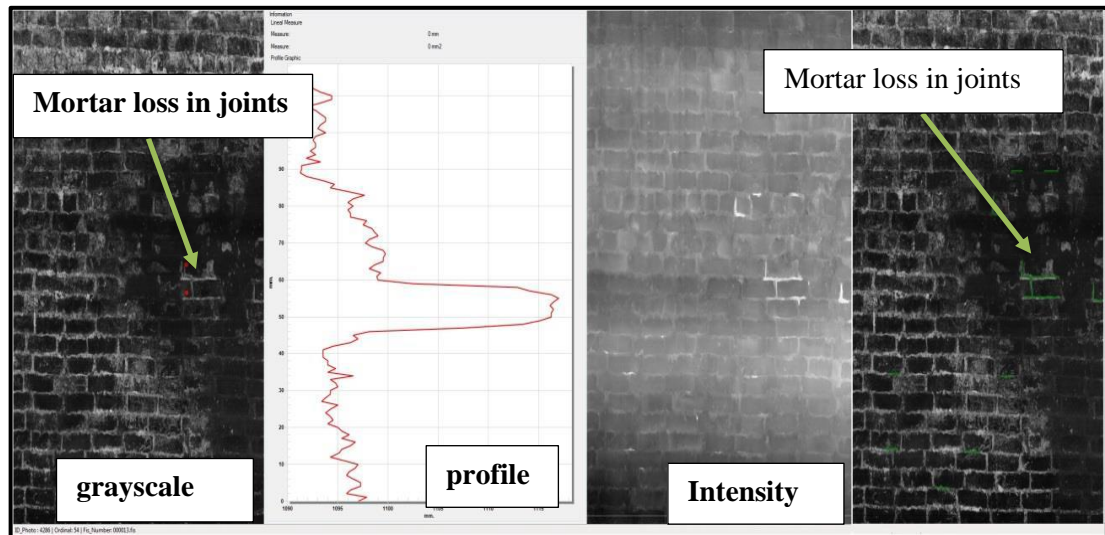
Figure 3-95 TL53 mortar loss in joints

Figure 3-95 shows screenshots of the Tunnel Viewer software. Starting on the left, a grayscale image of the tunnel is used to manually select points (highlighted in red). The second image shows a profile of the depth between the two points previously selected. This profile shows a lack of material in the joint and it could be measured to understand how deep the mortar loss is. The intensity image (third from the left), shows mortar loss identified as a bright white line. Finally, the last image is what the Tunnel Viewer software presents to the user mortar loss in the tunnel wall after analysing the laser scanner data, represented by the green lines.

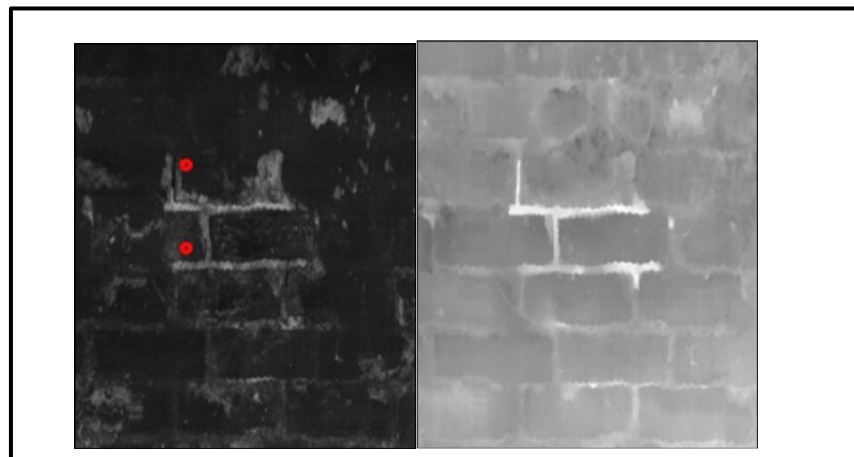
Figure 3-96 Mortar loss in joints, (enlarged)

To better analyse the results of mortar loss in brick joints, Figure 3-96 shows an enlarged image where the red points indicate the beginning and end of the evaluated profile. The brighter pixels on the depth image (right image) indicate the presence of the greater depth.

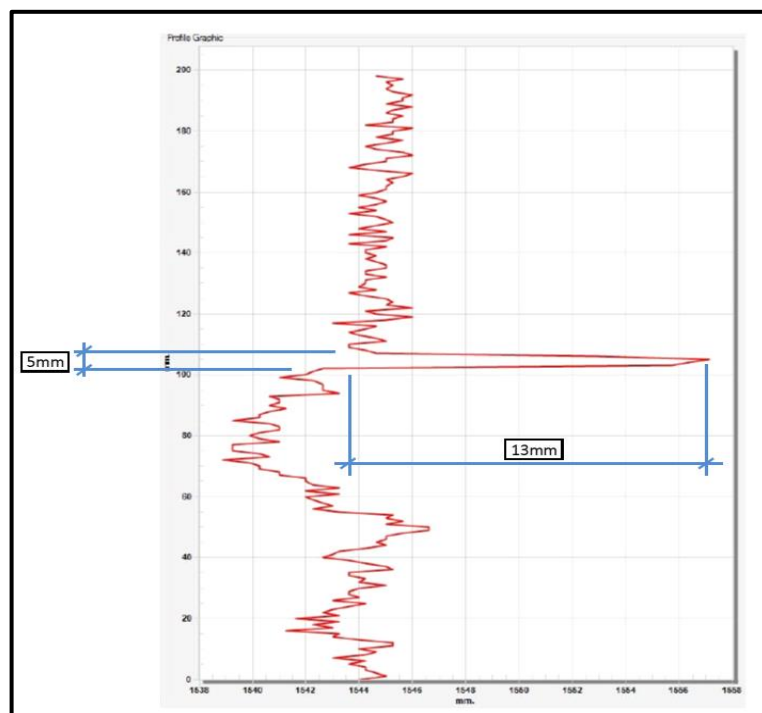
Figure 3-97 TL53 mortar loss in joints- profile

Figure 3-97 shows the profile from the points mentioned above. Here the mortar loss has a width of 5mm and a depth of 13mm.

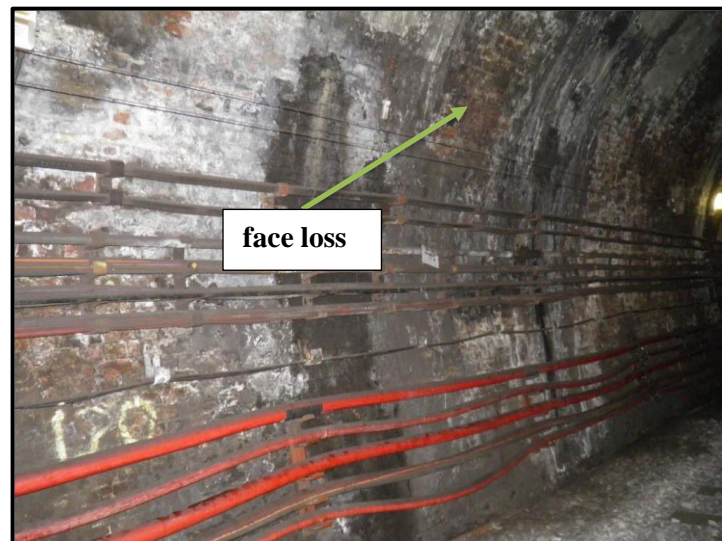
Figure 3-100 TL53 face loss at chainage 470 visual inspection

Figure 3-100 shows same face loss was identified by the 2013 visual inspection as well.

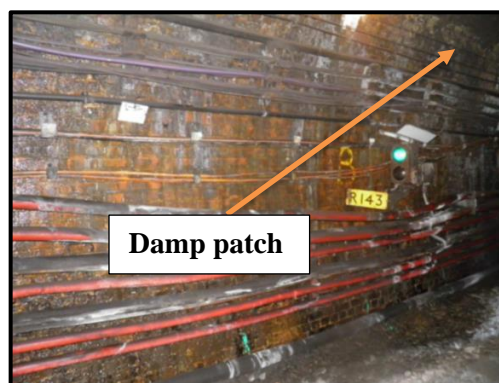
Figure 3-101 TL53 active water seepage at north abutment chainage between 95m and 100m West

Figure 3-101 shows that the visual inspection identified an active water seepage, but this was difficult to locate in the picture apart from the water stain on the ballas and on the black pipe located where the tunnel wall meets the ballast. The seepage is located between chainage 95m and 100m in the west direction. Figure 3-102 shows that the laser inspection identified the same active water seepage as damp patches and in slightly different locations at the same chainage.

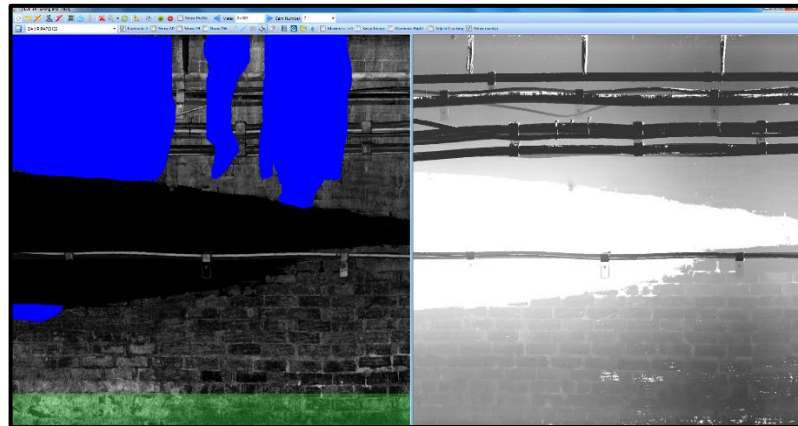
Figure 3-104 TL56 water seepage at 2014 scan

Figure 3-104 shows water seepage identified by the 2014 laser inspection. The same seepage was also identified on the visual inspection of 2011. However, seepage was identified in the 2015 laser inspection of the same area (see Figure 3-105). Furthermore, the 2015 inspection did not show any repaired areas in the same location. Therefore, this seepage may have been inactive during the 2015 scan, indicating that it may be weather-related.

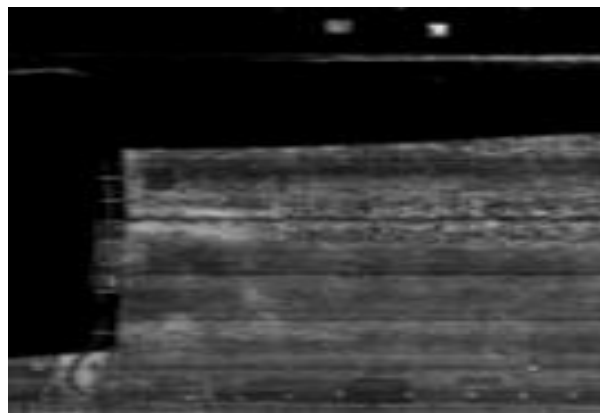
Figure 3-105 TL56 no water seepage at 2015 scan

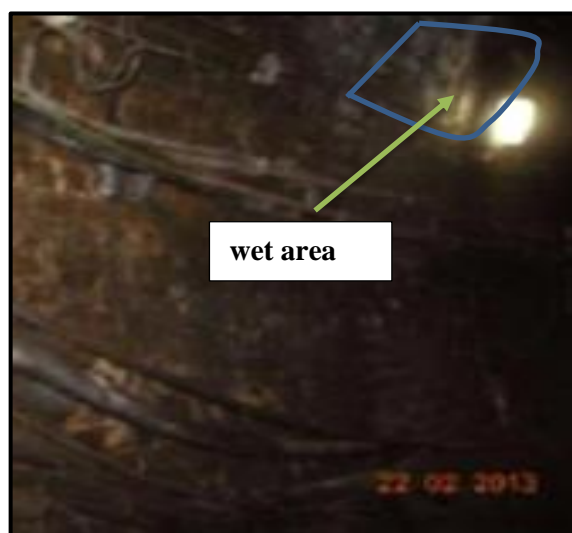
Figure 3-106 TL56 visual inspection wet area
(LUL, 2011)

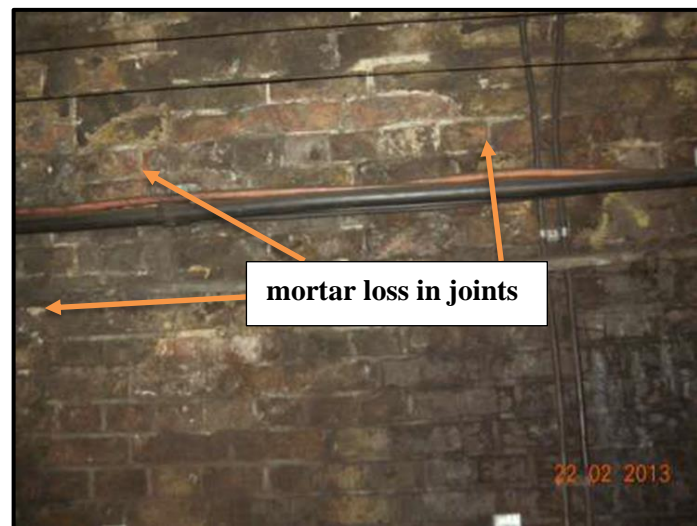
Table 3-40 shows mortar loss in joints between chainage 98 and 100. Mortar loss in joints at chainage 100 were identified by the visual inspection also (see Figure 3-107, which was taken from the visual inspection report). However, in the 2015 inspection, this defect was not detected.

Figure 3-107 TL56 mortar loss in joints at chainage 100m south sidewall visual inspection, 2013
