EVALUATION OF NEW TECHNOLOGIES TO SUPPORT ASSET MANAGEMENT OF METRO SYSTEMS

GUNASINGAM RAVINDRAN

**A thesis submitted in partial fulfilment of the requirements for the award
of the degree Doctor of Engineering (Eng.D) at the
University of College London**

August 2020

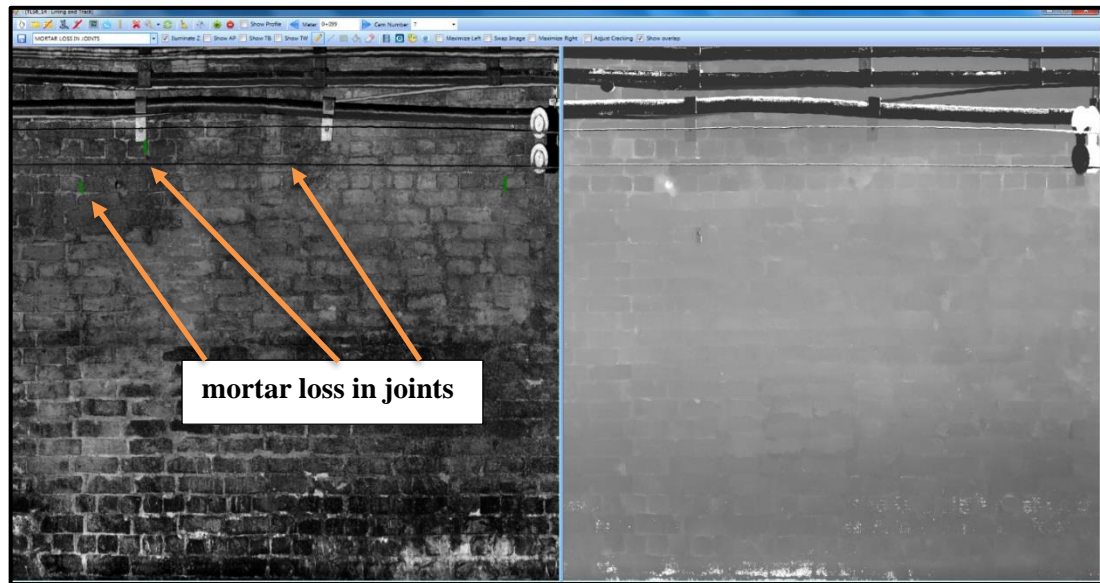
**Figure 3-108 TL56 mortar loss in joints at chainage 100
2014 laser inspection**

Figure 3-108 shows locations of mortar loss (shown by green dots) in joints at chainage 100 in the 2014 laser inspection.

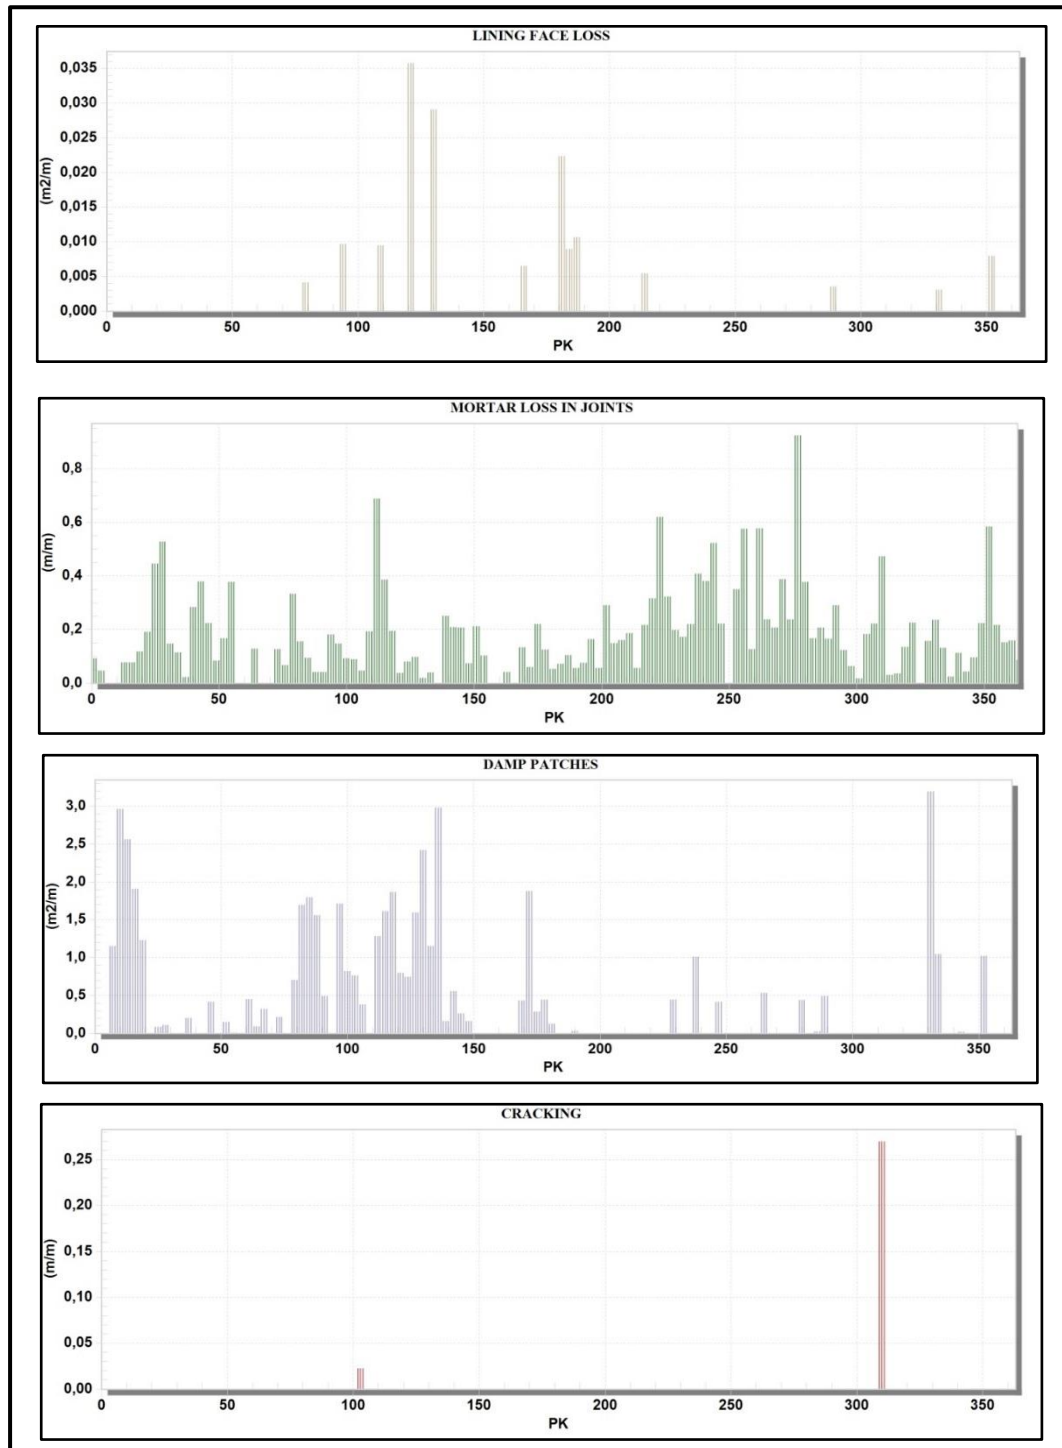
Figure 3-109 Defects along tunnel 26

Figure 3-109 shows different defect types, such as lining face loss, mortar loss in joints, damp patches and cracking, along scan direction of the D086/TL26 tunnel. The X-axis is in m and the Y-axis the area and length of the defects.

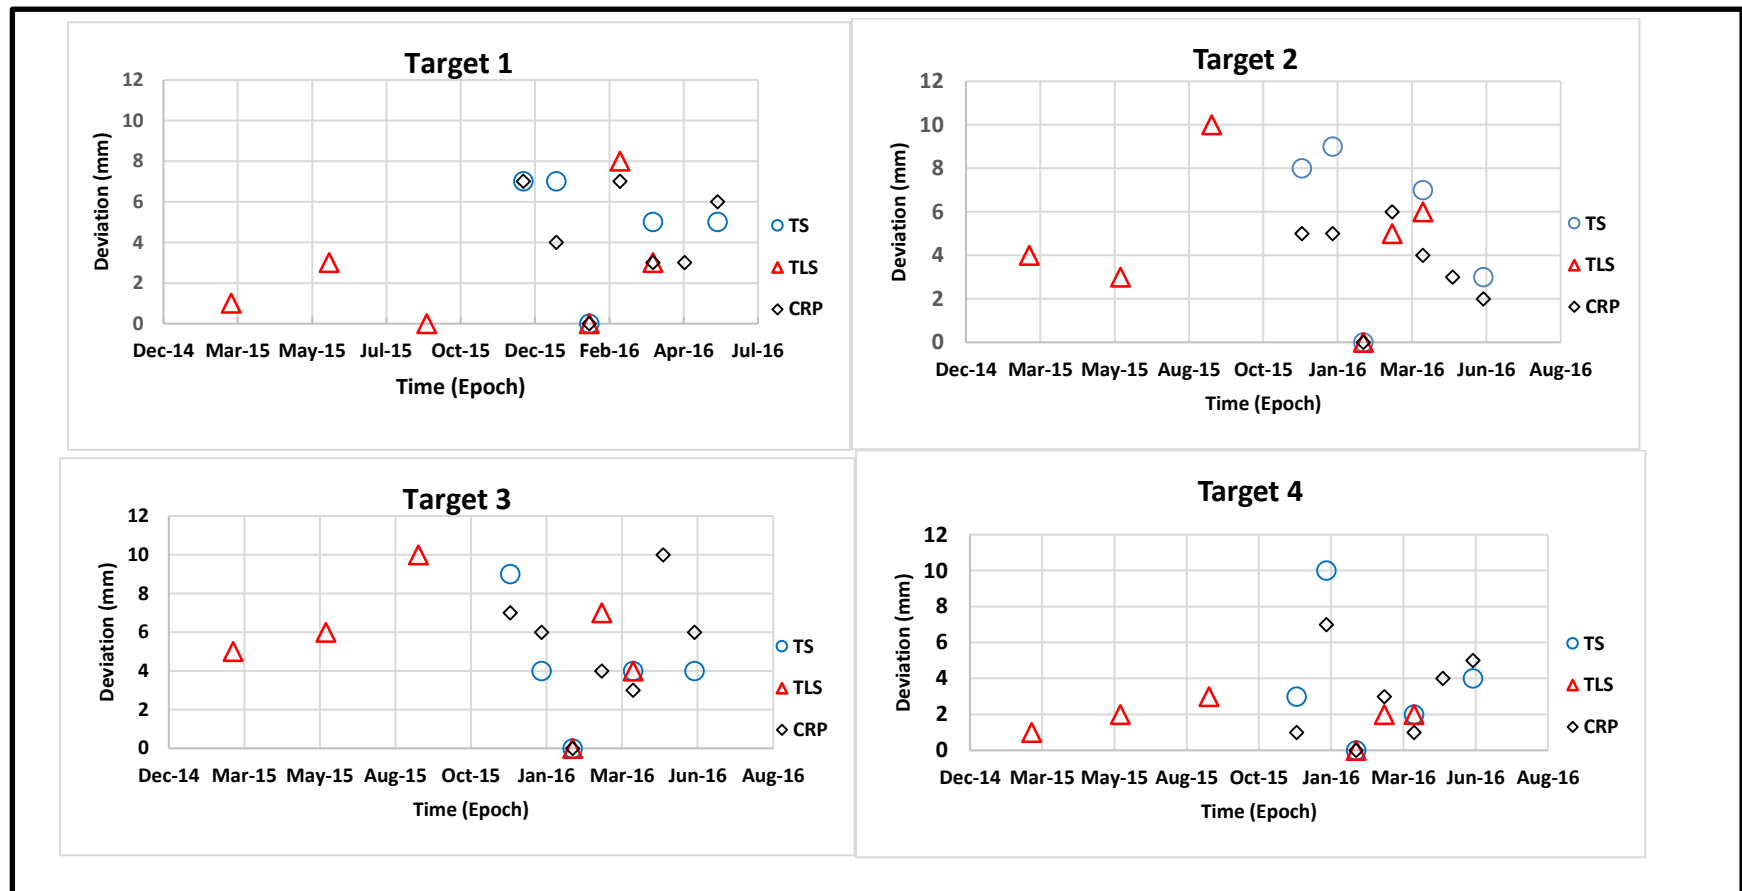
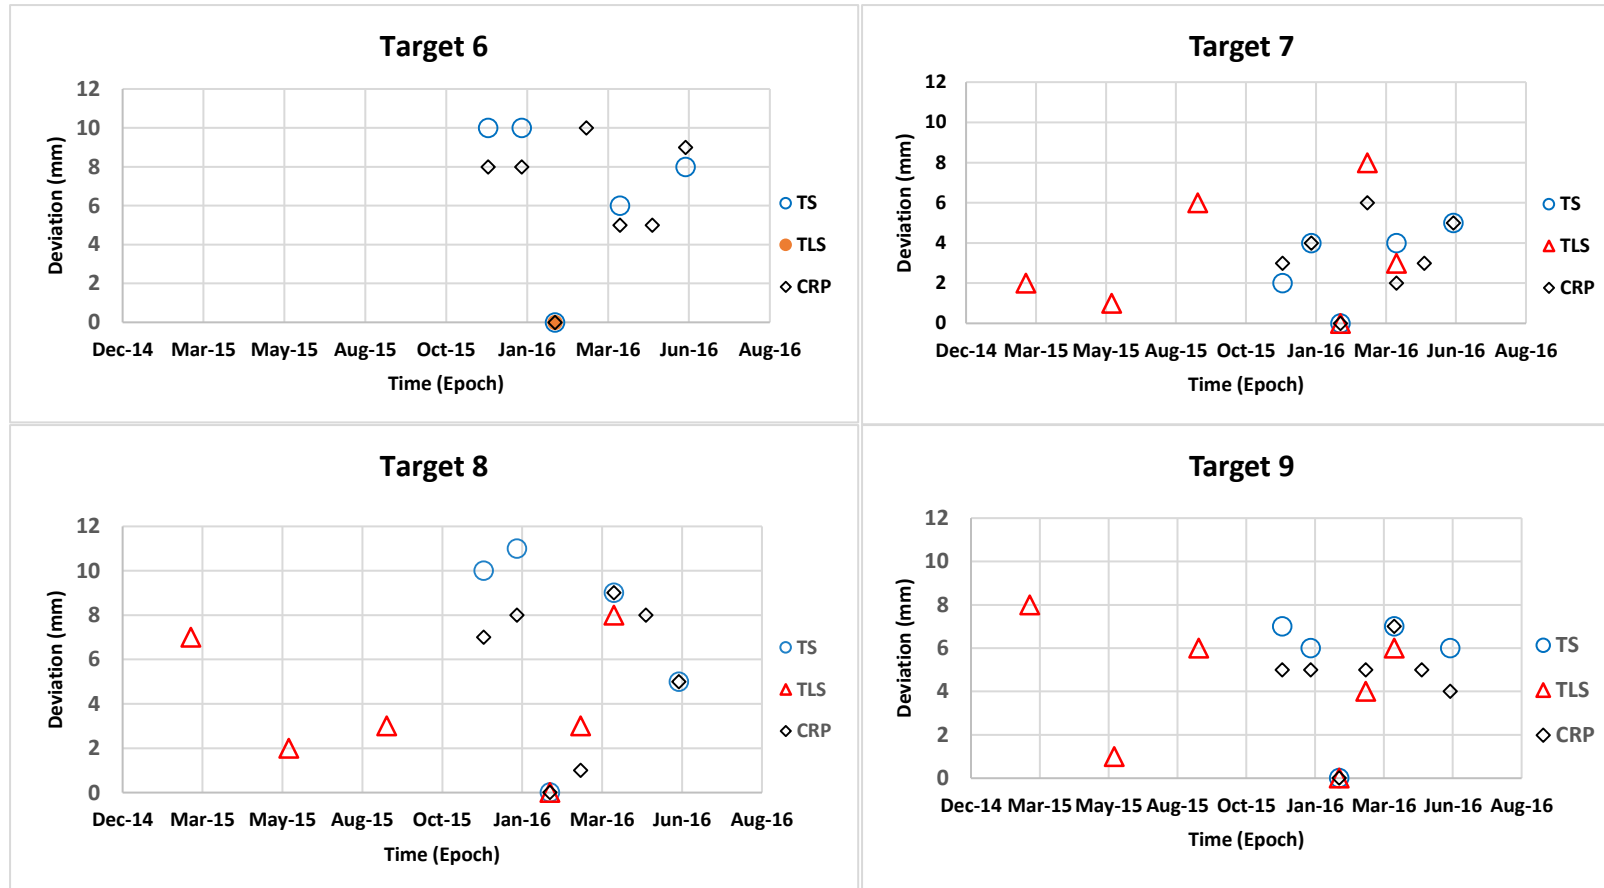
Figure 5-26 and Figure 5-27 show that TLS and CRP have a similar precision to TS in most of the target locations, except target 8, as this was closer to the crack.

Results show that millimetre level accuracy can be achieved in deviation/deformation analysis through plane fitting techniques. However, the wall was not a plane surface if we consider the whole section. Therefore, in section 5-10, an analysis mesh was created to compare the whole section of the wall between the baseline and inter epochs.

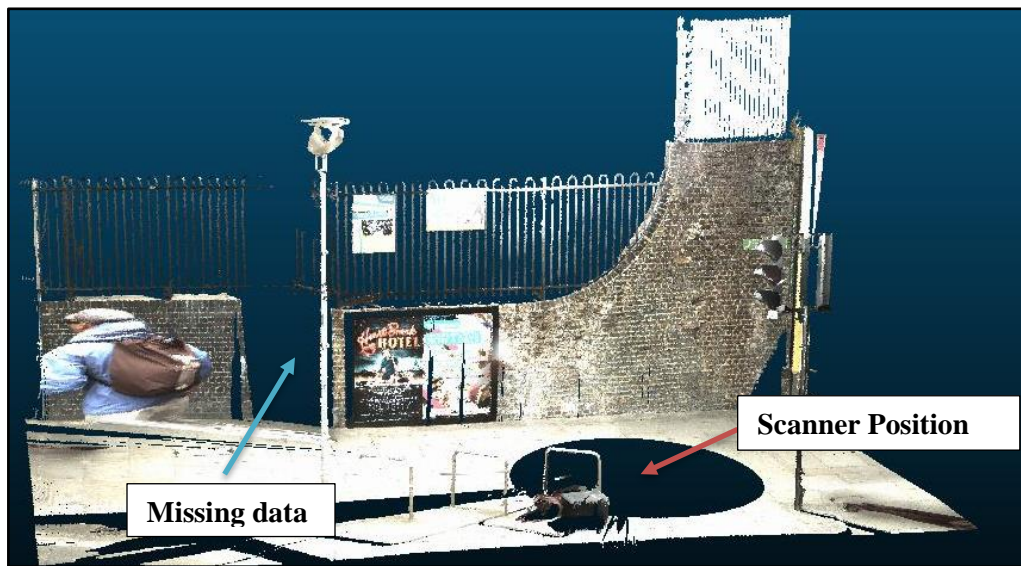
Figure 5-28 Non-suitable scanner position to scan the area of interest

Figure 5-28 shows the non-suitable position of the scanner to capture the whole of the wall and the figure clearly shows a missing part of the wall. Due to non-availability of the point cloud data created by TLS, this portion of the wall was not compared with other epochs of TLS and CRP point cloud. However, point clouds created by CRP in different epochs were compared.

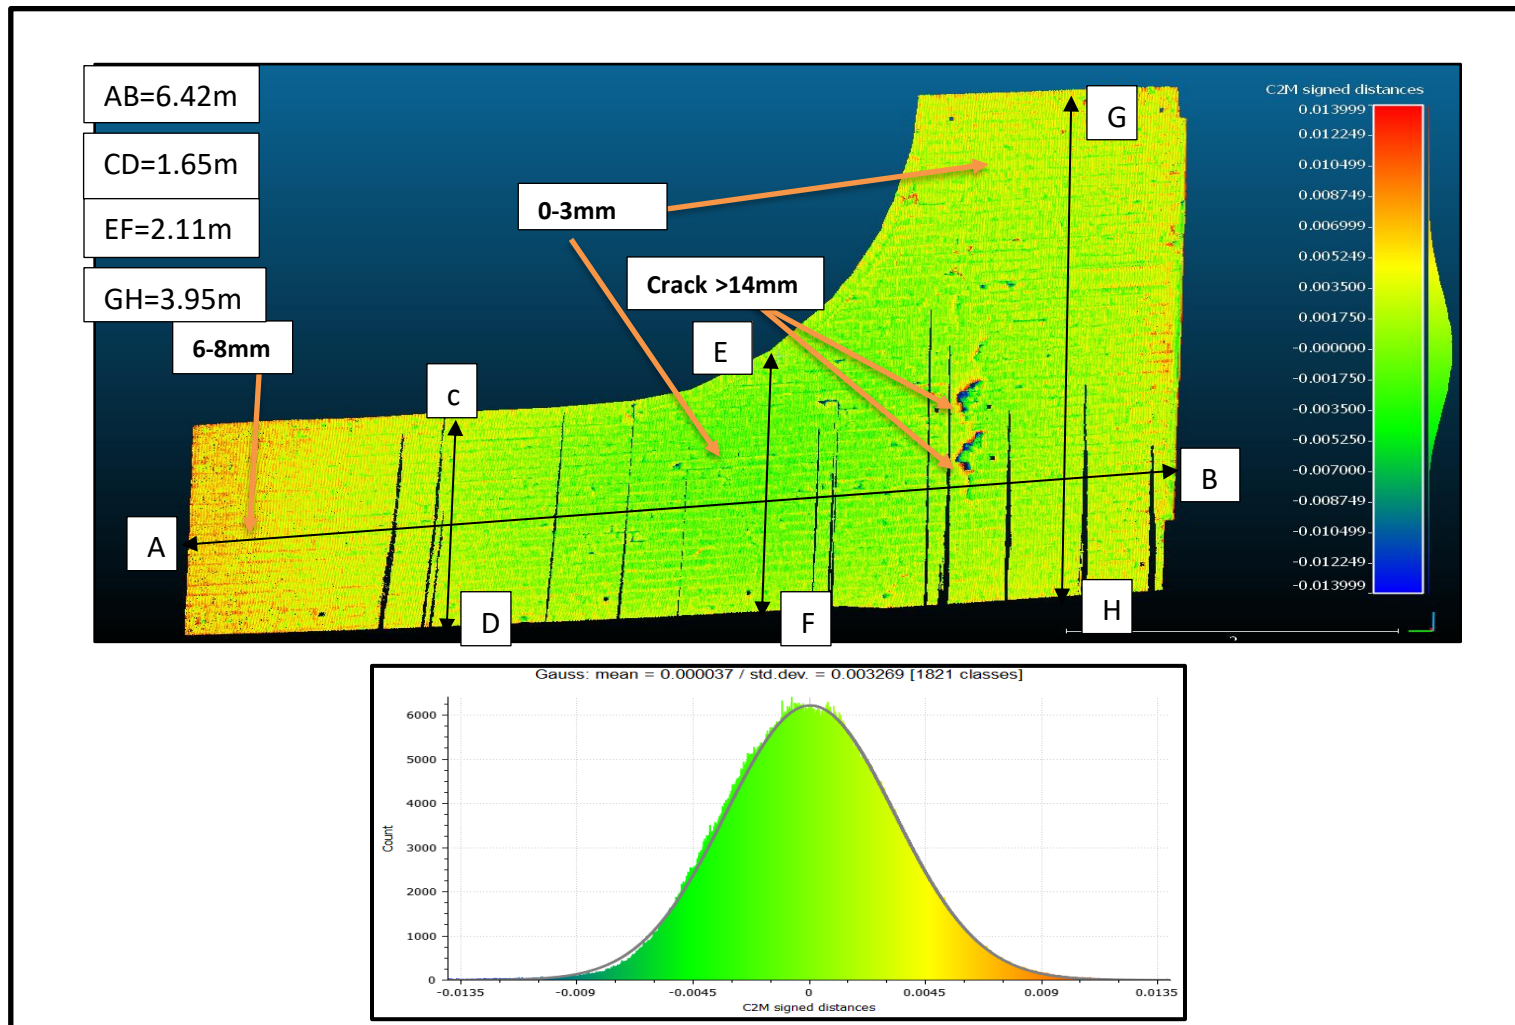
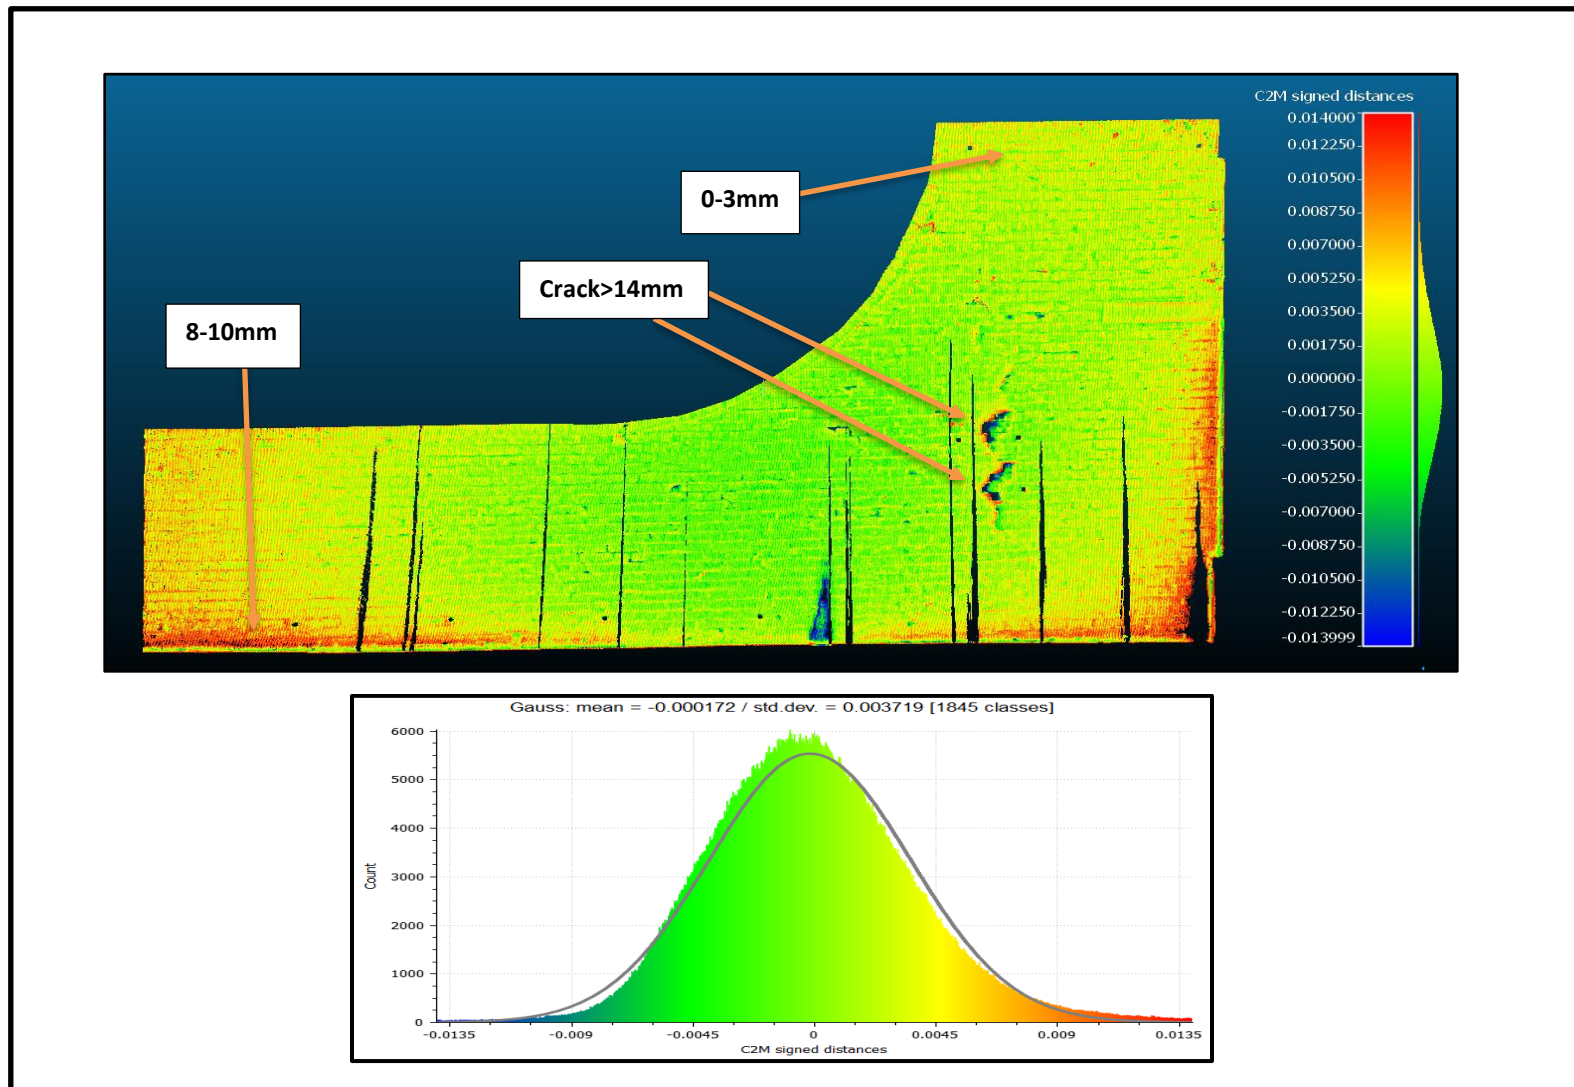
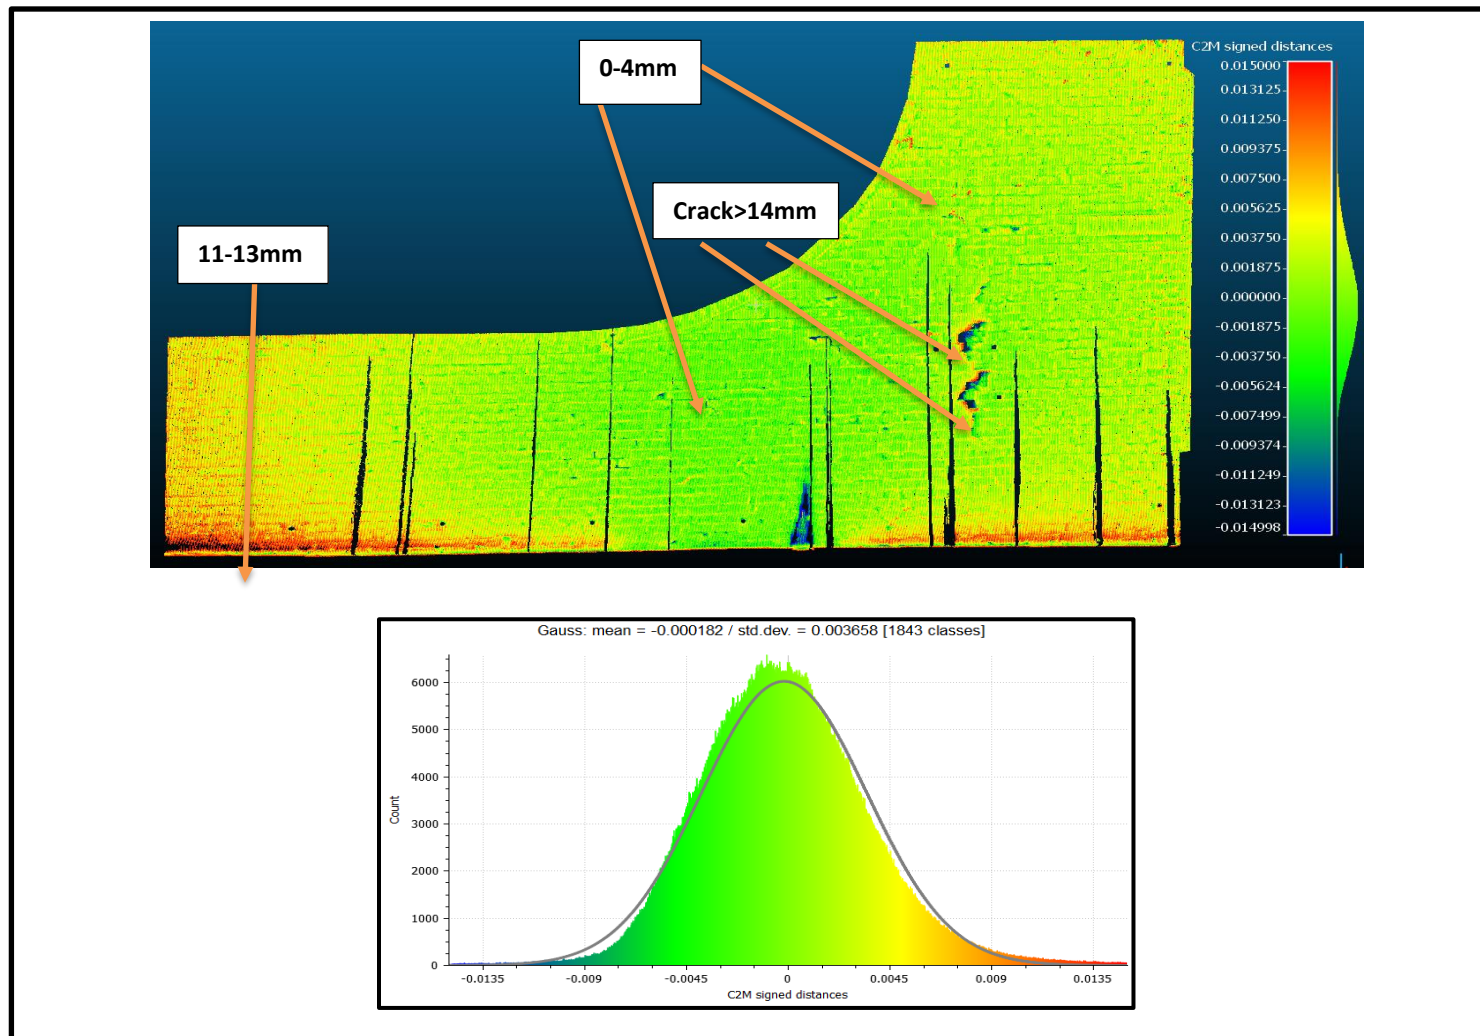
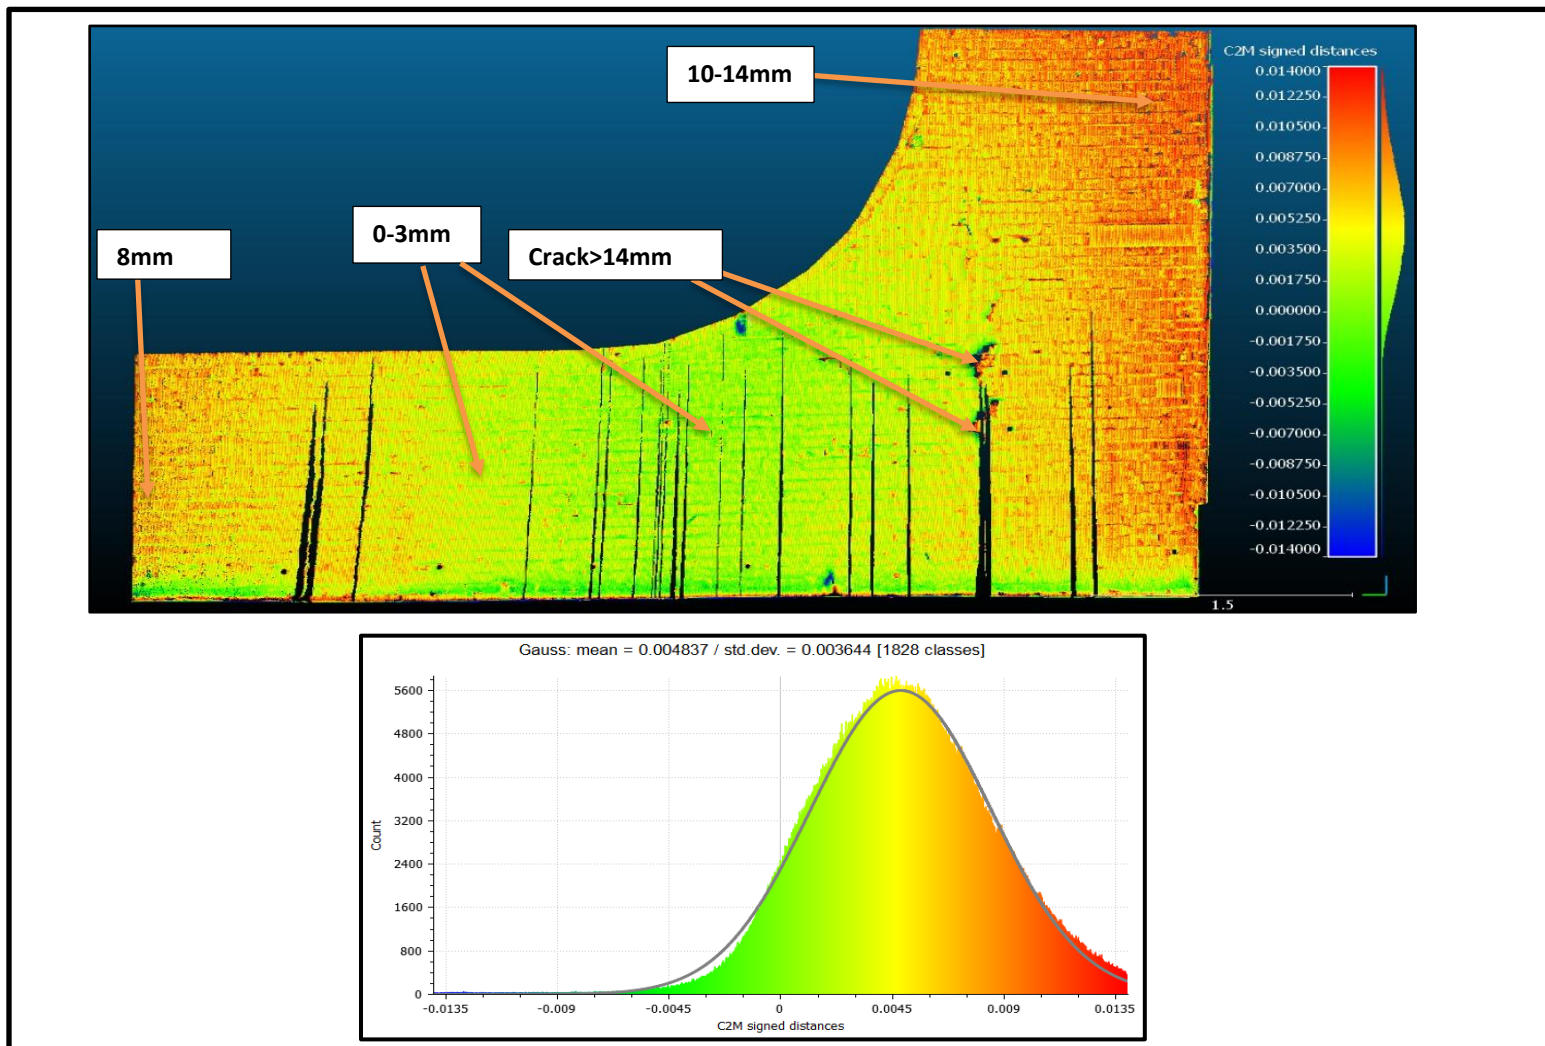
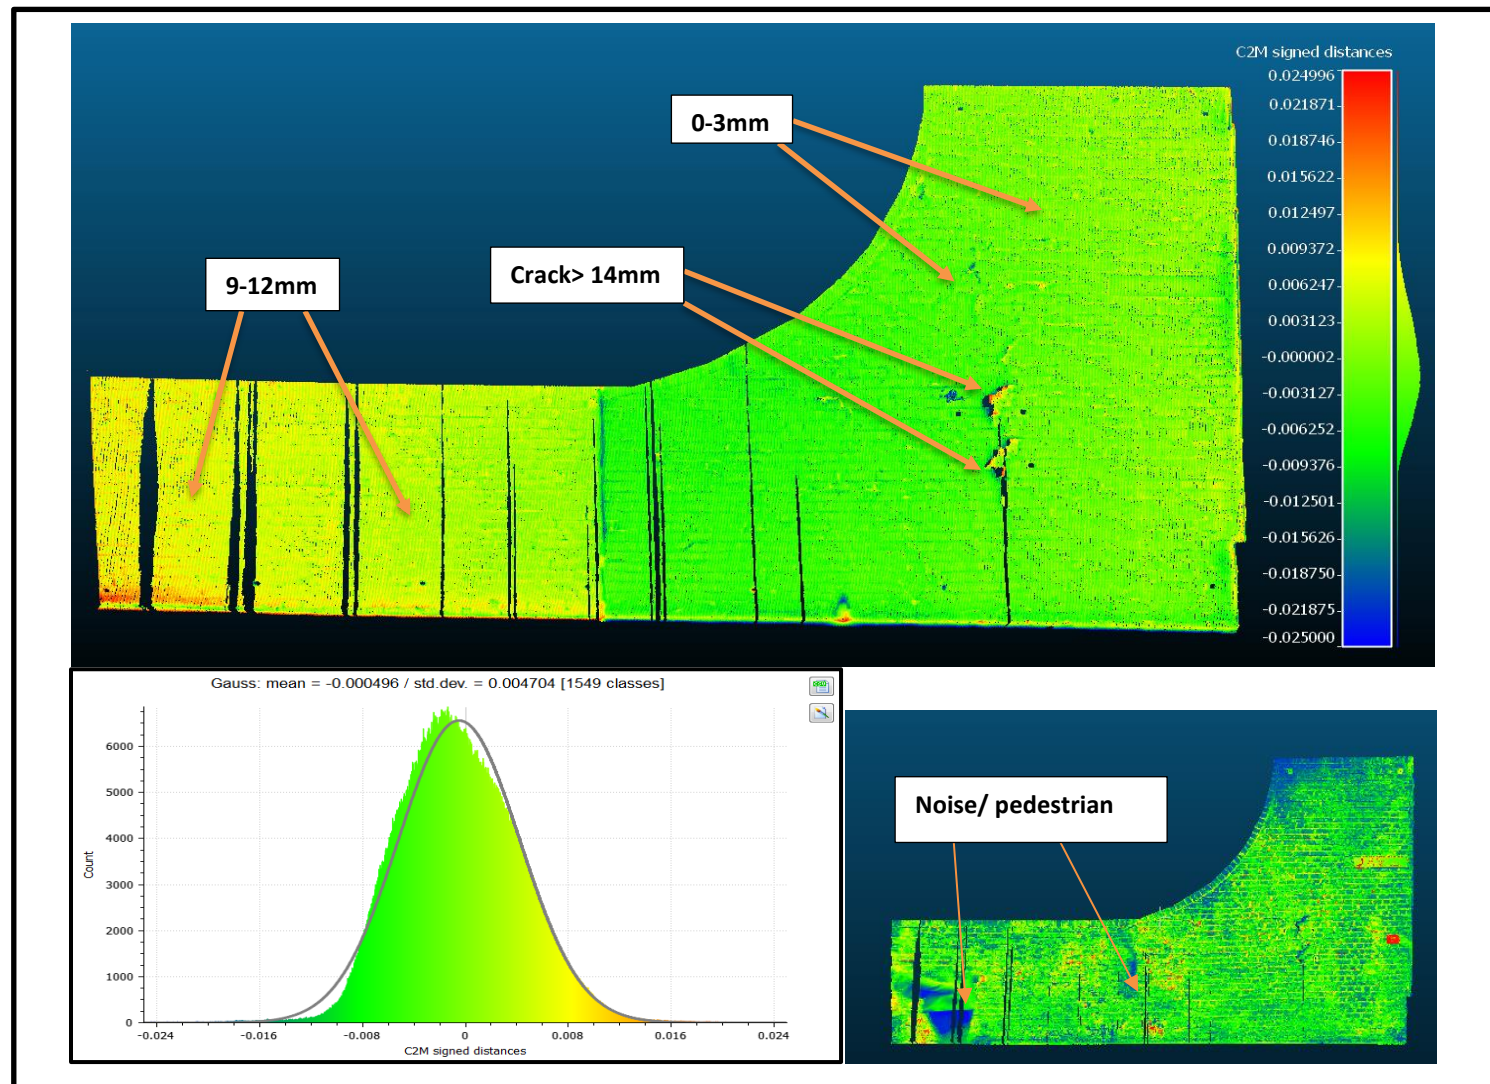
Figure 5-29 to Figure 5-32 show the deviation maps computed between baseline and different epochs of TLS data. The colour scale used on the surface displacement map highlights a deviation or deformation of the wall. Results agree with the observations from the TS monitoring. The accuracy of the deviation map is dependent on the ICP registration between the epochs calculated by the Cyclone software. The majority of the errors came from the registration process as it seems that the alignment is normally done at the centre of the point cloud (lowest differences), whilst the edges of the point cloud tend to be where the largest differences were found.

The Gaussian mean and the standard deviation show that most of the wall deviates between 0mm and 3mm (shown in light green colour). The differences between the point clouds follow a normal distribution with a bell curve. However, the area closer to cracks deviated more than 14mm. The area shown in orange had deviations varying from 6-8 mm. Figure 5-33 shows a higher deviation value range of 9-12mm due to noise caused by a pedestrian in the April-2016 data and visible in the point cloud data.

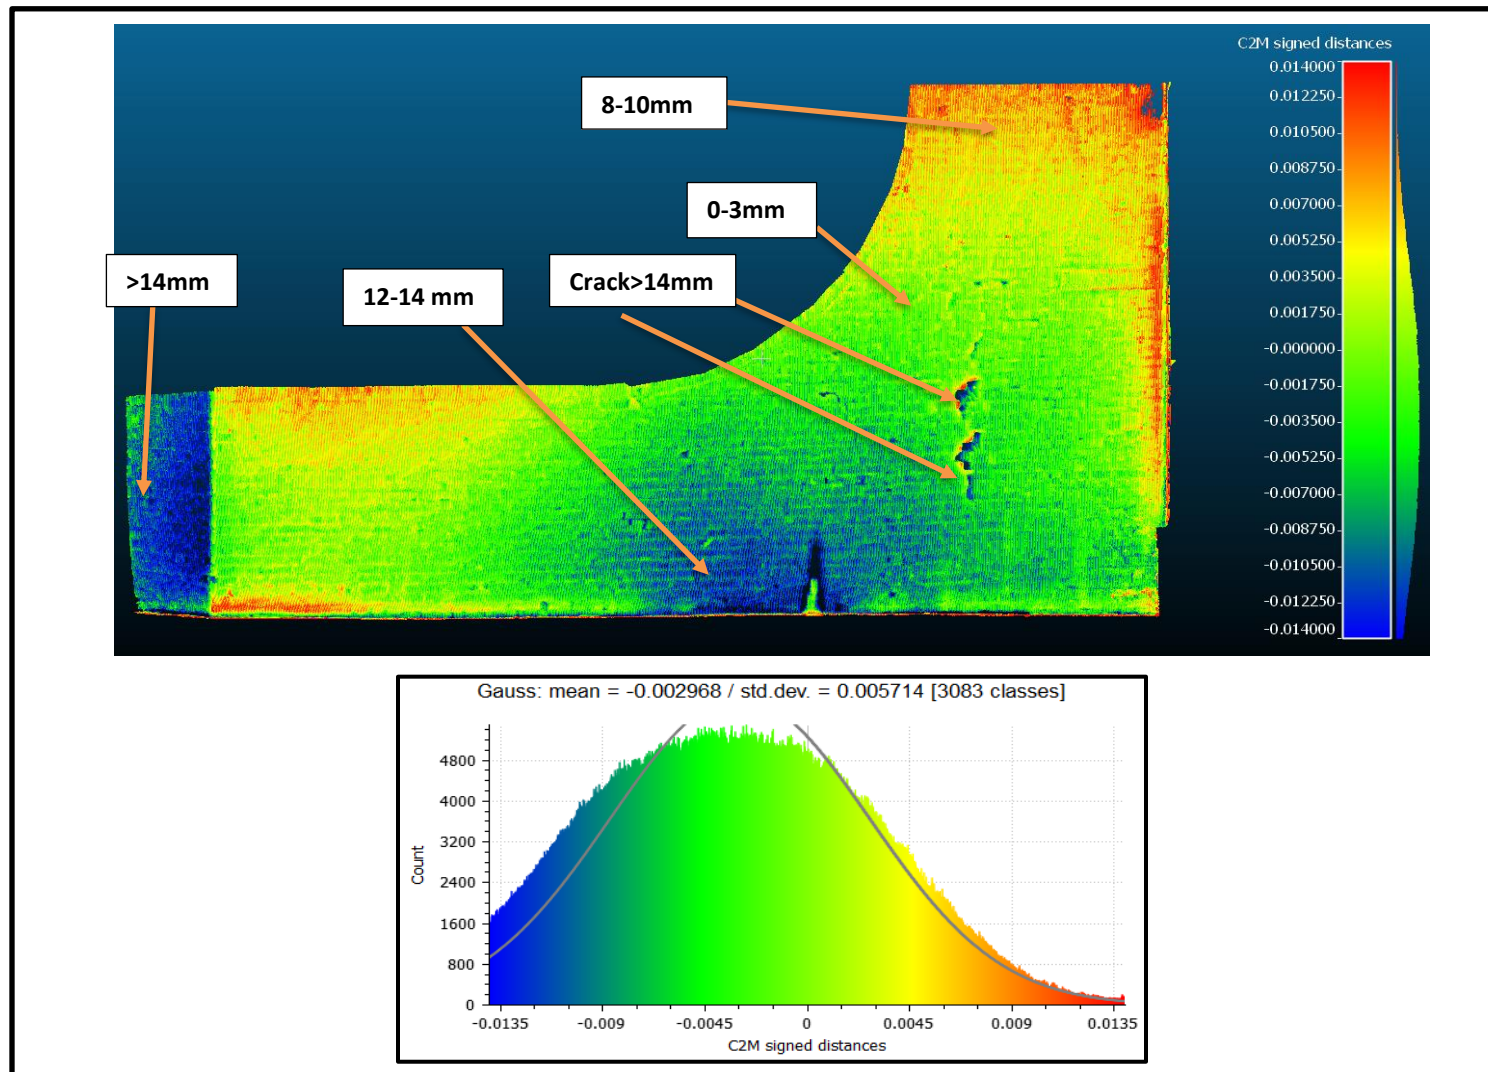
Figure 5-34 Deformation displacement map of the whole wall between Feb16 TLS and Dec-15 CRP (deflection in metres)

The left side of the wall moved more than 14mm and Figure 5-34 shows this part was not captured by the TLS, except the baseline. Therefore, TLS comparison was not performed. Overall, many areas deviate by 0-5mm (yellow areas), and the mean deviation is around 1-4 mm. The crack and the vegetation area deviated more than 14mm.
