EVALUATION OF NEW TECHNOLOGIES TO SUPPORT ASSET MANAGEMENT OF METRO SYSTEMS

GUNASINGAM RAVINDRAN

**A thesis submitted in partial fulfilment of the requirements for the award
of the degree Doctor of Engineering (Eng.D) at the
University of College London**

August 2020

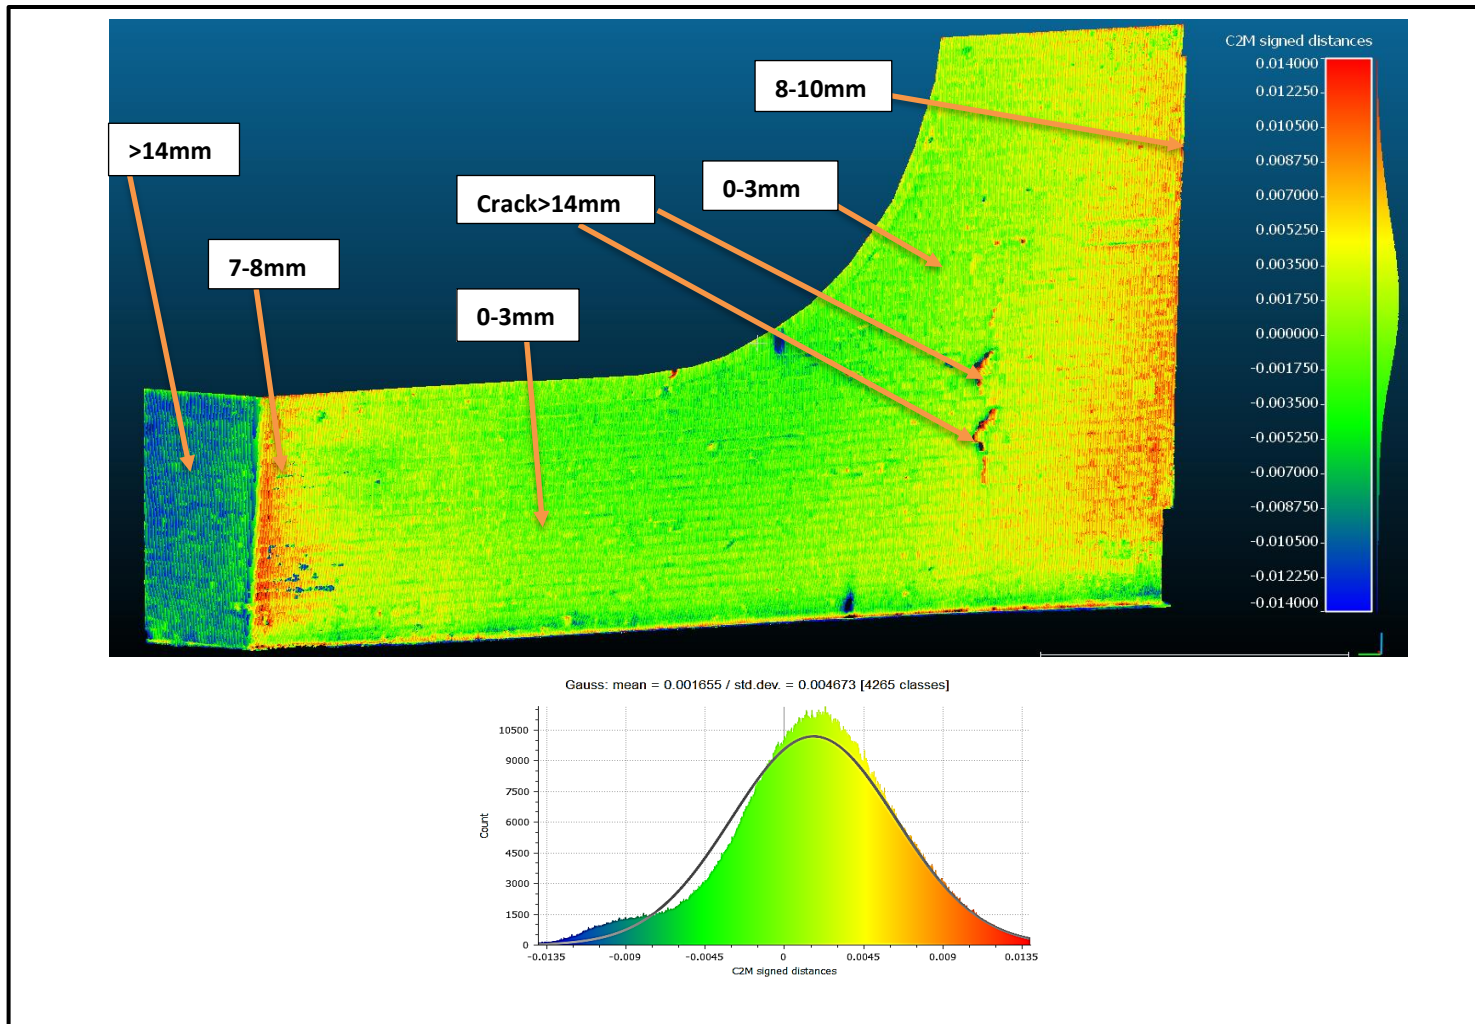
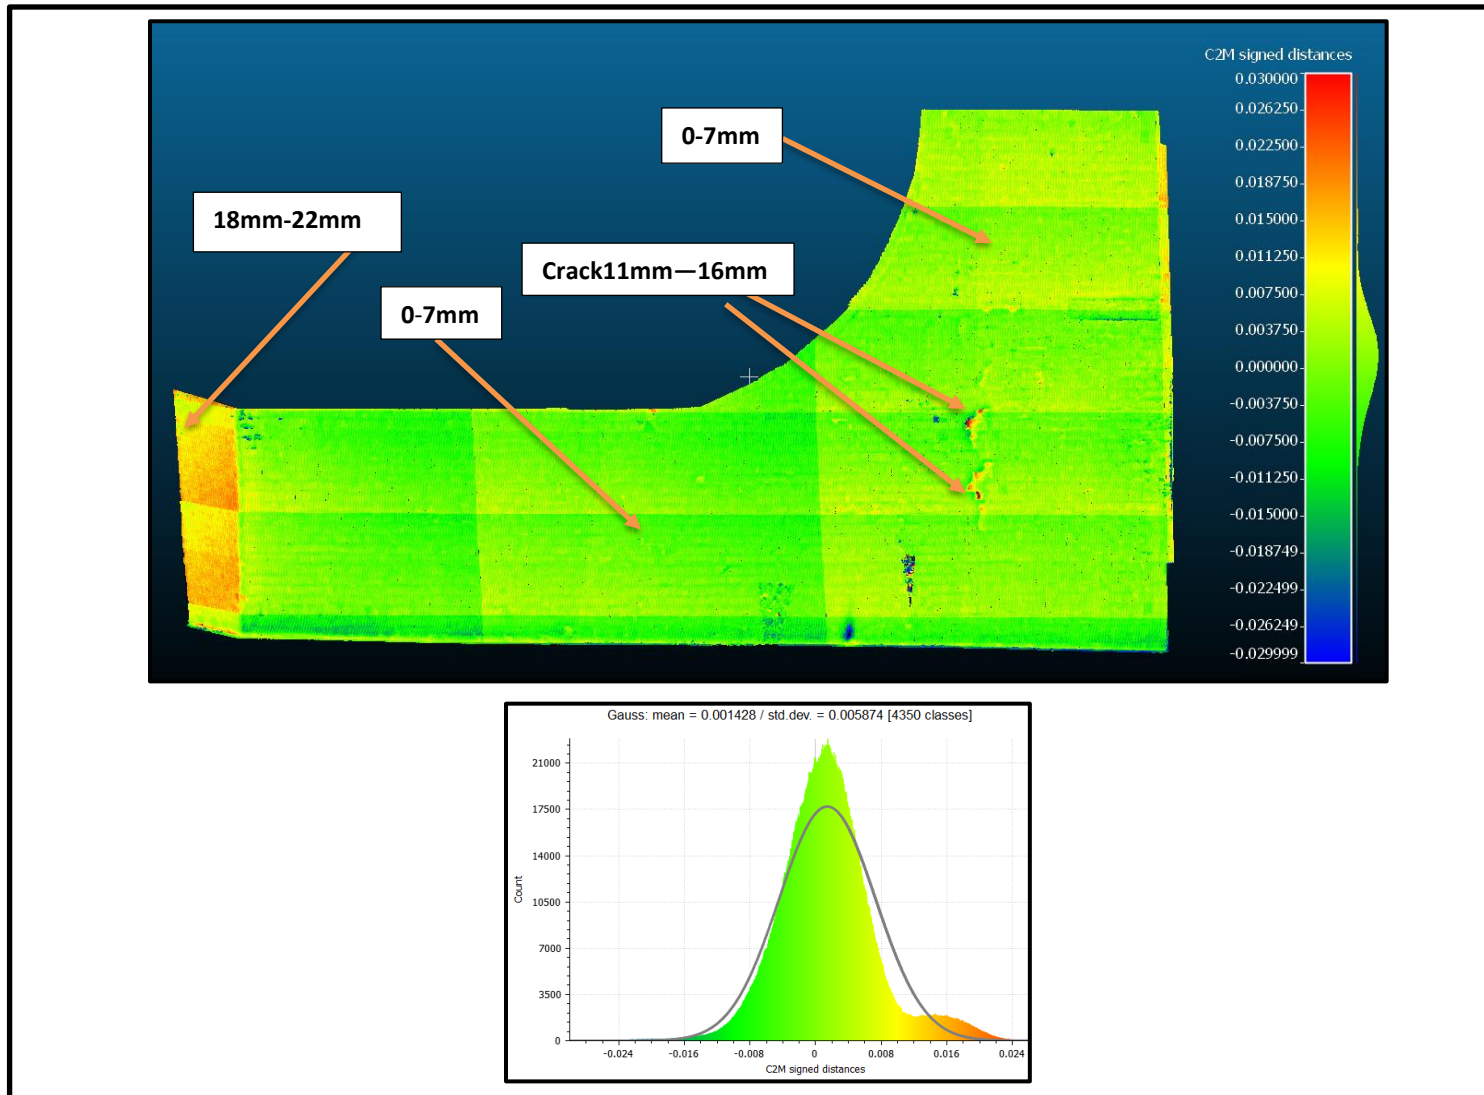
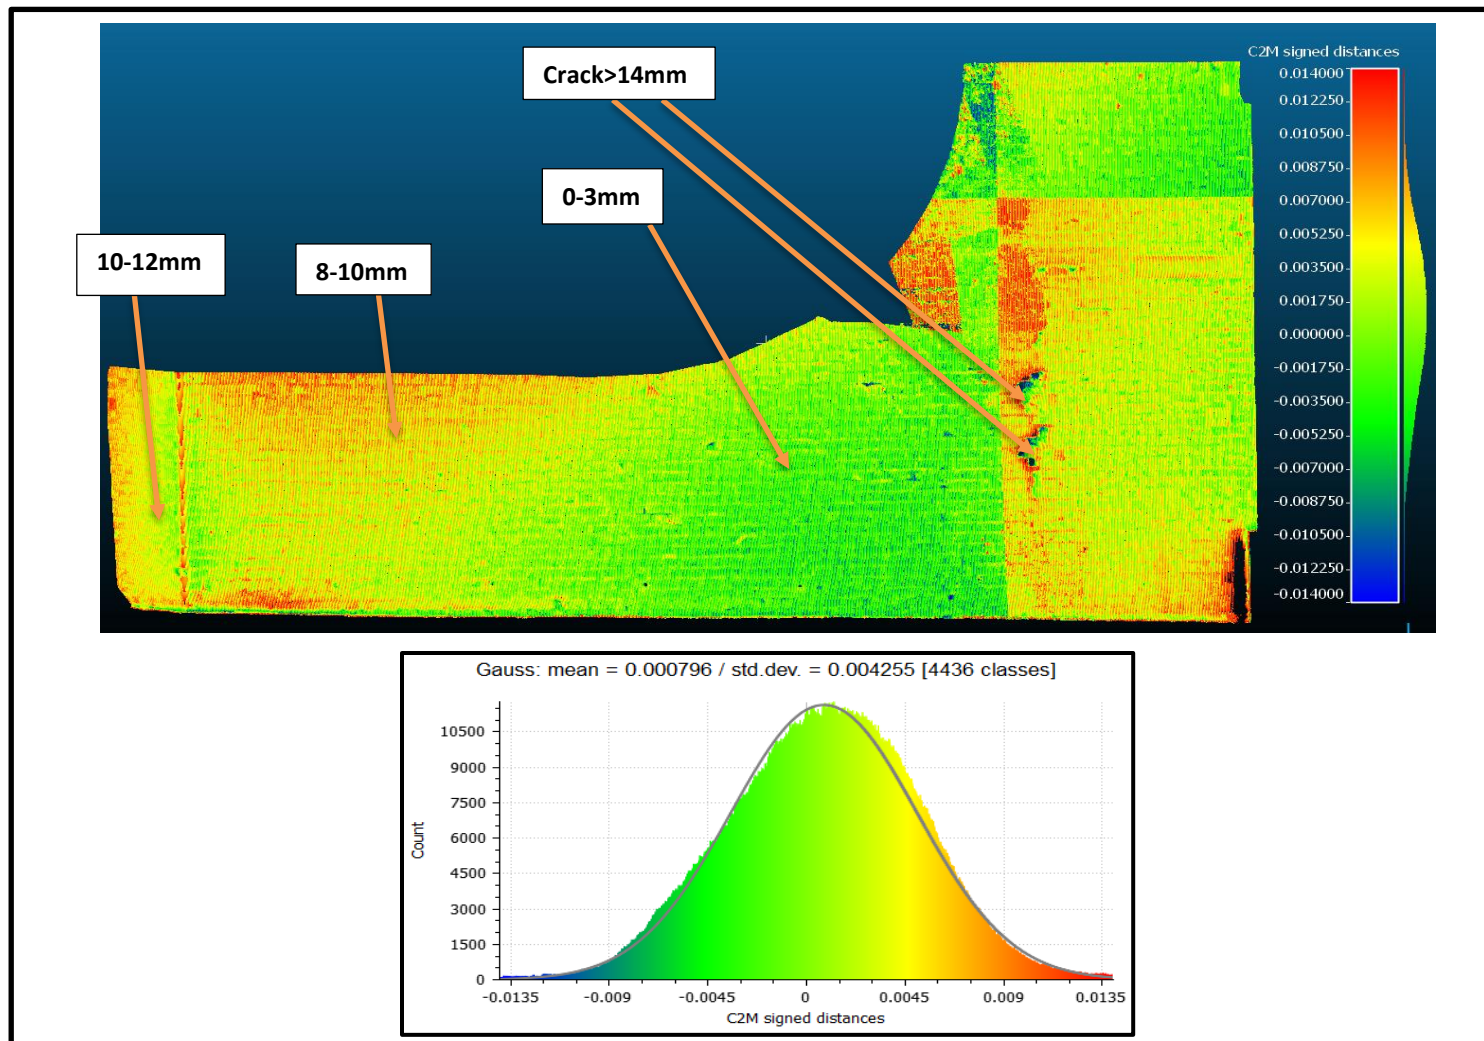
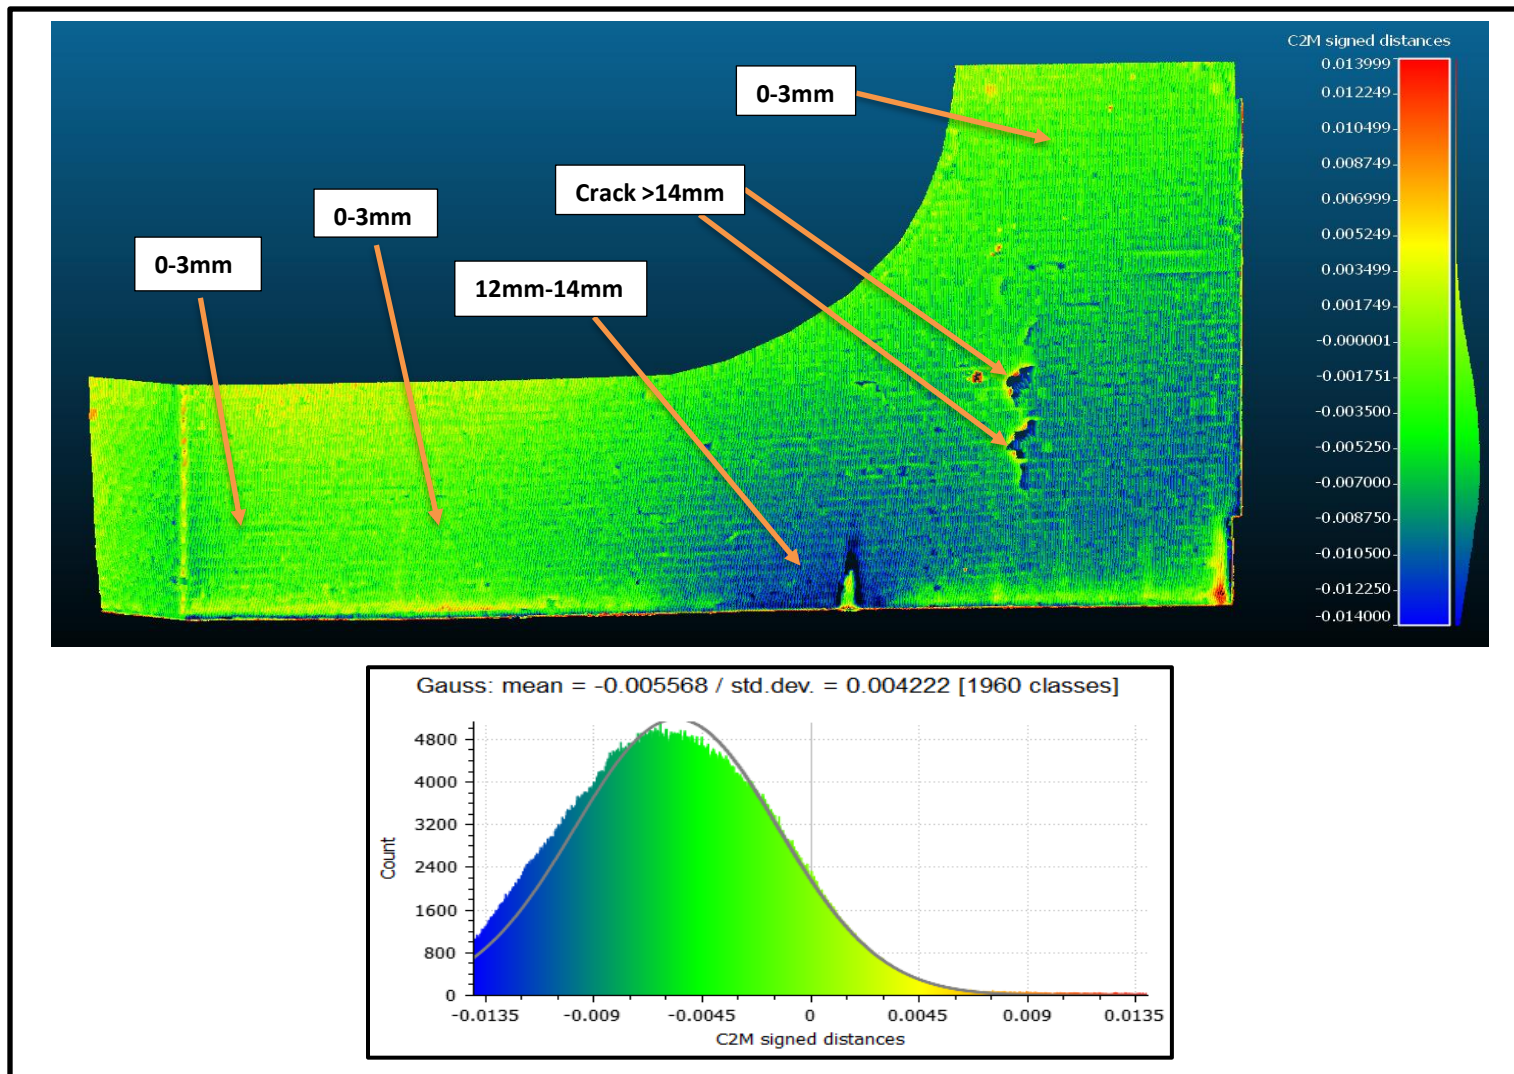
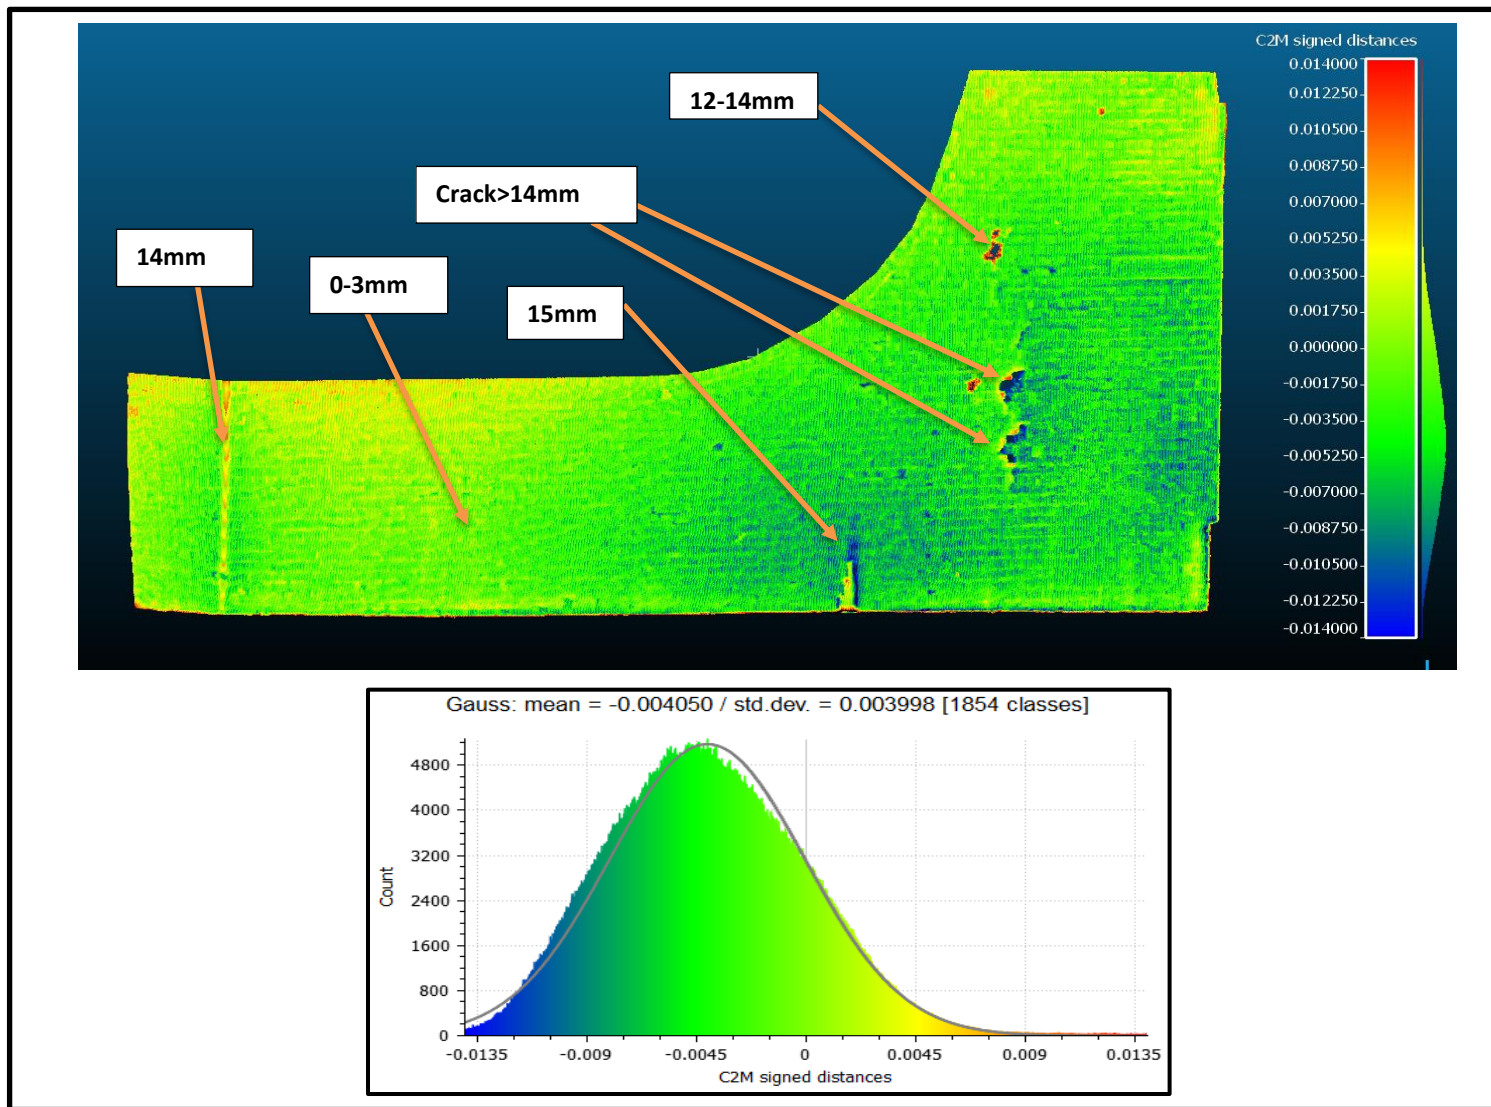
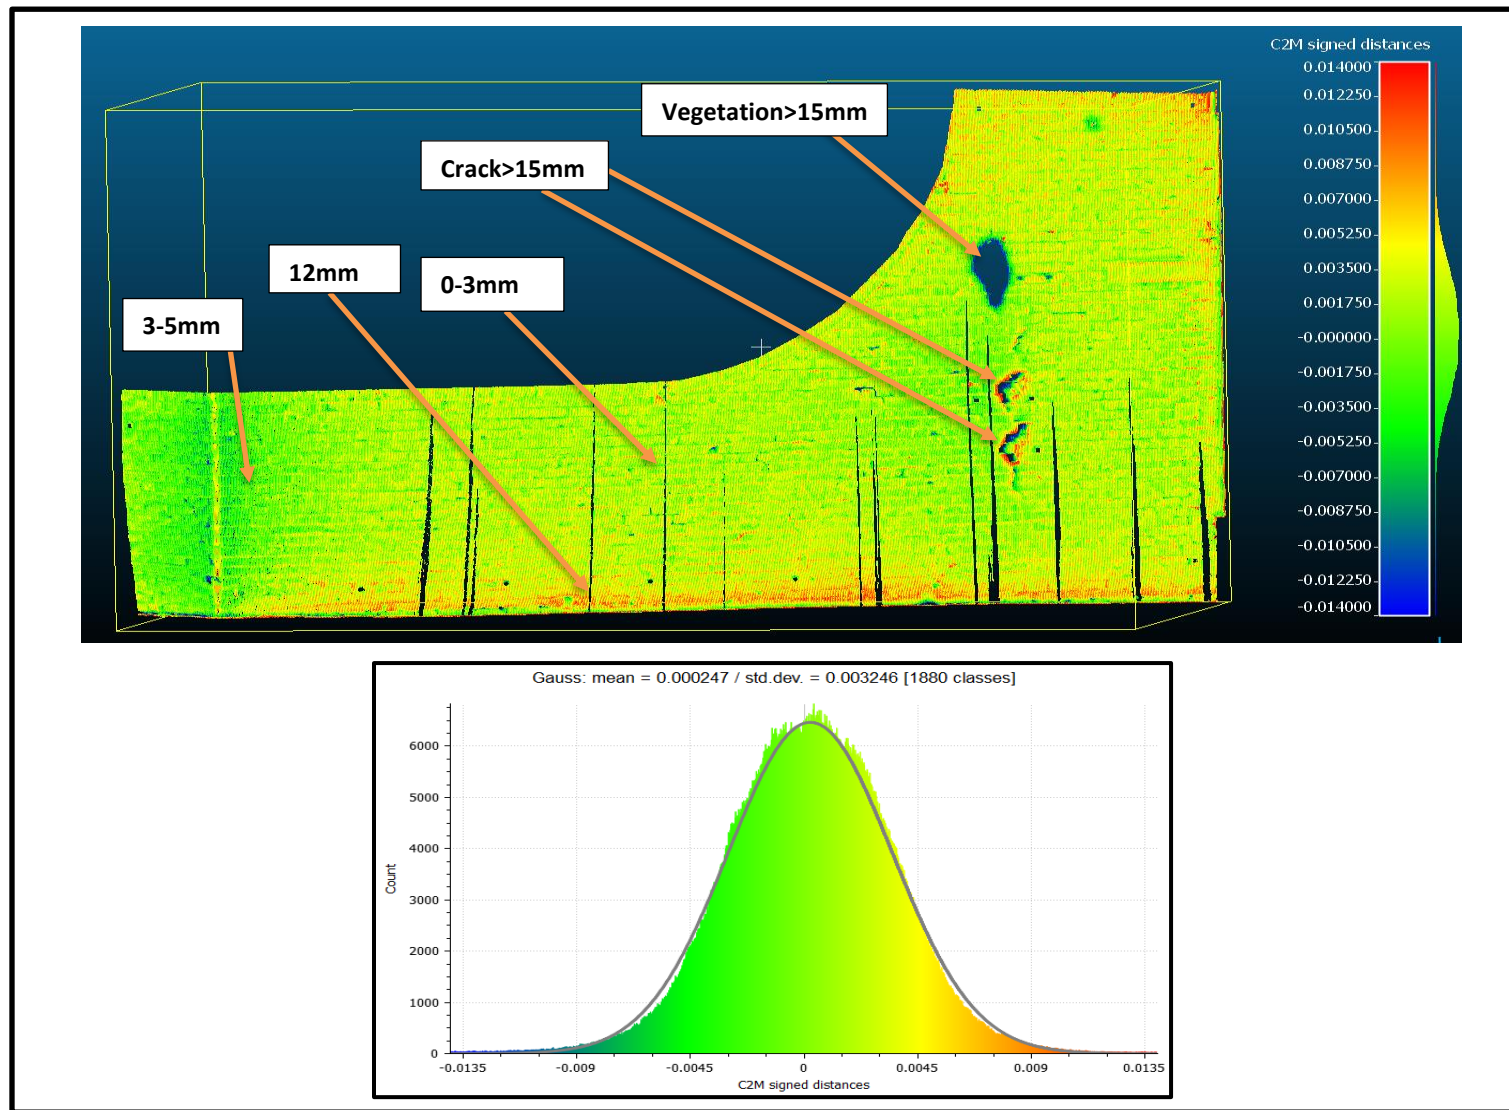
Figure 5-34 to 5-40 show deviation maps computed between the baseline (Feb 16 TLS) and the different epoch of CRP data. Furthermore, these figures show mean and standard deviations with the "theoretical" 95% confidence interval ($\text{mean} \pm 2\sigma$). Standard deviation expresses the variation from the mean value. Therefore, a low standard deviation refers to values which are close to the mean and oppositely, a high standard deviation indicates a bigger variation in comparison with the mean value. All the standard deviations in the figures are closer to their mean value and indicate that most of the point values are closer to the mean value.

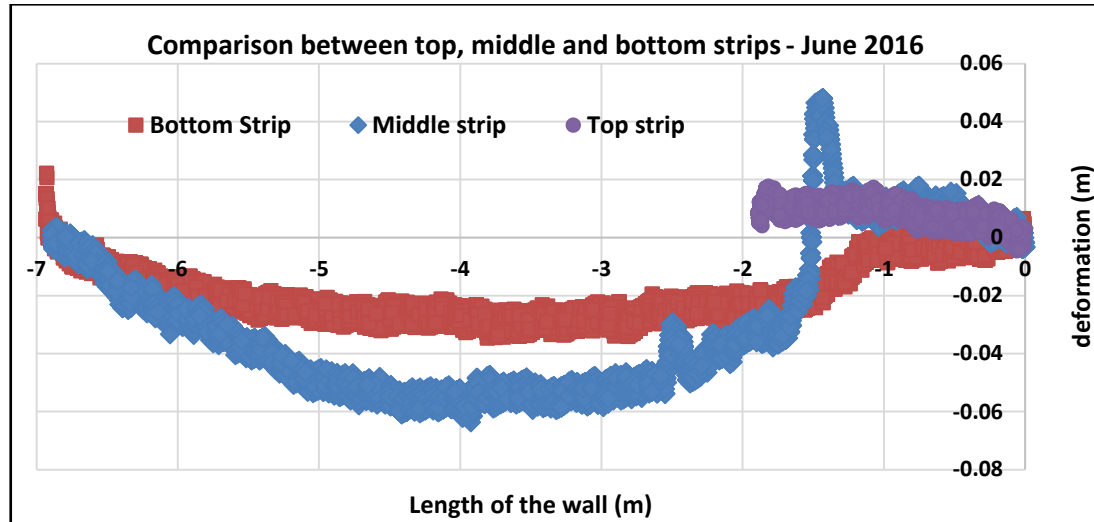
Figure 5-43 Comparison between top, middle and bottom strips for June 2016 (last epoch of Photogrammetry)

The wall movements, determined by photogrammetry of June 2016 (the last epoch), for the three strips are plotted together and shown in Figure 5-43. The figure shows that the wall deformed towards the pavement with the bottom strip showing deformation of around 35mm, whilst the middle strip shows deformation of around 60mm. The raw data for each strip shows a scatter of around 15mm and it may be possible to reduce the scatter by filtering the data, however, this was not attempted here, so that the quality of the data, generated by both methods, can be appreciated. Also, filtering the data would smoothen drastic changes in shape; an example is a crack in the structure whereby, any filter applied here would mask the true depth of the damage. For the wall movements, the outside edge of the scatter has been used, i.e. the largest value. As changes in movement between surveys are required and provided that this outer edge is consistently used, this method is valid. However, with the improvements in the accuracy of measuring instruments, the scatter will reduce and therefore, the mid-point of the scatter should be used in future works. The figure also shows that the right side of the wall did not move much from the middle to the top strip, showing small movements from the bottom to the middle strip. This would appear to suggest that the right-hand side of the wall is significantly stiffer than the rest of the wall and, as a consequence, a crack (peak seen in the middle strip, depth of around 50mm) appeared at around -1.5m along the wall. A later site visit confirmed that behind the area of the wall of no movement, there is a buttress to the wall; a much more rigid structure, as seen in Figure 5-44. The buttress, being significantly stiffer than the wall, creates a discontinuity in stiffness, thereby causing the crack to occur at their junction.

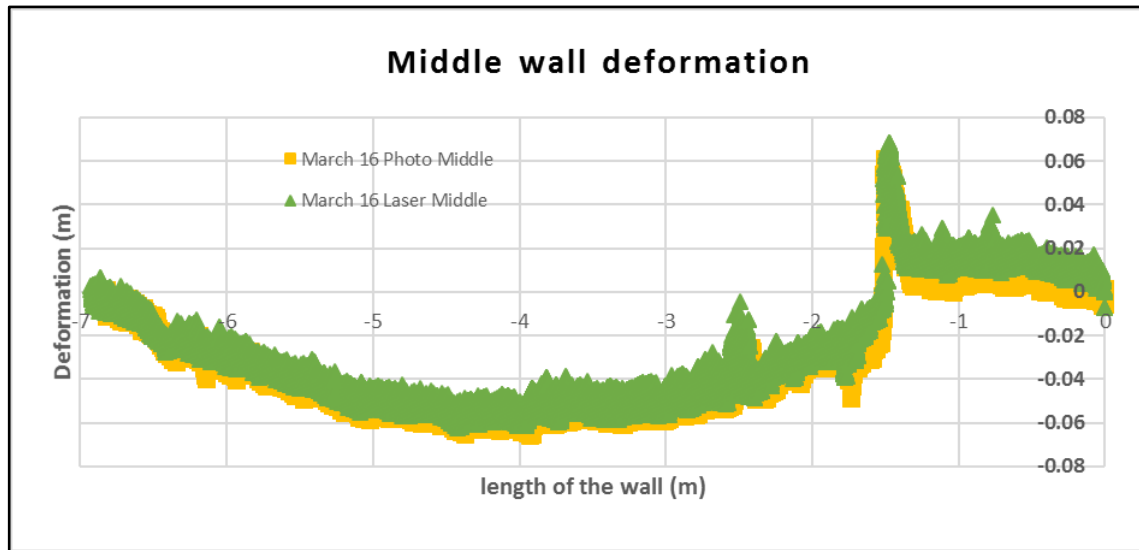
Figure 5-45 Comparison of the middle strip from laser scanner and photogrammetry

Figure 5-45 shows that both point clouds have similar scattering, around 15mm, furthermore, they have the same shape and show that the wall has deformed towards the pavement by as much as 60mm. It is also possible to discern the depth of the crack, on both strips, with similar dimensions, i.e. around 60 mm. Unfortunately, the depth of the crack may not be accurate. However, cracks can also be determined by the abrupt change in the direction as seen in the figure. This observation is important as it means that measurements taken by LUL in March 2015 with the laser scanner, can be compared directly with the later work using the photogrammetry technique performed by the author.

The results presented in Figure 5-45 also show that despite being obtained using different equipment and being geo-referenced by different persons, the point clouds are compatible and can be directly compared. The results also demonstrate that when comparing point cloud to point cloud or point cloud to plane (definition in section 5.8), a difference is likely to be seen given that there is a 15mm scatter in the strips. Therefore, direct comparisons between point cloud to point cloud should be avoided unless larger deformations are measured; hence, point cloud to plane is preferred.

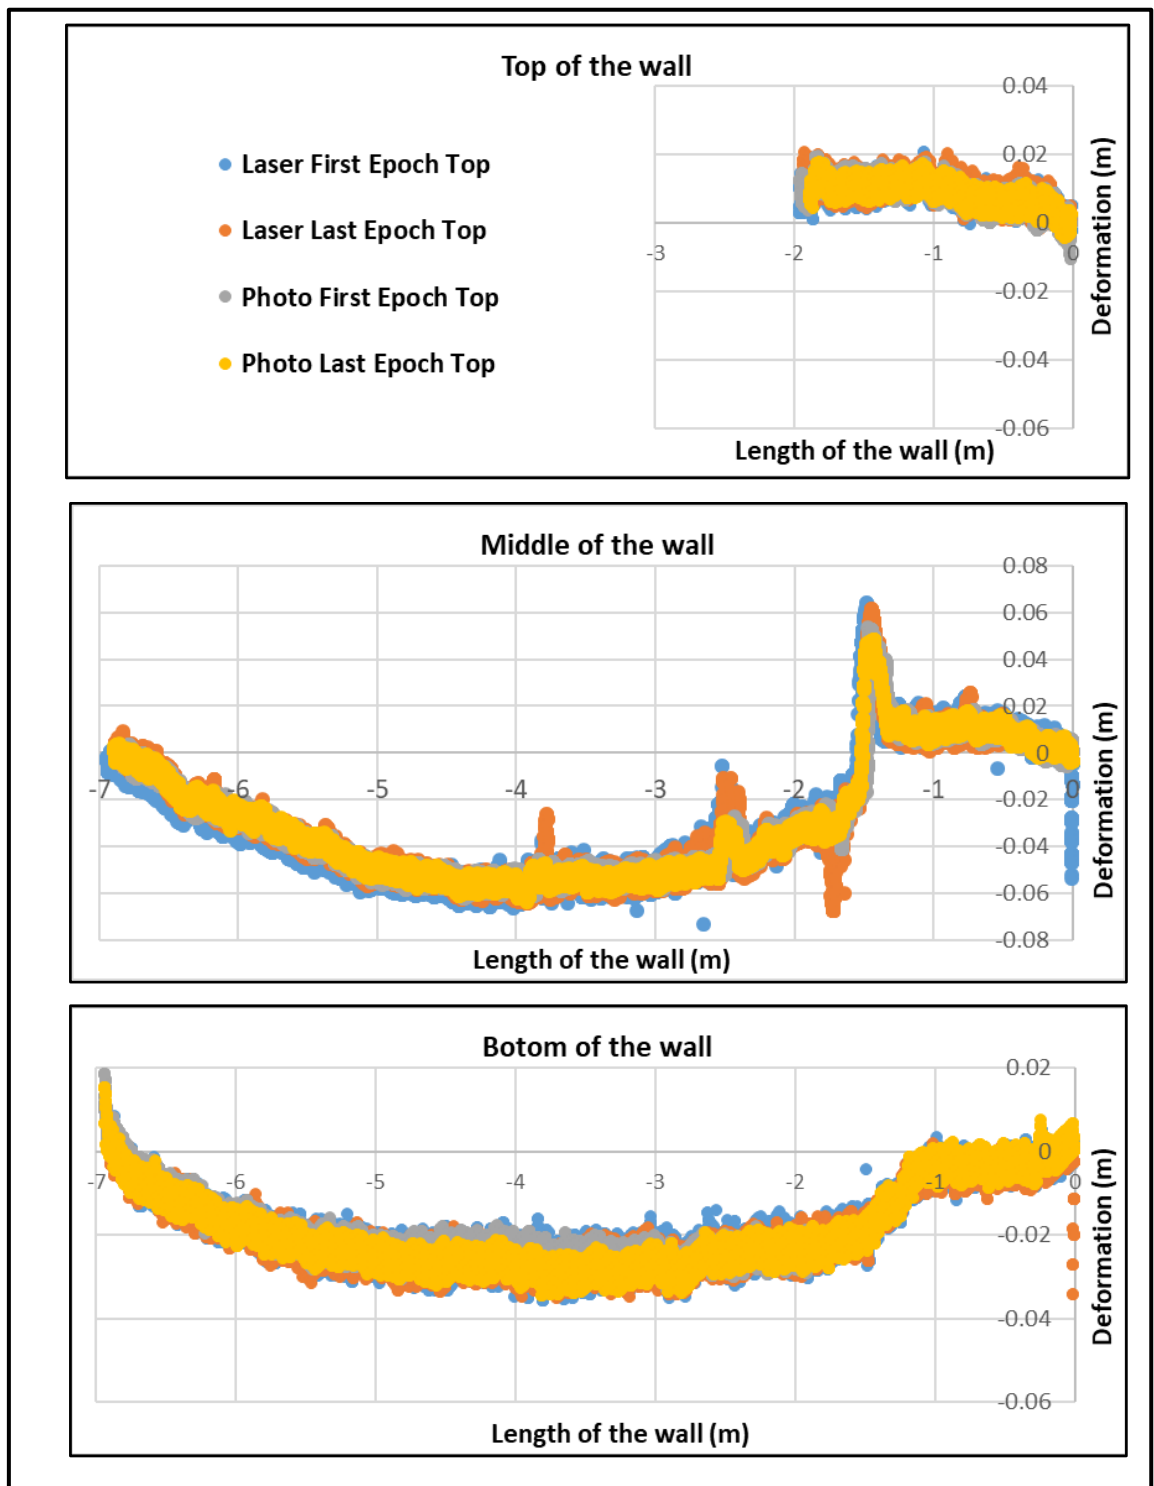
Figure 5-46 Comparison between the first and the last epochs of Laser scanner and photogrammetry: a) Top strip; b) Middle strip and c) Bottom strip

Figure 5-46 compares the first and last epochs of the point clouds, for top, middle and bottom strips obtained by using laser scanner and photogrammetry. Figure 5-46 shows that for all epochs, the deformation of the bottom part of the wall is between 30 and 35mm, whilst for the middle, the difference shows between 60 and 65mm, and for the top, this difference is around 15mm. Comparing all 4

The results are shown here demonstrate the potential of this technique to measure deformations in the shape of the structure, whether by laser scanner or photogrammetry. When analysing Figure 5.46, it was predicted that the behaviour implied a stiffer structure at the top strip of the wall than could be observed from the front of the wall; this was confirmed (Class A prediction¹) by a later site visit. It is clear that the use of these new technologies will require analytical skills not generally taught to those using more conventional surveying techniques. Hence, interpretation of movements will need a combination of skills and, most likely, different or retrained personnel.
