Factors for Improved Fish Passage Waterway Construction

Final Report

**SPR 654
OTREC-RR-11-19**

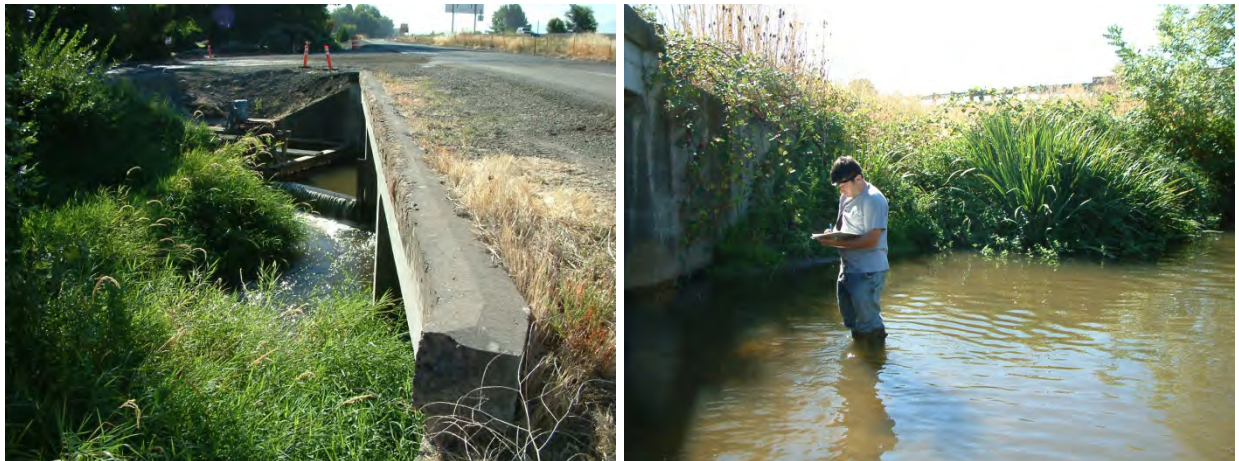
Figure 4.10: Site 08 - Jackson Creek downstream and upstream

Jackson Creek (2) is in Jackson County and crosses Interstate 5 at a location close to Central Point. The creek is accessible from the downstream side after following an exit from the interstate towards Blackwell Road and then following an unnamed gravel road. The upstream side is not accessible from the road, and was accessed after walking through the culvert. The investigators had to clear the area of some vegetation in order to perform some measurements. The structure consisted of three culverts side by side. One of the culverts had a water pump close to it that was used by a local farmer to pump water for the fields. Cross-sections of the flow were not possible due to vegetation. Photos of the site appear below in Figure 4.10.

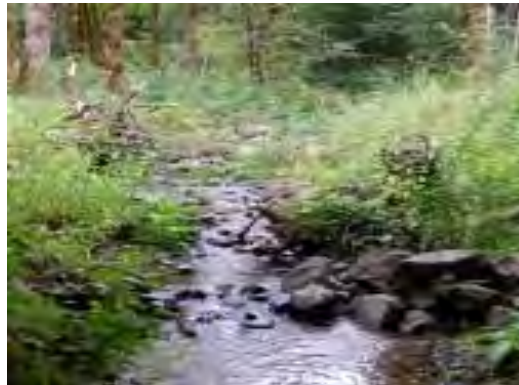
Figure 4.15: Site 13 - Bateman Creek downstream

site has an easy access from the road. Cross sections of the flow were produced, and the slopes were easily measured. A photo of the downstream side of the culvert is shown in Figure 4.15.

Some history of this site was available: The slope of Bateman Creek is 4 to 6%. In summer 2006 the culvert at the site was replaced by a roughened channel and a bridge. At this site bed slope was reduced from 6% to 4.3% by introducing sinuosity to the channel. Grade control structures were buried in the streambed to prevent the stream from head-cutting. The banks of the stream were armored with large rocks to prevent erosion. ODOT used a 50 yr event as their design flow for this installation (*HDR 2004*).

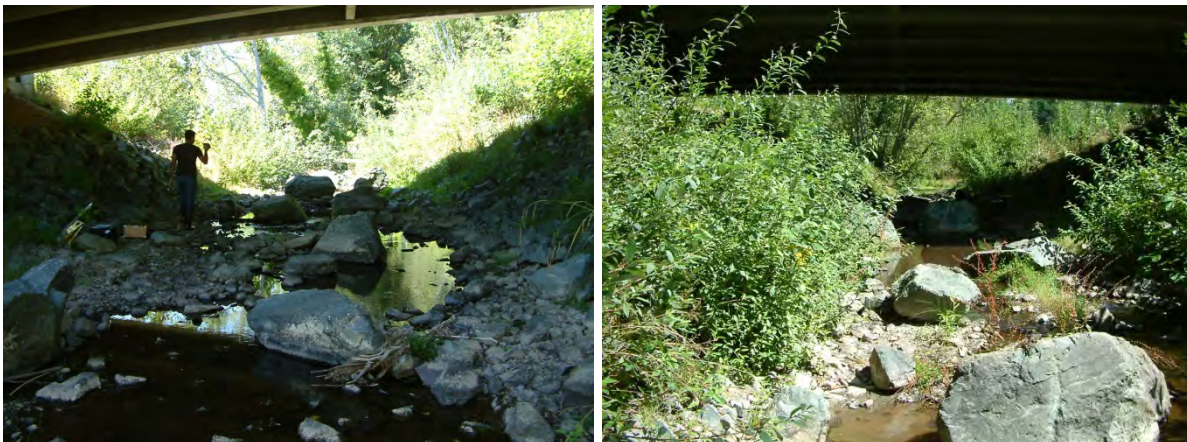
Figure 4.16: Site 14 - Bethel Creek under structure and downstream

Bethel creek is located in Coos County and crosses highway 101 at MP 284.79. The site was easily accessible, but the investigators had to jump the protecting fence separating the highway from the surrounding area. Access to the creek was from upstream. There were no major concerns about the area and river cross-sections were taken. Views of the structure are shown below in Figure 4.16.

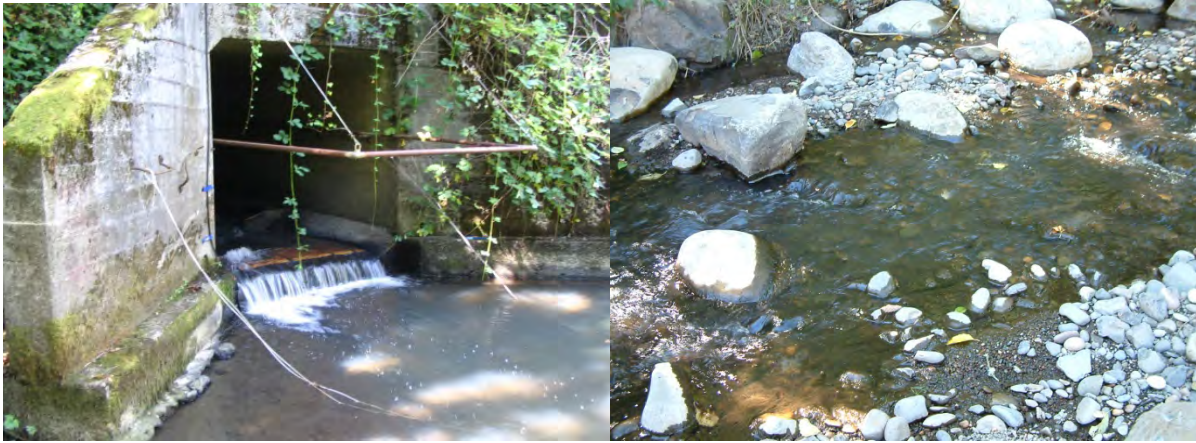
Figure 4.19: Site 17 - Tryon Creek outlet and downstream

Tryon Creek is located in Clackamas County and it crosses OR 43 at MP 5.8. The creek is accessible from the downstream site. There is a large scour pool at the mouth of the culvert and that did not allow the investigators to access the culvert itself. Access from the upstream site was very steep. All measurements were taken from the downstream site (Figure 4.19 right).

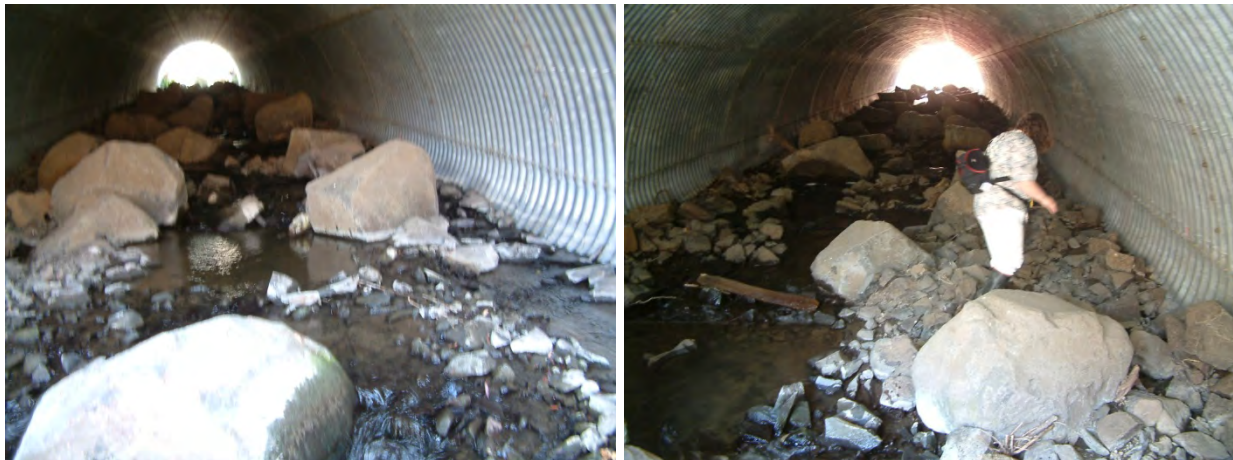
Figure 4.21: Site 19 - Three Mile Creek structure looking downstream and upstream

Three Mile creek is located in Wasco County on the East side of The Dalles, and crosses Highway 30/197 at three locations. At the time of the investigation only the northernmost site was modified with a roughened channel. The roughened channel was inside the culvert and the water was flowing normally. There was no evidence of scour. There were some locations inside the culvert with jumps greater than 12 inches. The creek was accessible from downstream, through the property of a private business. After asking for permission, the owner allowed the investigators to approach the creek.

The upstream side was not accessible from the road, since the approach was very steep. There were no measurements taken for the upstream side of the culvert due to the large amount of vegetation that was present. Photos of the inside of the culvert are shown below in Figure 4.21.

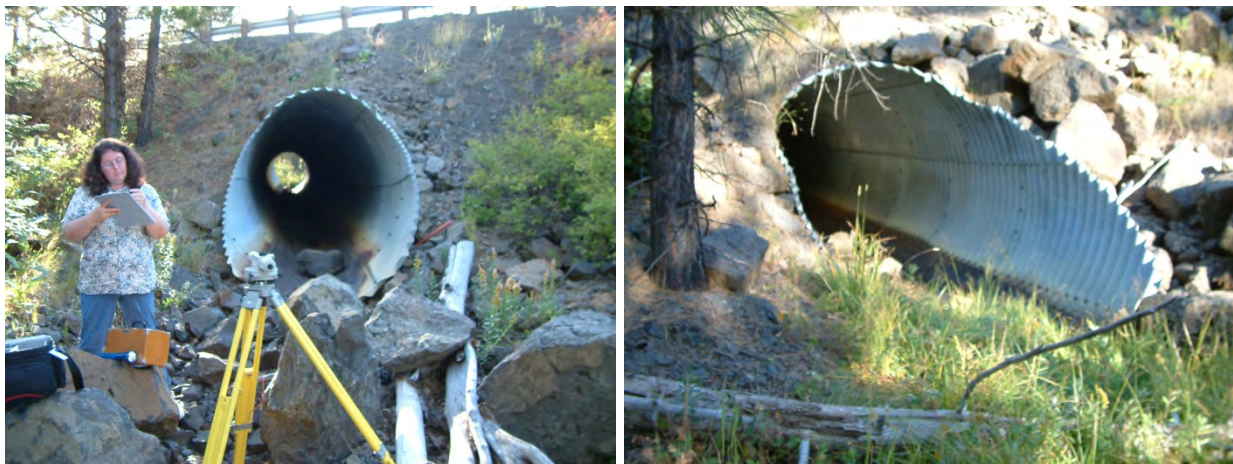
Figure 4.23: Site 21 - Porter Creek downstream and upstream

Porter Creek is located in Wheeler County and intersects Highway 207 at the county border line. Access to the creek was easier from the downstream side and it was a little steep. There was no water flowing and the slopes could be measured easily. The culvert, which was made of corrugated metal, had no baffles or weirs inside. The downstream side (Figure 4.23 right) had a large accumulation of boulders, which seems to have been placed intentionally. There were no obvious water marks for estimating the high flow elevations of the water in the downstream side of the culvert, while the upstream side (Figure 4.23 left) had a lot of vegetation.
