A plane slide that occurred during construction of a national expressway in Chongqing, SW China

Z.Q. Yue and C.F. Lee

Quarterly Journal of Engineering Geology and Hydrogeology 2002; v. 35; p. 309-316
doi:10.1144/1470-9236/01004

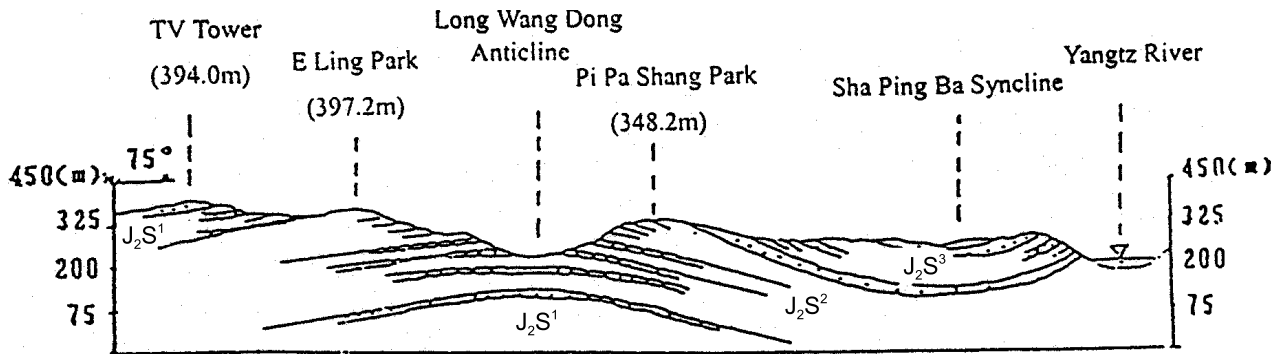
Fig. 8. Typical profile of geology and fold geological structure in Chongqing (J_2S^1 =Lower Shang-Sha-Xi-Miao Formation of the Middle Jurassic; J_2S^2 =Middle Shang-Sha-Xi-Miao Formation of the Middle Jurassic; J_2S^3 =Upper Shang-Sha-Xi-Miao Formation of the Middle Jurassic).
