**EUROPEAN COMMISSION
JOINT RESEARCH CENTRE**

NEDIES PROJECT

Lessons Learnt from Maritime Disasters

EUR 20409

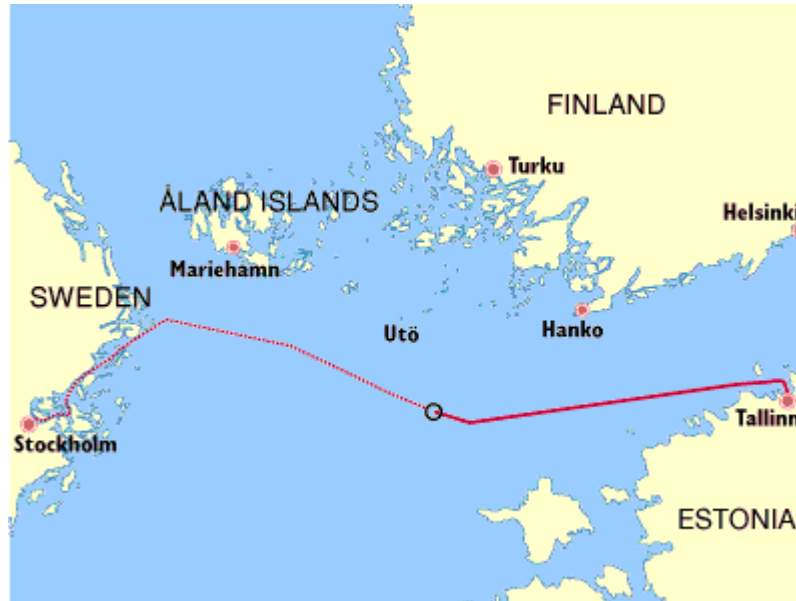
Figure 2.1.b - Route of the MV Estonia.
© Accident Investigation Board Finland

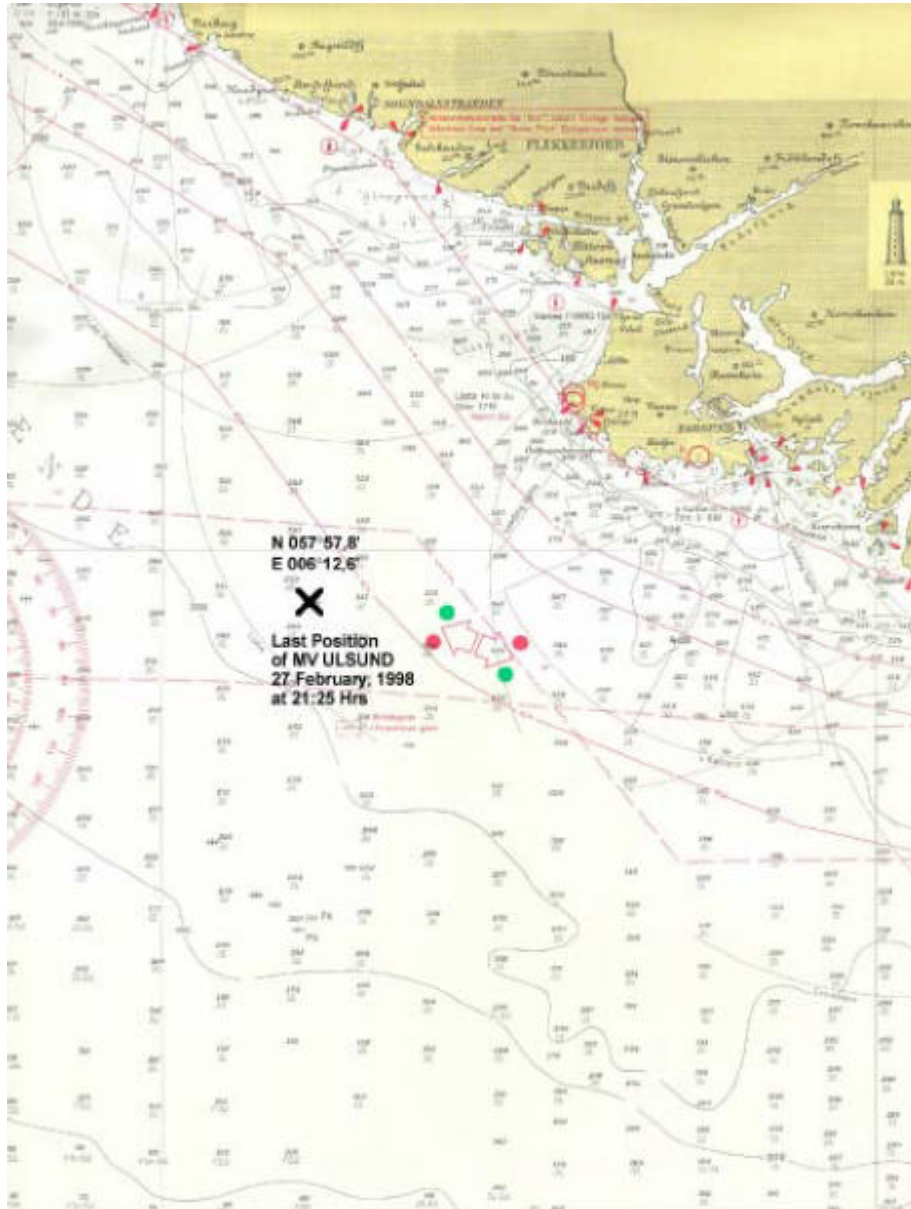
It is assumed that the ship went down in the course of about 10 to 15 minutes, as no other vessel observed any clear radar echo in the indicated casualty position. The first vessel reached the indicated casualty position about one hour later, at which time there was only wreckage left.

*Figure 2.3.b– Last position of MV Ulsund.
© Accident Investigation Board Finland*
