Failure analysis and numerical simulation of slab carrying clamps

Branislav Đorđević, Simon Sedmak

HBIS Group Serbia Iron & Steel Ltd., 11300 Smederevo, Serbia

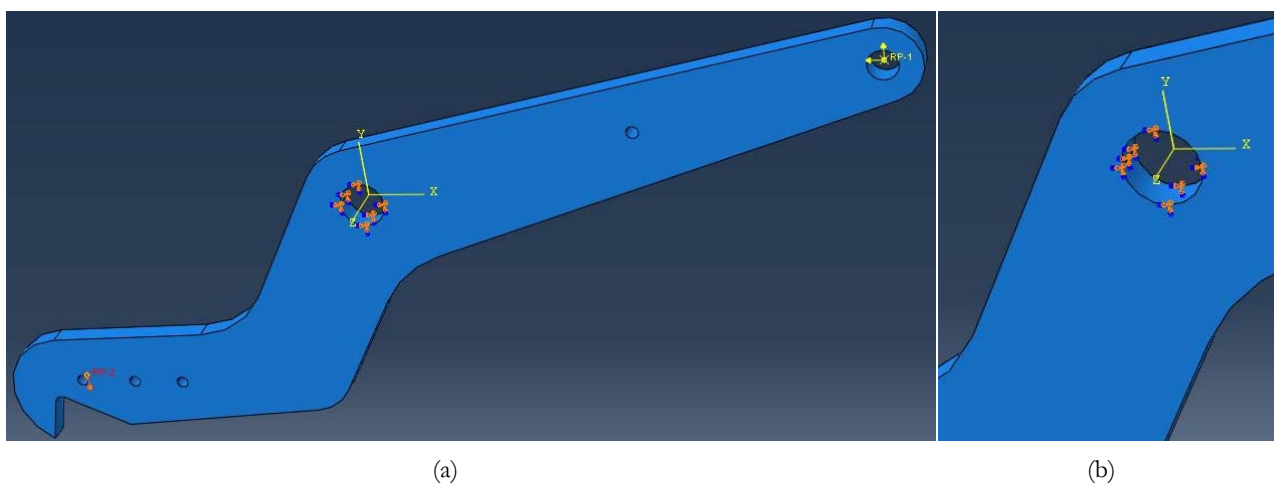
Numerical simulation in this research was focused on one of the levers, for the purpose of determining the stresses that would occur in it, and whether the critical location (where highest tensile stresses were observed) would correspond to the actual fracture location, without taking into account the material heterogeneity. This was done in order to see if the initial assumptions about the model were correct, and to determine the location of crack initiation in the future, improved models. For the reason of initial model simplicity, certain approximations were made to the model – only the fractured lever itself was modelled, and its connection with the upper lever which is supported in point A from the Fig. 4 was replaced with the corresponding force F_p . It should be noted that this force was decomposed into x and y axes components, instead along the lever axis, due to ABAQUS requirements. Hence, the values of this load were -269034 (x axis) and 143048 N (y axis). To avoid confusion with the results, all forces were defined in Newtons and dimensions were assumed to be in millimeters, so that the stress results would be obtained in N/mm², i.e. in MPa. Another load was defined at the bottom part of the lever, and it was equal to one quarter of the work load (since only one lever was modelled). Hence it was equal to -85837.5 N. Model geometry and loads can be seen in Fig. 5a. Boundary conditions were defined in the central opening, by constraining its inner surface. All displacements and rotations were prevented, with the exception of rotation about the z axis, in order to replicate the real boundary conditions as close as possible. There is also a possibility to further improve this boundary condition, but this will be done in the future, once new and more complex models are developed. The boundary condition can be seen in Fig. 5b.

Figure 5: a) Numerical model geometry and loads (defined in RP-1 and RP-2 points) b) The boundary condition (only the rotation about the z-axis is allowed).

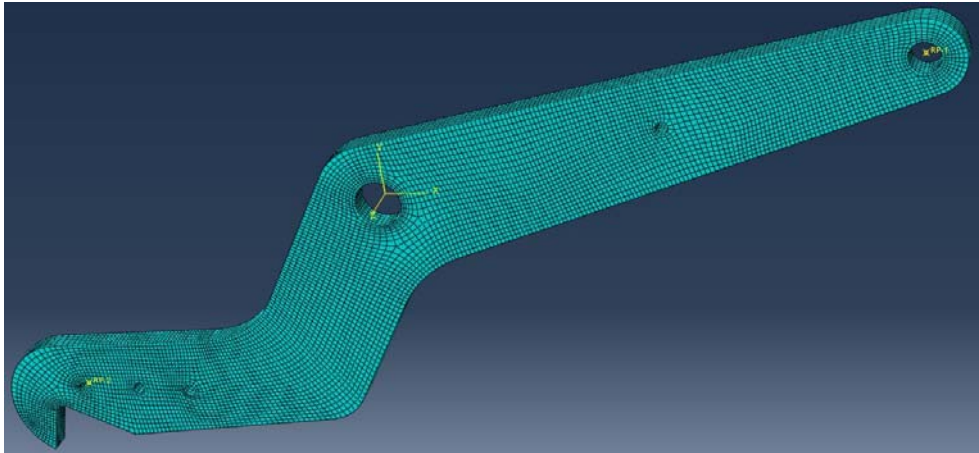
Finally, the finite element mesh is given in Fig. 6. Element size was approximately 13.5 mm, since it was determined that this size provides sufficient convergence of results, after a number of iterations. Element type used for this analysis was C3D8R, and the total number of elements and nodes was 30285 and 38330, respectively.

Figure 6: Finite element mesh of the model.
