European Laboratory for Structural Assessment (ELSA)

The Garda Area (Italy) Earthquake of 24 November 2004: A Field Report

S. Dimova, E. Mola, P. Negro, A.V. Pinto

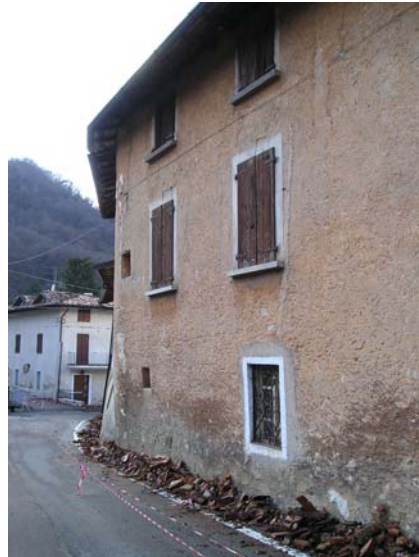
Figure 3.17. Fallen 'coppi' tiles

The survey has shown diagonal cracks in the masonry walls of many houses, failure of masonry due to the lack of separation joints between buildings with different levels of the horizontal elements (Figure 3.16), disintegration and failure of the unconfined masonry under the roof structures. In many houses the 'coppi' tiles have fallen from the roof

(Figure 3.17). The church was considerably damaged: the upper part of the bell tower suffered shear failure (Figure 3.18), the masonry was considerably cracked in many places due to interaction with adjacent structures (Figure 3.18), shear effects and out-of-plane bending. Partial separation of the façade walls was observed (Figure 3.19). Near Clibbio a rock-fall caused damages of the road (Figure 3.20).

Another source of failure was the lack of separation joints between the houses. Adjacent structures with different height of the floors “bumped” against each other causing failure of the masonry in the neighbouring parts, as shown in Figure 4.16 for Collio. The irregular distribution of the stiffnesses and masses in-plan and along the height provoked failures in a house in Clibbio, as shown in Figure 4.6. The use of different materials for construction of the masonry walls caused their cracking and disintegration. In Figure 4.7 the failure of a masonry wall containing bricks and stones with different size is presented. The horizontal seismic loading caused sliding and failure of the ‘coppi’ tiles in many roofs in Clibbio and Pompegnino, as shown in Figure 3.17 and Figure 4.8.

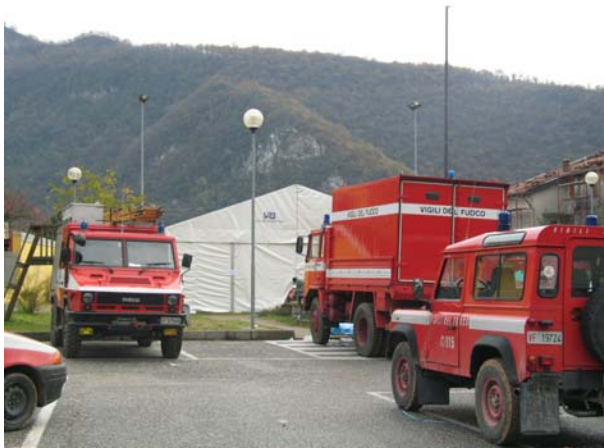
Figure 5.7. Vigili del Fuoco vehicles in Pompegnino
