# 2007 August 15 Magnitude 7.9 Earthquake near the Coast of Central Peru

Earthquake Field Investigation Team (EEFIT) Field Mission, 5-12 SEPTEMBER 2007 / Final Report

**Fabio TAUCER, Joint Research Centre (Editor and Team Leader)**  
**Dr John ALARCON, Arup**  
**Emily SO, University of Cambridge**

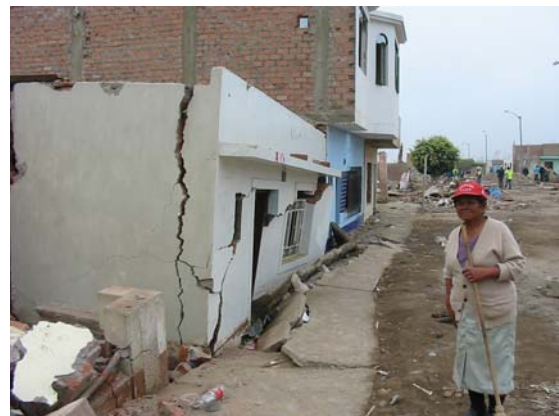
Figure 3.2 Houses in the area affected by liquefaction were mostly confined masonry

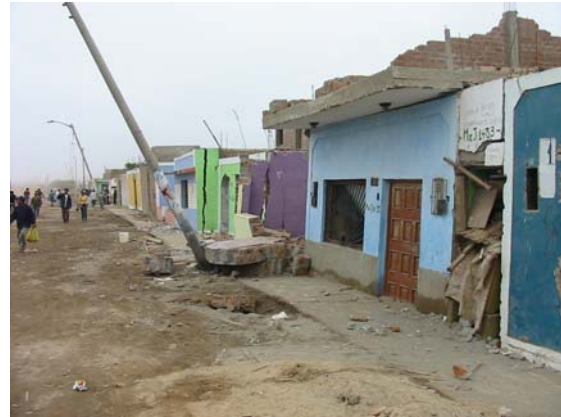
Figure 3.4 Street lamps toppled at the base up to approximately 50° with the horizontal plan

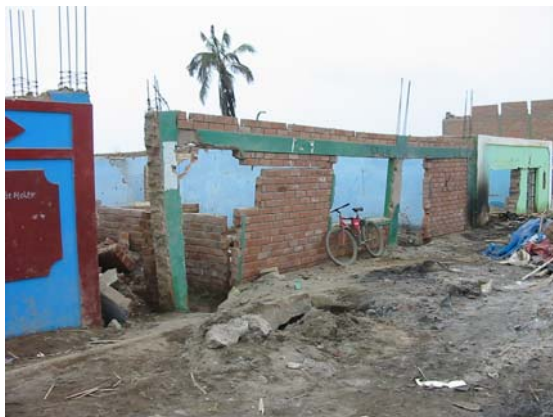
Figure 3.5 Large settlements reached values of approximately 1.0 metre

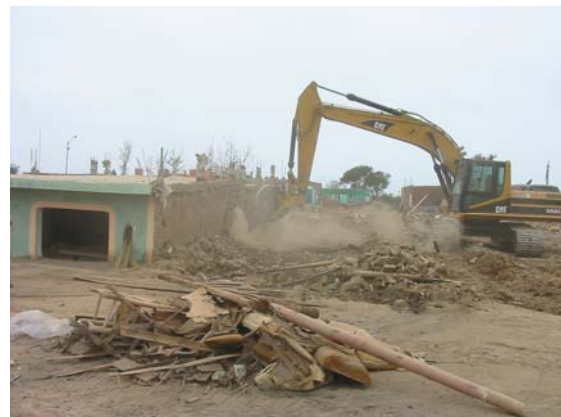
Figure 3.6 Liquefaction affected houses being demolished by the government

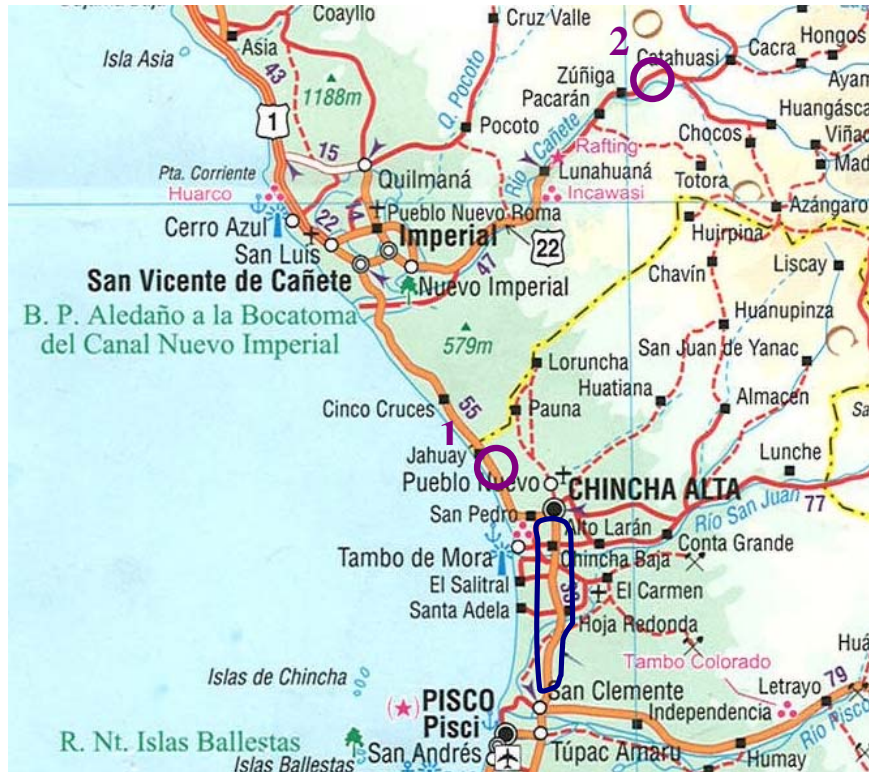
Landslides were reported to occur along the Pan-American Highway, which extends from Alaska to Chile crossing Peru along its coast from North to South; this is the main highway of Peru. At the time of the EEFIT team visit, 22 days after the main event, the Pan-American Highway had been cleared from debris and entirely repaired. According to information received at the *Pontificia Universidad Católica del Perú* (PUCP), the area mostly affected was the stretch between Chinchá Alta and San Clemente (see area limited in blue colour in Figure 3.7).

A section with slope instability was observed along the Pan-American Highway at approximately 10 km north of Cincha Alta (see point No.1 in Figure 3.7 and Figure 3.8). The landslide covered an area of approximately 50 x 10 m, affecting a soil mass (quaternary deposits of predominantly granular material) of up to 10,000 m<sup>3</sup>. The largest vertical displacement of the scarp was measured at 0.4 m (Figure 3.9). Evidence of few shallow landslides was observed in the stretch between Chinchá Alta and Pisco, but the material had been removed at the time of the visit.

Figure 3.7 Stretch of the Pan-American Highway affected by landslides and soil failure of road structure (delimited in dark blue colour). Points 1 and 2 (violet circles) show the location of landslides observed during the visit.

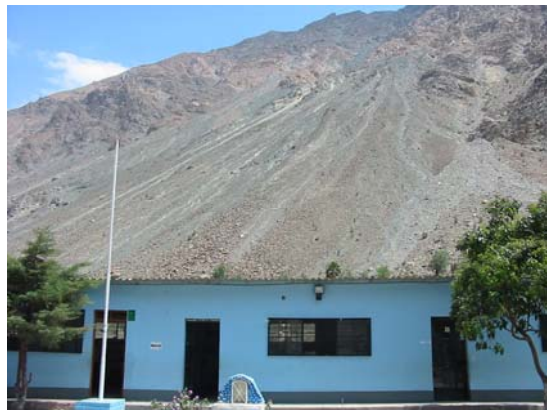
On the last day of the mission, the EEFIT team travelled eastwards to the mountains in order to identify the boundary between areas of significant and minor damage. During this journey into the mountains the most common process of instability observed were debris flows and rock falls, such as those shown in Figure 3.11 and Figure 3.12. The rock fall given in Figure 3.11 hit the abutment of a pedestrian bridge, leading to the collapse of the structure (see Section 6.2). No evidence of deep landslides was observed during the field visit.

Figure 3.12 Debris and rock flow on the slope of mountains; most of the landslides shown in the photo were already there before the earthquake

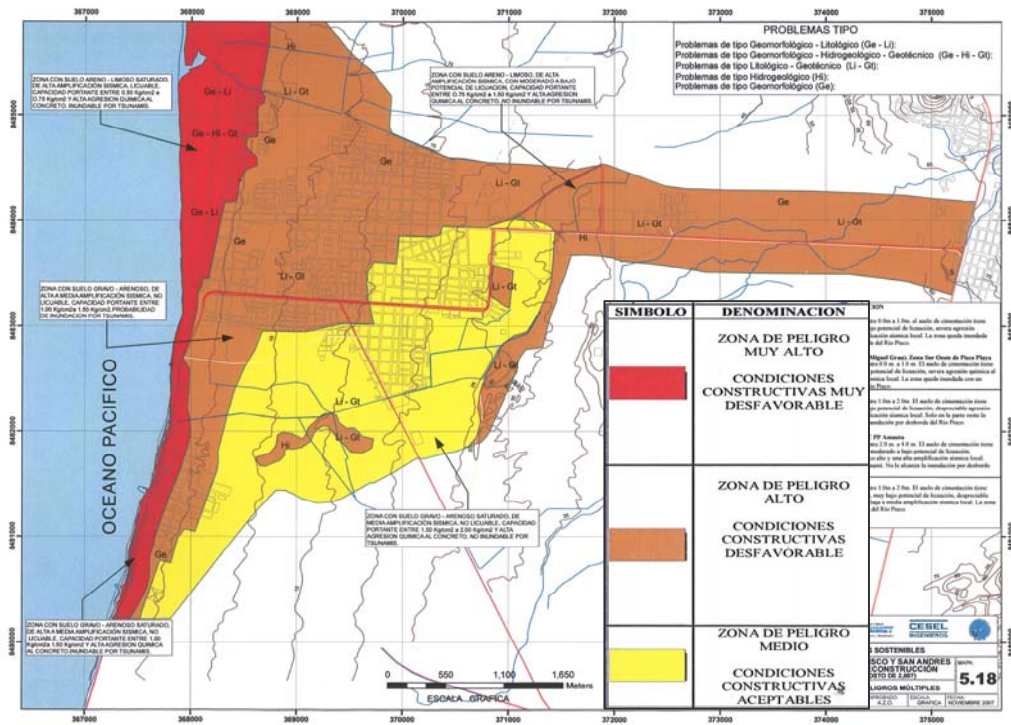
Site effects may be evident in the level of damage observed in the city of Pisco and the town of San Andrés. Besides political limits, the boundaries between these two agglomerations are indistinguishable and thus, from the spatial point of view, can be considered as one city. Damage in Pisco, especially in the central part of the city, showed a greater degree of damage than in San Andrés. This may be due to various reasons, such as age of constructions (being older in central Pisco), structural typology and quality of construction (being better in San Andrés), and more unfavourable site conditions in central Pisco, as shown by the hazard zonation map elaborated by the Peruvian National Civil Defence (INDECI) (Figure 3.15). Characteristics of the delimited zones are:

- Very high hazard (Zone a – red colour): soils with undrained strength capacities between 0.5 to 0.75 kg/cm<sup>2</sup> (about 50-75 kPa)
- High hazard (Zone b – orange colour): soils with undrained strength capacities between 0.5 and 1.5 kg/cm<sup>2</sup> (about 50-150 kPa)
- Intermediate hazard (Zone c – yellow colour): soils with undrained strength capacities between 1.5 and 2.0 kg/cm<sup>2</sup> (about 150-200 kPa).

Figure 3.15 Hazard zoning map of the city of Pisco (source: INDECI); the map summarises hazard evaluation from earthquakes, tsunamis and floods

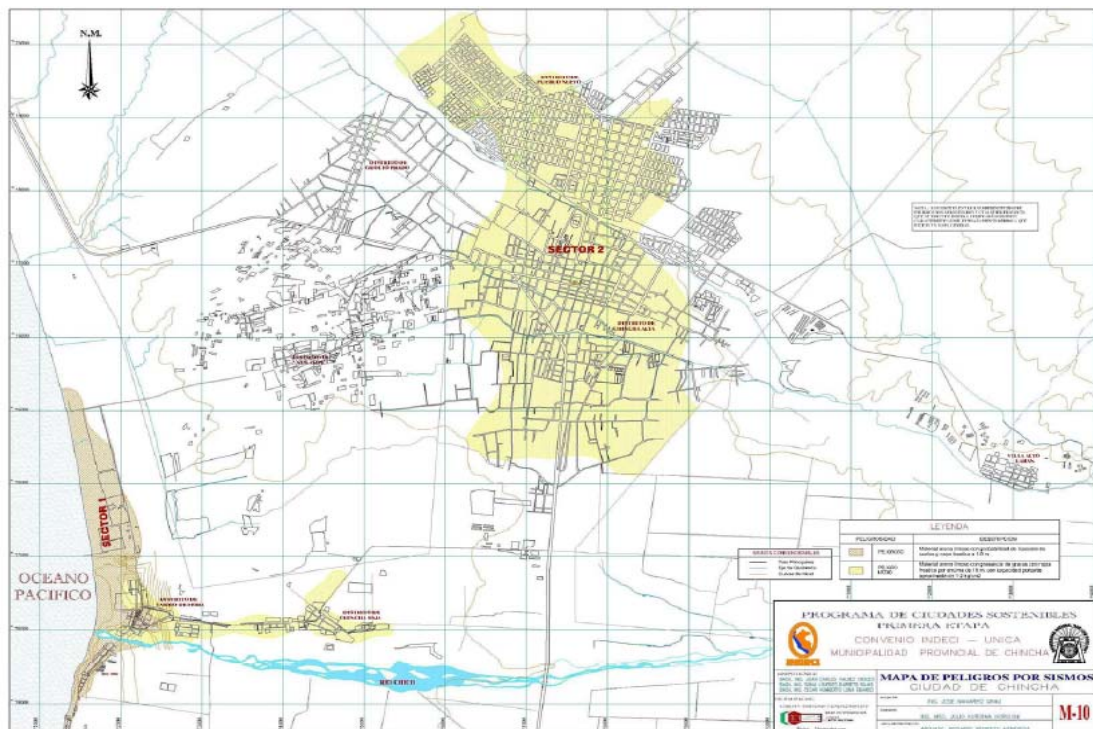
Figure 3.16 Hazard zoning map of the city of Chincha (source: INDECI)

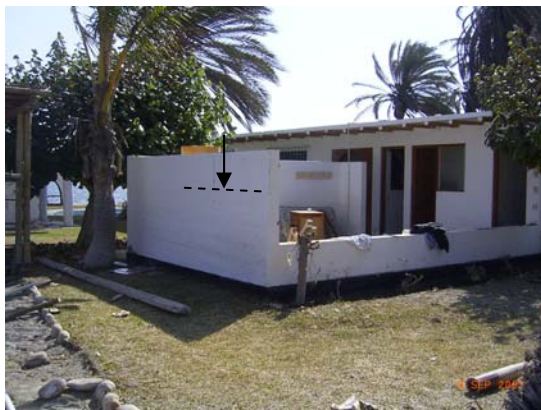
Figure 4.1 Tsunami water height in holiday villas at Paracas

Along the road next to the holiday villas of Paracas, there was very little visible structural damage, with only one wooden access-gate smashed due to water ingress and some damaged light structures for keeping boats; water marks were measured at 1.4 m with respect to the ground (approximately 2.5 m with respect to sea level), as shown in Figure 4.1 and Figure 4.2.

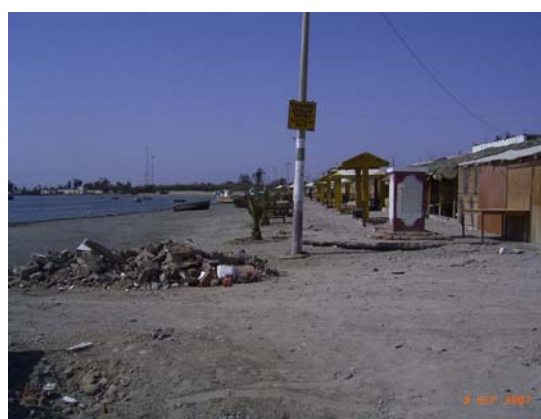
Locals in the town of Paracas recall a wave height reaching up to 1.6 m at the coast, which damaged a row of lightweight vendor stalls along the beach (the wave height was measured with respect to ground level at the vendor stalls). When the team visited the area, these stalls had already been reconstructed, as shown in Figure 4.6. Along the water front promenade of Paracas, opposite to where the vendors were located, water marks of up to 1 m were observed (with respect to the RC pavement of the waterfront); an underground fresh water cistern of a restaurant in front of the promenade was flooded with sea water. The local population informed the EEFIT team that the runup of the tsunami went as far as 200 m inland, though no clear evidence was observed.

Figure 4.6 Reconstructed vendor stalls along the Paracas beach front

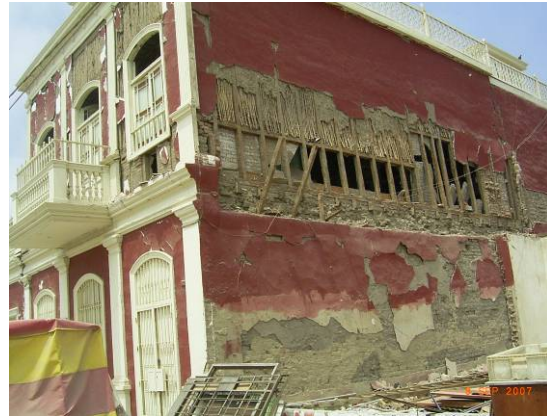
Figure 5.2 Pisco historic waterfront: adobe building with *quincha* exposed at second storey

Adobe structures are the most common type of earth construction in Peru; structures using *quincha* at the second storey are less frequent, being usually present in cultural heritage areas (Figure 5.1 and Figure 5.2) along the coast. *Tapial* structures, which are mostly used for the construction of boundary walls in rural areas, suffered damage from overturning, without causing injuries or substantial economic losses.

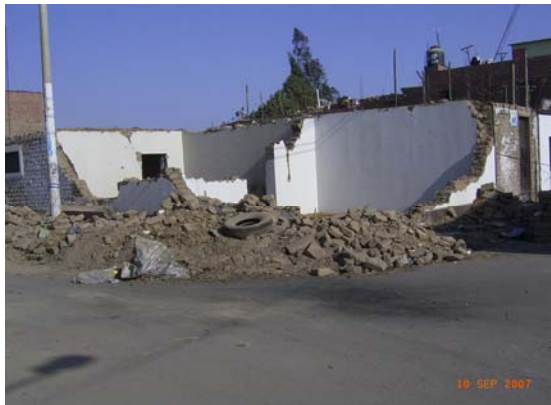
Figure 5.3 Collapsed adobe house in Ica

According to information received from INDECI, in the most affected areas (Pisco, Chincha Alta and Ica) approximately 80% of adobe houses collapsed (Figure 5.3 and Figure 5.4)<sup>3</sup>, an outcome that was more than predictable in view of the lessons learned from previous disasters in Peru and worldwide (Eje Cafetero, Colombia, 1999; Bam, Iran, 2003; El Salvador, 2001), as well as from the research

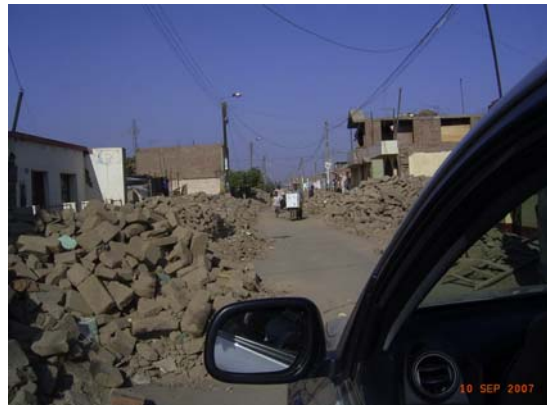
Figure 5.4 Debris of collapsed adobe houses in Ica

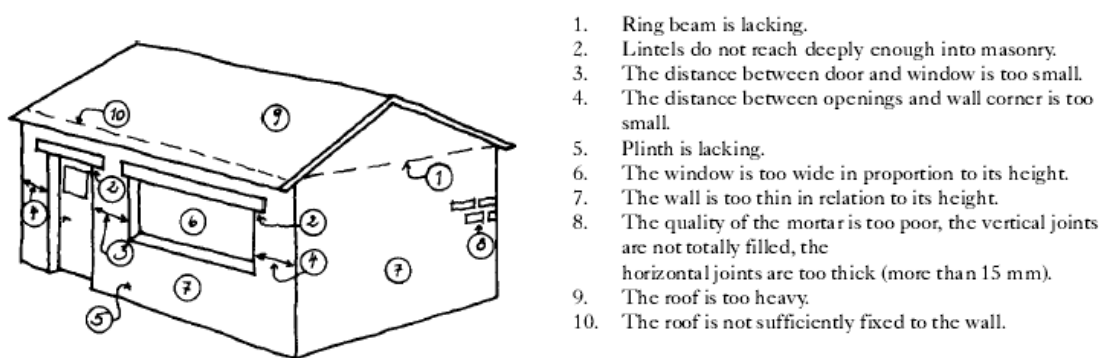
A sketch summarizing the typical construction mistakes, which are held responsible for the partial or total collapse of earthen structures, as observed in the areas affected by the earthquake, is provided by Minke (2001) in Figure 5.5.

Figure 5.5 Graphical indication of the most common deficiencies found in self-built adobe houses (Minke, 2001)

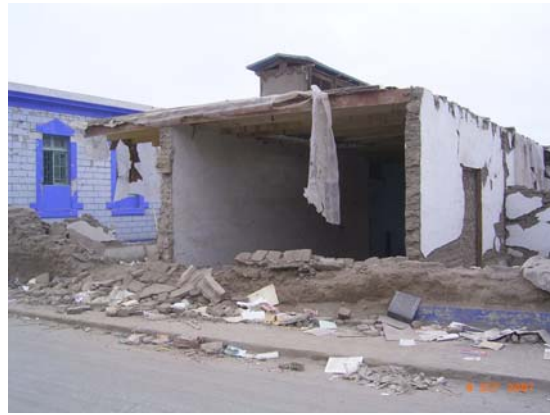
Figure 5.7 Walls not restrained by the roof collapsed out-of-plane

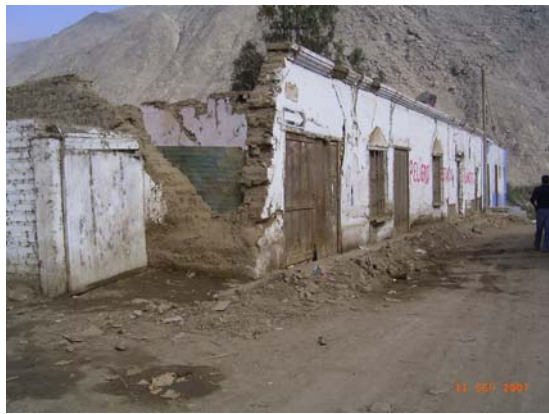
Figure 5.8 Sturdier walls up the Cañete river valley in Zúñiga close to collapse

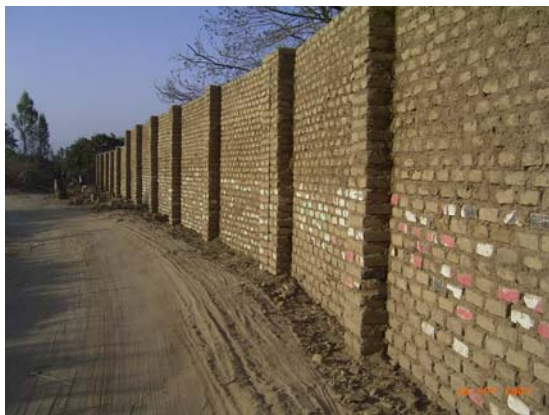
Figure 5.10 Freestanding adobe wall near Guadalupe with lateral supports (or *machones*)

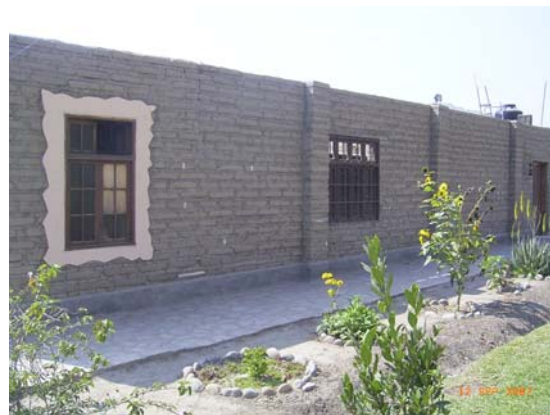
Figure 5.11 Manor in Lunahuaná showing walls laterally supported by *machones*

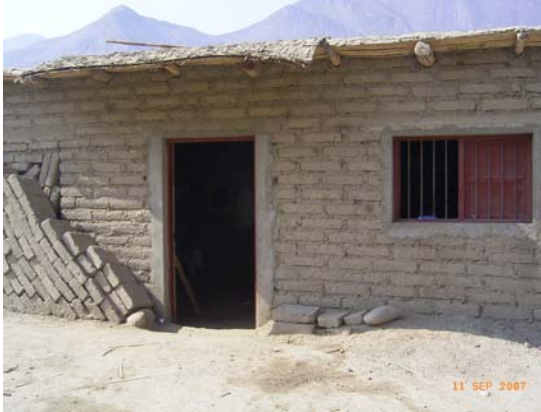
Figure 5.12 Low height adobe houses up the valley of river Cañete showing no damage

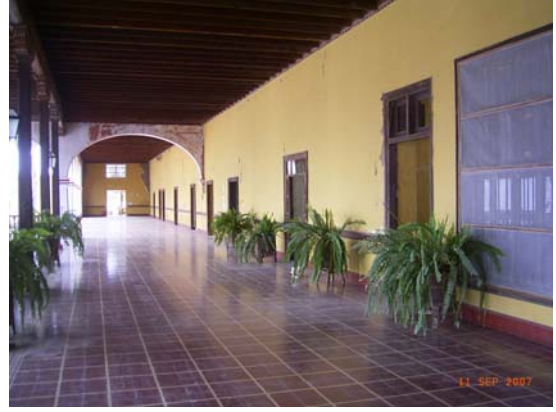
Figure 5.13 Historic hacienda in El Carmen showing limited damage

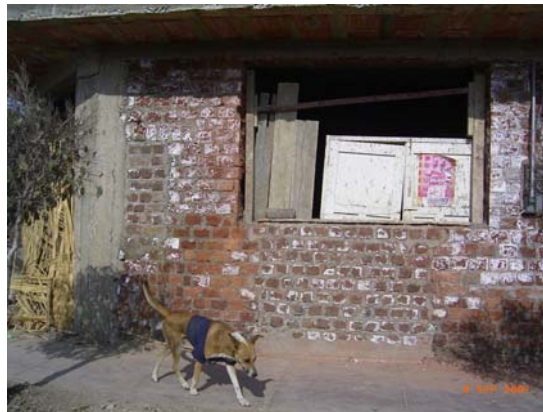
Figure 5.16 RC infilled confined brick masonry house in Guadalupe

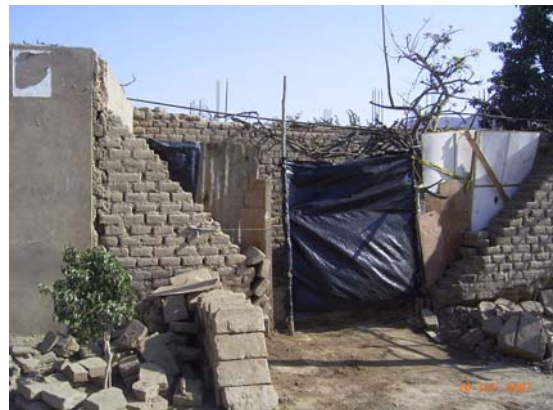
Figure 5.18 Collapsed right corner of the adobe house shown in Figure 5.17 (not upgraded due to insufficient funds)

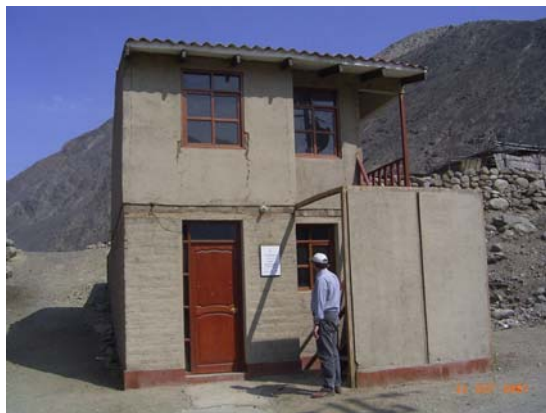
In the town of Zúñiga a new two-storey house built by the Japan International Cooperation Agency (JICA) resisted the earthquake with minor damage (Figure 5.21), apart from some cracks that developed at the corners of window openings at the second storey *quincha* walls. The design features that contributed to the good performance of the house were: well constructed thick adobe walls, *machones* (thicker portions of the wall) spaced at short intervals and at corners, a rigid wooden roof connected to all walls through a wooden ring-beam, a rigid slab foundation at the base, and, although not verified in the field, bamboo reinforcing rods running inside the adobe walls. It is worth noting that nearby houses of traditional adobe construction did not suffer significant damage, probably because of weaker ground motions due to attenuation effects or from better ground conditions, as well as due to the lower height of the adobe walls of these constructions.

Figure 5.21 Two-storey adobe (and *quincha* at second storey) built by JICA in Zúñiga for earthquake resistance

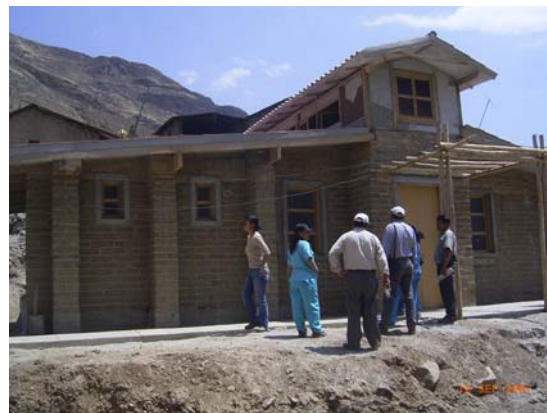
Figure 5.22 Adobe house in Huangáscar built by JICA and designed for earthquake resistance

Other adobe houses designed with earthquake resistant features were found in the village of Huangáscar: a first group of two storey houses similar to that visited in Zúñiga was found at the entrance of the village, whereas a second house, at the centre of the village, was constructed with closely spaced *machones* providing lateral support to the walls (Figure 5.22). While these houses were built by JICA and performed satisfactorily during the earthquake, other nearby houses of adobe traditional construction in Huangáscar were severely damaged (Figure 5.9).

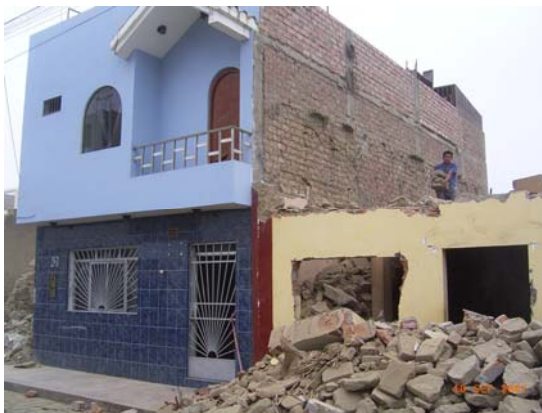
RC confined masonry structures performed very well during the earthquake, with minor or no damage, as shown in Figure 5.24, where a two storey building standing next to a collapsed adobe house shows no signs of damage in its tile covered façade.

Figure 5.24 Undamaged two storey RC confined masonry building next to a collapsed adobe house in Ica

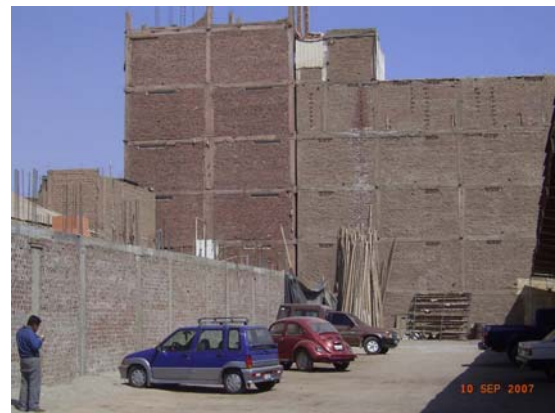
Figure 5.25 Six-storey RC confined masonry building in Ica, showing no signs of damage

The good performance of RC confined brick masonry houses, which may reach a height of up to six storeys (Figure 5.25), may be explained by the inherent large capacity of the structure to resist lateral loads. However, these structures, when reaching their ultimate capacity after failure of the clay brick masonry walls, may form soft storey mechanisms if not properly detailed and designed. It is possible that this type of failure may have developed in many buildings had the ground motions been higher in the affected areas, especially for structures with low construction quality. Therefore, it is recommended that the complete load displacement path of these structures up to failure is carefully examined, assessing the level of energy dissipation that they can provide and the associated type of failure mechanism.

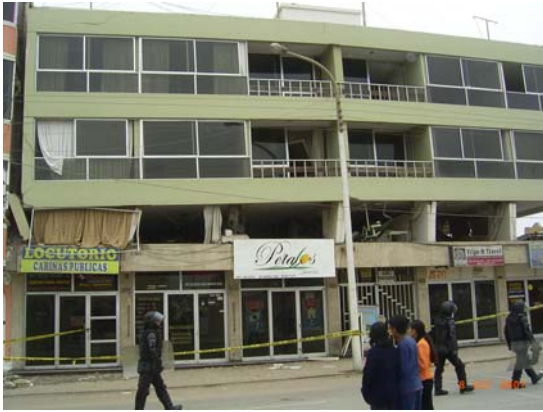
In Figure 5.29 a four-storey RC infilled structure that collapsed after developing a soft storey mechanism is shown, possibly due to the reduction of flexural capacity in the column from the first to the second storey, or to deficient detailing of the beam-column connection as shown in Figure 5.30.

Figure 5.29 Four-storey RC infilled frame in Pisco showing soft storey collapse at 2<sup>nd</sup> floor

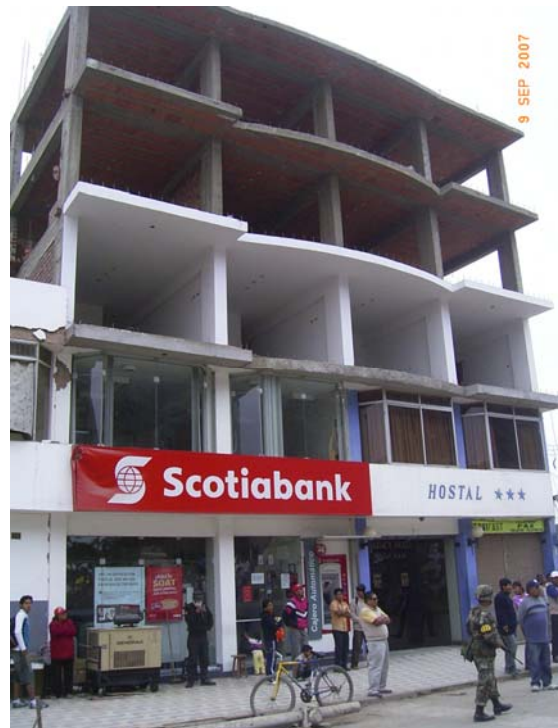
Examples of buildings under construction are shown in Figure 5.31 and Figure 5.32: the first figure shows an irregular vertical geometry arrangement that caused extensive yielding of the column at the second, soft storey; whereas the second figure shows a five-storey building with flat-slab beams running in the direction parallel to the street and that may have suffered extensive damage if it had not been properly detailed.

Figure 5.32 Five-storey RC building frame with flat-slabs under construction in Ica

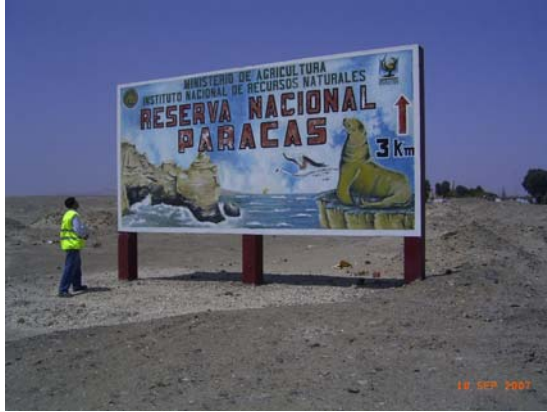
During the field visit, the EEFIT team found several RC billboard structures infilled with clay bricks: one near the Paracas National Reserve (Figure 5.33), which suffered practically no damage, and one at Pozo Santo, approximately 25 km southeast of Pisco, which collapsed (Figure 5.34) and is used in the present report to perform back calculations to determine the ground accelerations sustained at the site. It is worth mentioning that the adjacent structures located at Pozo Santo suffered heavy damage, including a church (Figure 5.40) and several one-storey adobe structures.

Figure 5.33 RC infilled frame billboard near the Paracas National Reserve

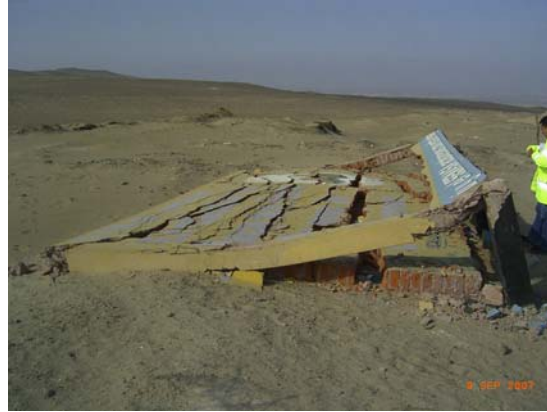
Figure 5.34 RC infilled frame billboard that collapsed at Pozo Santo

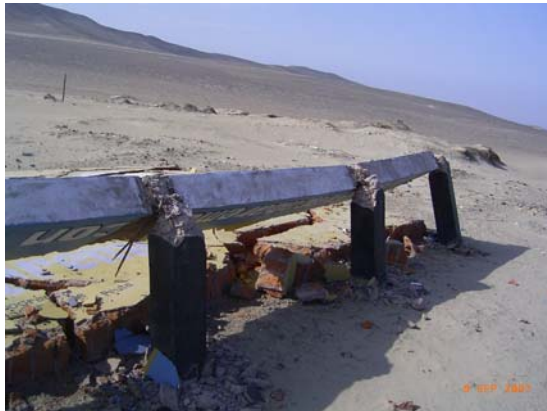
The geometry of the billboard at Pozo Santo was measured on site: a 250 mm thick, 7 m in length and 4.7 m in height rectangular section of clay bricks bounded by 250 mm deep RC elements along the perimeter, supported by four 250x250 mm cross section 1.05 m free standing RC columns (Figure 5.35); in the longitudinal direction the columns were linked by a stiff 500 mm deep RC beam.

Figure 5.35 Overall view of the collapsed billboard at Pozo Santo, showing four 250x250 mm 1.05 m RC columns

The collapse mode of the billboard shows that failure took place at the boundary between the top of the free standing columns and the longitudinal deep beam, suggesting that the damage of the structure started in the longitudinal direction (in-plane) followed by overturning of the structure in the transverse direction (out-of-plane)<sup>4</sup>. From the geometry, materials and collapse mode of the structure, it is possible to infer the spectral accelerations that occurred at the site. This is done by computing the base

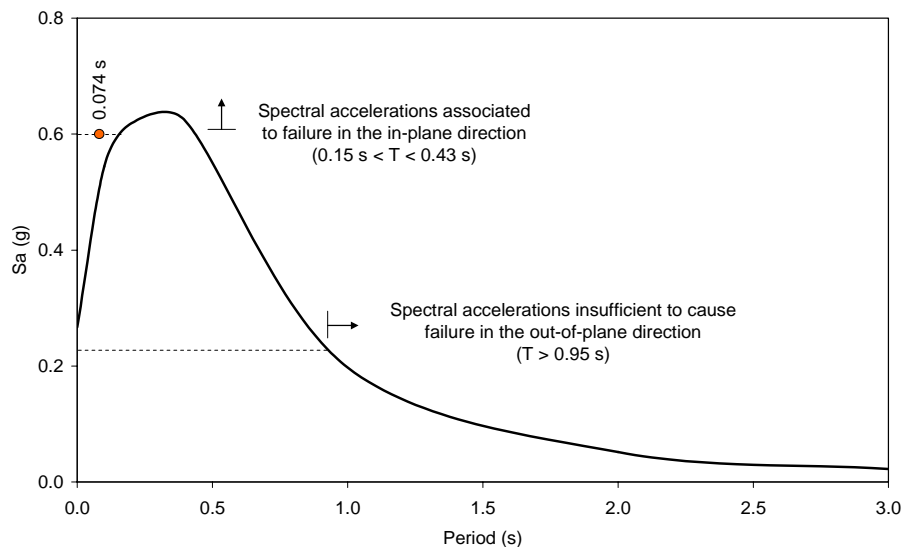
The elastic 5% response spectrum predicted by the Atkinson and Boore (2003)<sup>6</sup> equations at Pozo Santo for stiff soil conditions shows that the periods for which spectral accelerations can induce failure in the in-plane direction are between 0.15 and 0.43 seconds (Figure 5.37), the lowest bound not being too dissimilar from the value of 0.074 s obtained from the above calculations.

Figure 5.37 Predicted 5% response spectrum at Pozo Santo, using Atkinson & Boore (2003) equations with NEHRP class C (stiff soil) site conditions.

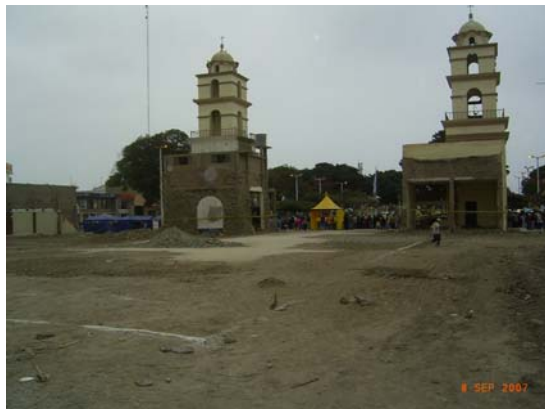
Figure 5.38 Location of the collapsed church in Pisco after demolition and debris removal

The church of San Clement of the Compañía de Jesus, in front of the Plaza de Armas in Pisco, collapsed during a mourning service at the time of the earthquake event, causing the single largest death toll of any structure during the earthquake (Figure 5.38).

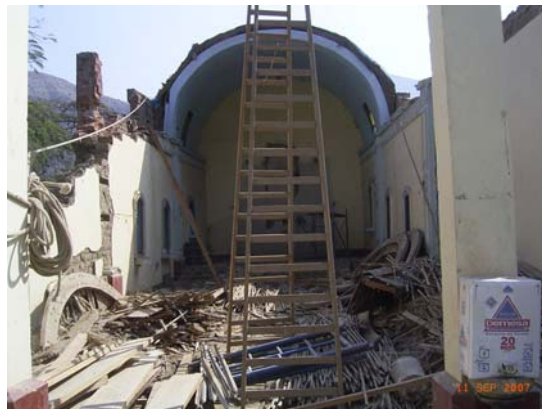
Figure 5.39 Typical collapse of a *quincha* vaulted roof of a church in Zúñiga

The large majority of churches surveyed during the field mission sustained considerable damage after failure of the roof (Figure 5.39 and Figure 5.40), longitudinal walls (Figure 1.1) and tower bells (Figure

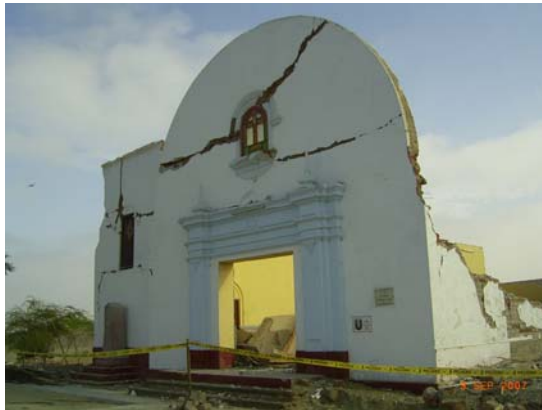
Figure 5.40 Church front remains of a collapsed church at Pozo Santo

The deficient performance of these structures calls for an extensive effort of earthquake performance assessment and upgrading, where required, of those churches that did not collapse or where only lightly damaged during the earthquake event.

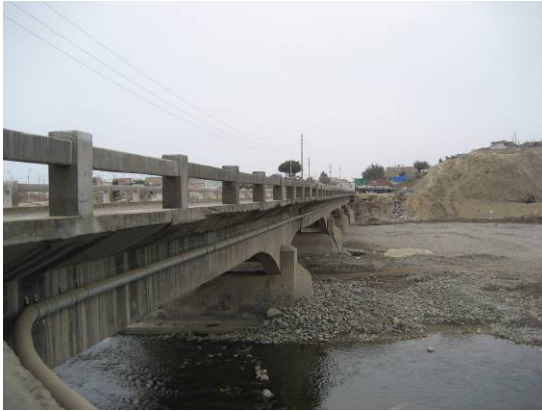
The Huamaní Bridge in Clemente Bridge is a five span reinforced concrete motorway bridge located at km 228 along the Pan American Highway linking the town of San Clemente to Pisco, with a total length of approximately 150 m (Figure 6.4). The two main roadways of the earthquake affected area, namely the Pan-American Highway and the Carretera los Libertadores, cross at the town of San Clemente (Figure 6.3).

Figure 6.4 Huamaní Bridge along the Pan-American Highway

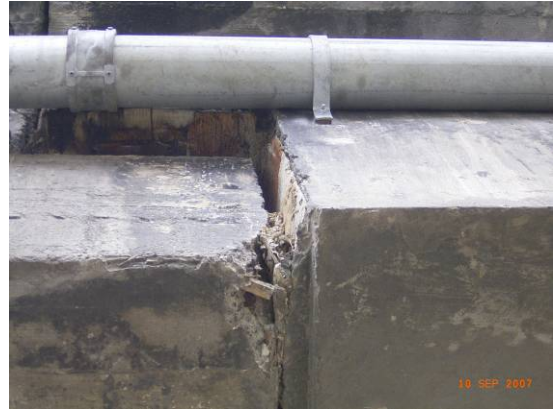
The superstructure of the bridge is continuous, with pinned connections symmetrically located at the second and fourth spans. The bridge deck, 0.3 m thick, is supported by three 0.6x1.3 m RC girders running in the longitudinal direction and connected by transverse beams. A relative displacement of 10 cm was observed between the two portions of the superstructure at the south pinned connection, resulting in local damage to the deck from the pounding action (Figure 6.5). Slightly lower displacements, of approximately 5 cm, and local damage, were observed at the north pinned connection. Underlying utility pipes running in the longitudinal direction of the bridge showed transverse displacements at the pinned connections, whereas the south section of the deck revealed a permanent clockwise rotation (vertical positive axis), damaging the west parapet of the south abutment (Figure 6.6). The failed portion of the abutment showed large rounded aggregate, which could have compromised the strength of the concrete of the abutment (Figure 6.7). No damage was observed on the surface of the deck itself, or on the longitudinal girders supporting the bridge, apart from some minor cracking of the traverse beams.

Figure 6.5 Huamaní Bridge: relative displacement between bridge sections at hinge location

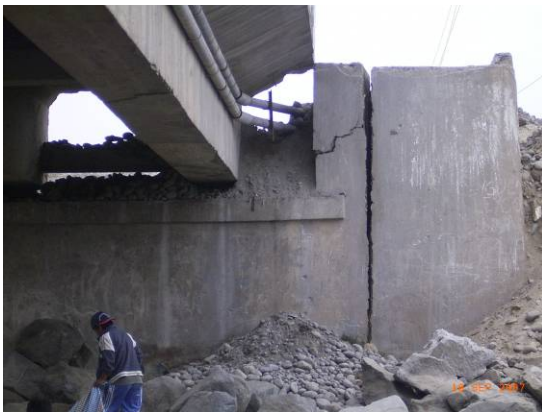
Figure 6.6 Huamaní Bridge: shearing off of the west parapet at the south abutment

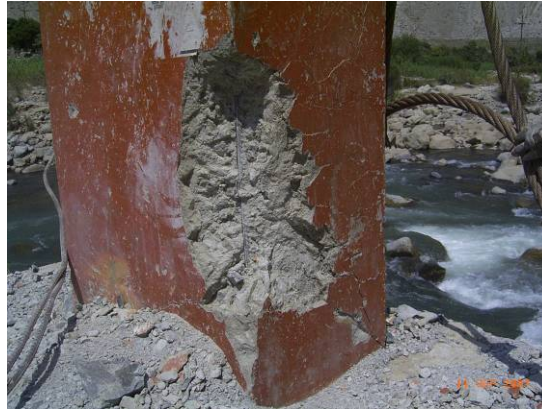
Figure 6.11 Reinforcement detailing of the RC tower of the collapsed footbridge.

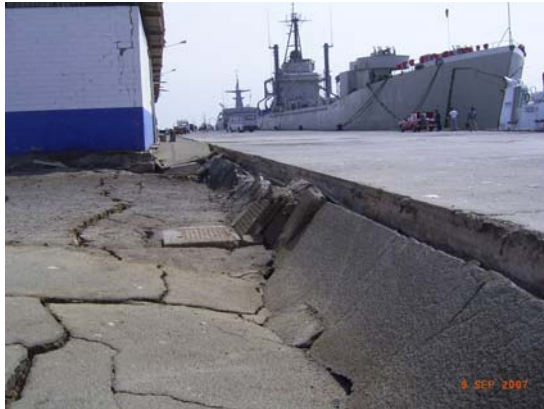
The visit to the port of San Martín revealed that the access to the dock structures was severely damaged (Figure 7.3), resulting from failure and settlement of the underlying soil, composed of a conglomerate of angular stones of up to 150 mm in size, mixed with sand (Figure 7.4). The access area at the south end of the port showed extensive cracking (with deep cracks widths up to 50 mm) and settled approximately 1.2 m with respect to the dock structure and to an adjacent warehouse, both of which did not suffer much damage. Two watch towers (located at each end of the port) toppled due to failure of the ground and of the supporting RC column (Figure 7.5); one electric transformer next to the warehouse also toppled after failure of its support (Figure 7.6). Punching of the pavement from piles supporting the access area on the northern part of the port was also observed (Figure 7.7). It was reported by the employees of the port that most of the damage took place after the strongest aftershocks, with continuous settlement of the ground taking place during the weeks following the main earthquake event.

Figure 7.3 Port of San Martín: paved access 1.2 m settlement with respect to the dock and warehouse

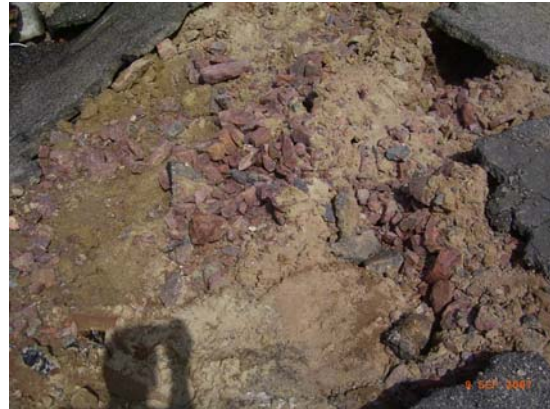
Most of the damage suffered by the port of San Martín was due to the poor characteristics and compaction of the material used to fill the access structures to the dock; the fill material may have been extracted from the nearby shore, which was present along the beaches surrounding the port.

Figure 7.4 Port of San Martín: fill material of the paved access to the dock structure

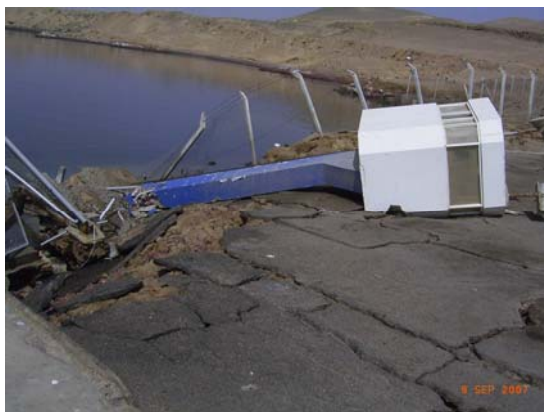
Figure 7.5 Port of San Martín: toppled RC watch tower (south end)

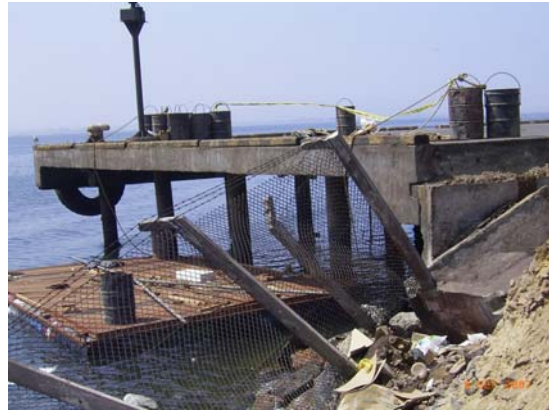
The dock structure, an 18 m wide reinforced concrete 0.55 m thick slab supported on 600 mm diameter circular steel piles spaced at 4 m (Figure 7.8), did not suffer major damage, however, due to failure of the access structures it could not be used immediately after the earthquake. The use of the port as an emergency centre for receiving assistance became possible only when a temporary access for trucks was constructed by levelling with sand and gravel the settlement that had occurred between the access and the dock (Figure 7.9). However, major repairs will be needed to restore full operation of the port.

Figure 7.8 Port of San Martín: RC dock structure showing steel piles

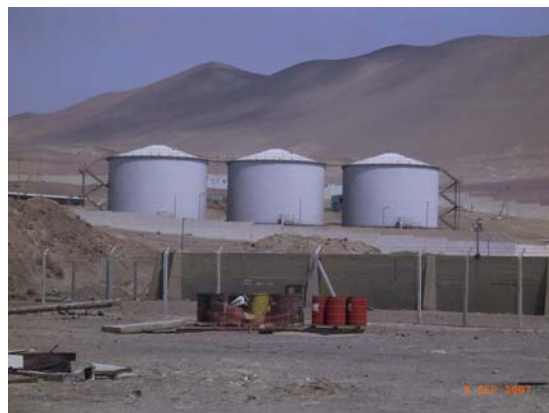
The supporting infrastructure adjacent to the port suffered only minor damage, such as minor buckling that was observed in a braced steel latticed structure; large steel tanks did not suffer major damage and remained operational (Figure 7.10).

Figure 7.10 Port of San Martín: adjacent steel tanks showing no damage

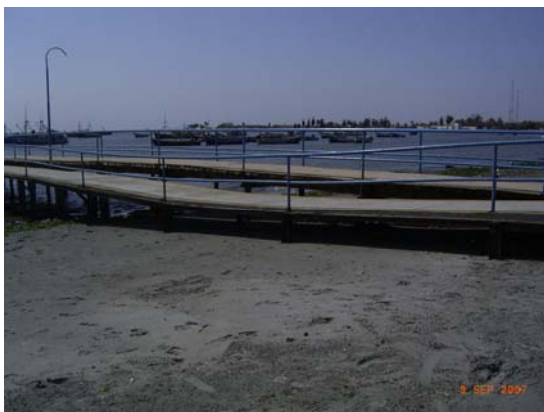
Other minor dock structures were surveyed in the area of Paracas, one at the waterfront which showed settlement of the dock (Figure 7.11), and a jetty at a Yacht Club south of Paracas that had sustained damage after longitudinal hinging of the steel piles at the connection with the pile cap in the longitudinal direction (Figure 7.12). The damage to these structures may compromise the development of the tourist activity of the area, as many boats depart from Paracas to visit the nearby National Reserve.

Figure 7.11 Dock structure in Paracas

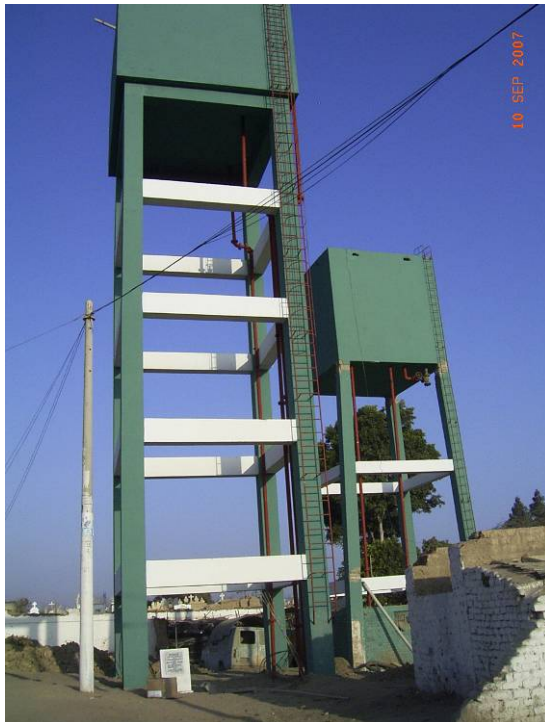
In San Juan, a small town 10-15 km away from Guadalupe, one out of two water towers close to the main square was severely damaged (Figure 8.3). Upon closer inspection it was found that the two tanks were built at different periods of time, the undamaged, higher tank being of newer construction. The older tank showed cracks at the level of an infill wall built at the base (Figure 8.4) and at the connection with the main body of the tank. After closer inspection, it was found that there were no stirrups and splicing was made at the joints. The fact that the newer tank did not suffer damage is a very good demonstration that good earthquake performance can be achieved by following current design standards.

Figure 8.3 Water towers in San Juan (older tank in the background).

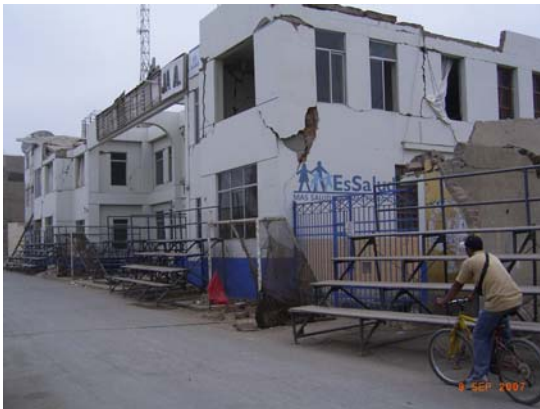
According to preliminary assessments of the Peruvian Government (6 September 2007), 14 hospitals were destroyed, and 103 were affected in the area (OCHA SR14, 2007). Figure 10.1 shows a public structure for the supply of health related services that suffered severe damage; the structure was of RC construction in combination with brick masonry. The large damage sustained may have been caused by an irregular geometry in plan and to the presence of large window openings at the second storey; the building was being evacuated at the time of the survey; however, it was not clear whether the structure would have been demolished or repaired.

Figure 10.1 Public health structure being evacuated in Pisco

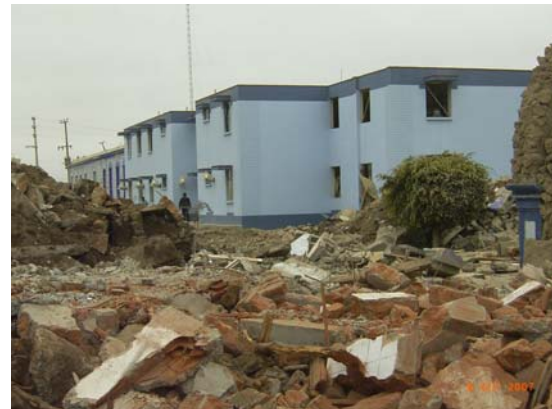
Figure 10.2 shows a new hospital built prior to the earthquake that exhibited adequate performance, next to the remains of an older part of the hospital which was severely damaged and demolished after the earthquake.

Figure 10.2 New hospital, built prior to the earthquake, next to a previously existing one that was severely damaged and demolished in Pisco

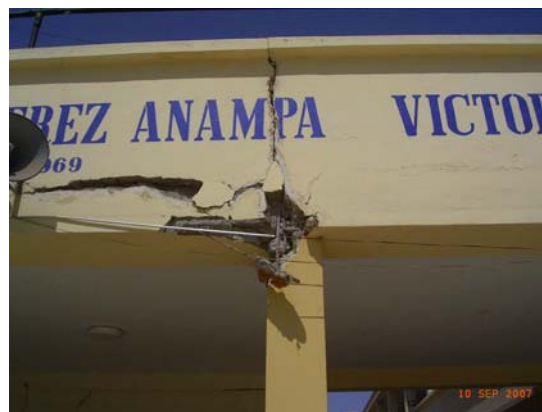
- Large openings at the first storey, with slender, tall columns and rigid roofs/slabs and/or beams, resulting in soft-storey mechanisms with failure at the top of columns (Figure 10.3 and Figure 10.4)

- No compliance with capacity design principles that guarantee that plastic hinges are developed at beam ends, whereas columns remain elastic or near yielding, thus dissipating energy while maintaining structural stability; in fact, in none of the schools visited, cases where beams had developed plastic hinges were observed (Figure 10.3, Figure 10.4 and Figure 10.7).

Figure 10.4 *Gran Unidad Escolar San Luís Gonzaga*: column failure at top end; roof parapet activated a strong-beam-weak-column mechanism

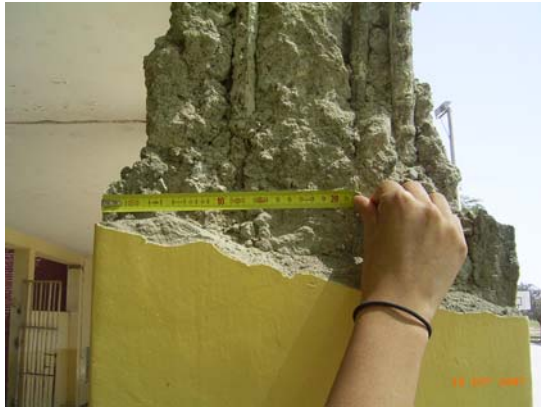
- Low quality of materials, low strength of concrete and use of poor-quality, large sized stones from river beds as aggregate (abundant all through the coast of Peru) (Figure 10.8 and Figure 10.9).

- Insufficient detailing of reinforcement (Figure 10.8) concerning: lengths and staggering of splicing, development lengths, transverse reinforcement for shear strength and confinement at element ends, small diameter of shear links and stirrups with respect to longitudinal reinforcement, small diameters of longitudinal reinforcement, excessive or insufficient cover of longitudinal reinforcement (Figure 10.9).

Figure 10.9 *Gran Unidad Escolar San Luis Gonzaga*: excessive concrete cover, lowering design flexural capacity, and poor concrete quality

The damage caused by the disaster on the school infrastructure calls for an immediate and urgent need to assess the earthquake performance and associated risk of collapse of all those schools built prior to the enforcement of modern standards of earthquake design and of good construction practice, especially of those schools that were not damaged during the present disaster, and upgrading those showing poor performance and unacceptable risk of collapse.

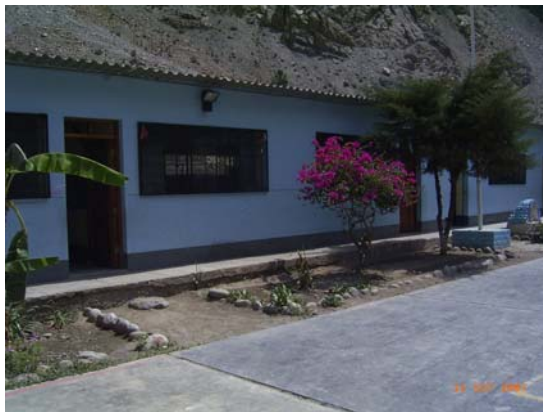
In spite of the fact that most schools were of reinforced concrete construction, in the rural mountain areas many schools were of adobe construction. In the town of San Jerónimo (point No. 2, Figure 3.7) up the valley of river Cañete, the team visited a school constructed out of adobe (Figure 10.11 and Figure 10.12), showing only minor damage, possibly due to attenuation of the ground shaking from the larger epicentral distance and to the better quality of the underlying soil (i.e., rock). Had the ground shaking been larger, this school would have probably suffered extensive damage.

Figure 10.11 San Jerónimo (Cañete river valley): adobe school showing limited damage

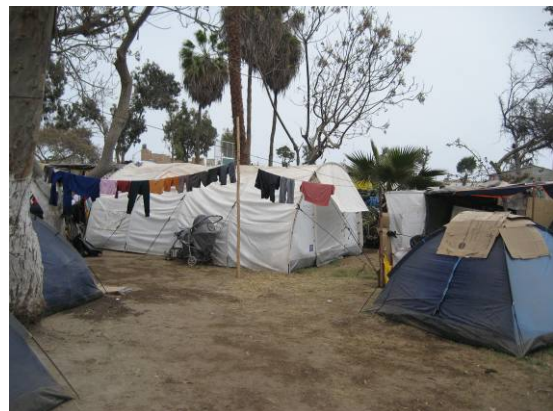
Figure 11.2 Relief camp at a park in Pisco

In Pisco, the team visited two temporary relief camps based at the sites of the *Viejo Club Atlético* (Figure 11.1) and at a local park (Figure 11.2). The tents were supplied by INDECI and each of these facilities housed nearly 50 families. The shelter camps were working at overcapacity, while the adjacent building structures were unusable and hazardous, as these were severely damaged by the earthquake. In addition, many of the relief camps visited by the team were set up next to the premises of public institutions, such as hospitals, schools, sport facilities, impairing their use and resumption of activities (Figure 11.3).<sup>2</sup>

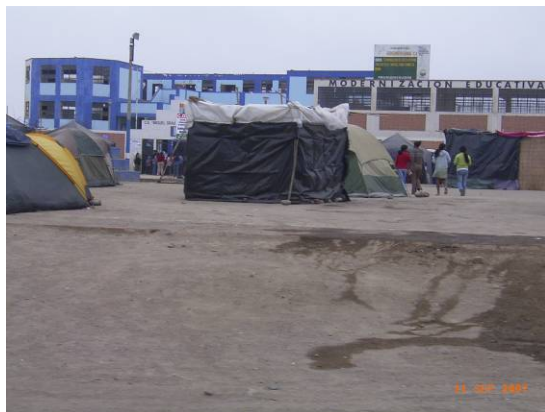
Figure 11.3 Relief camp in premises adjacent to a school

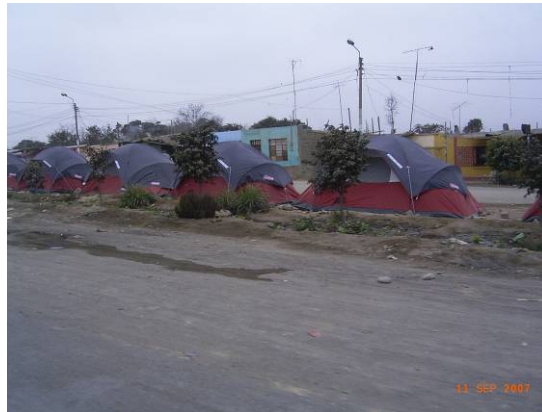
The EEFIT team also noted that there were groups of tents being erected adjacent to a busy road (Figure 11.4) with no proper coordination, amenities or protection, showing that there were no common standards or panning in setting up relief camps. The location of these camps next to important roads or to areas of demolition, with large quantities of dust particles, could cause respiratory diseases in the affected population.

Figure 11.4 Relief camp by the side of the Pan-American Highway in Chincha.

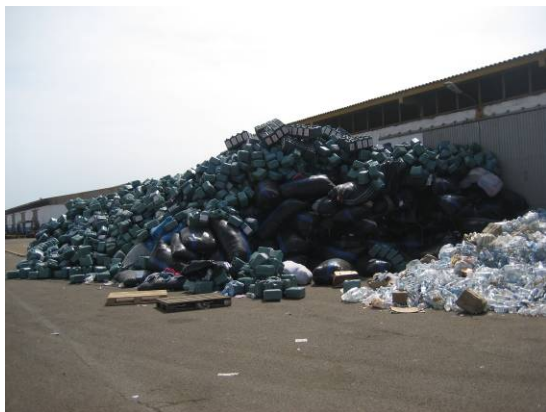
The EEFIT team, during the survey of the installations of the Port of San Martín, visited a large warehouse used by INDECI to store part of the relief material arriving from other areas in Peru and from donor countries and International Organisations<sup>3</sup>. Outside and inside the warehouse (Figure 11.5 and Figure 11.6), large quantities of material were stocked and piled up, waiting for distribution one month after the disaster, such as tents, mattresses, cooking stoves, water and clothes.

Figure 11.5 Relief stock of water piled up outside the warehouse at the Port of San Martín

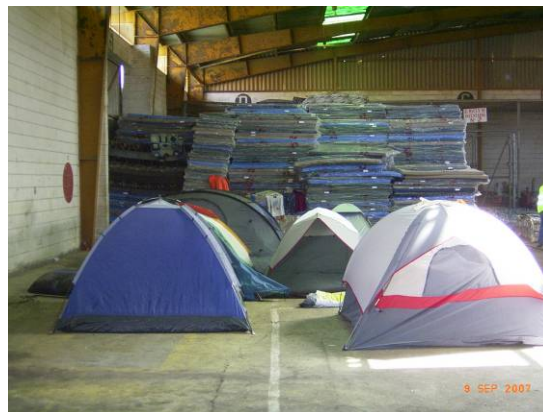
Figure 11.6 Tents being stocked inside the warehouse at the Port of San Martín

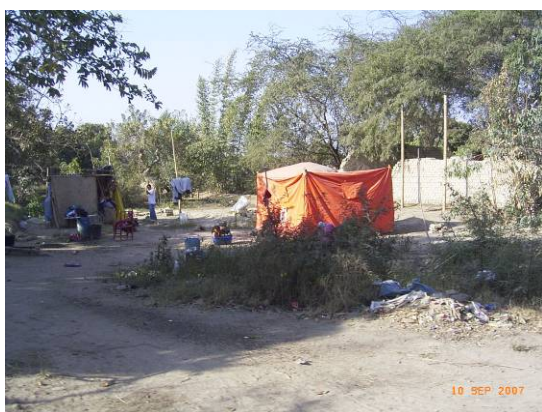
aid had reached the local population, which was relying on local resources to set up temporary shelters (Figure 11.7 and Figure 11.8). OXFAM cited the same problems in their assessment reports, saying that many villages away from the main roads had been left unaided; serious security problems were also recorded, with reports of looting and robberies in towns and villages, as well as along some roads immediately after the disaster.

Figure 11.7 Informal relief camp in rural area near Guadalupe
