# 2007 August 15 Magnitude 7.9 Earthquake near the Coast of Central Peru

Earthquake Field Investigation Team (EEFIT) Field Mission, 5-12 SEPTEMBER 2007 / Final Report

**Fabio TAUCER, Joint Research Centre (Editor and Team Leader)**  
**Dr John ALARCON, Arup**  
**Emily SO, University of Cambridge**

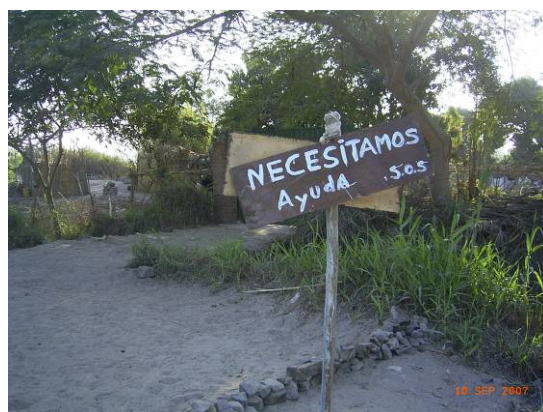
aid had reached the local population, which was relying on local resources to set up temporary shelters (Figure 11.7 and Figure 11.8). OXFAM cited the same problems in their assessment reports, saying that many villages away from the main roads had been left unaided; serious security problems were also recorded, with reports of looting and robberies in towns and villages, as well as along some roads immediately after the disaster.

Figure 11.8 “We need help” sign in rural area near Guadalupe.

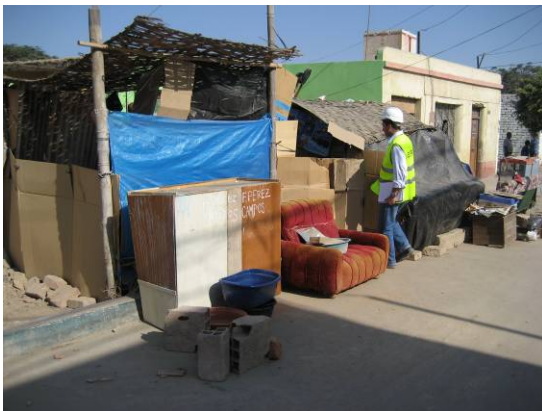
Figure 12.3 Affected dwellers piling their belongings outside their collapsed houses in Guadalupe

homes (Figure 12.3). As a result, the active population, especially single mothers, was not able to carry out their daily activities and jobs to economically support their families.

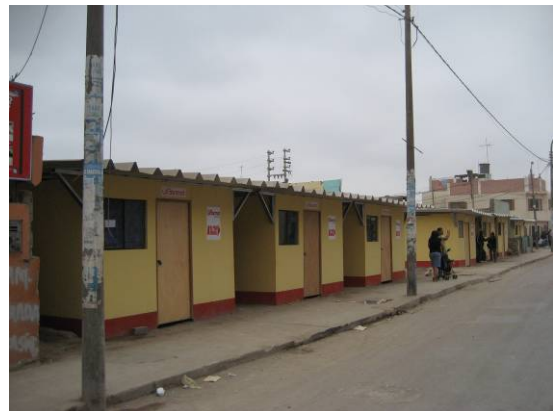
Figure 12.4 Temporary accommodations in Pisco (made of steel/ aluminium sheets)

In addition, there were problems of schooling, hospital care and security. During informal interviews of the EEFIT team with the local population, it was common to hear that people had lost their homes and that all they had were insecure tents or temporary make-shift shelters (Figure 12.4). Most children were at home or at relief camps, as most schools were not functioning and parents had to look after them. In most of the towns the team reported people clearing in appalling dusty conditions, salvaging adobe bricks and in some cases starting reconstruction. There is, however, interest within the locals to build with earthquake safe houses and many had enquired about seismic resistant adobe housing.

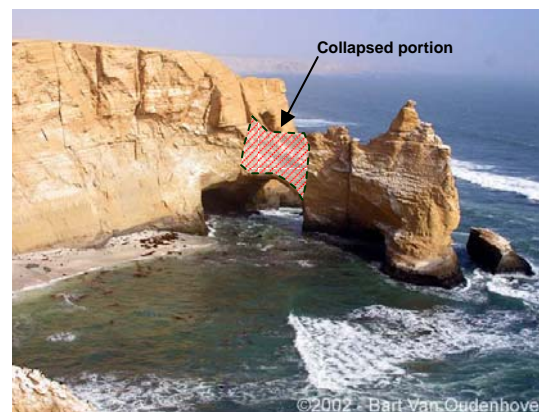
Figure 12.10 La Catedral natural rock formation in Paracas National Reserve (from [www.tierra-inca.com](http://www.tierra-inca.com))

A natural rock formation, known as the “Catedral”, a major tourist attraction in Peru located in the Paracas National Reserve, had collapsed into the sea during the earthquake (Figure 12.10).

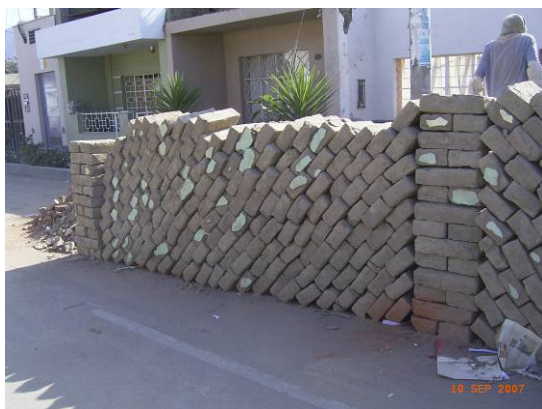
As mentioned in Sections 11 and 12, emergency relief had not been very effective in rural areas, especially in the mountains, where families that had lost their homes were starting reconstruction using adobe bricks (Figure 13.1) from the previous existing houses that collapsed.

Figure 13.1 Adobe bricks ready for use in reconstruction in Chincha Alta

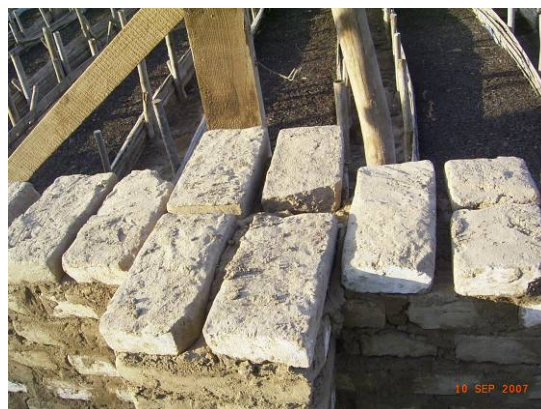
Most of the reconstruction was taking place using either traditional techniques of adobe construction (Figure 13.2), in the case of the more poor families, or non-engineered techniques for the construction of reinforced concrete confined masonry houses, in the case of families with higher economic means (Figure 13.3 and Figure 13.4).

Figure 13.2 Reconstruction of an adobe wall using traditional techniques in El Carmen

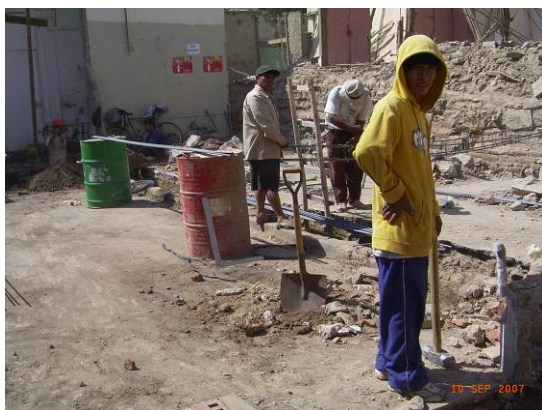
Figure 13.3 Reconstruction taking place in Chincha Alta

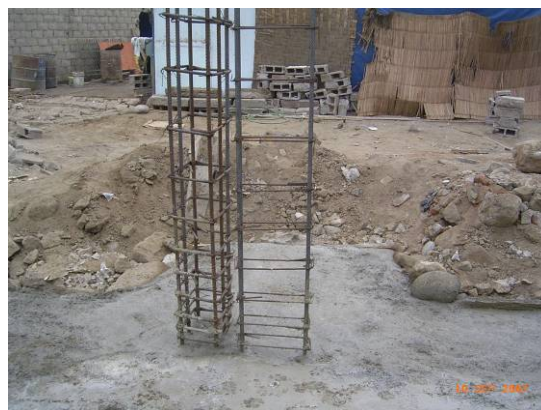
Figure 13.4 Reconstruction using RC in Chincha Alta without adequate technical assistance

The reconstruction of adobe houses was mostly observed in rural areas, while that of non-engineered RC frame and RC confined masonry houses was typically observed in urban centres, resulting in both cases in highly vulnerable constructions to earthquake hazard, thus re-establishing the same high risk present before the earthquake event.

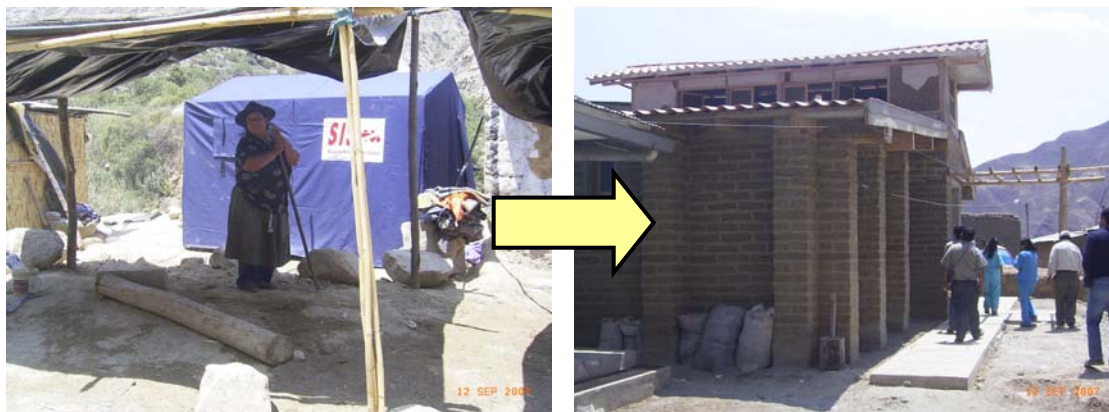
Figure 15.2 A sustainable reconstruction process should lead to the transition from temporary shelters built after the disaster to earthquake resistant designs using local materials and workmanship (Photos from Cañete river valley near Huangáscar)

10. In view of the fact that the building stock in Peru, especially in rural areas and away from large urban centres, is mostly composed of adobe houses, it is recommended that the Peruvian Construction Standards are updated to reflect the latest techniques for the construction of earthquake resistant adobe houses and the upgrading of existing ones.
