Living Shoreline Sea Level Resiliency: Performance and Adaptive Management of Existing Breakwater Sites, Year 2 Summary Report

Living Shoreline Sea-Level Resiliency: Performance and Adaptive Management of Existing Breakwater Sites

Year 2 Summary Report

**Shoreline Studies Program
Virginia Institute of Marine Science
William & Mary**

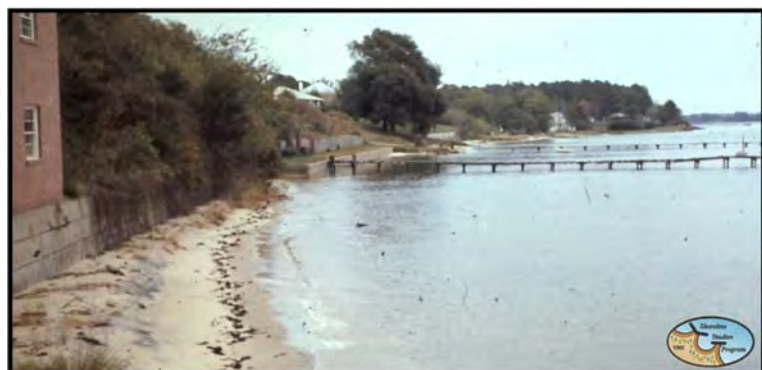
Figure 4-1-4. Very little sand existed along the VIMS shoreline in 1970.

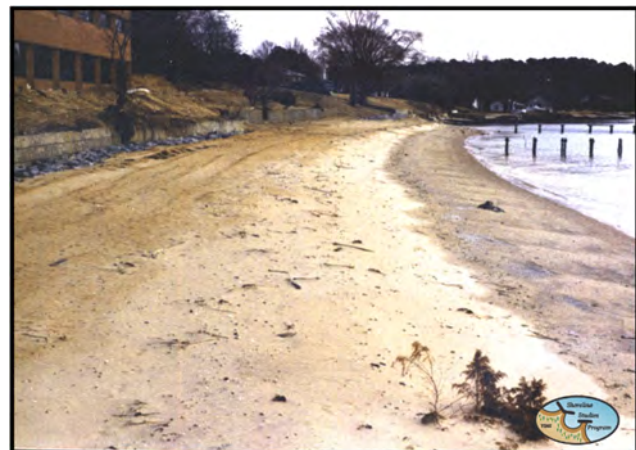
Figure 4-1-6. A revetment was installed and covered with beach fill along the shoreline to provide protection to the seawall.

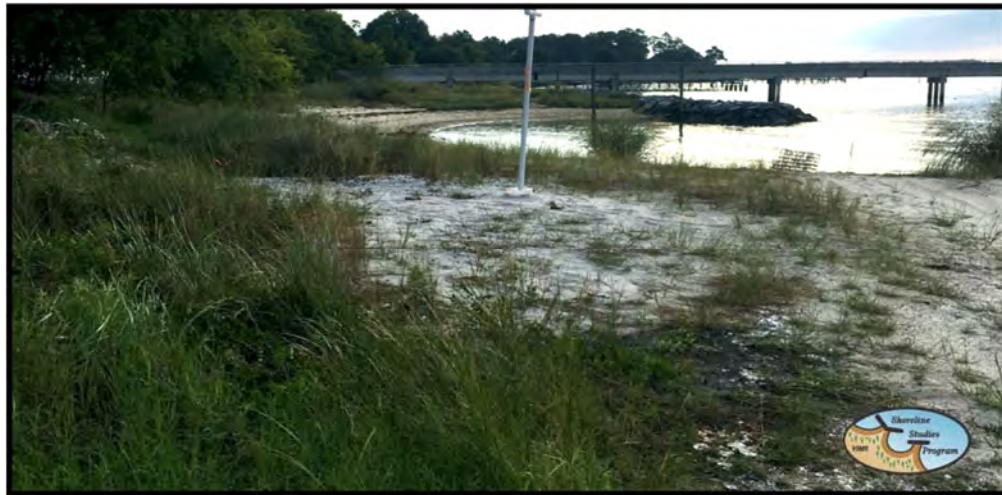
Figure 4-1-9. VIMS shoreline in 2017.

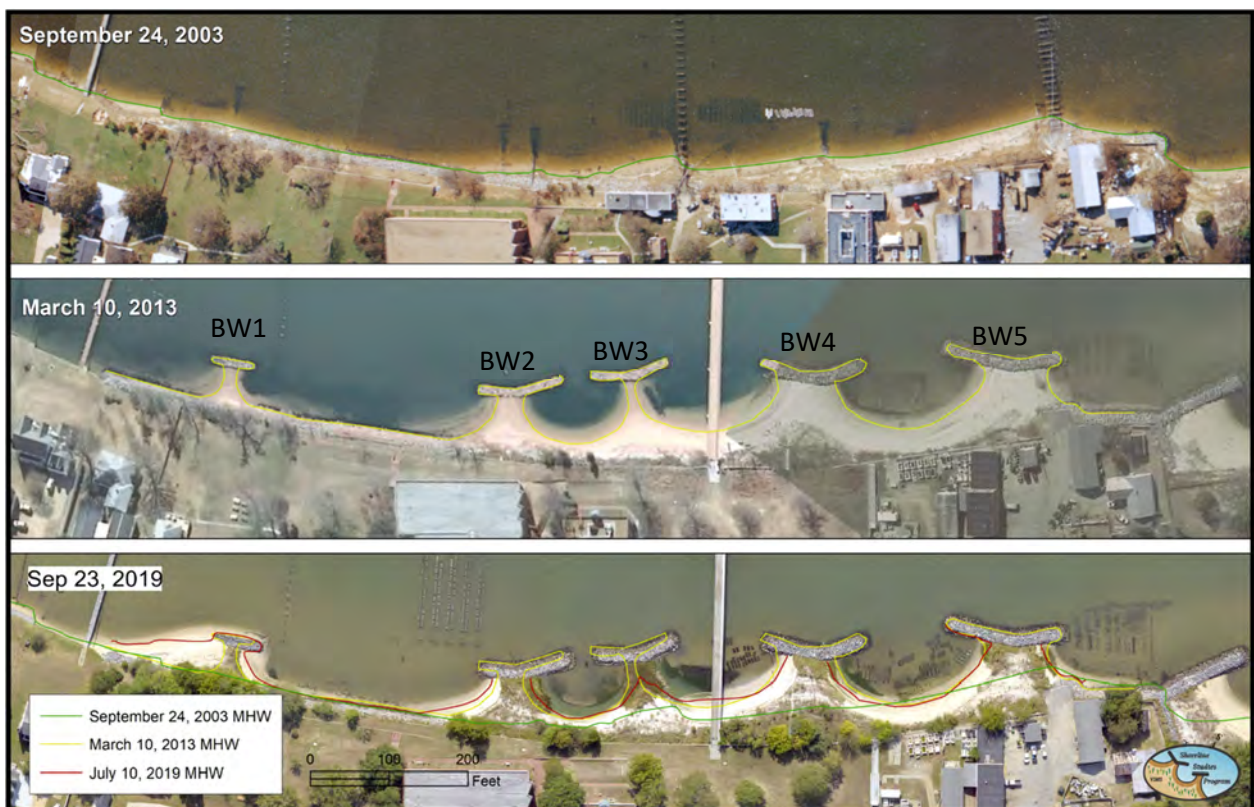
With time, the system has become more robust with the low marsh being replanted and expanding across the back and flanks of the breakwater tombolos (Figure 4-1-9). Though grasses were planted after breakwater installation, they had not taken hold behind the structures by 2013 (Figure 4-1-10). The breakwater 5 tombolo was relatively narrow.

updrift breakwater because sand movement along this section of shoreline is to the south. In addition, SAV has established itself in the embayments. It should be noted that the 2013 and 2019 MHW shorelines in the embayment between breakwater 4 and 5 are slightly landward of the 2003 post-Hurricane Isabel high water shoreline. Positioning of the structures and sand fill had to accommodate the established biological experiments located in the nearshore. As such, the gap between the structures was placed such that the minimal amount of fill would be placed near these experiments. This has not impacted the effectiveness of the system because the embayment is still wide enough that vegetation grows in the backshore to help hold the sand and should an extreme event occur, the embayment is backed by the seawall. The highest areas are along the backshore next to the seawall (Figure 4-1-11). Though the tombolo right adjacent to the pier is vegetated, it still does not have as much sand behind the structure as the other breakwaters.

Figure 4-1-10. Shoreline change between 2003 and 2019 at the VIMS breakwaters. The 2003 pre-installation date is shown for reference. The 2003 and 2013 shorelines are approximately mean high water based on the digitizer's best guess of the features shown. The 2019 shoreline is from the survey data.

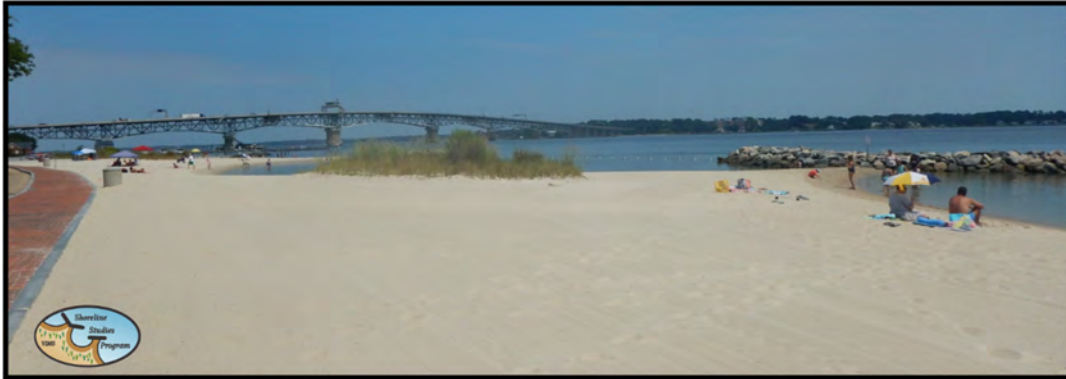
Figure 4-2-4. A wide recreational beach exists at Yorktown Beach shoreline on 31 Jul 2019. Though the backshore is low, the beach provides protection to upland structures.

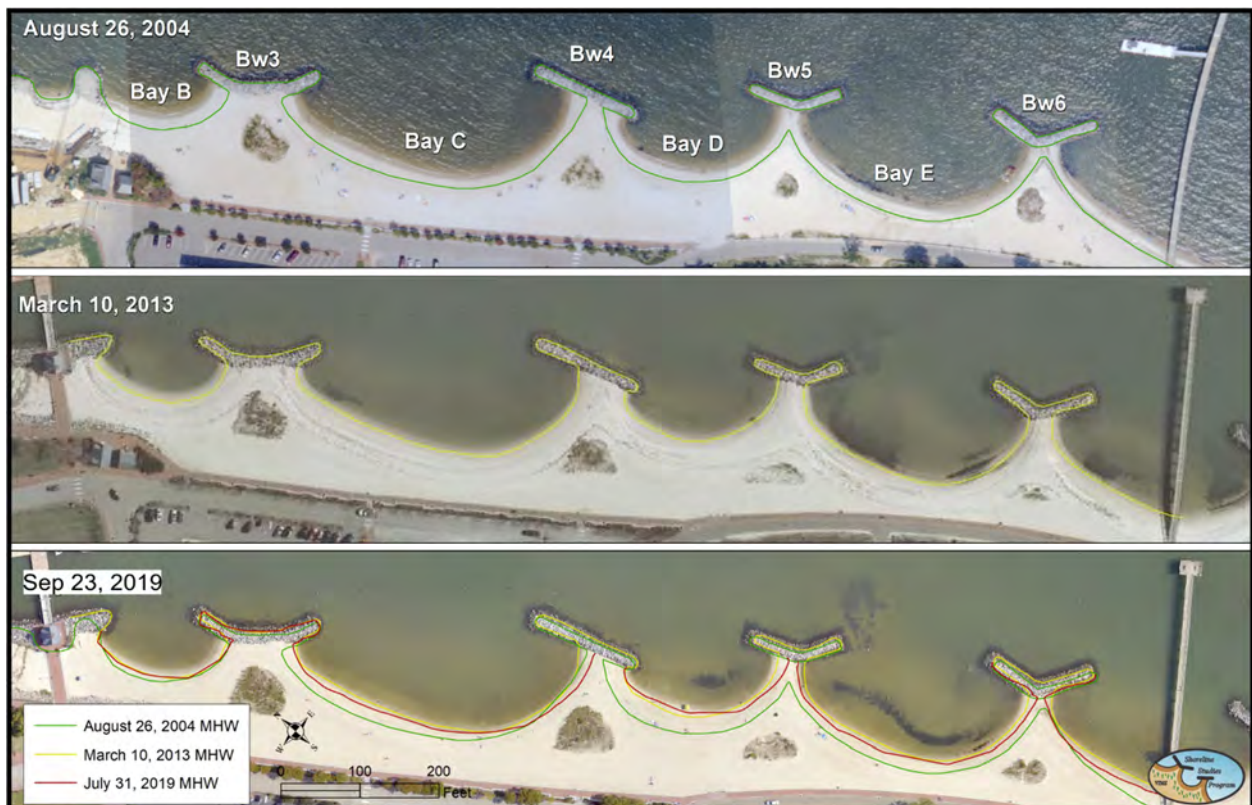
Today, the beach is wide and heavily used for recreation (Figure 4-2-4). The MHW shoreline is farther riverward than it was in 2004 and 2013 (Figure 4-2-5). This wide beach provides protection for infrastructure in the backshore because during high water events, the waves will break on the breakwaters or the beach before they cause damage. Highest elevations are located along the backshore and in the middle of the tombolos where the vegetation occurs (Figure 4-2-6).

Figure 4-2-5. Shoreline change between 2004 and 2019 at the Yorktown breakwaters. The 2004 and 2013 shorelines are approximately mean high water based on the digitizer's best guess of the features shown on the aerial photo. The 2019 shoreline is from the survey data.

At Yorktown, in addition to raising the backshore barrier, to address the 1 and 2 foot SLR by 2050, an increase in breakwater height is recommended (Figure 5-2). The new armor should be at least 2-3 feet higher to accommodate the required rock size which is 1 to 2-ton armor. Perhaps a more reasonable approach to raising breakwaters is to add rock blocks/rectangles along the crest. As an example, these would be on the order of 3x3x8 ft concrete structures that can weigh about 6 tons. Dimensions placement could vary. These would simply be placed along the top of each unit, and, although expensive to fabricate, it might be cheaper than adding and constructing additional armor layers. More sand will be required for the system as well. The shore planform can only adjust vertically with SLR unless the system is moved offshore. Moving the breakwaters offshore and adding much more sand might be cost prohibitive as the breakwater rock volume would increase and additional rock would be required. The high value of infrastructure behind Yorktown Beach as well as the economic value of beach usage make maintaining the beach important.

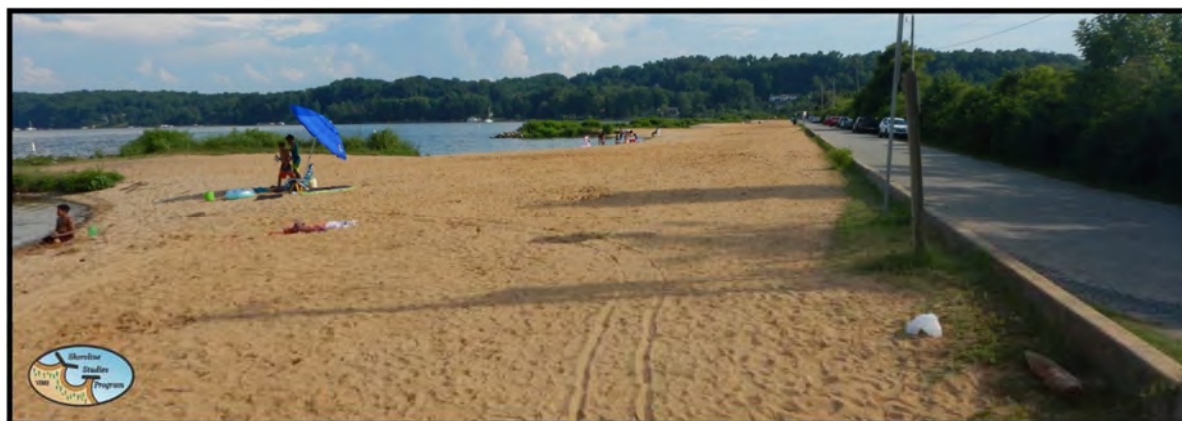
Figure 4-3-4. A wide recreational beach exists at Aquia Landing shoreline on 16 Jul 2019.

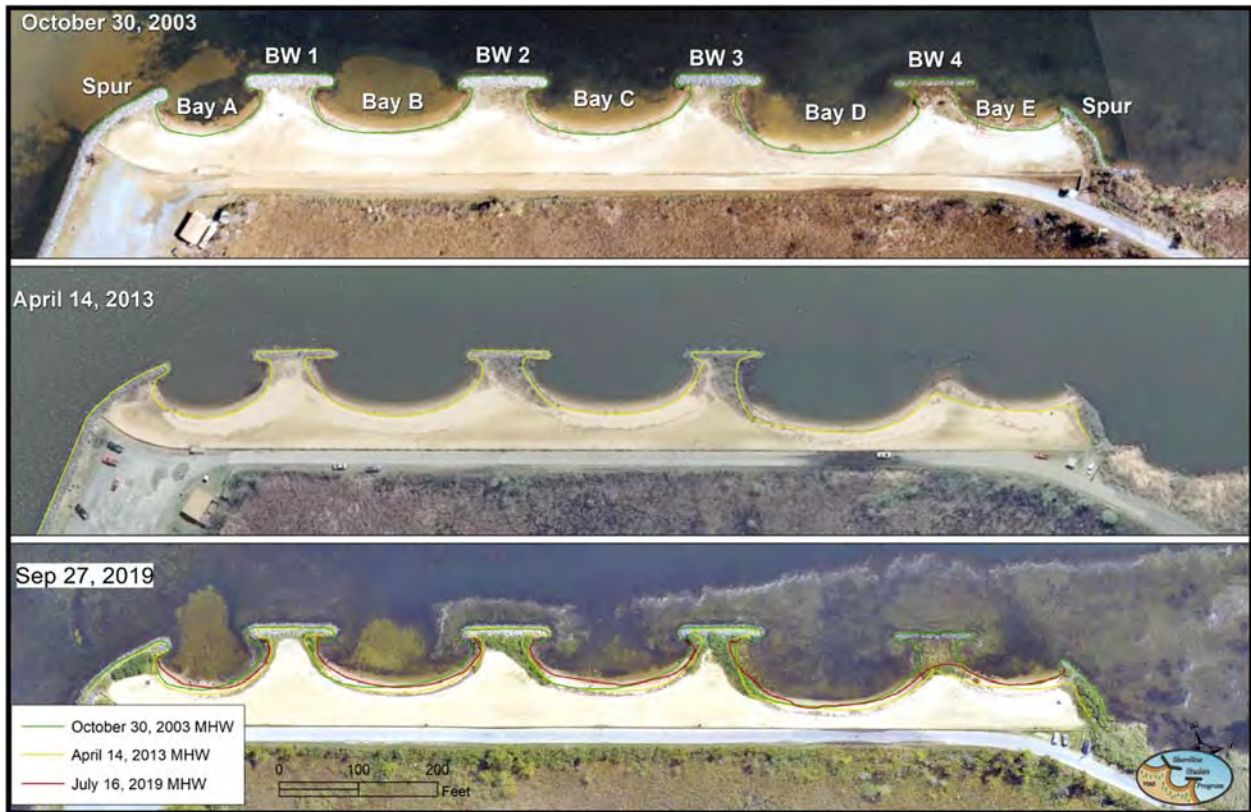
Figure 4-3-5. Shoreline change between 2003 and 2019 at the Yorktown breakwaters. The 2003 and 2013 shorelines are approximately mean high water based on the digitizer’s best guess of the features shown on the aerial photo. The 2019 shoreline is from the survey data.

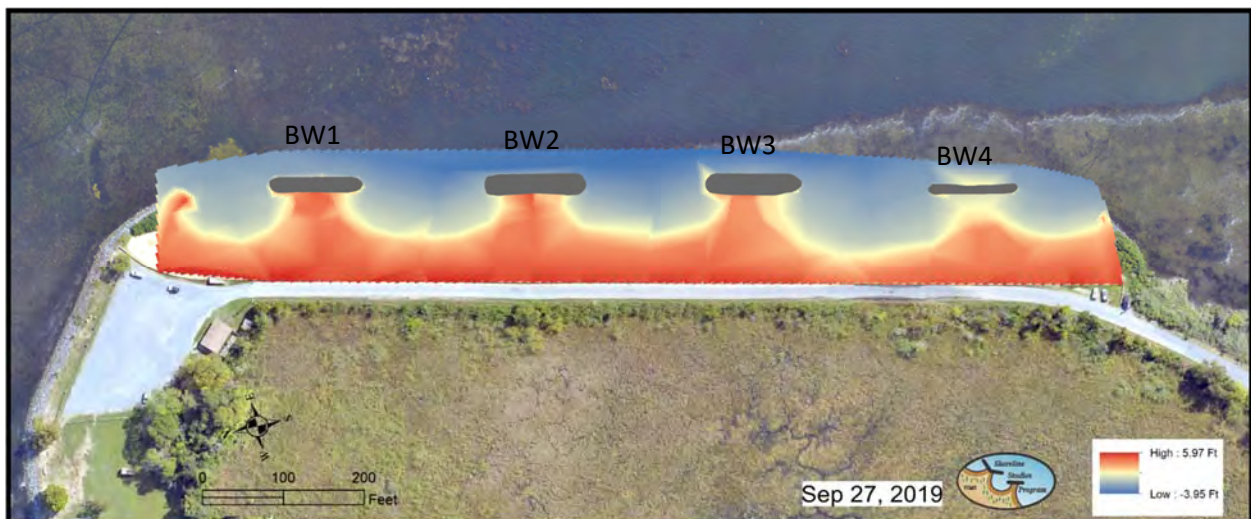
Though the storm surge topped the system during Hurricane Isabel and sand washed over the jersey wall onto the road (Figure 4-3-3), no extreme changes in topography were measured indicating that overall, the breakwater system remained stable during the storm (Hardaway *et al.*, 2006). The beach along Aquia Landing has been relatively unchanged since Hurricane Isabel. The shore planform has remained relatively stable since Isabel except for the thinning of tombolo attachments which have not impacted the beach and backshore (Figure 4-3-4). A wide recreational beach occurs at the site. The tombolos are heavily vegetated and a great deal of SAV occurs in the nearshore. Some variation has occurred in the position of MHW over time (Figure 4-3-5), but it has been relatively minor. The position of the embayments post-Hurricane Isabel shoreline on October 30, 2003, were slightly shifted due to wind and wave action during the storm. The 2013 and 2019 high water shorelines are similar although the 2019 tends to be riverward of the 2013. The tombolo at breakwater 4 has lost its attachment over time as the structure itself sank. Though heavily vegetated, the breakwater 4 tombolo is lower than the others (4-3-6).

Figure 4-3-6. Digital elevation model of the collected survey points at Aquia Landing.

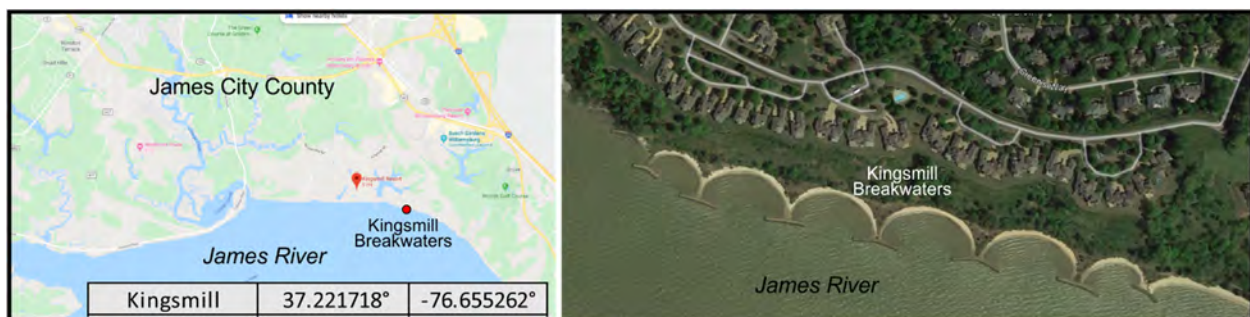
Figure 4-4-1. Left: Location of Kingsmill breakwaters, and Right: Google Earth image of breakwaters taken in May 2018.

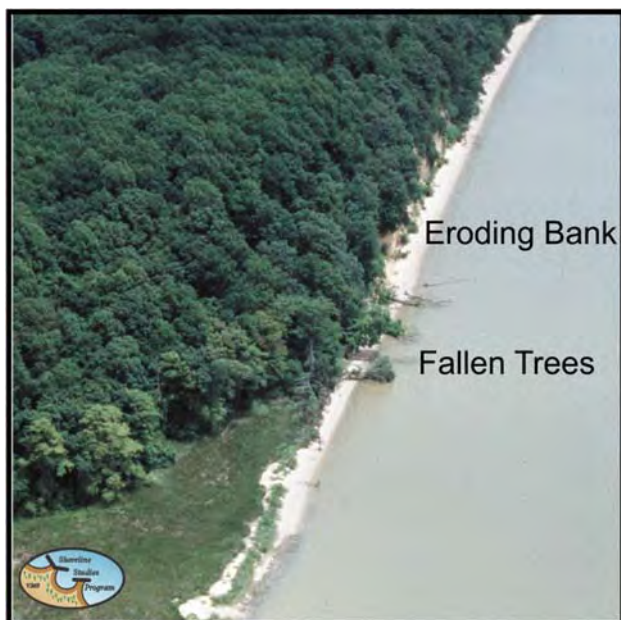
Kingsmill is located on the north shore of the James River in James City County, Virginia (Figure 4-4-1). It is a privately owned site that had chronic bank erosion and has a long fetch exposure to the south of over 12 miles and the southwest of over 5 miles (Figure 4-4-2). Wind frequencies from these directions are about the same, and the site occurs in what is considered a bimodal wind/wave setting. The developer of the upscale residential community wanted shore erosion control with environmental edge so a 2,800 ft breakwater system was installed in 1996. It consisted of six headland breakwaters ranging in size from 115 ft to 210 ft, a 110 ft low breakwater and a 170 ft revetment for boundary interfacing structures, beach fill, and wetlands plantings, all of which were designed for a 50-yr storm event. The site's seventy-foot-high banks had little sand and posed potential upland drainage problems. The design routed upland drainage to an adjacent marsh, and low swales in the bank were used to allow storm water to diffuse through a vegetated beach fill. Beach fill was obtained from an upland borrow pit. The overall purpose of the project was to provide shore protection and habitat enhancement.

Figure 4-4-2. Kingsmill shoreline June 1996 prior to breakwater installation.

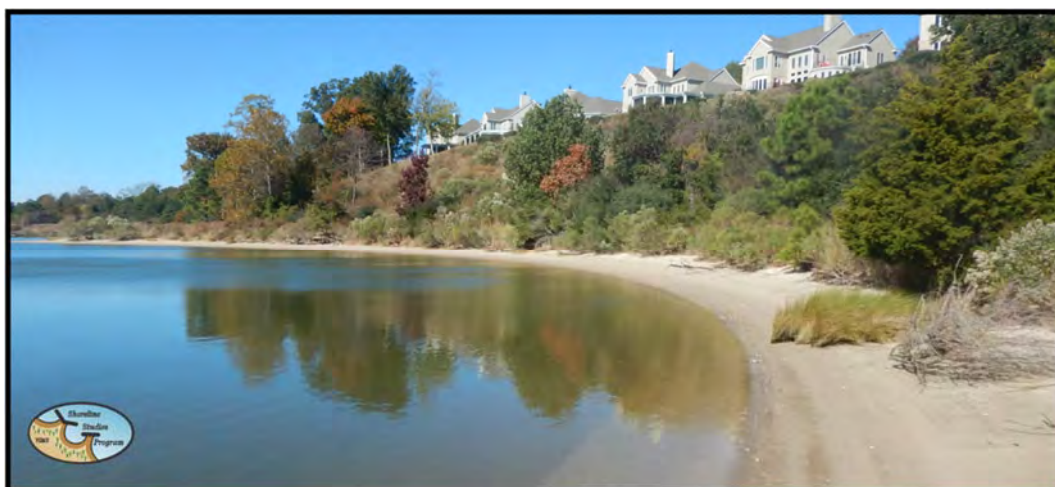
The shoreline is similar today with heavily vegetated tombolos and backshore and stable embayments (Figure 4-4-3). Post Hurricane Isabel, the tombolo attachment behind the breakwaters was lost (Figure 4-4-4). However, over time, sand accumulated behind the structures, particularly breakwaters 3 and 4, and became vegetated. Breakwaters 5 and 6 are still subaerially attached

Figure 4-4-3. Stable embayment along the Kingsmill shoreline in 2019.

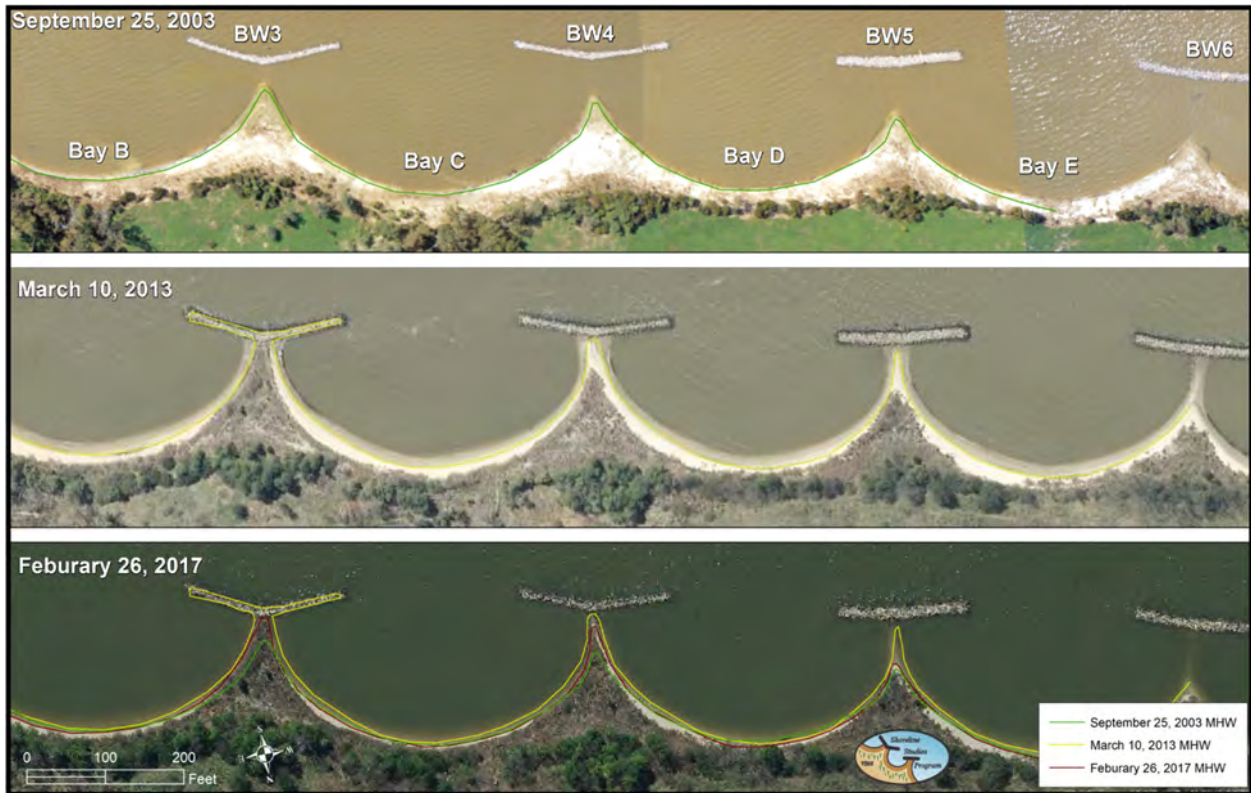
Figure 4-4-4. Shoreline change between 2003 and 2017 at the Yorktown breakwaters. The shorelines are approximately mean high water based on the digitizer's best guess of the features shown on the aerial photo.

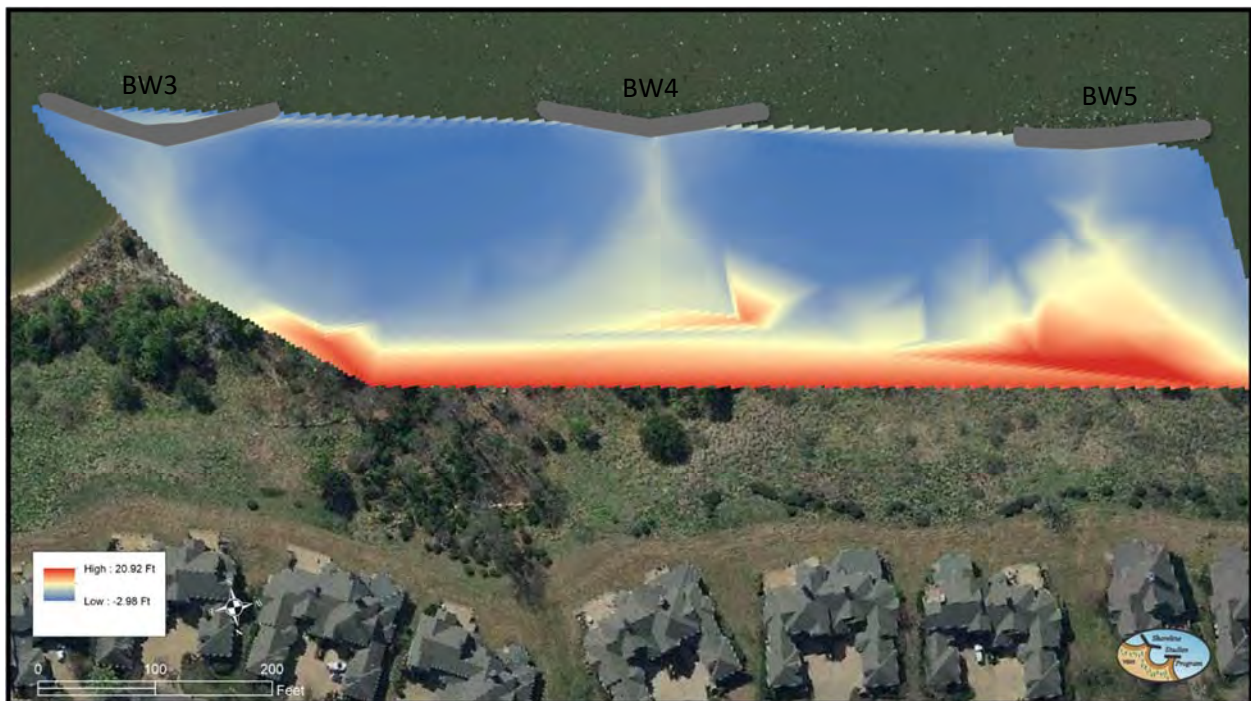
Figure 4-4-5. Digital elevation model of the collected survey points at Kingsmill.

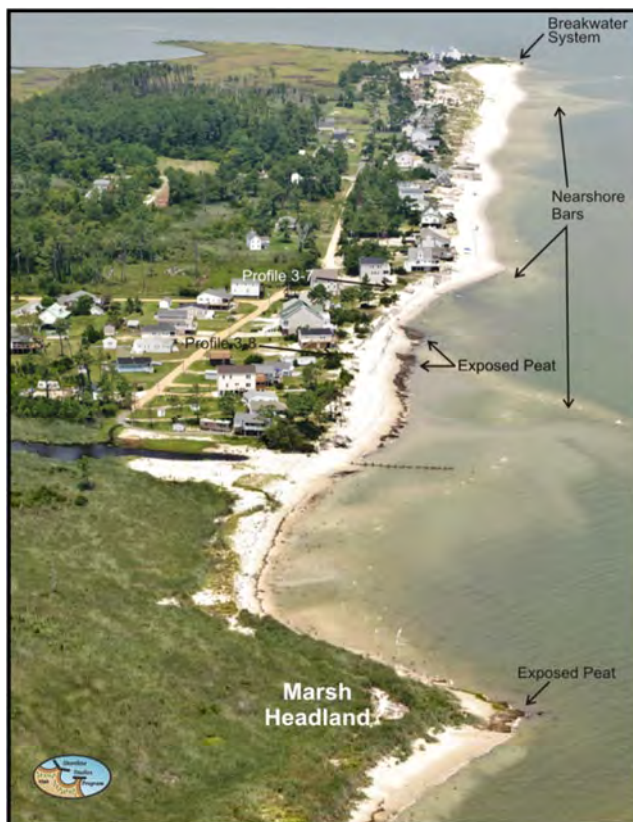
Figure 4-5-2. A 2011 aerial photo of MA3 depicting morphologic features (from Milligan et al., 2013). The breakwaters shown are on the northern end of the system and are not the ones studied for this project. They occur at the southern end near where the exposed peat is shown in front of the houses.

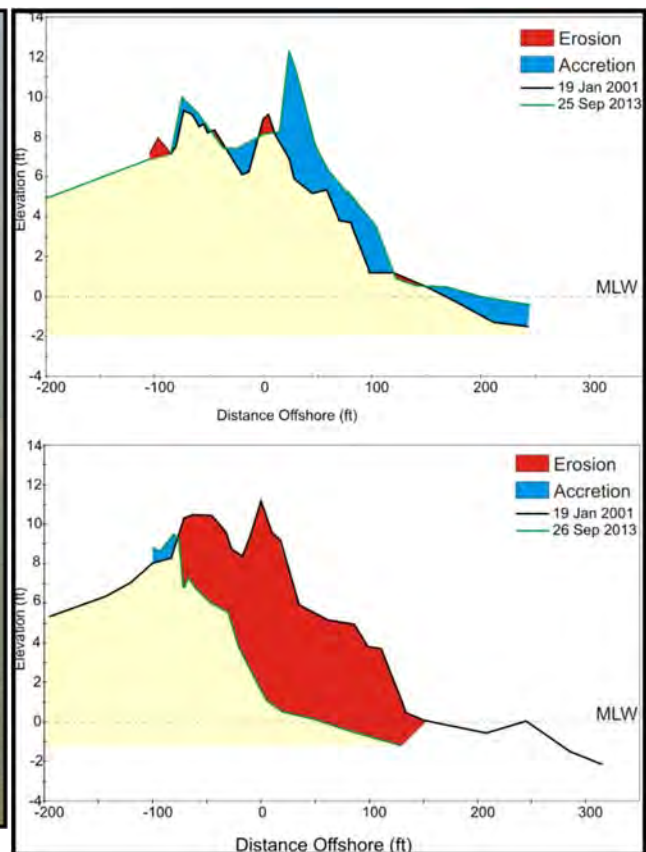
The Chesapeake Shores/Bavon Beach shore reach was significantly impacted by storms since monitoring began including those listed in Section 1.3 as well as Hurricane Sandy in October 2012 (Figure 4-5-3). The beach and dune system along the north half of the reach remained fairly well intact between 2001 and 2013 (Figure 4-5-3, top). The southern reach was particularly impacted as eroded beach sands were driven south with very little returning via northerly alongshore transport. As a result, several revetments were constructed along the subreach to protect houses exposed on the shoreline (Figure 4-5-4). Finally, in 2016, the breakwater system was constructed and consisted of 3 breakwaters with significant sand nourishment. Though the system has not weathered significant storms, overall, it has maintained its system integrity by maintaining tombolo attachment (Figure 4-5-5).

Figure 4-5-3. Depiction of the net change between 2001 and 2013 along the northern end (top) and southern end (bottom) of Ma3 (from Milligan et al., 2013). The southern end is where the breakwaters were constructed.

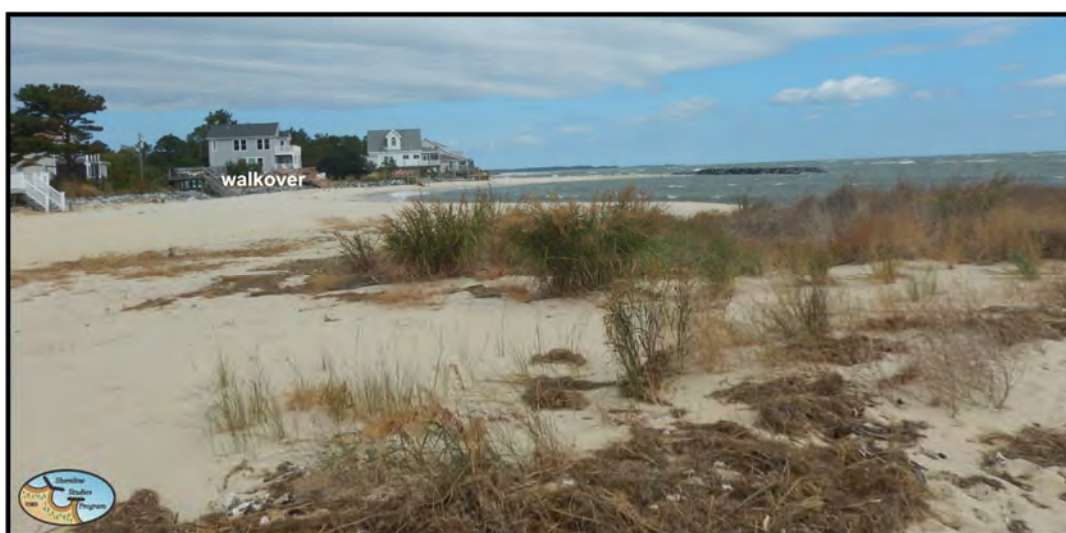
Figure 4-5-5. The beach is wide and the tombolo attached and vegetated along Bavon's shoreline in 2019.

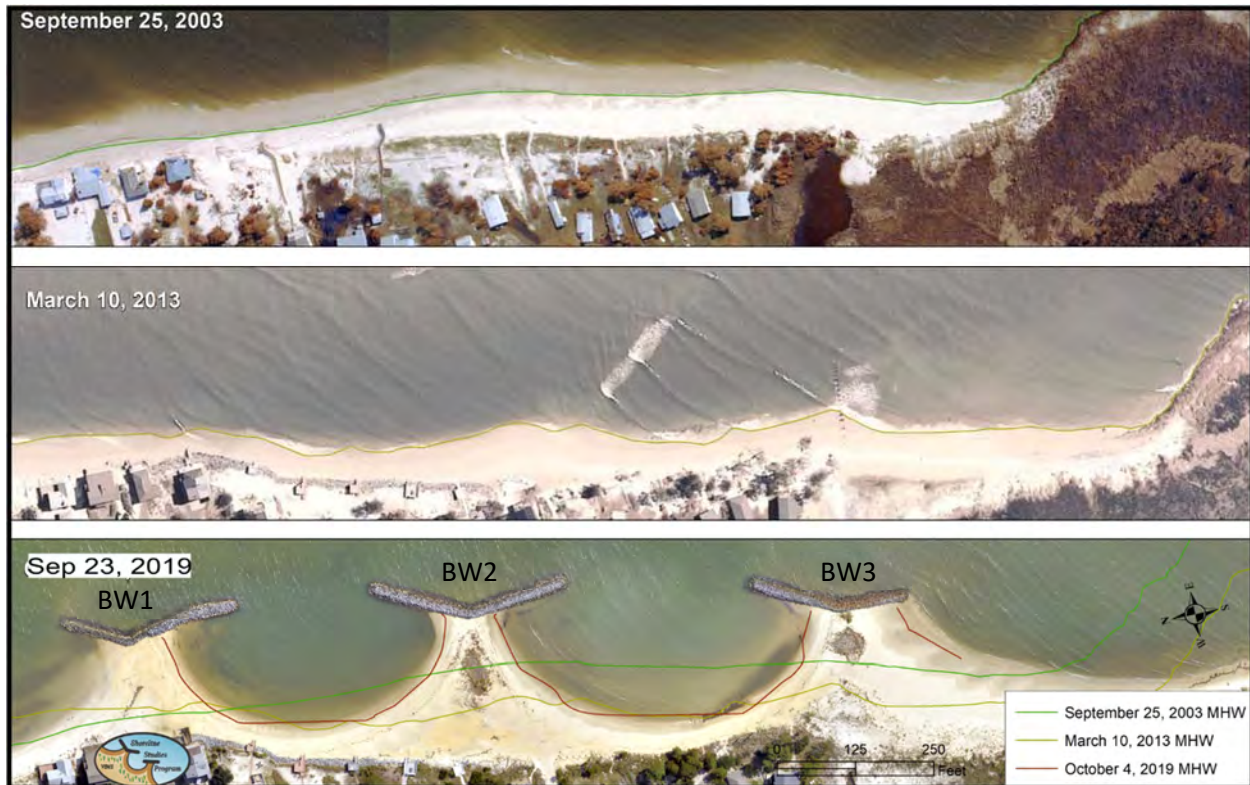
The southern section of the Bavon reach has been eroding rapidly. Between 2003 and 2013, the shoreline significantly retreated (Figure 4-5-6). Though high water advanced along most of this shoreline between 2013 and 2019 due to the construction of the breakwaters, its

position in the embayment between breakwater 2 and 3 is slightly landward of the 2013 shoreline. This is due to the erosion that occurred before 2016 when the breakwaters and fill were placed as well as to the placement of the structures. Their placement determines the bay shape based on the static equilibrium bay model. Sand may shift from side to side, but now the embayment is in dynamic equilibrium and should not retreat farther except possibly under a large storm event. Breakwaters 2 and 3 have the highest tombolo elevations (Figure 4-5-7) and vegetation is growing there. Breakwater 1 is still attached, but its attachment is lower and narrower.

Figure 4-5-6. Shoreline change between 2003 and 2019 at the Yorktown breakwaters. The 2003 and 2013 shorelines are approximately mean high water based on the digitizer's best guess of the features shown on the aerial photo. The 2019 shoreline is from the survey data.

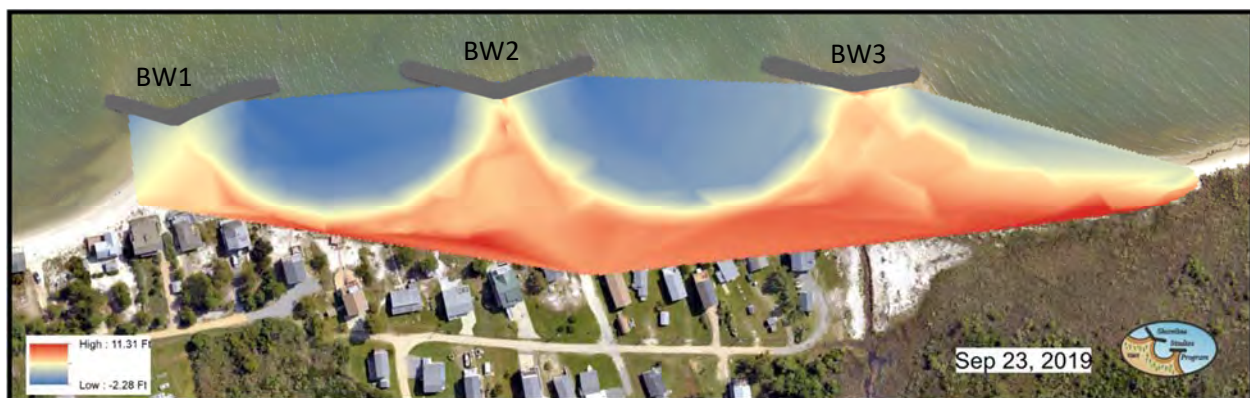
Figure 4-5-7. Digital elevation model of the collected survey points at Bavon.
