Dorra ABID, Ahmed KTARI, Dhouha MELLOULI, Nedia GAFSI, Nader HADDAR - Failure analysis of shot-sleeves used in brass high pressure die-casting process - Engineering Failure Analysis - Vol. 104, p.177-188 - 2019

Failure analysis of shot–sleeves used in brass high pressure die–casting process

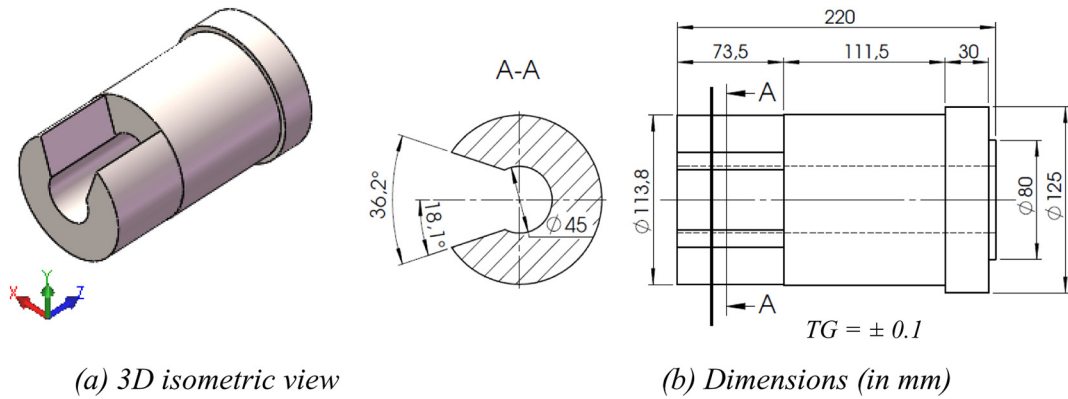
Fig. 1. Geometry and dimensions of the studied shot-sleeves.

In the present study, samples of shot-sleeve failed in service, were investigated to understand the mechanisms, which can lead to their damage. The shot-sleeve (Fig. 1), used in brass high pressure die-casting process, undergoes a severe thermo-mechanical loadings during cast cycles. Each cycle include principally four phases as following:

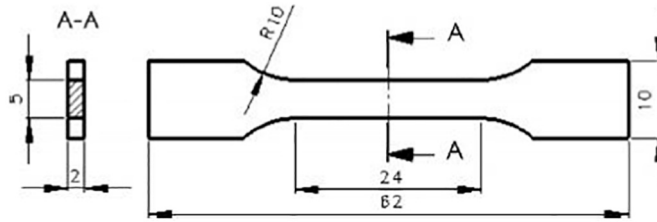
Fig. 3. Dimensions of tensile specimen (in mm).

In order to investigate the tensile properties of the studied material AISI H10, tensile tests were carried out on a three standard flat tensile specimens (NF A 03-151) as presented in [Fig. 3](#). The semi-finishing form of each one was obtained from the damaged

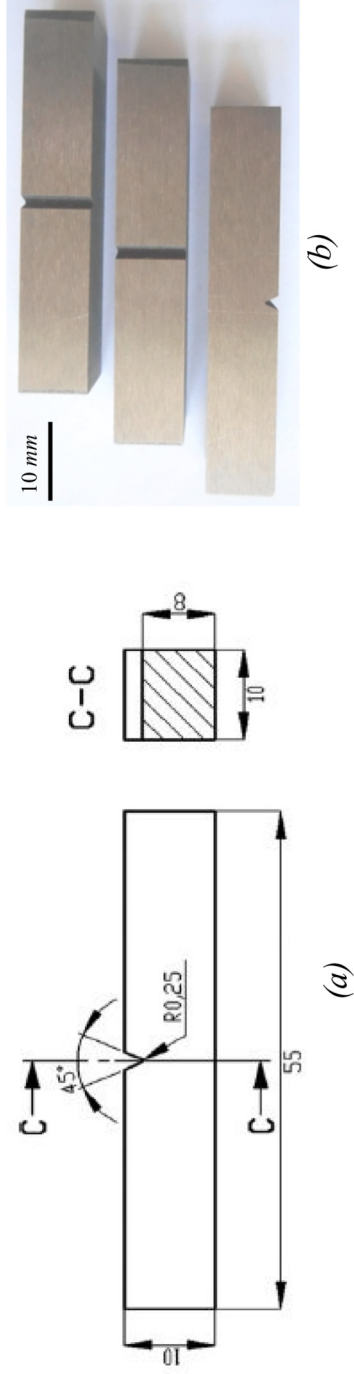
Fig. 4. Charpy V-notch specimens: (a) Geometry and dimensions (in mm), (b) machined Charpy V-notch specimens.

Standard Charpy V-notched specimens were machined from the failed shot-sleeve by a wire EDM machine (Fig. 4). Then, three tests were conducted at room temperatures to determine the material toughness. The average of the measured CVN energy (CVN = 3.4 ± 0.1 J) and the feature of the fractured surface prove the brittle nature of the specimen material (Fig. 5).

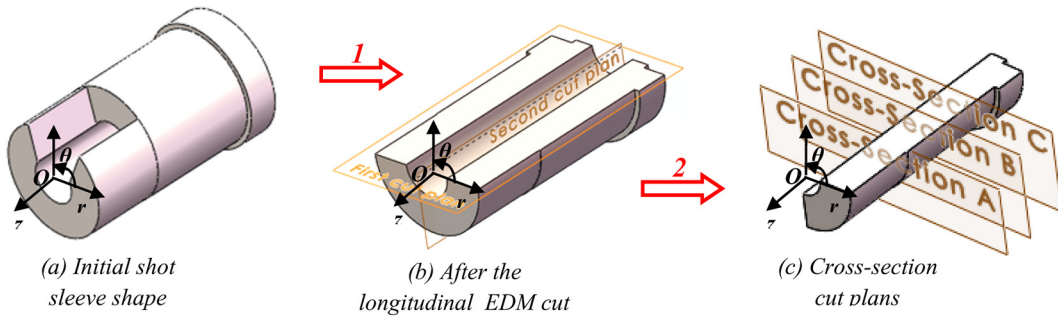
Fig. 6. CAO schema of shot-sleeve cutting planes: (a) Initial shot sleeve shape, (b) After the longitudinal EDM cut, (c) Cross-section cut plans.

The hardness profiles were measured, on a shot-sleeve longitudinal section (Fig. 6 (b)) polished until mirror state, from the entry plunger zone to the mold side and from the inner to the outer surface (Fig. 7). These profiles are performed with a Vickers hardness machine using a load of 15 kg. The measured profiles reveal that the hardness appears to be constant for all tested samples.

A finer observations of the shot-sleeve inner side were carried out after a longitudinal cut (Fig. 6 (b)). The examination of the damaged surfaces was made using an experimental device equipped with a digital *Baumer*[®] camera *GIG*E (8 bits). This camera is equipped with a CCD sensor allowing to have a resolution of 1624×1236 pixels. Several photos are taken and then assembled by means of Photoshop[®] software to obtain a large image that cover the entire shot-sleeve examined surface (Fig. 9). This surface reveals the presence of three different zones. The first one is located in the plunger entrance side. It presents a number of scratch according the longitudinal direction which corresponds to abrasive wear caused by the friction between the plunger and the shot-sleeve. The second one corresponds to the first zone which enter in contact with the molten metal ($T = 950^\circ\text{C}$). It undergo cyclic thermal shocks. This zone appears to be the most damaged surface in the shot-sleeve. It presents a dense crack network sign of the thermal fatigue. In addition, the investigation of this zone according to the $O\theta Z$ plan shows that some cracks, after initiation, were propagated in depth along the radial direction (Detail A). The last zone reveals also the presence of a crack network however it is less dense compared to this observed in the 2nd zone (Fig. 9).
