Failure Analysis of Brake Panel on Automotive Braking System

Munaji^a, Yoyok Winardi^a,

Abstract

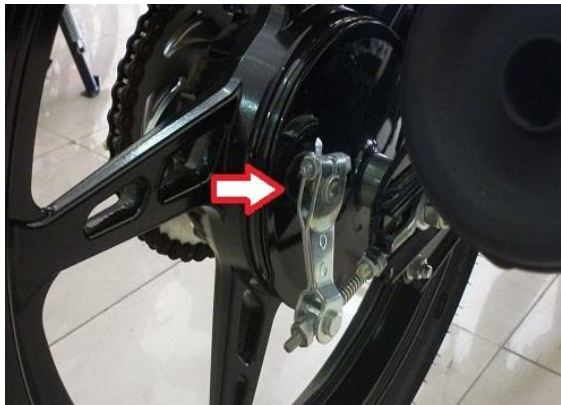
Figure 1. Braking system

Methods used to determine the occurrence of failed component are macro and micro observation, chemical composition, and testing of mechanical properties (7). Failure analysis of braking panel system of motorcycle are presented. Figure 1 shows the brake system component of a motorcycle. Brake panel/backplate is a failed component. This component has been repaired. After used in 3 months, the brake panel is fractured during braking process. From the result of the observation using digital camera, the obtained shape and fracture location as shown in Figure 2.
