# **Global monitoring of large concrete structures using acoustic emission and ultrasonic techniques: case study.**

Tomoki Shiotani<sup>1</sup>, Dimitrios G. Aggelis<sup>2</sup> and Osamu Makishima<sup>3</sup>

In the specific case presented herein, a 45 m bridge span was inspected. Preliminary visual inspection and testing of excavated cores did not reveal extensive damage. However, cores are

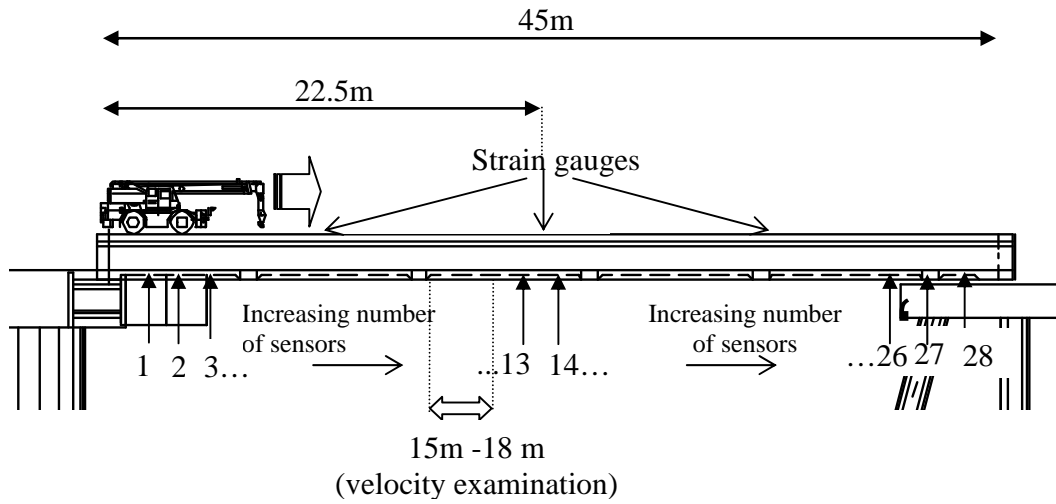
The load for the AE monitoring was supplied by a 20-ton crane, which passed over the bridge with a constant speed of approximately 0.5 m/s (see Fig. 1). As the crane moved over the bridge, the strain on the top surface of the bridge at the mid-span was monitored and can be seen in Fig. 2. The maximum strain was recorded at 88 s, when the truck was in the middle of the span, suggesting the highest tensile stress due to bending at the bottom layer of the structure, where the sensors were attached. In the same figure, the cumulative number of AE hits recorded by all the sensors is depicted for one passage. It can be seen that the rate of AE hits was more intensive before the crane reached the center of the bridge at 88 s. Up to that moment more than 70% of the total number of hits was recorded, implying that more active sources were located in the first half of the bridge. In the same figure, the cumulative number of hits recorded only by the two sensors located close to the center of the bridge is depicted. For clarity reasons they are multiplied by a factor of 5 in the figure. The hits of these sensors started at 14 s before the crane reaches the middle point, and the last hit was recorded 10 s after the crane had passed over that point, showing again higher activity at the first half of the structure.

Fig. 1. Representation of the crane passing over the bridge and sensor location.

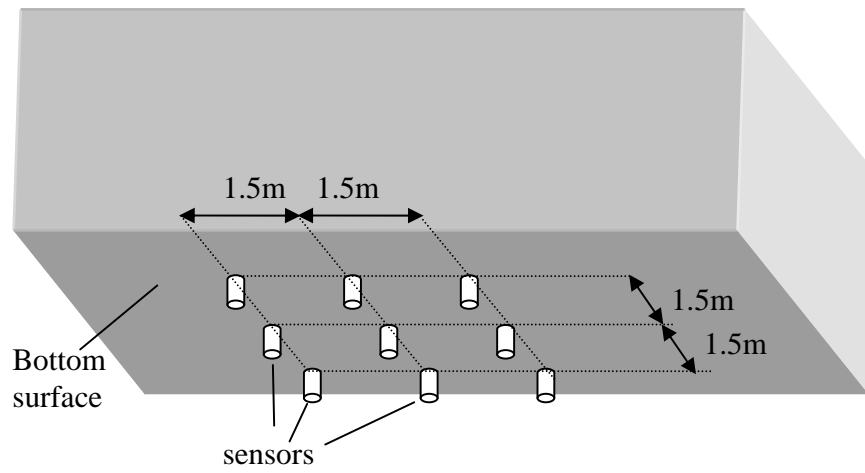
For the velocity measurement, nine AE sensors were used in an arrangement of three parallel arrays of three. The separation distance was 1.5 m, resulting in an examined area of 3 m by 3 m (see Fig. 5). The excitation was conducted by pencil lead break near the location of each transducer. Therefore, each time, one sensor was used as trigger for the acquisition and eight as receivers. This way a number of intersected paths were examined, and the results can be considered more representative of the area and more reliable than one single measurement between two points. The velocity was measured by the time of the first detectable disturbance of each waveform. Although surface propagation includes different kinds of waves, with the Rayleigh occupying most of the energy of the excitation, it is straightforward that the first arrival belongs to longitudinal waves which are the fastest type. It is mentioned that the excitation at each point was repeated five times to check repeatability. The waveforms were identical since the excitation of pencil lead break is quite repeatable.

Fig. 5. Sensor arrangement for surface wave measurements.

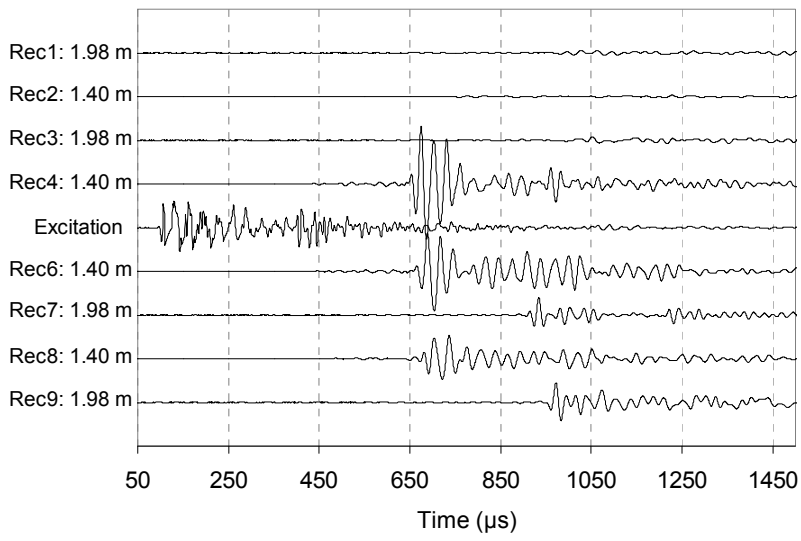
for Rayleigh wave measurement (Qixian and Bungey, 1996). This is shown in Fig. 7. This is an example of waveforms acquired after excitation at the center sensor. The excitation waveform has been reduced by a factor of 10 to fit in the graph. For sensors 4-9 the Rayleigh burst is easily identified, and the measurement of its velocity can be conducted by a reference point (i.e. the first positive peak). However, for sensors 1-3 which correspond to the top of Fig. 6, no Rayleigh part is identified and the energy is much lower. This again shows that the propagating zone was disrupted by a discontinuity. Using the Rayleigh velocity of 2500 m/s and the major frequency component of 50 kHz (see Fig. 8), the wavelength is calculated to approximately 50 mm. Therefore, since the Rayleigh component was not visible through some paths, this should be due to a weak material zone or discontinuity that extends very close to the surface (even closer than 50 mm). From Fig. 8 it is concluded that the major frequency component of around 50 kHz survives the propagation while attenuation severely diminishes the higher frequency content introduced by the pencil lead break. The characterization depth using surface wave examination (including Rayleigh and longitudinal components) needs further study, which is currently undertaken.

Fig. 7 Typical waveforms after excitation at the center position of Fig. 6.

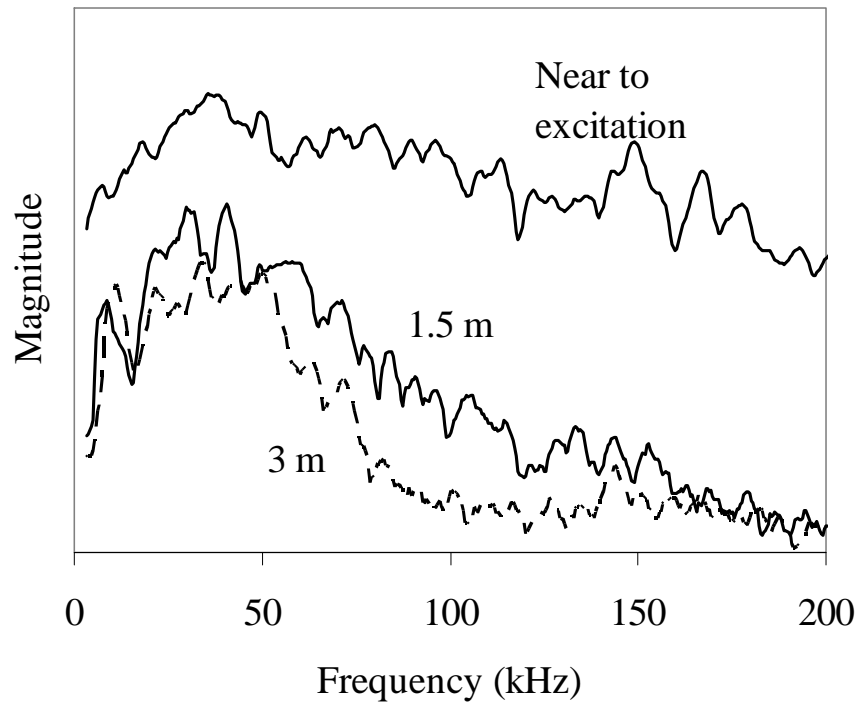
Fig. 8 Typical Fast Fourier transforms for three distances from the excitation.
