Case Study on Causes and Countermeasures of a Largely Deformed Reinforced Earth Wall with Geotextile in Hyogo, Japan

Satoru Shibuya

ABSTRACT: This study examines causes and countermeasures of large deformation that took place on the reinforced earth wall, a part of the Tottori expressway planned to pass Hyogo, Japan. Since this reinforced earth wall had experienced unexpected deformation of the wall during construction, the wall was re-constructed twice. However, the wall deformation showed no sign to cease even at the final stage of the construction. In this paper, case study was carried out on the interpretation of the mechanical behavior of the severely damaged reinforced earth wall comprising geotextile with the concrete panel facing. At First, the outline of the damaged reinforced earth wall is in detail described. The background and cause of the damage are discussed based on the results of site investigation. The engineering properties of the fill were examined by performing various in-situ and laboratory tests, including the surface wave survey (SWS), PS-logging, RI-logging, soaking test, the direct shear box (DSB) test, bender element (BE) test, etc. Consequently, the bac

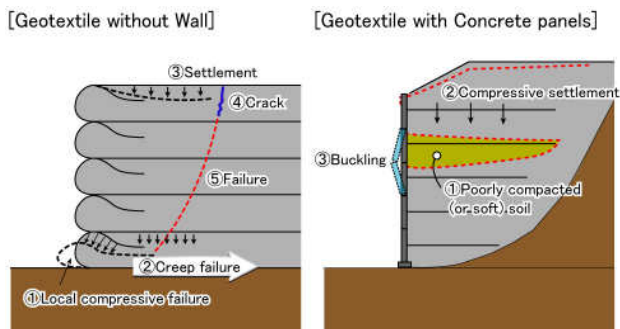
Fig. 1 Typical damages of reinforced earth walls.

Fig. 1 shows typical of damages for reinforced earth in general. In case of flexible reinforced earth without any concrete facing, a local failure involving with excessive compressive deformation would take place at the bottom portion, which in turn may trigger the overall active slip failure in a progressive manner (refer to Tatsuoka et al., 2000).

Conversely, when the reinforced earth with concrete panels comprises a poorly compacted (or soft soil) layer at the time of construction, a connection between the concrete panel and reinforcement member (i.e., the metal strip or geotextile) would be destroyed owing to the downward ten-

sion force at the connection, which eventually may bring about complete failure of the wall. Case study described in this sub-section refers to the latter case.

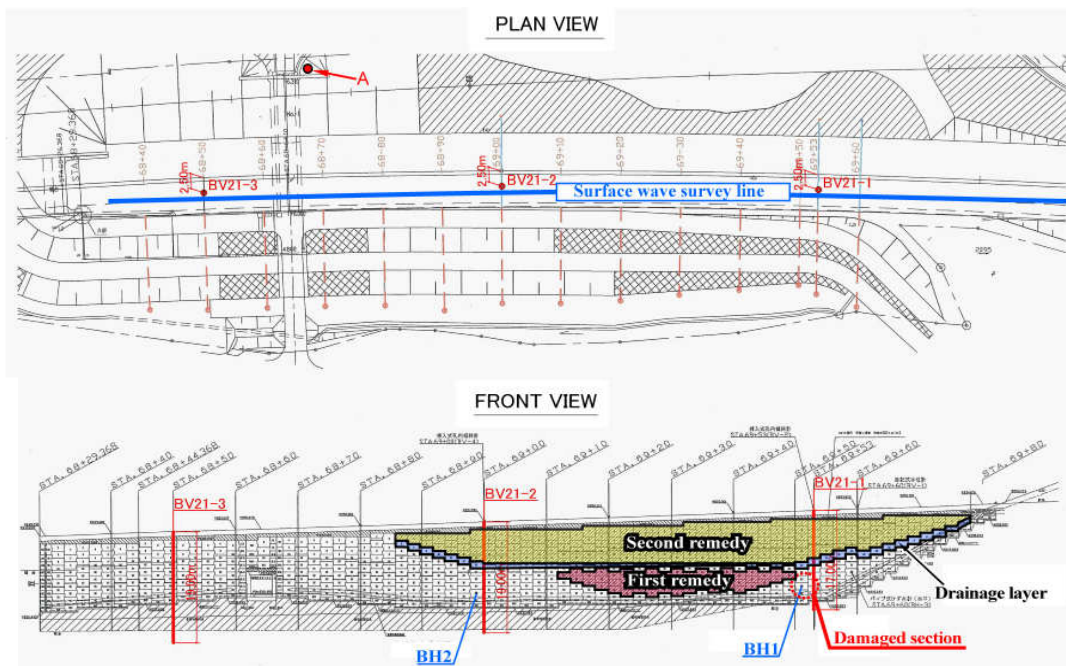
Fig. 3 Front and plan views of the site.

The details of the wall are shown in Fig. 3. In November of 2006, irregular deformation of the wall was observed at the middle stage of the construction. Accordingly, a partial reconstruction involved with cement stabilization to the fill was carried out after removing some parts of the reinforced earth wall, which is called “the first remedy” in this paper.

wall was again observed at the eleventh stage of the construction being close to the final construction stage. Therefore, after demolishing some parts of the wall, the wall was reconstructed with cement stabilization to the upper part of the fill. Furthermore, a horizontal drainage layer was installed in the middle part of the wall. In this paper, this reconstruction of the wall is called “the second remedy” (refer to Fig.15). The locations for HR-SW survey, PS-logging, RI-logging, boring and the SPT are indicated in Fig.3.

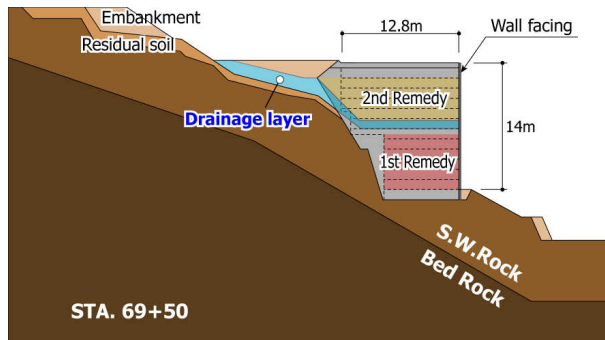
Fig.15 shows a representative cross section used in the numerical analysis, Note that the cross section of STA69+50 corresponds to the portion where the wall was severely damaged.

Fig. 15 Cross section used in the numerical analysis

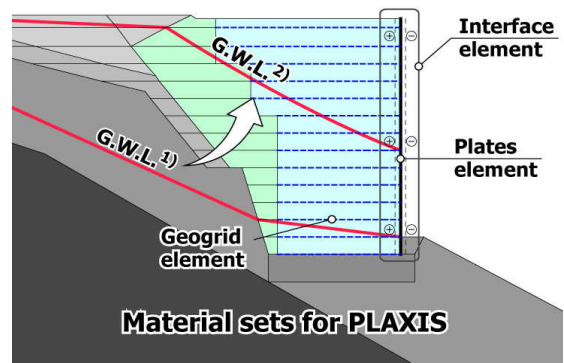
As shown in Fig.17, the geogrids were modeled using “GEOGRID ELEMENT” of the PLAXIS.

Fig. 17 Seepage analysis by PLAXIS
