## Collapse of Braced Excavation in Singapore

K. Ishihara

**ABSTRACT:** After the collapse of the subway excavation in the Nicoll Highway, extensive in-situ investigations were carried out to identify causes of the accident. The results of detailed studies disclosed that lack of toe-in depth of the diaphragm wall into the stiff competent strata could be one of the causes of the incident. This aspect of the studies is highlighted in this paper.

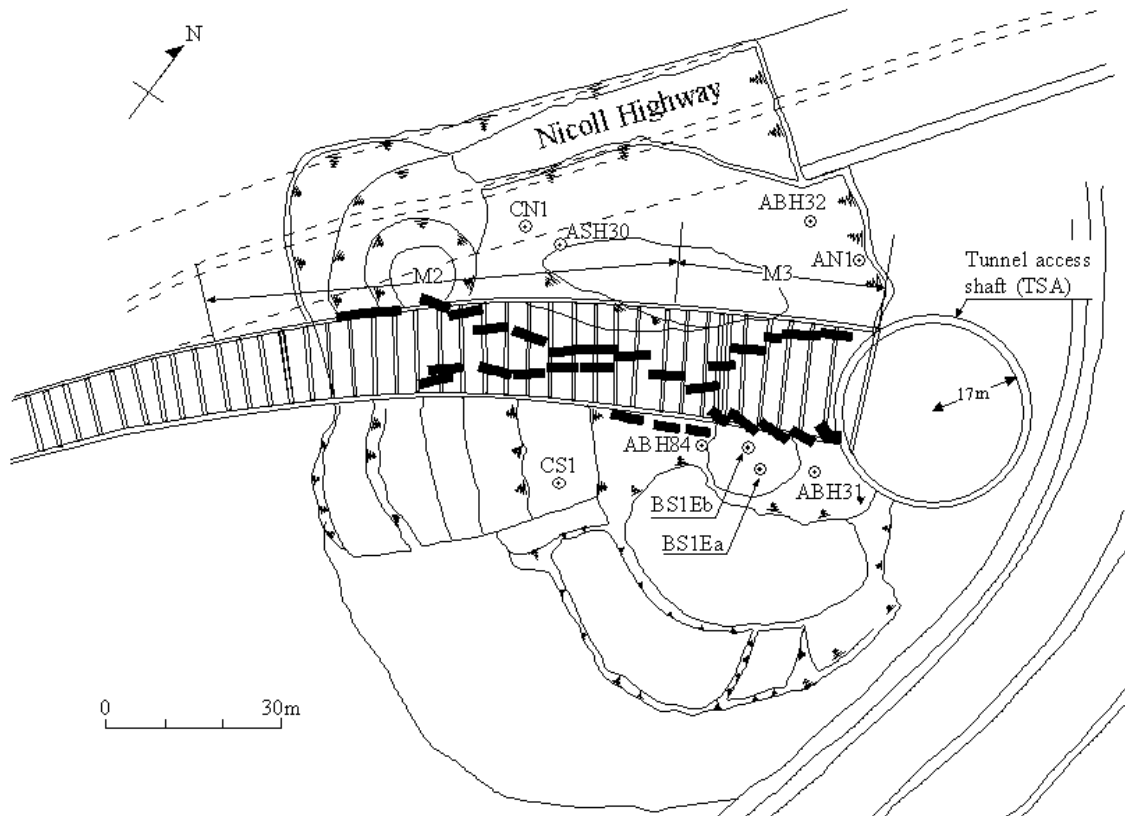
Fig.4 Plan view of the area of the failure and braced wall system.

huge amount of soil mass moved into the excavated space. In fact, a subsidence of the ground surface as much as 10m was observed on the south side in proximity to the wall and the settlement extended about 50m southward, as seen in Figs. 4 and 12. The area of the ground settlement extended also north towards the Nicoll Highway but to a lesser extent as can be seen in Fig. 4. Thus, it was considered certain that the failure was initially triggered by the breakage of the diaphragm walls on the southern side, thereby involving a landslide towards the excavated space. As a result of losing the horizontal support, the northern walls moved also towards the excavation, inducing sliding of soil mass towards the south but to a lesser extent.

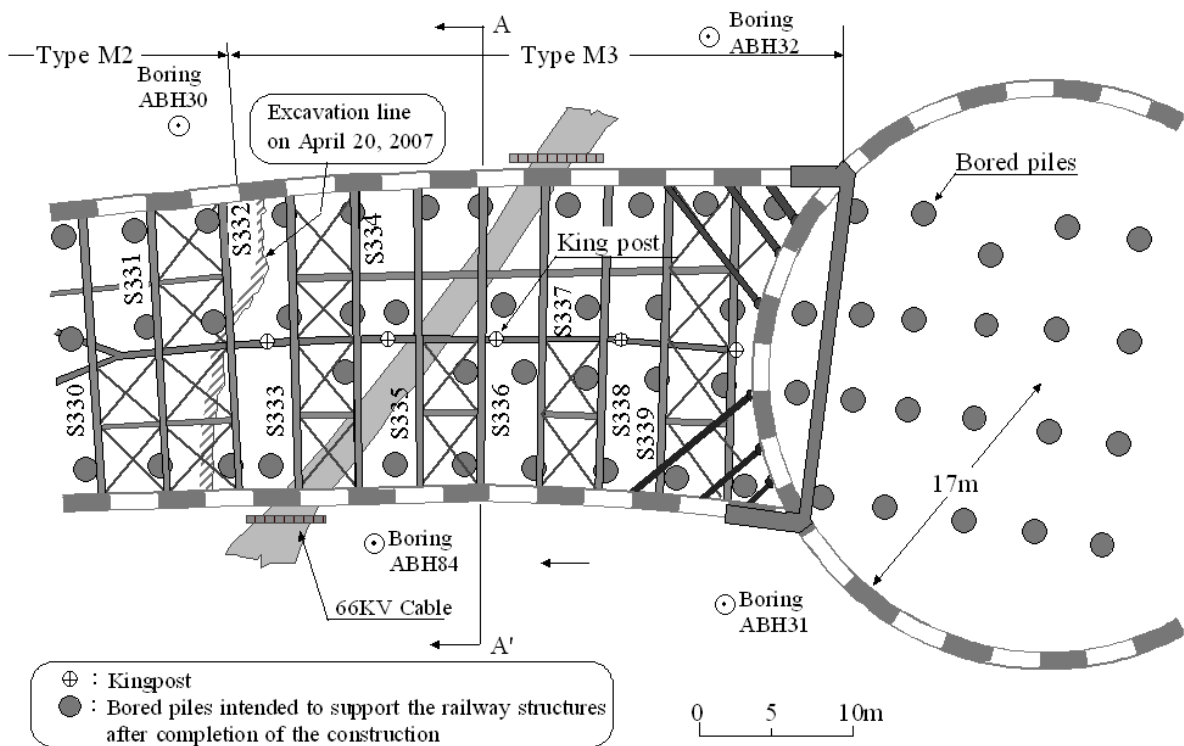
Fig. 5 Plan view of the Type M3 section due west of the access shaft.

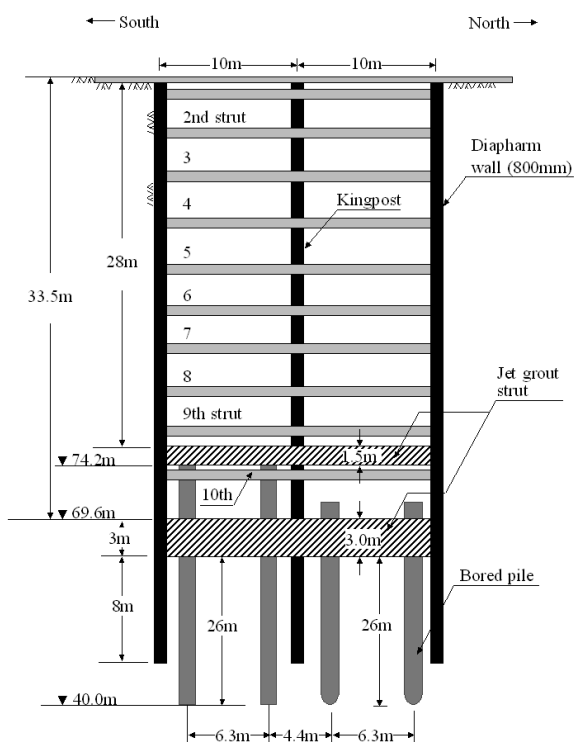
The diaphragm walls were supported by the 10 levels of steel struts with discontinuous walers except at the top strut. To reinforce the strutting action, two soil layers at the depths of 28 to 29.5m (sacrificial strut) and of 33.5m to 36.5m were stabilized as shown in Fig. 6 by means of the jet grouting which had been installed from the ground surface before the excavation began. At the same time, with an aim of providing support for the railway tunnel structures to be placed later, four lines of bored piles each 1.4 to 1.8m in diameter were installed from the ground surface at a spacing of 4m or 6m as shown in Fig. 6. The depth of the pile embedment was 34.2m on the north side counted downwards from the elevation of 74.2m RL and, it was 29.6m RL on the south side from the elevation of 69.6m RL as shown in Fig. 6, where RL (Reduced Level) means a local measure of elevation with a zero point taken at a depth 100m from the mean sea level.

Fig. 6 A typical side view of the struted system for the A-A' cross section.

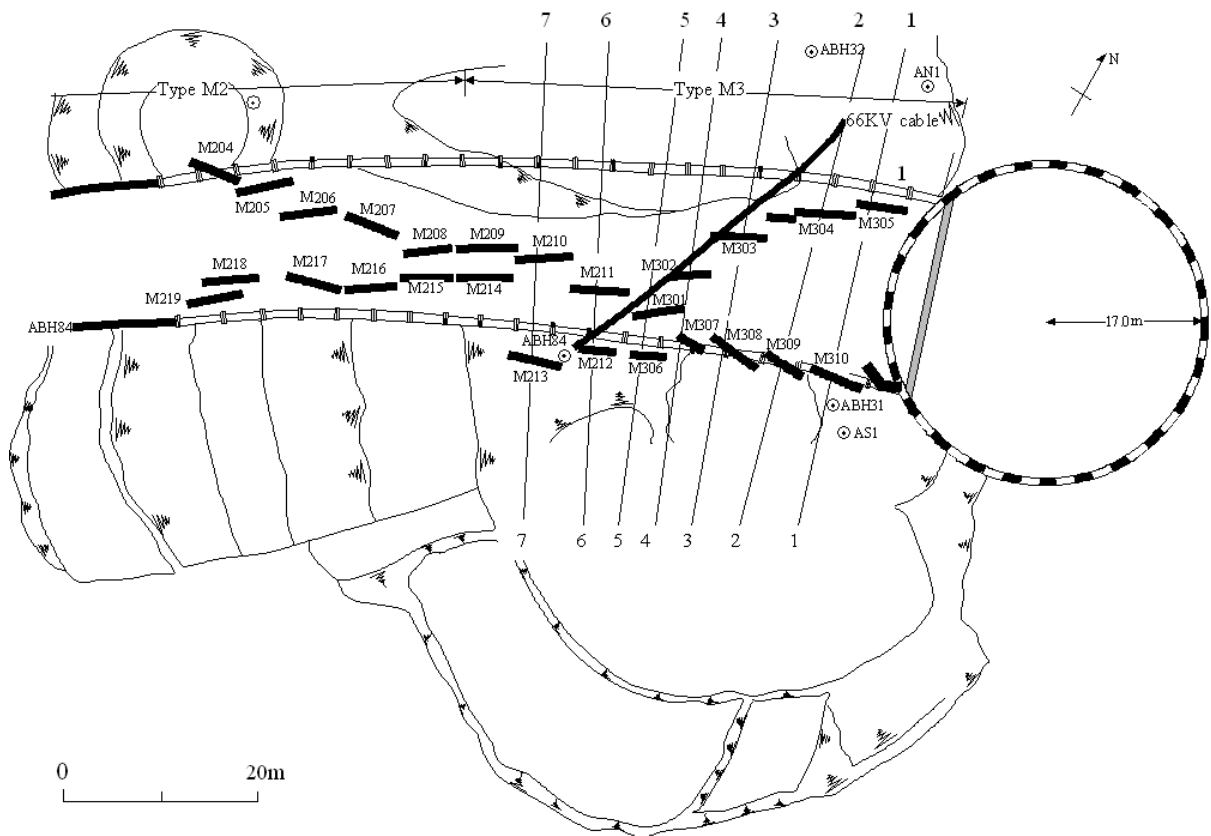
As a result of the post-incident in-situ investigations as above, it became possible to figure out approximately the states of collapse for each of the cross sections indicated in Fig. 14. Shown in Fig. 15 are probable features of the collapsed water-strut system buried within the ground which were speculated for the cross section 1, 5 and 7. It is to be noticed that in the cross section 1 and 5, the intermediate layer  $F_2$  is inclined towards the excavation as verified by the boring data at ABH31 and 32 and also at AS1 and AN1 conducted after the failure. This is indicative of the settlement of the even deep-seated soil layer involved in the slide.

Fig.14 Cross sections for which the damage features were depicted.

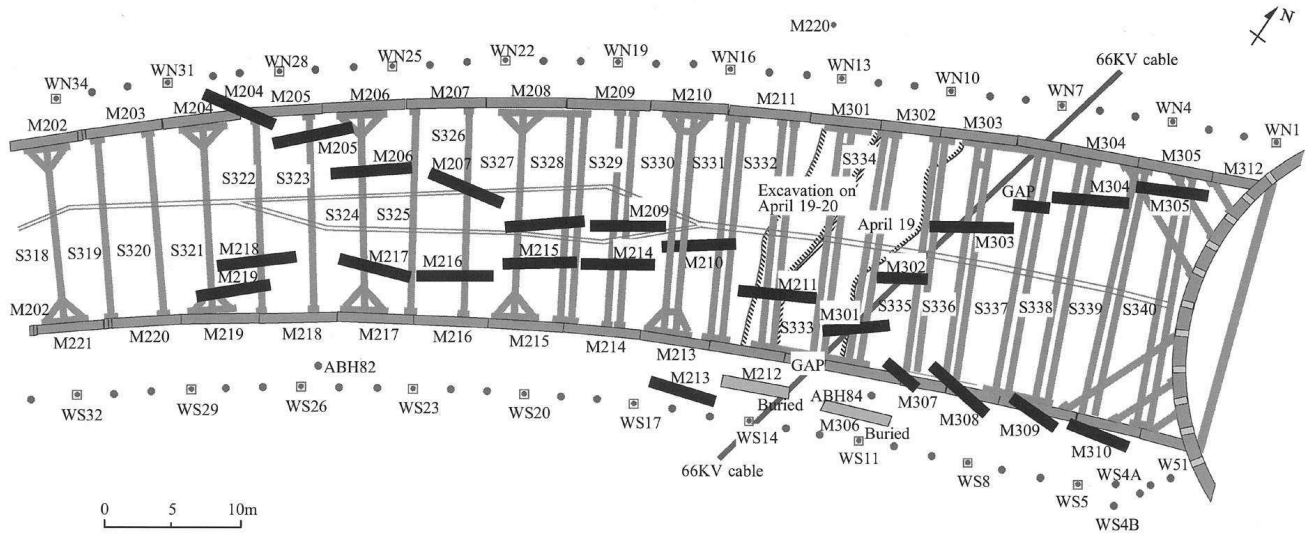
Fig. 18 Detailed arrangements of the struts, diaphragm wall panels and locations of the magnetic logging.
