An Investigation of Traditional Javanese Wooden Houses ‘Joglo’ Damaged during the May 2006 Yogyakarta Earthquake, Indonesia.

Yulianto P Prihatmaji^{1,4*}, Akihisa Kitamori², Kohei Komatsu³

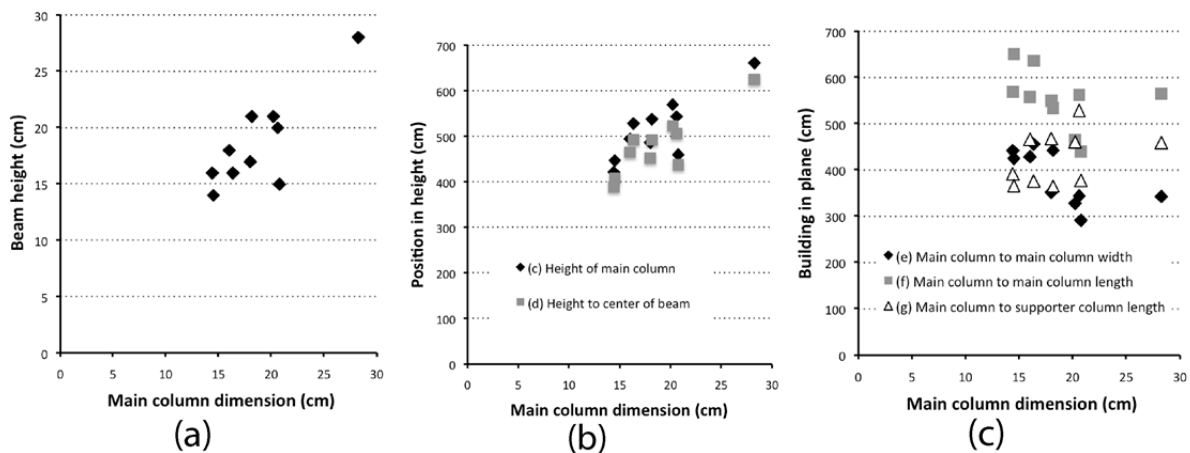
Figure 12. Relationship between each specific element's dimensions of the Joglo structure, (a) Beam height against main column dimension, (b) Position in height against main column dimension, (c) Building in plane against main column dimension.

From Figures 12a-b, a clear linear relationship can be observed between main column dimension (a) and beam height (b), as well as between height of main column (c) and height to center of beam (d). This indicates that the traditional carpenters have followed a common rule in construction to determine the dimensional proportion of the joints on the main column and its position in height. The proportion of the joints at the main column is about 1 to 1, and is located at almost 92% of the height of the column.

In addition, when comparing between main column dimensions (a) and main column to main column width (e), main column to main column length (f) or main column to supporter column length (g), there was no such relationship, as shown in Figure 12c. This means that the dimension of the column and the size of the joint at the main column have not been decided according to the scale of

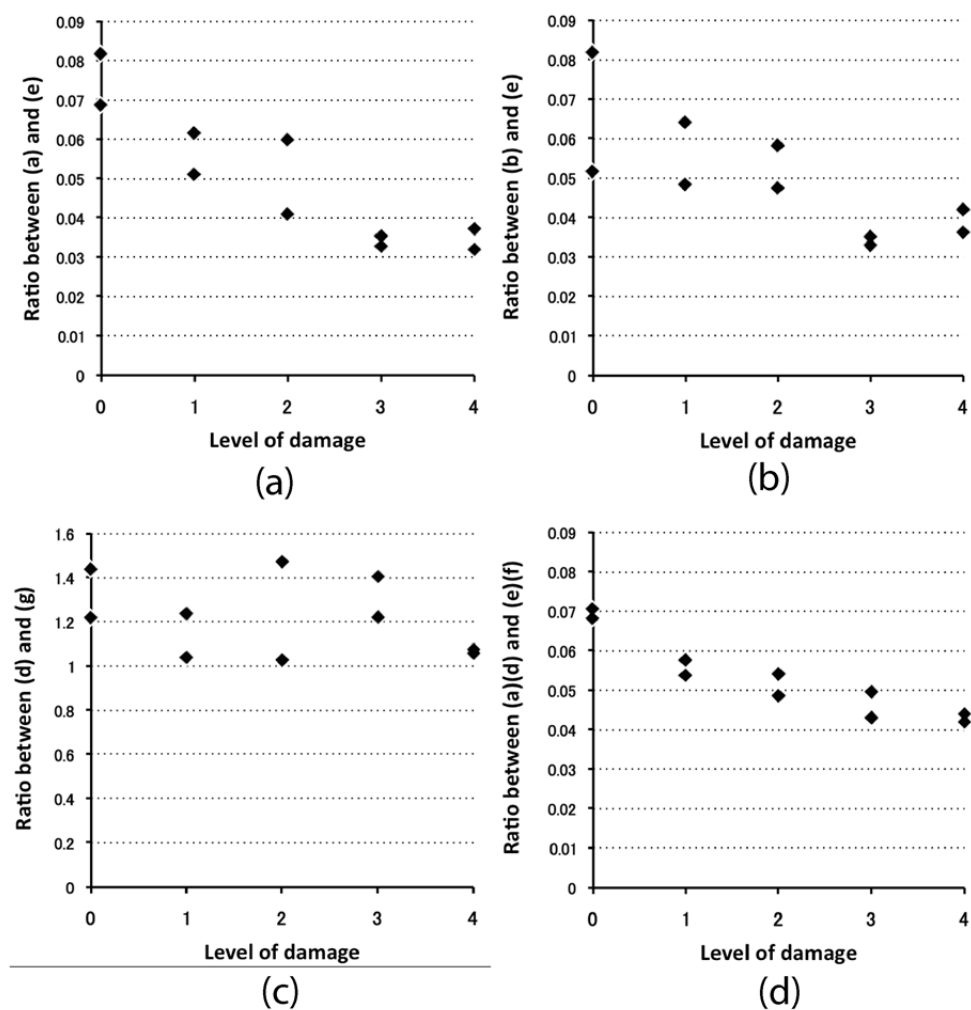
Figures 13a-c compare the structural proportion and the levels of damage. As mentioned above, the joints on the main column are the principal elements resisting against earthquake attack and its performance is size-dependent. Nevertheless the size of the joint has no relation to the scale of building. Thus the ratio in size of building can be an indicator of earthquake resistance performance of Joglo buildings.

Figure 13a depicts the relationship between the ratios of the main column's dimension and short span of the core structure and level of damage. A declining tendency can be found, which indicates that the smaller the ratio becomes, the more damaged the structure is. Similarly, figure 13b shows a minor relationship between the ratio of the beam's height and the short span of the core structure and the levels of damage. While, figure 13c shows that there is no apparent relationship between the ratio of height-to-beam center and span of side structure and the levels of damage. This means that the scale of side structures has a low influence on the damage of the core structure.

The ratio of the vertical area of the main column and the horizontal area of the core structure could give better correspondence on the level of damage, as seen in figure 13d. A clear tendency is observed, showing that the smaller the ratio is, the more damage on structures is caused. Indeed the horizontal area of the core structure corresponds to the roof weight. The roof weight compresses that area and contributes to the instability in case of lateral earthquake forces. Therefore the ratio of the vertical section area (height of the main column) of the main column and horizontal area of core structure is a reliable indicator to estimate the earthquake resistance of Joglo structures. It can be used for self-checking the Joglo structures (e.g. by the owner). Values lower than 0.05 indicate a serious danger for the structural security and a necessity of reinforcement.

Figure 13. Comparison between structural proportion ratios and levels of damage, (a) Ration between (a) and (e) against level of damage, (b) Ratio between (b) and (e) against level of damage, (c) ratio between (d) and (g) against level of damage, (e) Ratio between (a/d) and (e/f) against level of damage.
