## **Belleza Desnuda: A Conservation Assessment of the Exterior Concrete Surfaces of Henry Klumb's Parroquia Nuestra Señora del Carmen in Cataño, Puerto Rico**

# Belleza Desnuda: A Conservation Assessment of the Exterior Concrete Surfaces of Henry Klumb's Parroquia Nuestra Señora del Carmen in Cataño, Puerto Rico

BELLEZA DESNUDA: A CONSERVATION ASSESSMENT OF THE EXTERIOR  
CONCRETE SURFACES OF HENRY KLUMB'S PARROQUIA NUESTRA  
SEÑORA DEL CARMEN IN CATAÑO, PUERTO RICO

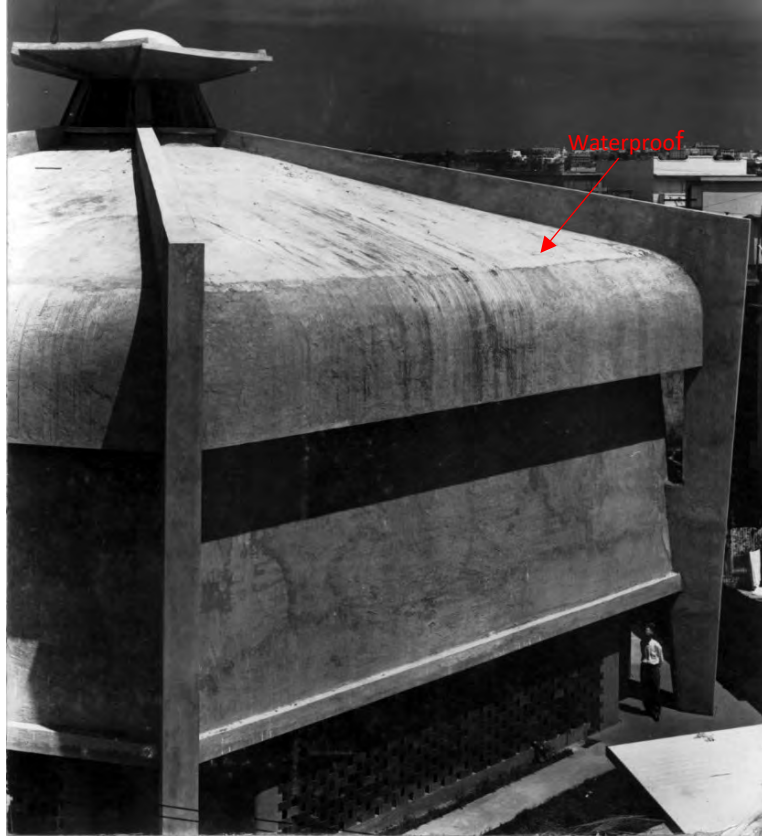
Stearox "100," manufactured by Master Builders Co., is a water-repellent admixture widely used between the 1950s through the 1970s in concrete and stuccoes. In a 1961 publication of Master Builders Co., the company describes the product as "an integral water-repellent for concrete and mortar."<sup>64</sup> The material is characterized as a "soft white powder of 100% stearic acid, atomized to mix readily with the batching water" that can be used in Portland cement stucco and cement plaster. The directions indicate that the Stearox can be mixed on-site and should not be mixed directly in the water. The company highlights some of its properties as it reduces relative absorption to 60%, preserves the concrete's strength, can be easily added to the mixed paste, and only 0.20 to 0.35 lb need to be added per bag of Portland cement for good results. Even though Klumb specified the use of Stearox "100" in the dome, its use could not be confirmed since height limitations on the church prevented sampling of that area. Still, this photo from c. 1963-1964 suggests the use of a waterproof finish in the upper sloped areas of the dome.

*Fig. 3.11* – Photo of the dome at the southeast side of the Church. Photo by Conrad Elger & Alexander Georges c. 1964-1966. Source: Henry Klumb Collection – AACUPR.

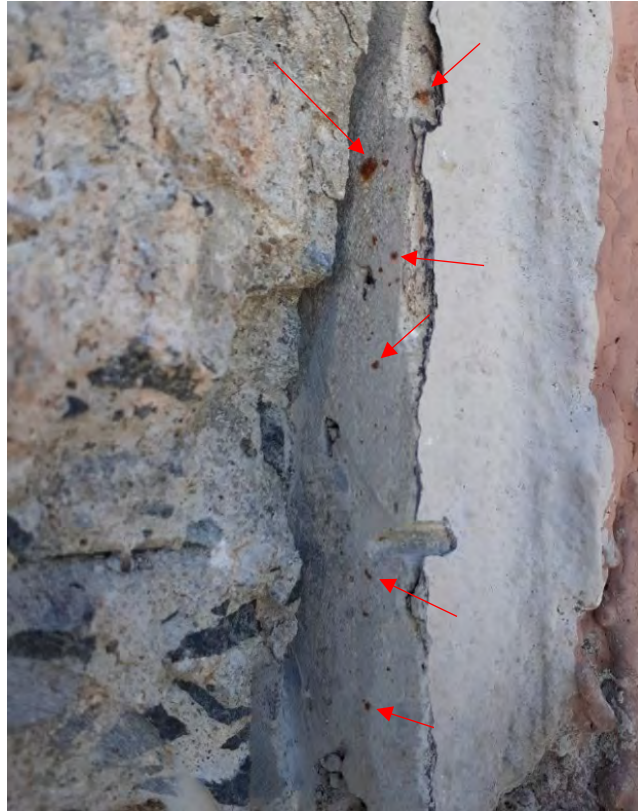
with the presence of water molecules ( $\text{H}_2\text{O}$ ) -  $\text{Fe} + \text{O}_2 \rightarrow \text{Fe}_2\text{O}_3$ , thus decreasing water penetration in the stucco by reducing porosity and permeability. Like traditional stucco, the metallic waterproofing system is usually applied in two to three coats over a concrete substrate. Followed by the usually specified preparation of substrates, the first coat can be applied with the traditional Portland cement-sand mix, and then the second coat is applied with cement-sand and the iron filings. Some 1950s handbooks recommended water spraying the surfaces to accelerate the corrosion process.<sup>69</sup> Although the system is generally applied by trowel, other methods include spray or brush.<sup>70</sup> This waterproofing system has been used extensively by engineers in infrastructure projects such as tunnels, underground vaults, swimming pools, sewage facilities, etc. It has been recognized as a successful technique since it protects the concrete substrate from moisture and deleterious chemical agents. Also, recent studies have found that the inclusion of controlled amounts of iron filings can enhance the workability, compressive tensile, and flexural strength of concrete mixes.<sup>71</sup> The addition of iron filings did not appear to change the color of the dome stucco significantly.

*Fig. 3.12* – A cross section of the dome stucco with the visible ferrous particulate fillings after sampling on the northwest elevation. Photo by Author, February 2020.

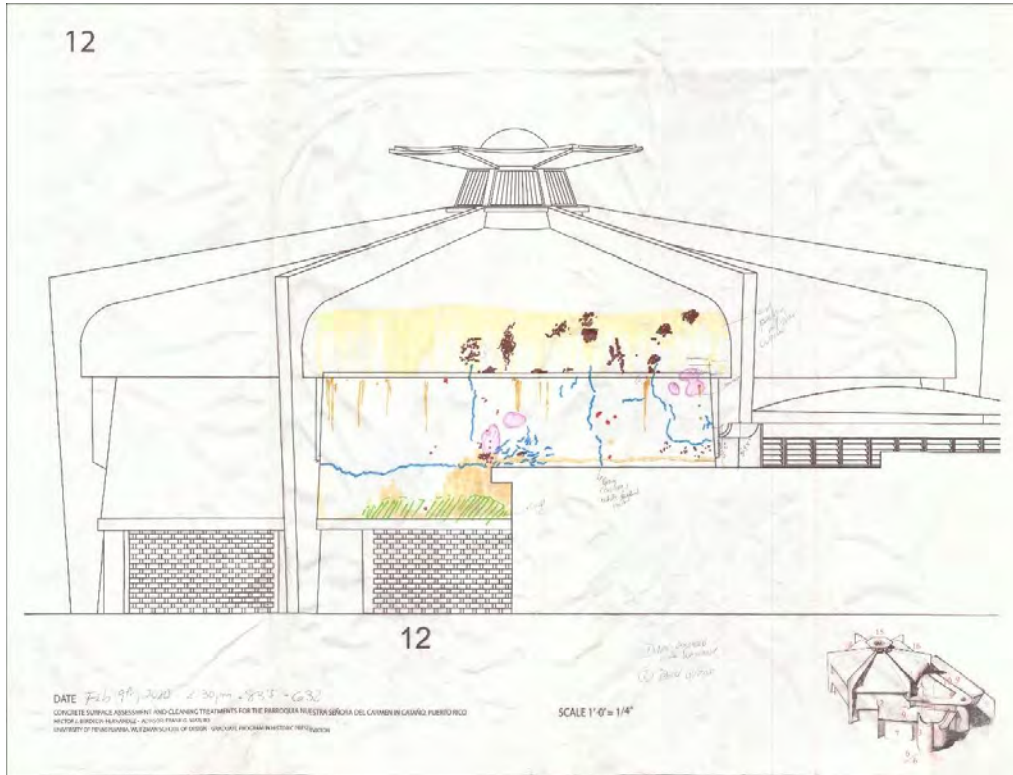
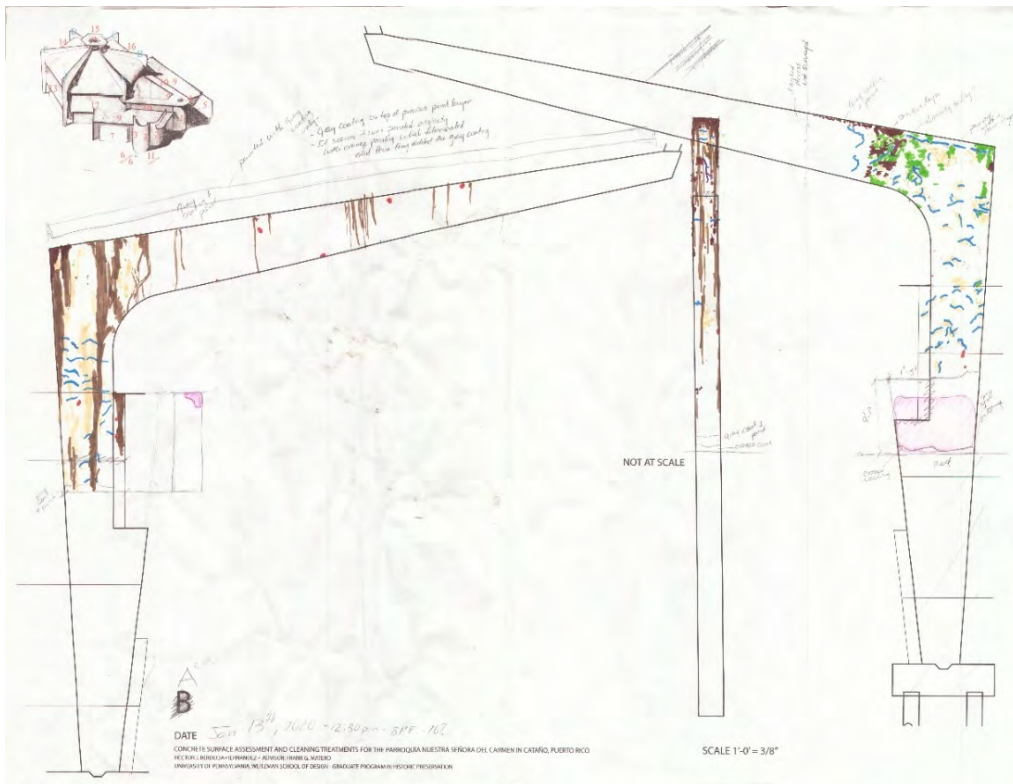
Fig. 4.6 & 4.7 – Sample elevation drawings with notes and conditions marked during the on-site assessment. Drawings by H. Berdecía-Hernández, 2020.

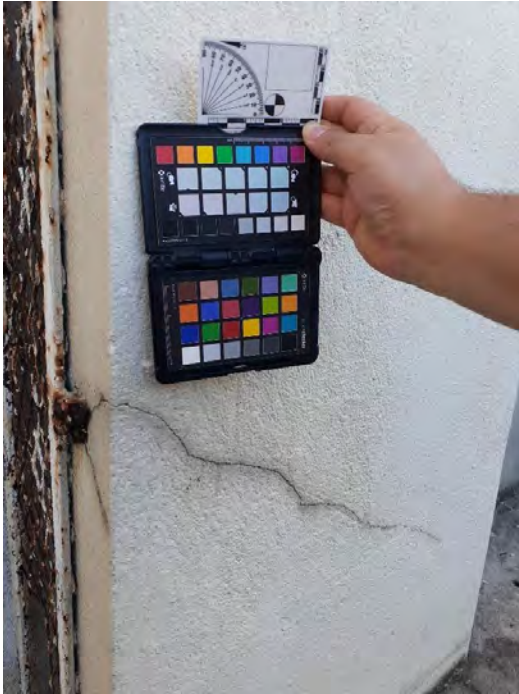
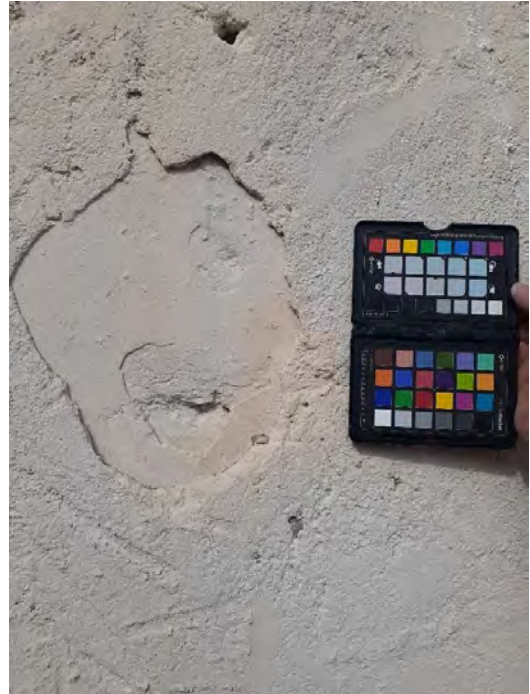
*Fig. 4.8 & 4.9 – Condition issues on precast wall (north side) and the stuccoed cast-in-place wall on the southeast side of the church. Photos by Author, 2020.*

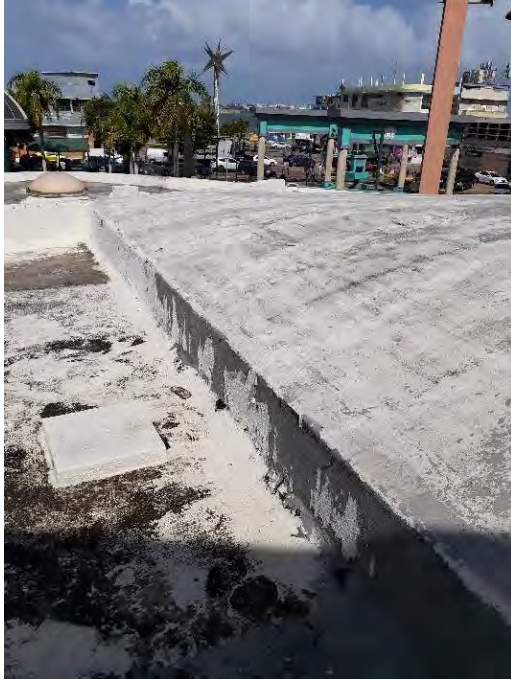
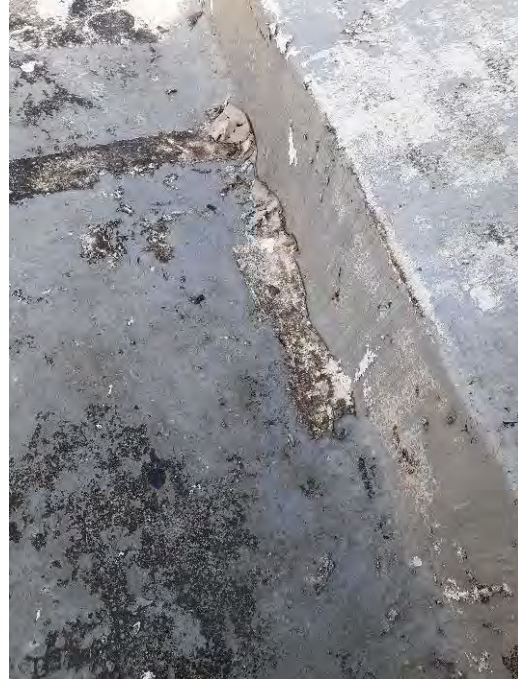
Over the last two decades, the original exposed Portland cement stucco and remaining concrete surfaces have been covered by several painting campaigns. At least two different paint colors have been identified in the north and principal elevation of the church. The roof slabs, dome, and structural columns on the roof have been painted using a modern sealing roof paint & waterproof coating. Several layers of ‘gray coating’ along with a waterproof white coating were found on the roof and dome in the on-site assessment and aerial photographs.

*Fig. 4.15 & 4.16 – Sealing roof paint & waterproof coating conditions at the Del Carmen Church. Photos by Author, 2020.*

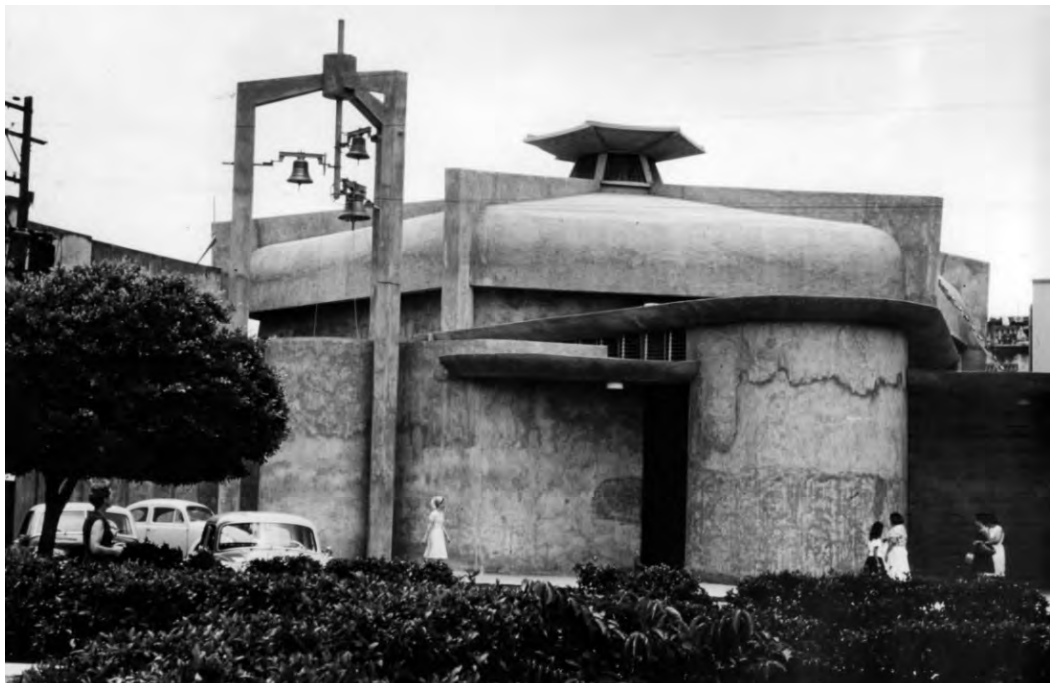
*Fig. 4.18* – Del Carmen Church before inauguration in 1963. The differences in the concrete masonry surfaces are evident vs. the dome finish. Source: Henry Klumb Collection, AACUPR.

As an example, these historical photos show how probably poor workmanship and quality control affected the exterior stucco surfaces. The application of stucco patches over the block masonry wall without control of the mix ingredients can produce curing differences between the already drying stucco and the newly applied stucco. Hot and humid tropical weather could affect the application and drying processes of these stucco patches, leading to a difference in appearance compared with the already dry stucco layer. In this process, bio-fouling, which usually attacks the wet stucco, becomes more visible because of the uneven surfaces.

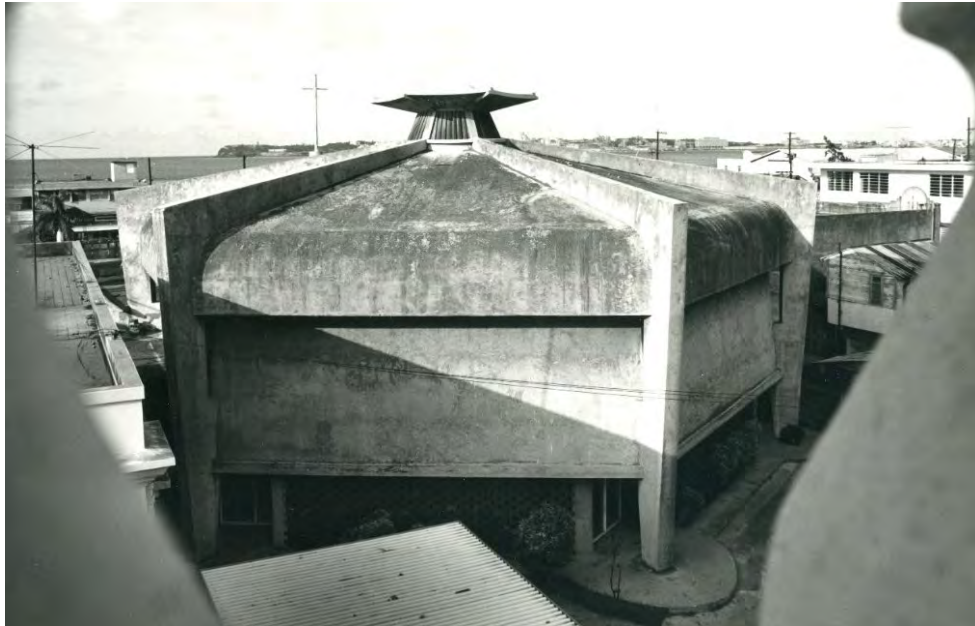
growth, usually fungal. In Puerto Rico, as a tropical archipelago with hot temperatures and high relative humidity, biological surface fouling is most common and indicates wetness areas. Surface fouling has been a constant issue in the past for the exposed surfaces of the Del Carmen Church, as seen in historic pictures since 1964.

*Fig. 4.22* – Del Carmen Church c.1965. Extensive surface fouling issues in the form of black bio-growth has been present in the dome since its early days. Source: Henry Klumb Collection, AACUPR.

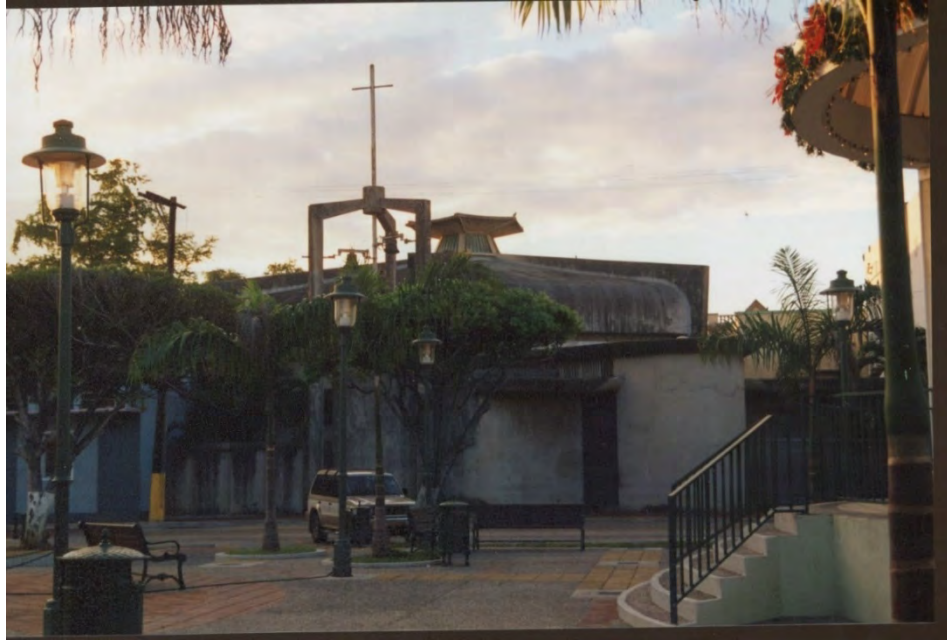
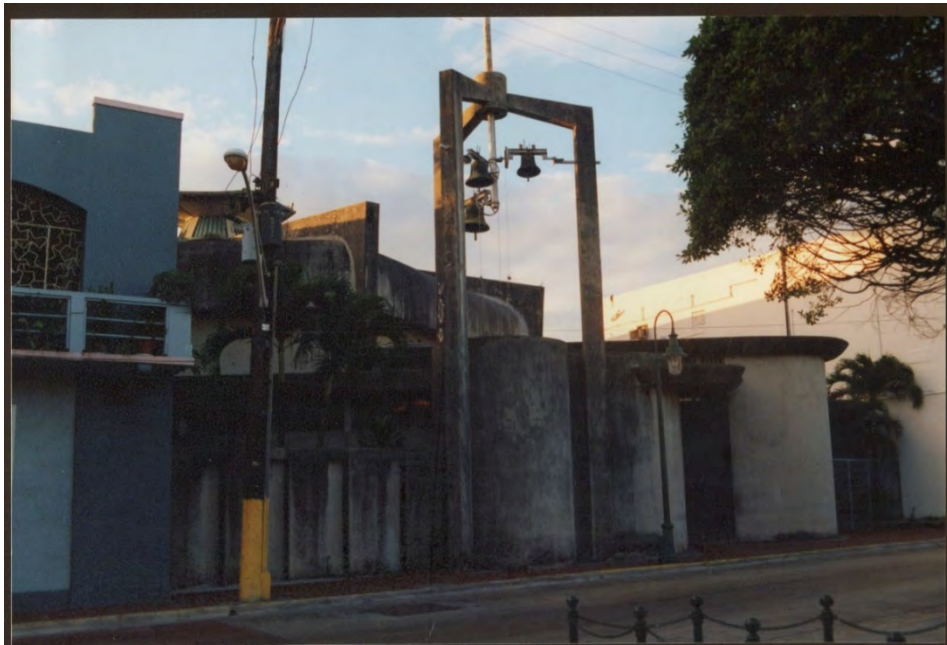
*Fig. 4.23 & 4.24 – Del Carmen Church c.1999. Atmospheric soiling and bio-growth on the exposed surfaces before the painting campaigns of the 2000s. It is possible that a coat of paint was applied in the late 1990s to address surface disfigurement. Source: R. Otero*

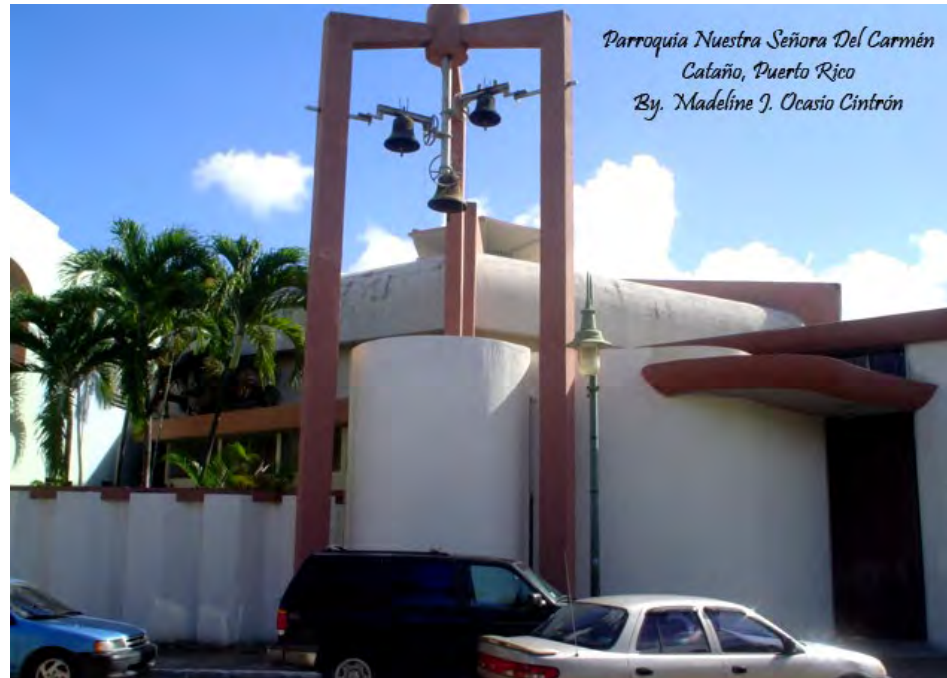
Fig. 4.25 – Del Carmen Church in 2006. All the concrete and stuccoed exterior surfaces after the second paint campaign. The first paint campaign was applied between the late 1990s and early 2000s. Source: Madeline Ocasio, Flickr.

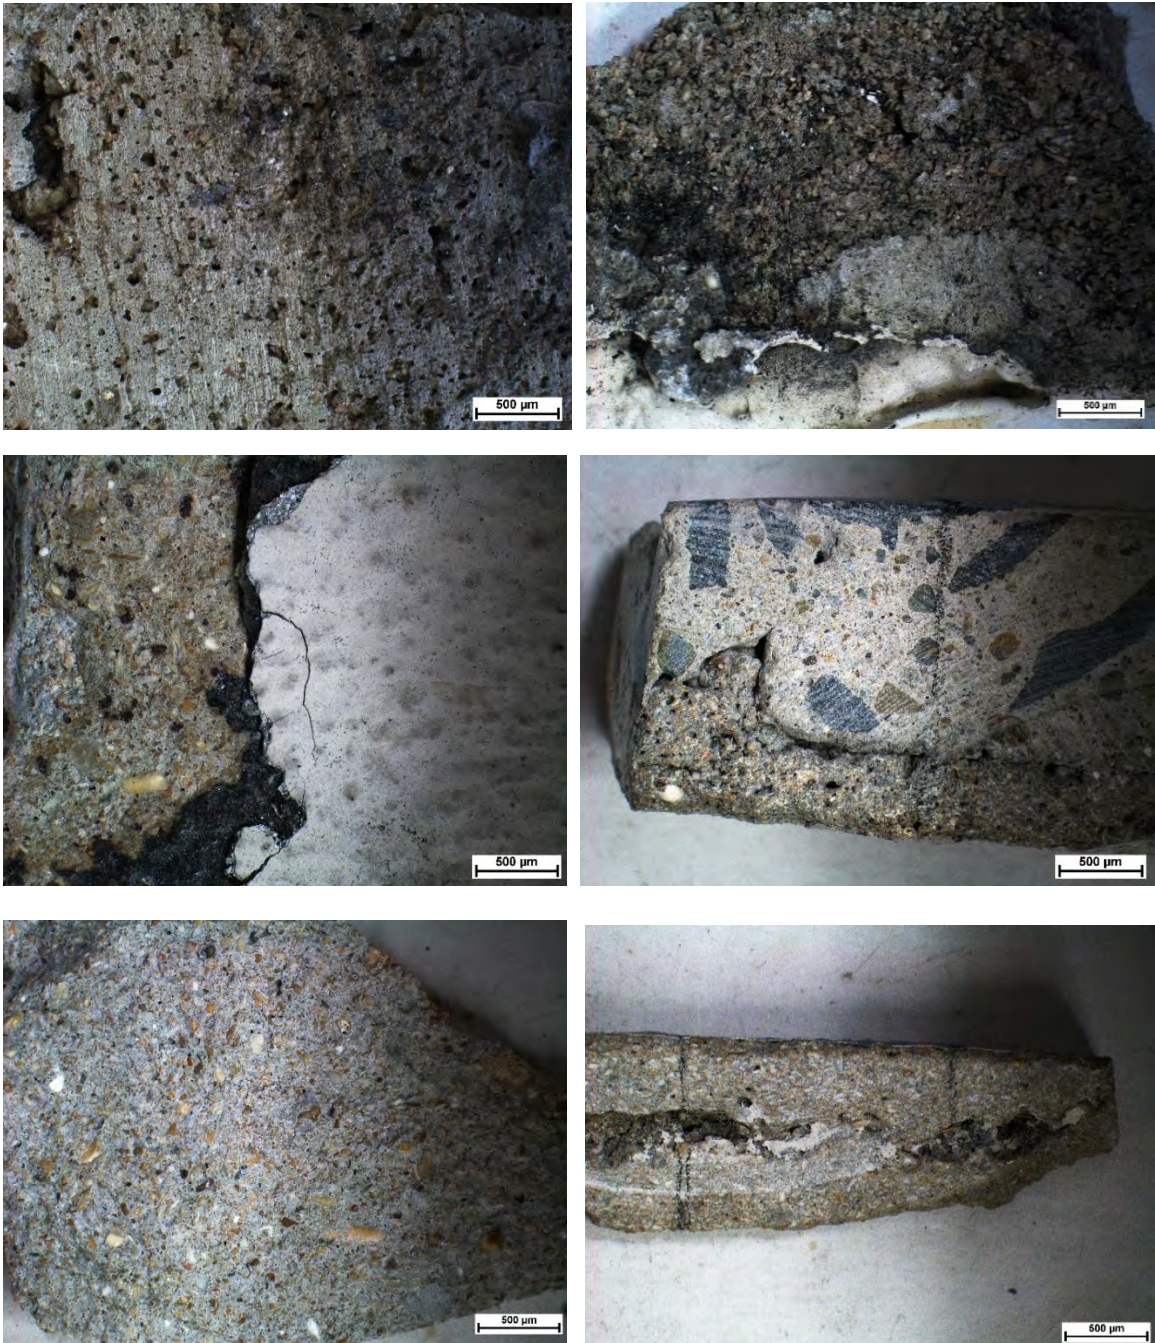
General observations include deteriorated and non-deteriorated areas (in the process) and differences in porosity on Samples 1A. Good bonding was observed between the stucco and poured-in-place concrete substrate in Sample 2B. A significant amount of fine aggregate was also observed in Sample B compared to other samples and less porosity in Samples 4; and few visible pores and no visible stucco coats were observed in Sample 5. Samples 2A and 3A showed considerable deteriorated areas.

*Figs. 5.1, 5.2, 5.3, 5.4, 5.5 & 5.6 – From left to right, Samples 1A (1A-1), 1A (1A-5), 2A (2A-1), 2B, 4 & 5. All cross-sections were examined at 1.0X, except 2A which was at 1.25X and Sample 5 at 0.71X. Photos by the Author.*

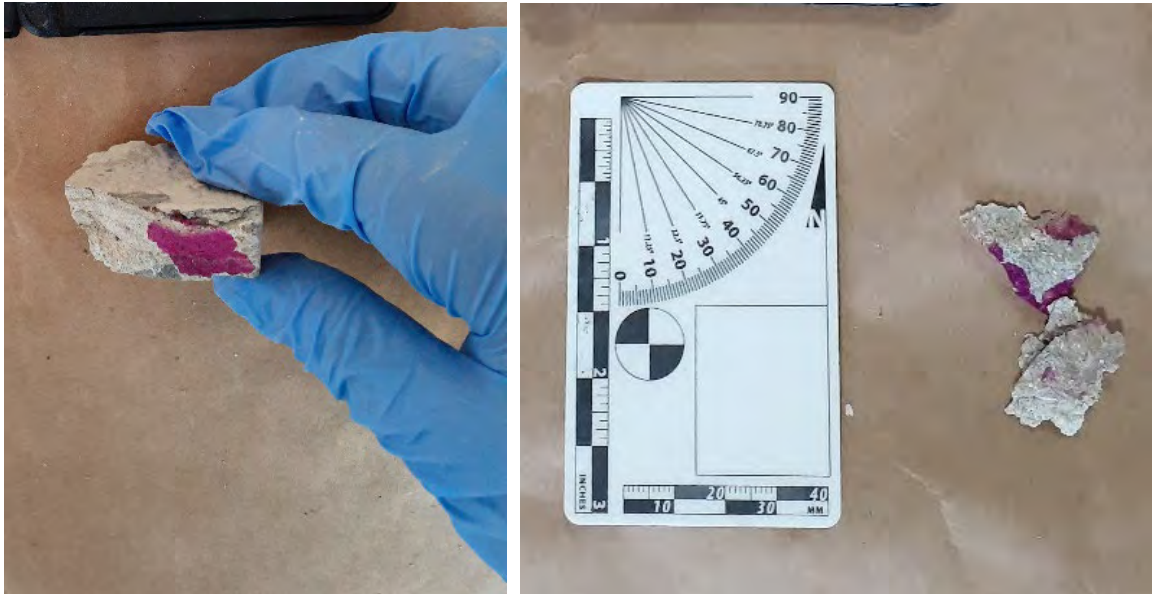
For this simple test, all eight (8) samples were analyzed. Since freshly exposed alkaline concrete/hardened stucco is required for optimal results, the samples were tested onsite approximately 30 mins after their collection. The phenolphthalein solution consisted of 1% phenolphthalein and 95% ethanol. The process consisted of applying 1 or 2 drops of the solution to the samples. Photographs are taken before and after the chemical reactions on the samples. After the test, the results indicate that 6 out of 8 samples showed full carbonation. Samples 2A showed partial and no carbonation (on the substrate), and the Sample 4-Stucco showed no carbonation at all. See Appendix 10.

*Figs. 5.7 & 5.8 – Samples 2A & 4 showing uncarbonated areas after the application of the Phenolphthalein chemical indicator. Photos by Author.*

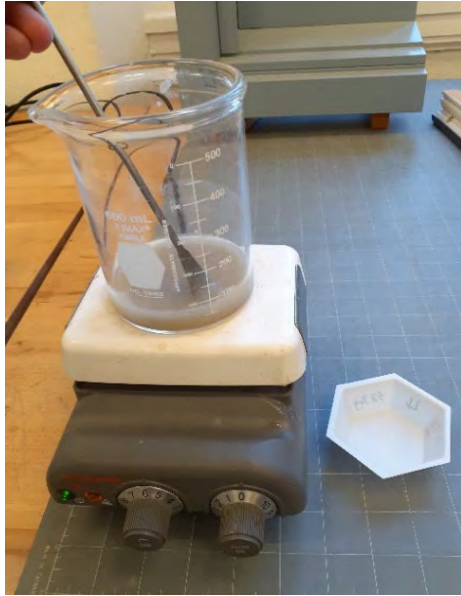
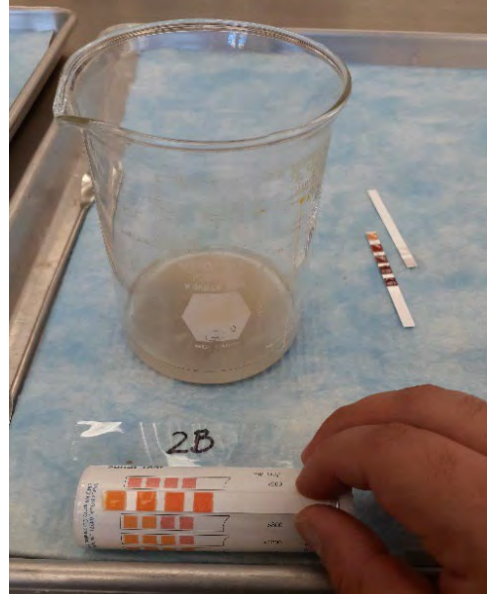
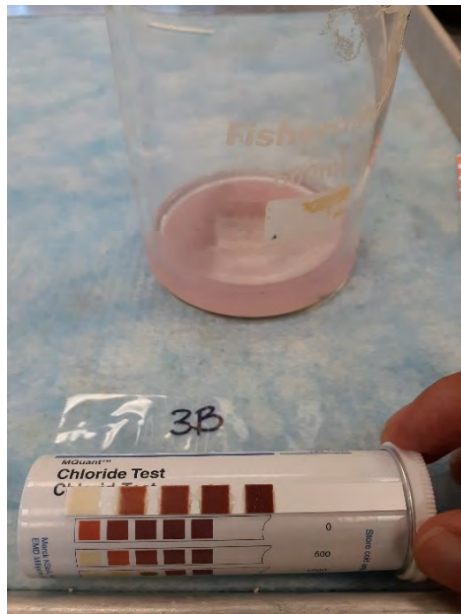
The results indicated that Samples 1A, 2A, 2B & 4 showed high sulfate content. Samples 1A & 3B showed low chloride content, while Samples 2A, 2B, and 1B showed very low chloride content. Only samples 1A & 3B showed very low nitrate levels, while the rest of the samples indicated no presence of nitrates. The deionized water in Samples 3B and 5 turned pink after the powder's addition. See Appendix 13 for specific data.

Fig. 5.10, 5.11 & 5.12 – Sample preparation process included dissolving the powder in deionized water. In samples 3B and 5 the deionized water turned pink after adding the powdered samples and after stirred by hand for 5 mins. Photos by the Author.

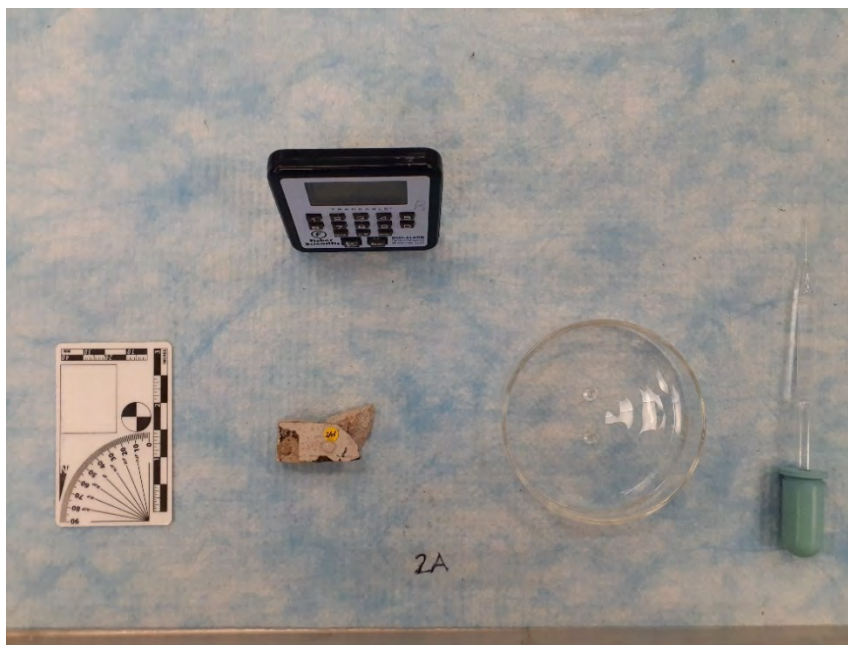
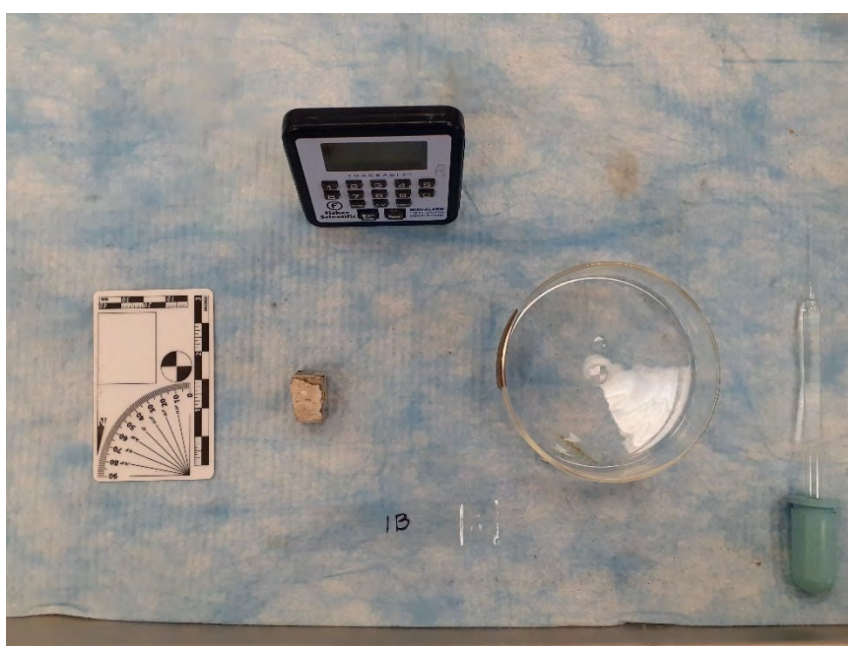
The test showed that the Shotcrete/sprayed stucco samples have higher absorption rates -between 47 seconds to 3 mins (2.6% to 5.5%) than the troweled stucco samples except for Sample 3A, which took a little longer -3 mins 10 secs (10%). The dome stucco with the iron filings and the troweled stucco on the masonry wall (Samples 2A & 4) took between 10 mins and 28 mins, respectively, showing a lower absorption rate (between 34.3% to 95.9%). The precast wall sample (Sample 5) also showed a high absorption rate with 45 seconds (between 2.5% and 6.6%).<sup>13</sup> See Appendix 11 for specific data. It is essential to mention that there are no standard test procedures for permeability on shotcrete/sprayed stucco.<sup>14</sup>

Fig. 5.13 & 5.14 – Drops were applied to samples and glass plates (as control). The time was measured with a chronometer. See Samples 2A & 1B. Photos by the Author.

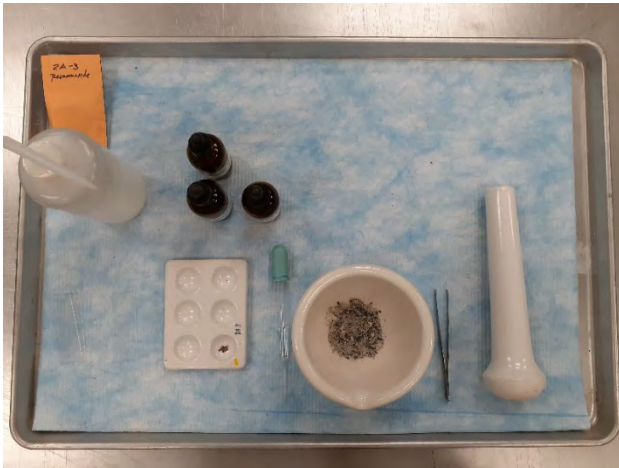
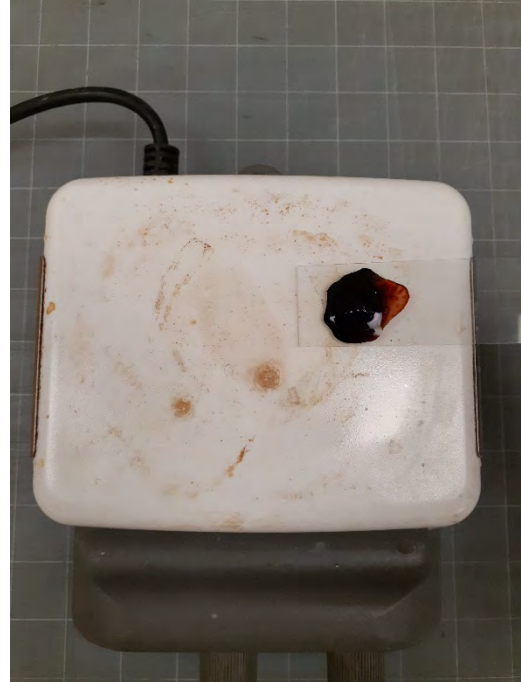
A chunk of the Sample was crushed with mortar and pestle to gather the filings for further analysis. The metallic aggregate pieces were selected for further examination with tweezers and placed on a glass plate. The metallic filings were first dissolved with a droplet of hydrochloric acid solution (HCl), then heated in a hot dish, and redissolved with two deionized water droplets. A drop of potassium ferrocyanide solution (C<sub>6</sub>FeK<sub>4</sub>N<sub>6</sub>) was added and turned to an intense Prussian blue (C<sub>18</sub>Fe<sub>7</sub>N<sub>18</sub>). Lastly, a droplet of ammonium thiocyanate solution was added to the previous solution, which produced a blood-red color due to the formation of Fe(SCN)<sub>x</sub><sup>(+3-x)</sup> ion. This last step confirmed the ferrous-metallic aggregate in Sample 2A as iron. The reaction was observed under 115x magnification with a Leica MZ15 stereomicroscope. The results of this test were completed with the results of the SEM-EDS. See Appendix 12 for additional photos.

Fig. 5.15 & 5.16 – Sample preparation for the test. Results confirmed the presence of Iron on Sample 2A. Photos by the Author.

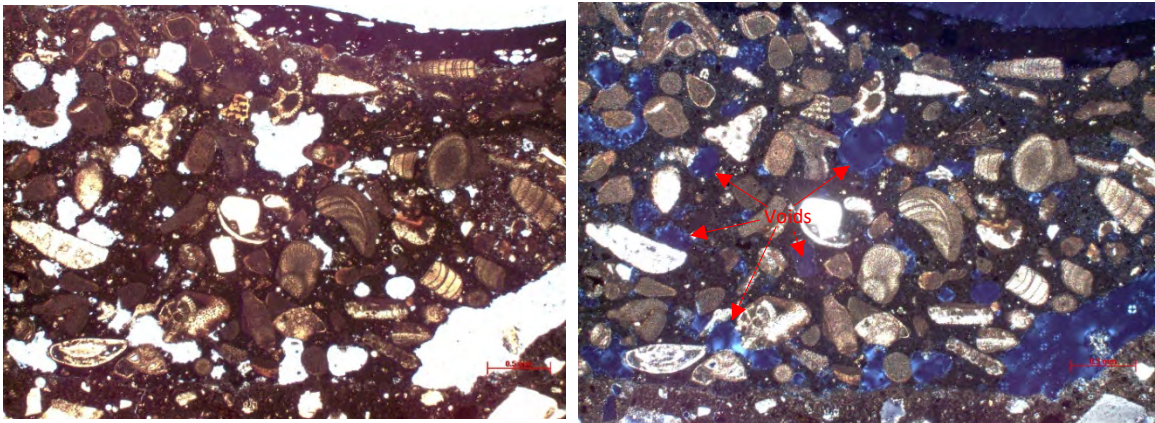
metallic-ferrous filings, and the presence of shotcrete/sprayed stucco. The shotcrete/sprayed stucco (Samples 1A-1, 1A-3, 1A-5, 1B, 2B, 3A & 3B) showed a relatively higher percentage of voids, and more non-spherical aggregate and, therefore, greater porosity and very poor compaction and a high water/cement ratio compared to the troweled stucco. A 'Dry method Shotcrete' was probably used since all these observed characteristics suggest the use of a dry mix-sprayed stucco on the Del Carmen Church. The shotcrete/sprayed Stucco also showed poorer bonding between the Stucco and concrete substrate.

Fig. 5.22 – Sample 1B which is a sprayed/shotcrete applied Stucco showing higher porosity (note blue dye).

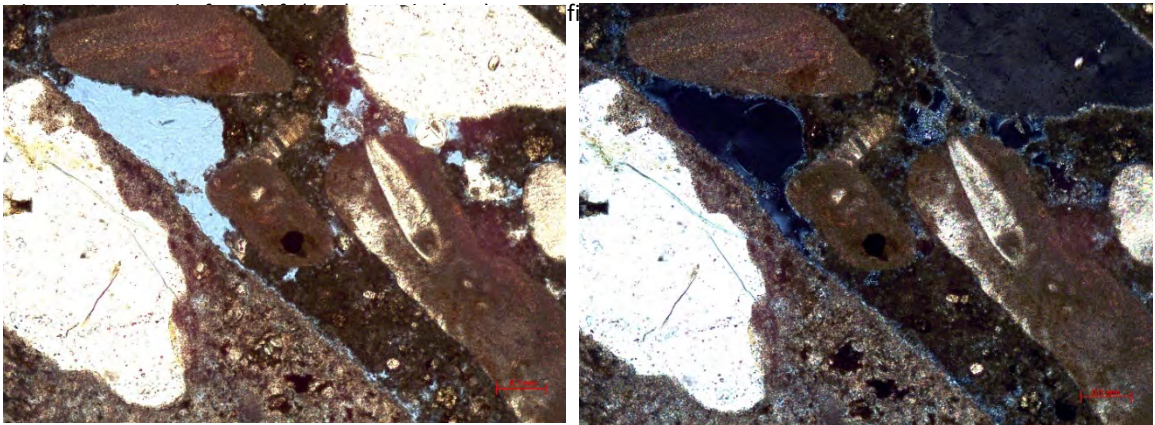
Fig. 5.23 – Sample 2B shows poor bonding between the sprayed/shotcrete stucco and the poured-in-place concrete substrate. Note the surface interface voids. Photomicrographs from left (PPL) to right (XPL), magnification at 2.5x. Photo by Author.

Both onsite investigation and petrographic analysis confirmed that the poured-in-place concrete substrates were not mechanically prepared (bush hammered or chipped) to apply the stuccos (mostly the sprayed stucco). A bonding agent/coating as a surface preparation method could not be identified on the hand specimens or the thin sections using optical microscopy, so fluorescence microscopy is recommended for this matter. The shotcrete/sprayed stucco was applied as one coat (usually 3/8-inch-thick), and the troweled stucco was applied as two layers, matching Klumb's general specifications for stucco application. The samples at the exterior structural columns (Samples 3A & 3B) showed the application of a traditional troweled, less porous stucco mix as a first coat and shotcrete/sprayed stucco as a second coat.

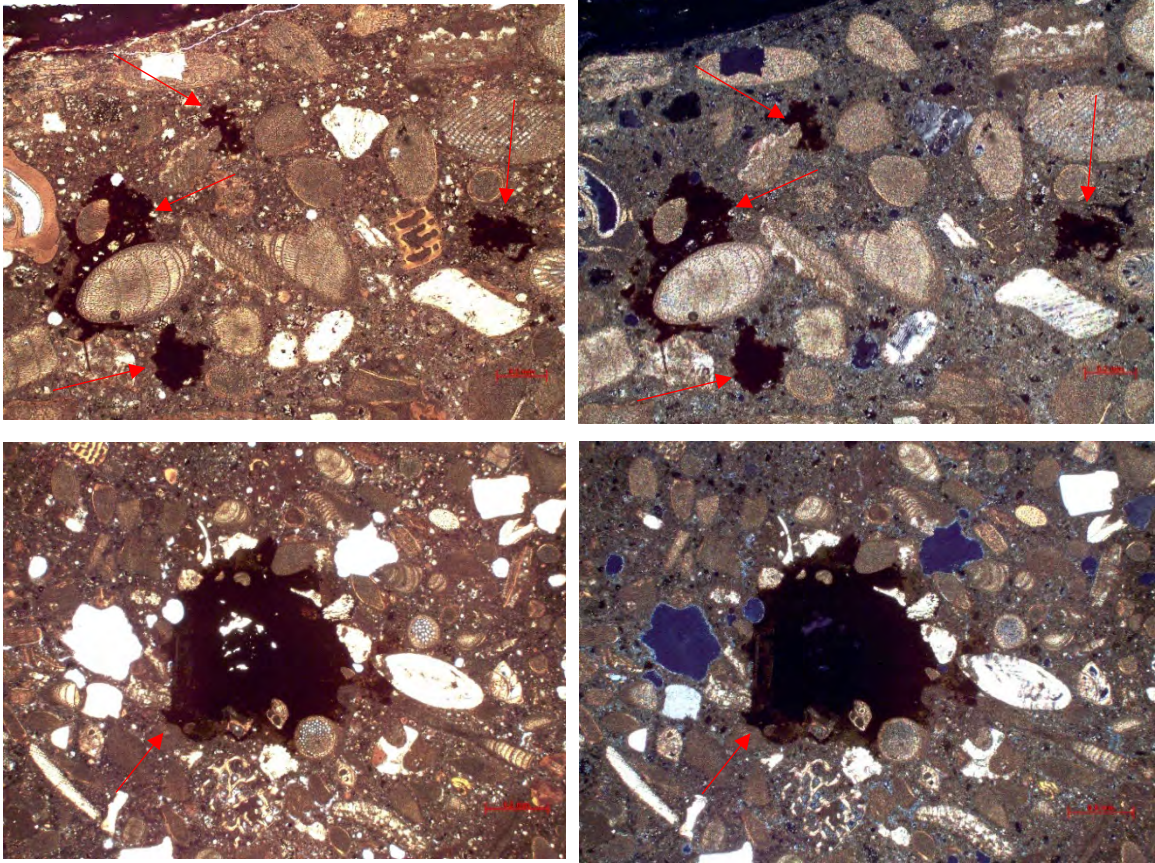
The investigation also provided key findings regarding the composition of Stucco. The preliminary confirmation of Ferrite phases in the Portland cement matrix shows the use of Grey Portland cement for all the stucco mixes and not White Portland cement as outlined initially.<sup>20</sup> Klumb specified the use of white silica sand as the fine aggregate for the mixes, but the petrographic analysis confirmed the use of a calcium carbonate biogenic beach sand, probably locally sourced and is composed of aragonite and calcite, both  $\text{CaCO}_3$ . The use of hydrated lime, as specified in the construction specifications, was also confirmed. A metallic aggregate with a particle size between 1.5 mm and 0.12 mm was identified in Sample 2A. The SEM-EDS and petrographic analysis showed that the metallic aggregate was only present and evenly distributed in the upper layer/coat of Sample 2A. In this sense, the compositions of the Stucco are not as outlined in Klumb's construction documents.

*Figs. 5.24 & 5.25 – Photomicrographs from left (PPL) to right (XPL) of the metallic ferrous (iron) filings in Sample 2A-3 at 5x magnification (Upper) and 2.5x magnification (lower). Photo by the Author.*

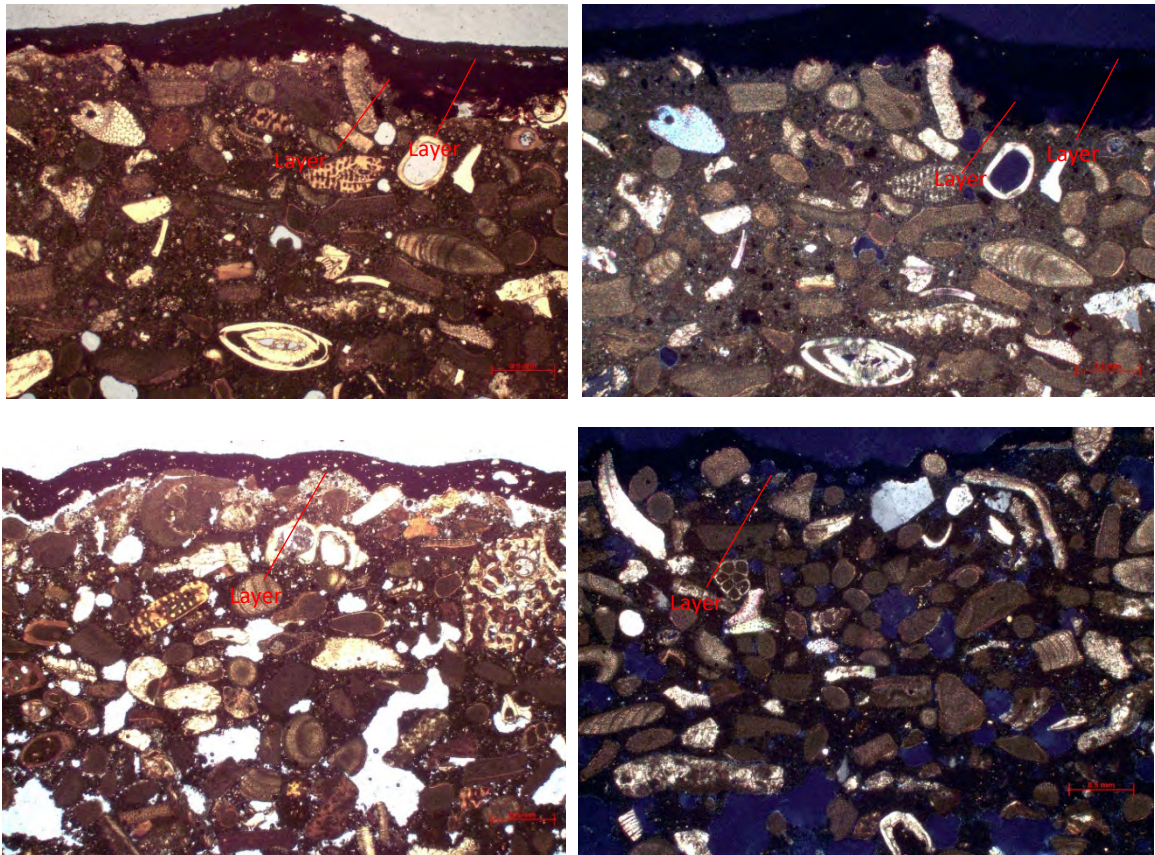
As part of the current research, surface treatments employed over the years were examined on the thin sections. Both onsite and petrographic analyses confirmed the application of between one (1) and two (2) layers of paint on the church's exterior. In the dome area, Sample 2A showed the use of an asphaltic coating and paint. Sample 5 from the precast wall showed only one layer of paint from the first painting campaign of the Church. The other areas in the building showed the confirmed application of one layer of paint. Since all the samples were taken from hidden or partially inaccessible areas, the majority showed one paint coat. Still, photos of the last decade and the onsite investigation revealed at least two-color variations on the exterior surfaces. No dirt layers were identified underneath the paint layers. The use of a pressure washer to clean the exterior surfaces

*Fig. 5.26 & 5.27 – Photomicrographs from left (PPL) to right (XPL) of Samples 2A-3 (Upper) and 1A-5 (Lower) both at 2.5x magnification. Sample 2A-3 shows two layers on the surface- one from paint and one from the asphaltic coating, while Sample 1A-5 shows only one layer of paint. Photos by the Author.*

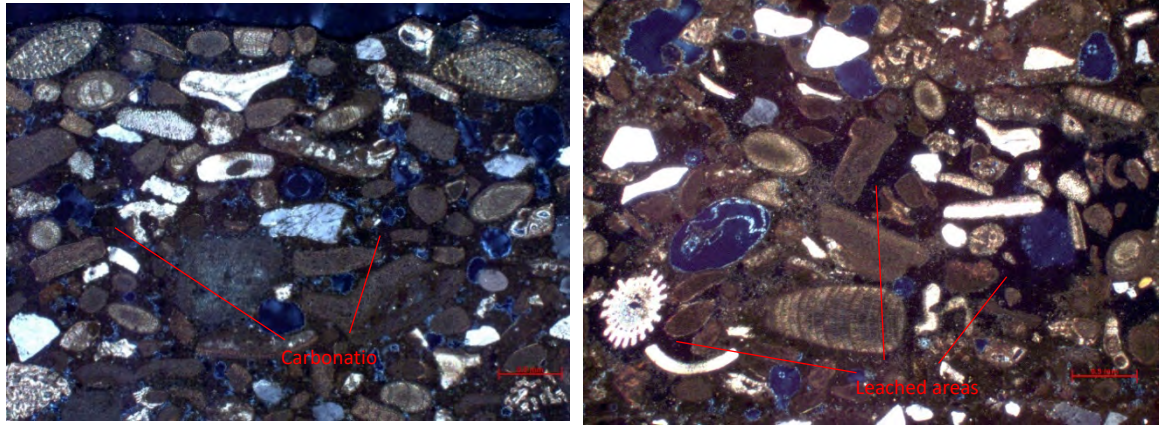
Another important aspect of the analysis was the identification of deterioration on the stucco. The investigation confirmed carbonation on both the stucco coats and some of the substrates. The Shotcrete/sprayed stucco samples showed higher carbonation rates than the troweled stucco samples, presumably due to their higher porosity. Samples 1A-1, 1A-2, 1A-5, 1B, 2B, 3A & 3B shows full and partial carbonation on the whole Stucco. Samples 2A-1, 2A-2, 2A-3, 4 & 5 show specific leached areas. The dark uncarbonated areas are extremely fine-grained, and there is no crystal large enough to distinguish between dolomite and calcite, so a more specific identification of those leached areas would require more specialized instrumentation such as x-ray fluorescence (XRF).

*Fig. 5.28 & 5.29 – Photomicrographs of Samples 3A (left) and 2A-2 both at magnification 2.5x. In Sample 3A calcium carbonate in cement is present as clumps of crystals. As carbonation advances, those crystals form a dense texture darkening the paste and can be identified better in XPL. Sample 2A-2 shows leached areas. Photos by the Author.*

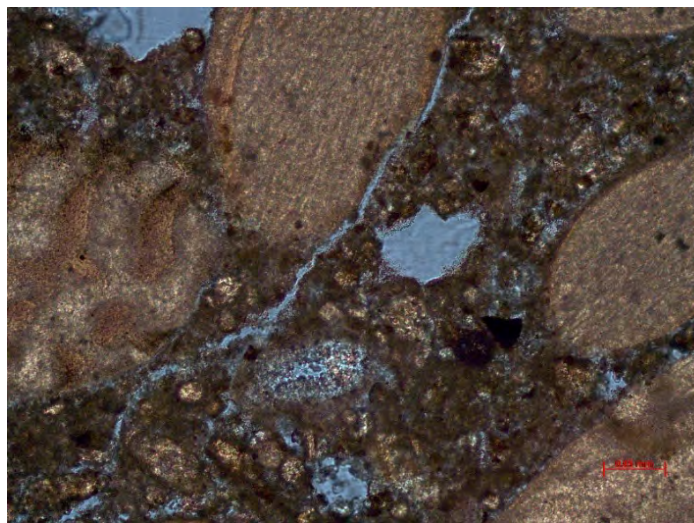
Also, shrinkage cracking, a naturally occurring process in the drying of the material, is evident. Some large cracks, as in Sample 1A-3, are the product of the sample preparation process to make the thin section. In Sample 1B, some cracks are filled with calcium carbonate deposits indicating dissolution and recrystallization of the paste.

*Fig. 5.30 – Shrinkage microcrack through the cement matrix surrounding the biogenic sand aggregate on Sample 1A-5 on PPL at magnification 20x. Photo by the Author.*

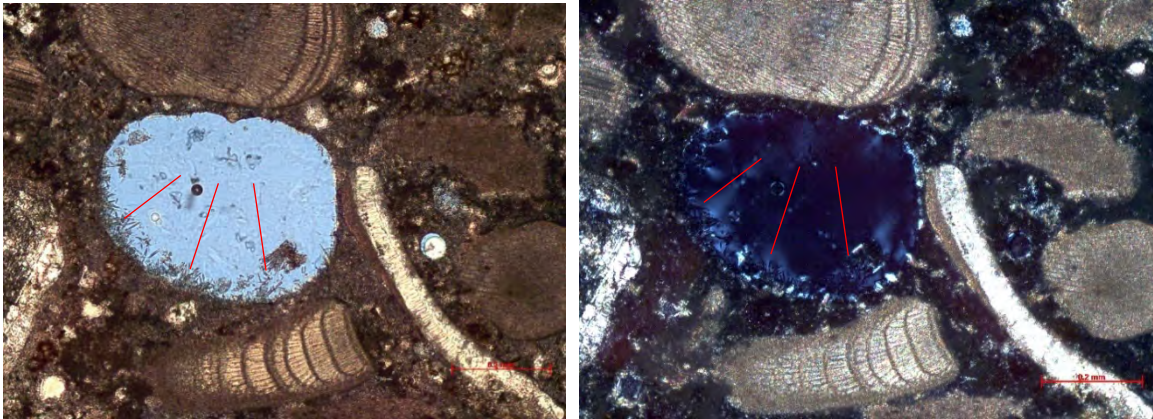
The investigation found that Sample 4-1 (Troweled Stucco from concrete masonry wall) are depleted of ettringite crystals in its voids within the Portland cement matrix, showing the possibility of delayed ettringite formation (DEF). This phenomenon occurs in concrete with high curing temperatures and where it is exposed to constant moisture

Fig. 5.31 – Photomicrographs from left (PPL) to right (XPL) of Sample 4-1 (troweled stucco) showing secondary needle-like ettringite crystals on a void. Magnification at 10x. Photo by the Author.

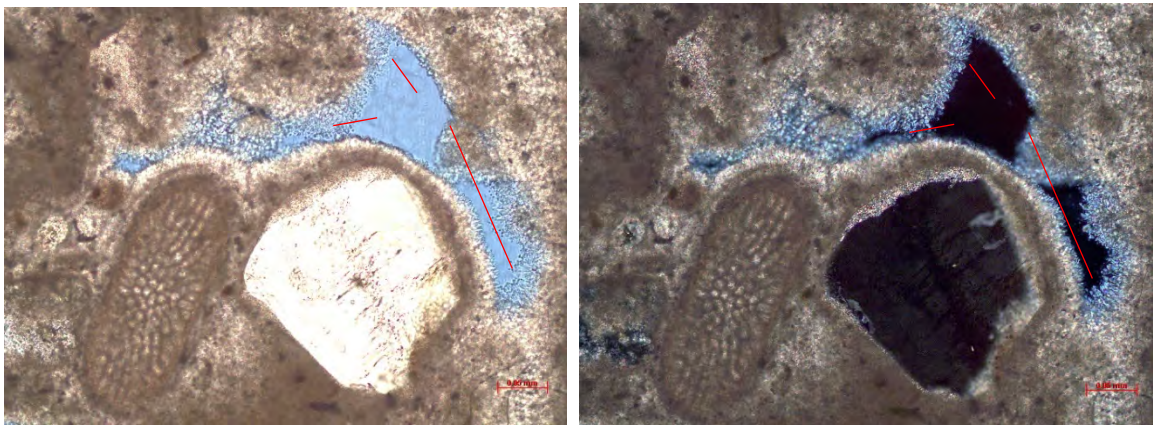
ingress. Sample 2A (Troweled Stucco with iron filings from the Dome) shows the initial formation of salt deposits in a considerable number of voids. Samples 1A (1A-1), 2B, 3A & 3B show some salt deposits and expansive secondary needle-like ettringite crystals within the matrix. These ettringite crystals were most likely formed during the hardening of concrete.<sup>21</sup> Salt deposits can also be formed as the concrete is exposed continuously to wetting and drying patterns in the harsh tropical marine environment.

Fig. 5.32 – Photomicrographs from left (PPL) to right (XPL) of Sample 3B (sprayed/shotcrete stucco) showing salt deposits and ettringite crystals on its voids. Magnification at 20x. Photos by the Author.

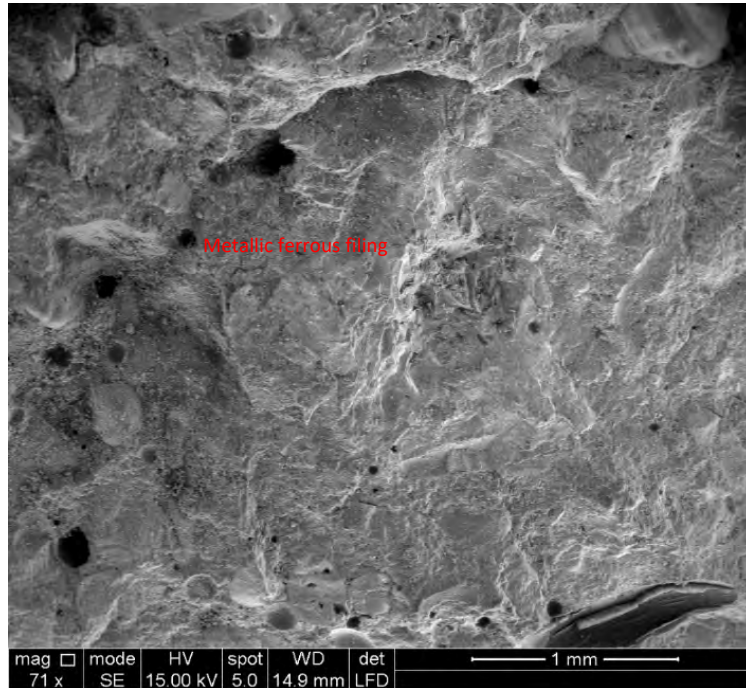
The results on Sample 2A confirmed the metallic aggregate as Iron. The black 'asphaltic' coat contains carbon, sulfur, aluminum, and magnesium, while the paint coating is confirmed to be titanium-based. The cross-section is homogeneous, containing high concentrations of oxygen, calcium, and chlorine, the latter presumably from the maritime environment. The results on Sample 3A are also homogeneous, containing high concentrations of oxygen, carbon, and calcium as expected. The paint coating was confirmed to be titanium-based, and a high amount of silicon was found.

Fig. 5.40 – SEM micrograph on a metallic ferrous filing which confirmed to be Iron at .71x magnification using secondary electrons in Sample 2A-1. Photo by J. Ford.
