## **Belleza Desnuda: A Conservation Assessment of the Exterior Concrete Surfaces of Henry Klumb's Parroquia Nuestra Señora del Carmen in Cataño, Puerto Rico**

# Belleza Desnuda: A Conservation Assessment of the Exterior Concrete Surfaces of Henry Klumb's Parroquia Nuestra Señora del Carmen in Cataño, Puerto Rico

BELLEZA DESNUDA: A CONSERVATION ASSESSMENT OF THE EXTERIOR  
CONCRETE SURFACES OF HENRY KLUMB'S PARROQUIA NUESTRA  
SEÑORA DEL CARMEN IN CATAÑO, PUERTO RICO

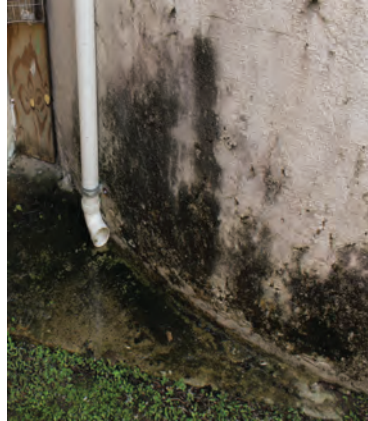
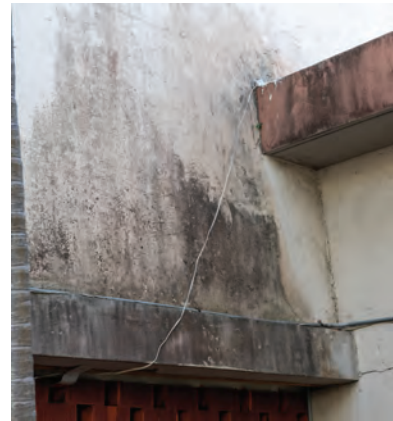
### BIO-FOULING

Blackening of the surfaces due to the deposition of airborne pollution or other materials. Very thin layer of deposit.

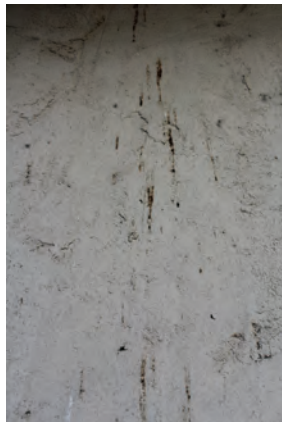
### BIRD GUANO

Accumulated excrement of pigeons, seabirds and bats. There is a considerable presence of pigeons and nests in the site.

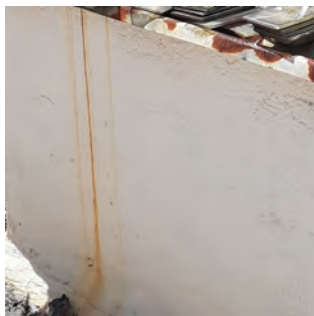
### METALLIC STAINING

Colored staining derived from the oxidation/weathering of metallic sources either intrinsic or extrinsic. Typically, yellow (iron).

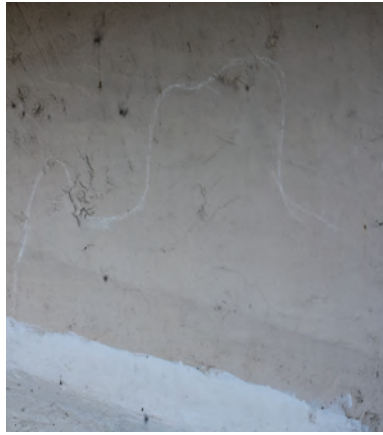
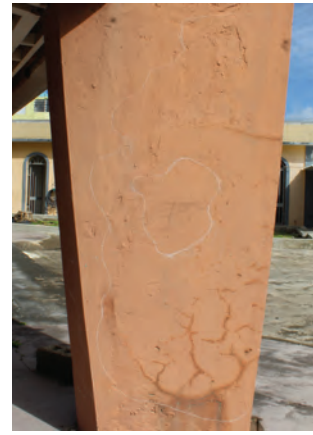
### DETACHMENT/DEBONDING OF RENDER

Hollowness, poor or loss of adhesion of the render to the concrete substrate (wall). These areas were marked with white chalk over the surfaces.

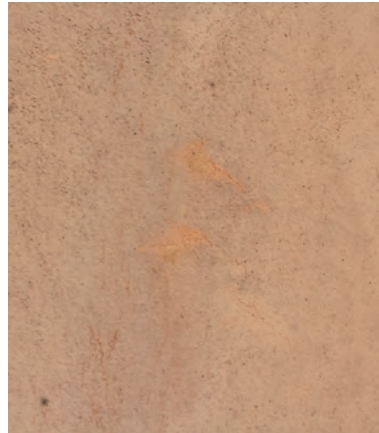
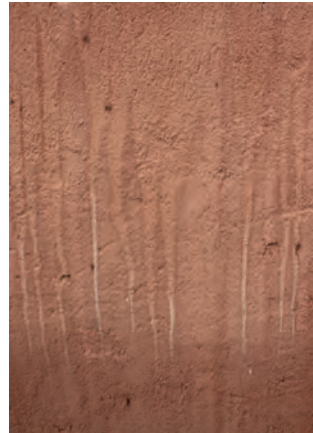
### DISCOLORATION

Discoloration of paint layers in render surfaces on selected areas.

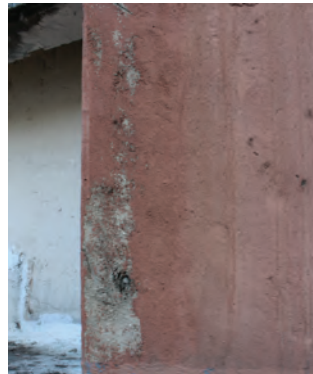
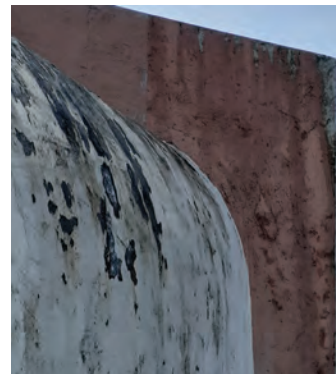
### PEELING OF PAINTING

Peeling (shedding off ) of paint coatings. Usually, the paint forms a nonbreathable coating. Moisture accumulation due to presence of a coating with limited vapor permeability leads to the separation of paint from the substrate.

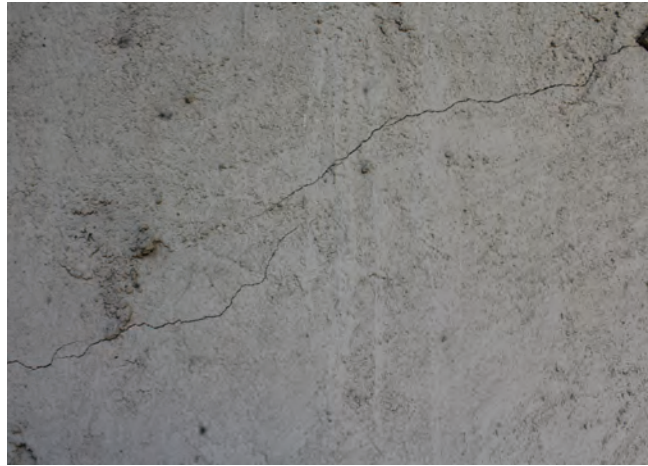
#### HAIRLINE CRACK

Hairline or thin cracks with opening less than 1/32" and are barely perceptible.

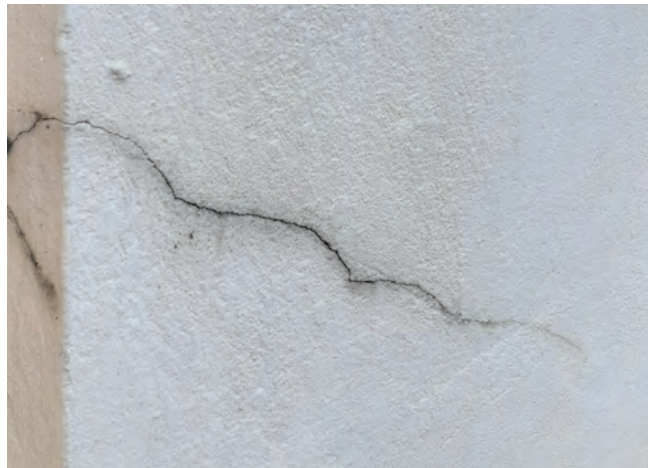
#### SLIGHT CRACK

Slight (Small) cracks are those with opening between 1/32" and 3/16"

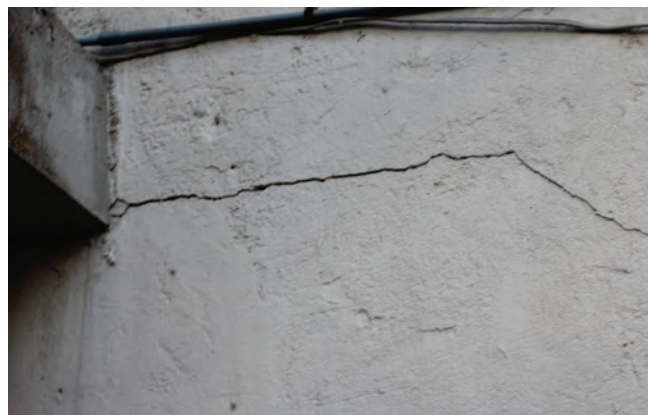
#### LARGE CRACK

Cracks larger than 3/16"

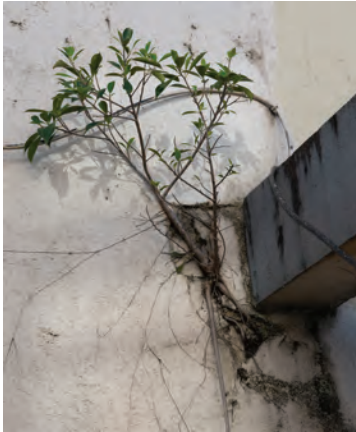
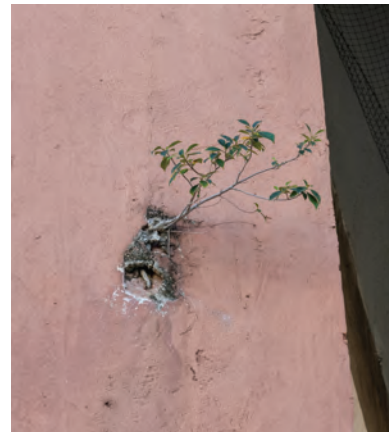
### MACROFLORA

The presence of large leafy plants and ferns on the building. Associated to open joints and areas containing enough moisture to sustain plant life.

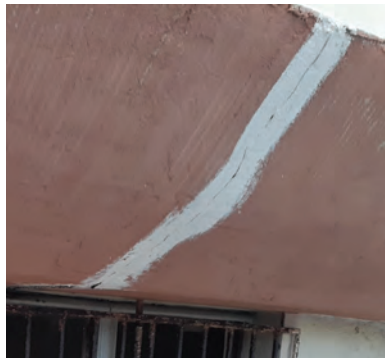
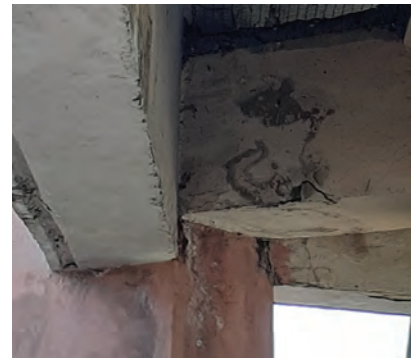
### PREVIOUS REPAIRS

A mortar or resin-based treatment system used as a surface repair for spalls, cracks and losses.

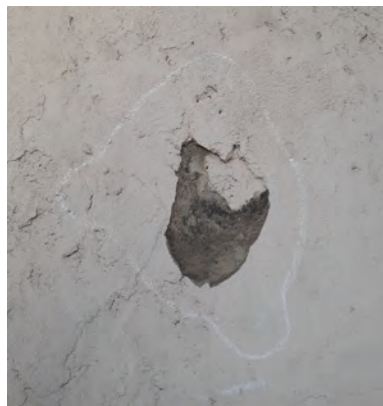
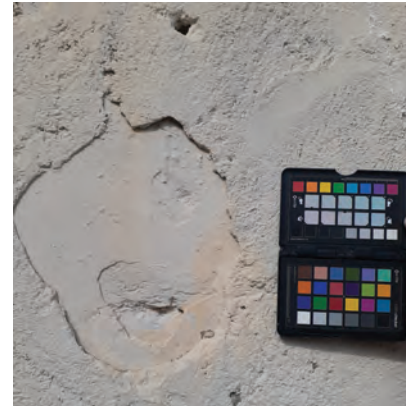
### SURFACE LOSS / LOSS OF RENDER

Loss of render along the exterior surface layers (of various sizes and depth).

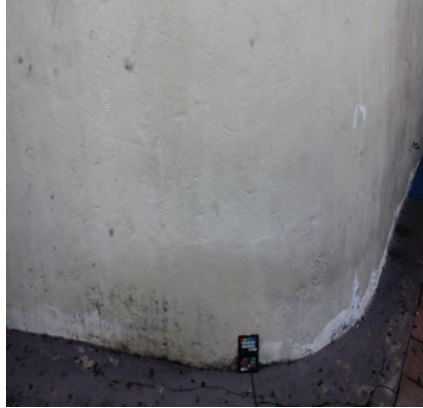
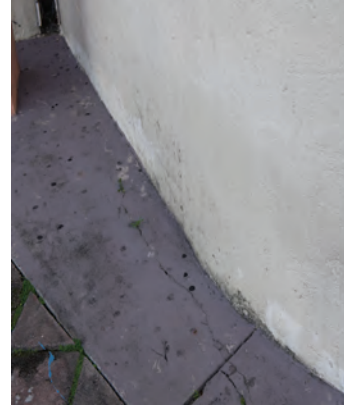
### RISING DAMP DAMAGE

Rising damp is the upward movement of moisture through walls and some-times floors by capillary action from below the ground. It can rise to one or more walls, depending on the masonry type, water table level and evaporation rate.

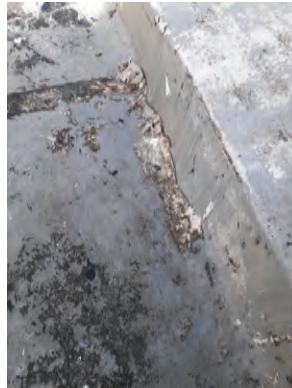
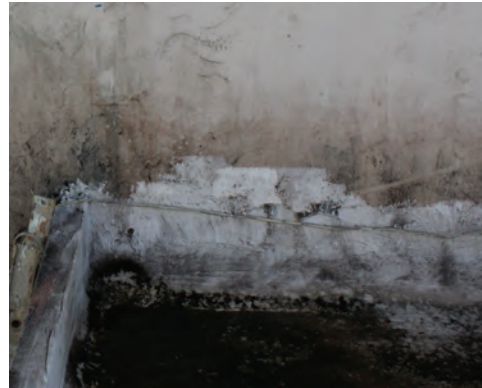
### ROOF COATING

Monolithic, fully bonded, liquid based roof coating that forms a rubber-like elastomeric waterproof membrane. The coating is found almost all over the roof and dome.

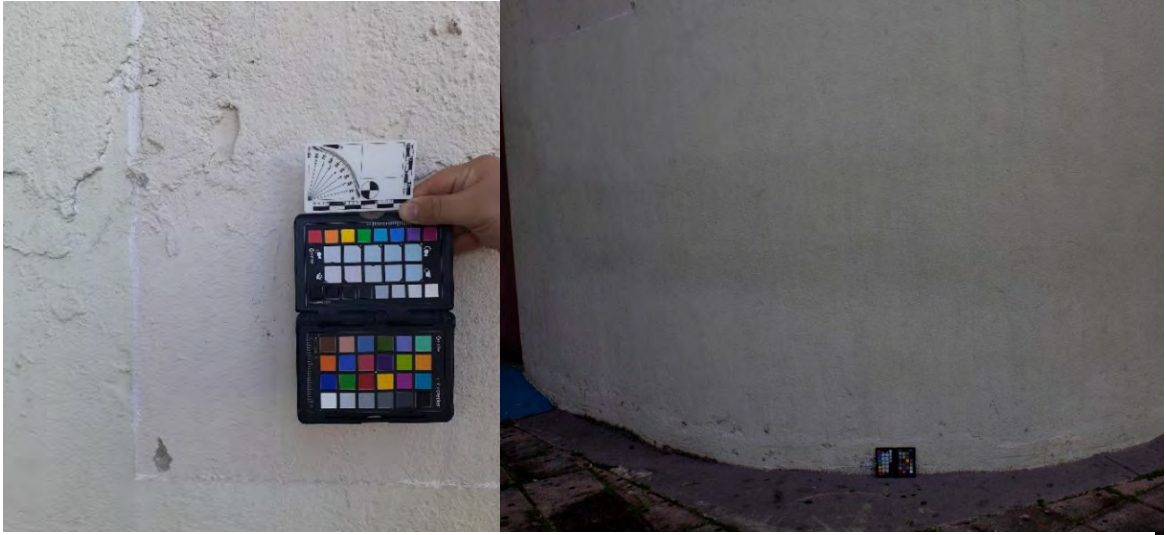
*Figs. A2.2 & A2.3 – Scaling and rising damp issues on Elevation 1. As the main entrance to the church, a big sign was originally installed using screws and eventually removed. At least two paint coatings could be identified in the wall. Photos by Author, 2020.*

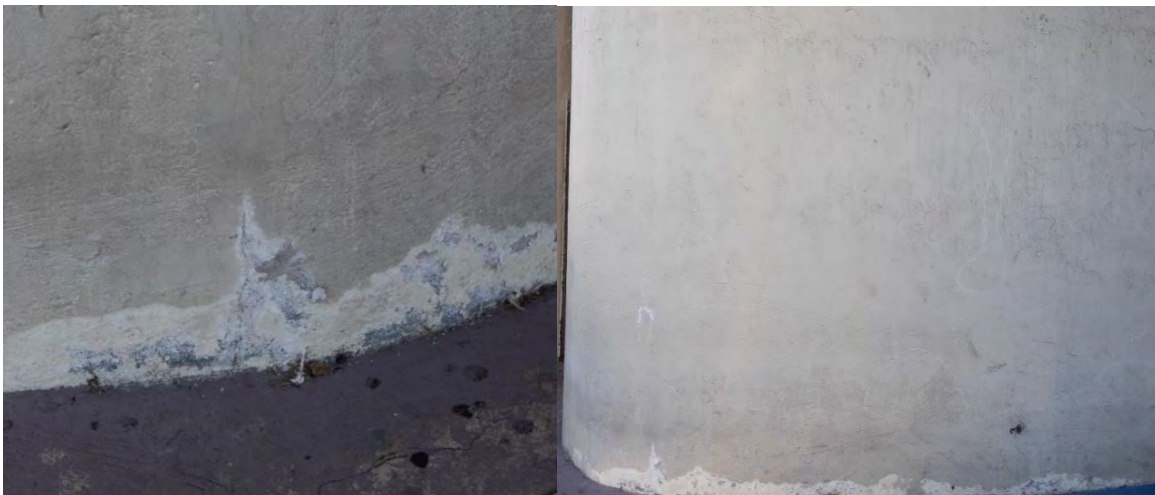
*Figs. A2.4 & A2.5 – Rising damp, discoloration and paint peeling issues on Elevation 2. Photos by Author, 2020.*

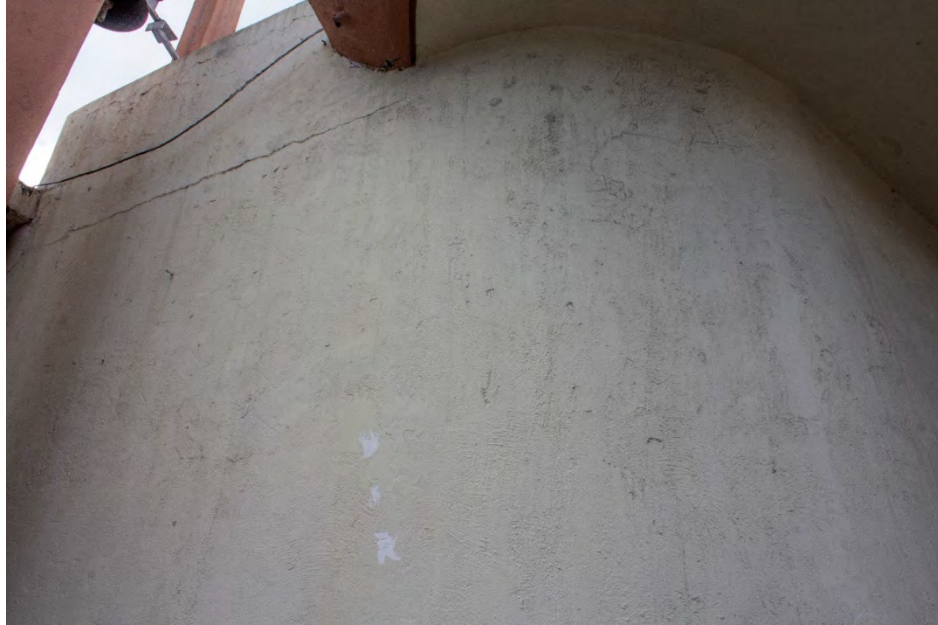
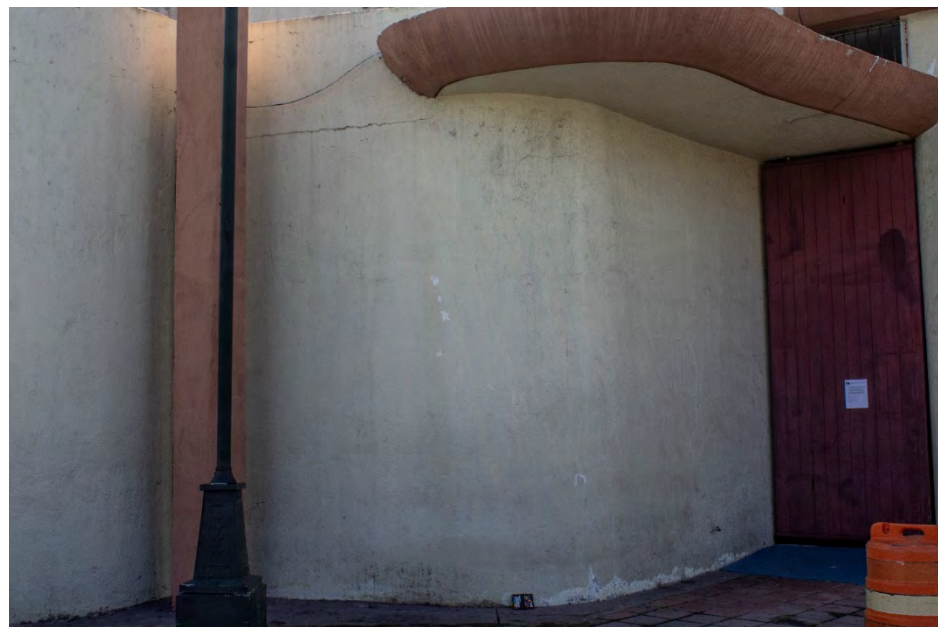
*Figs. A2.6 & A2.7* – The wall is also affected by a small drainage in the curved eave which manage rainwater directly to the wall and concrete floor. A continuous horizontal crack in the wall surface is a sign of steel reinforce corrosion on the concrete masonry. Photos by Author, 2020.

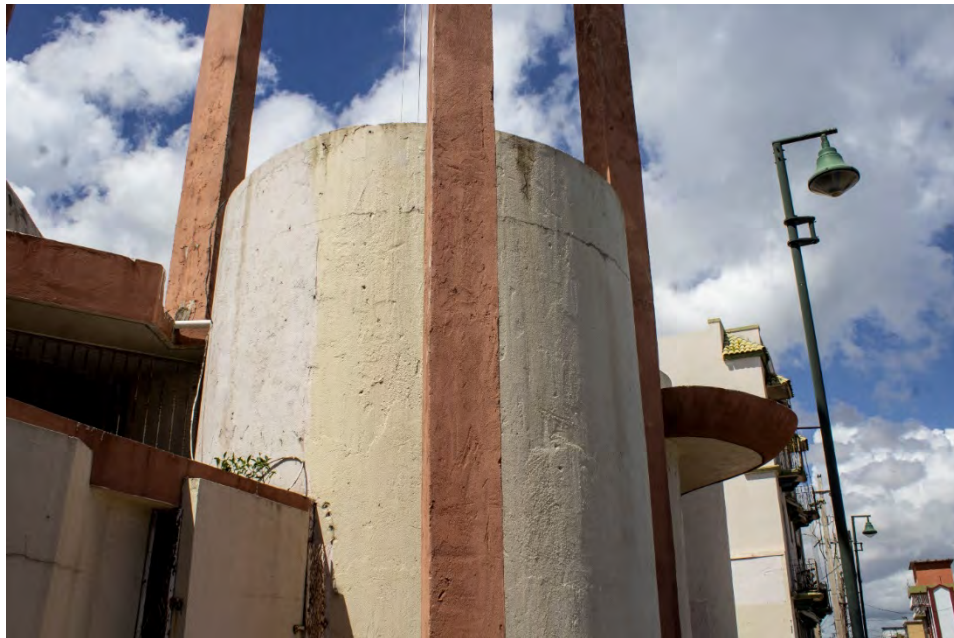
*Fig. A2.9* – In elevation 3 two different paint coating applications can be found. A horizontal continuous slight crack along the concrete masonry wall show signs of steel reinforced corrosion. A vertical crack stained by mold is also seen on the top part of Side A. Photos by Author, 2020.

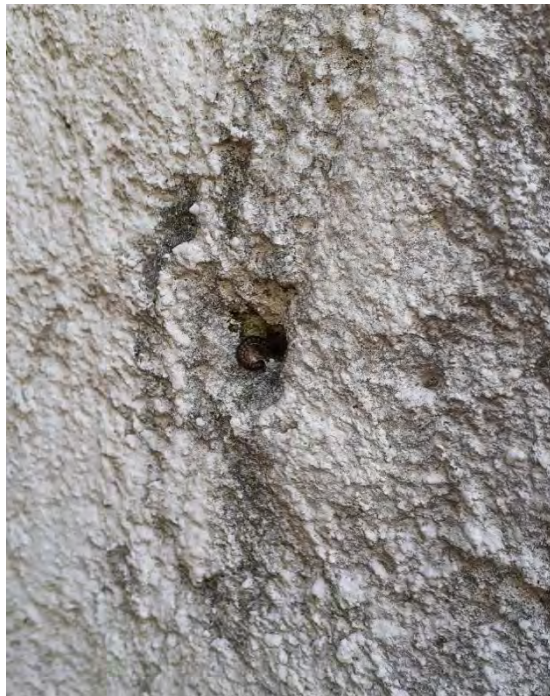
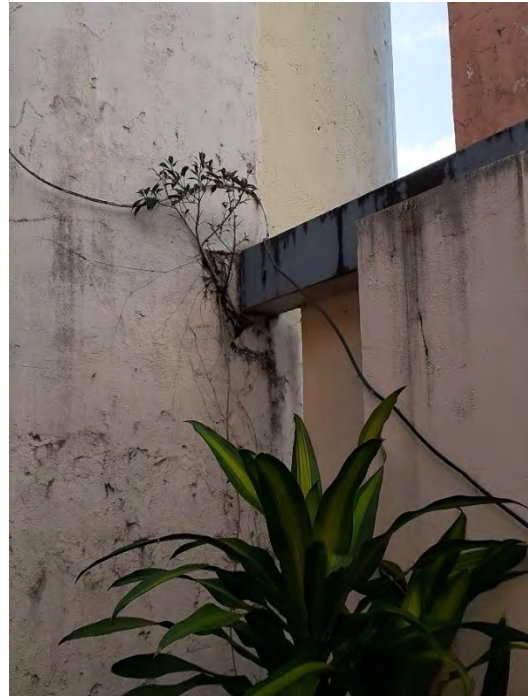
*Figs. A2.10, A2.11 & A2.12 - Water ponding due to the new drainage along poor water management issues have increased the chance of development of micro and macro biogrowth on Side B of Elevation 3. These include mold growth, leafy plants and insects living on scaled stucco. Photos by Author, 2020.*

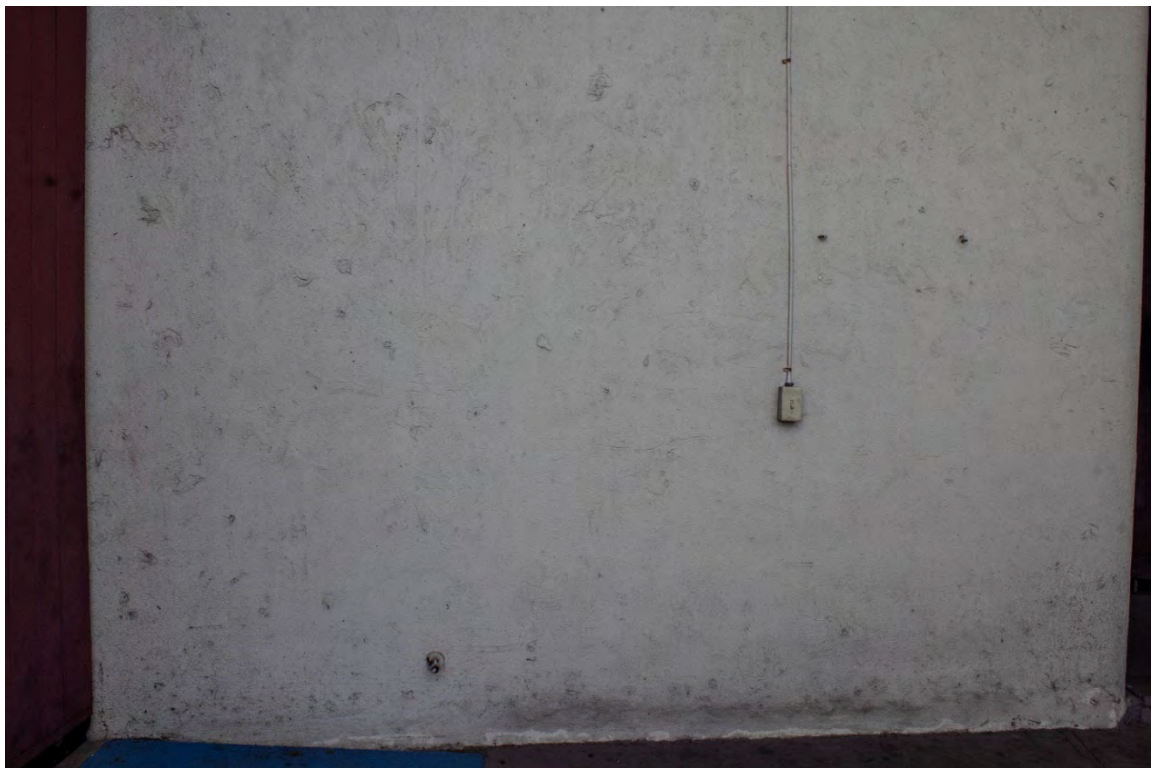
*Fig. A2.14 – Major scaling, rinsing damp and paint peeling issues can be seen in Elevation 4. Photo by Author, 2020.*

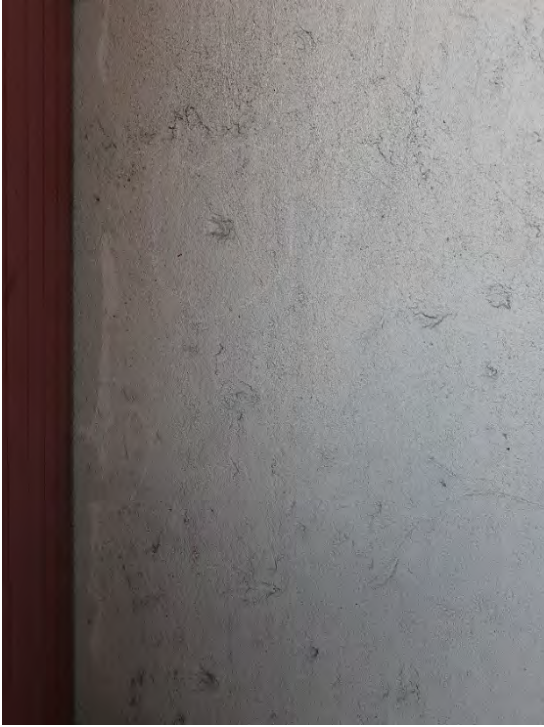
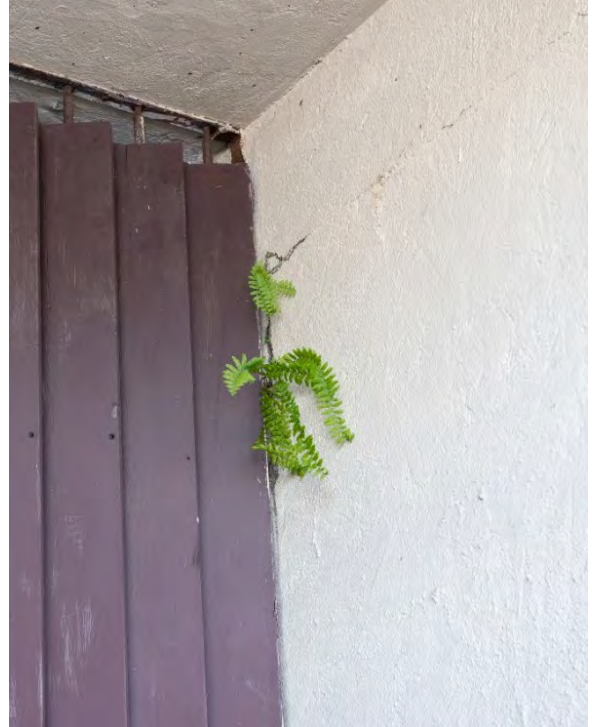
*Figs. A2.15, A2.16 & A2.17- Scaling along detachment/debonding and discoloration of stucco near the entrance in Elevation 4 (top left photo). Macro biogrowth and development of vertical and horizontal slight/hairline as sign of reinforced corrosion on Elevation 5 (top right and bottom photos). Photos by Author, 2020.*

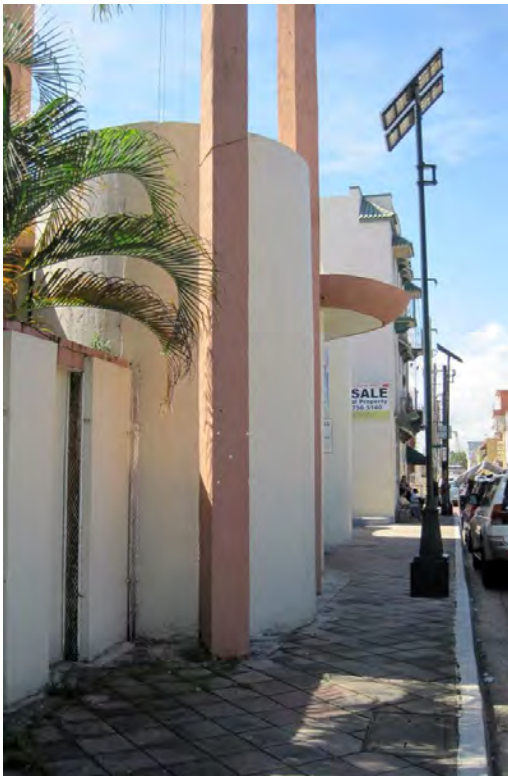
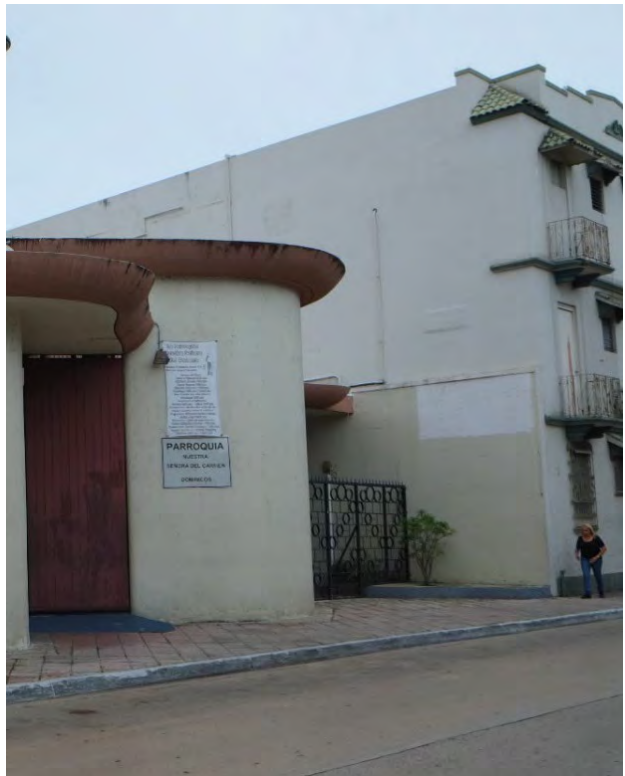
*Fig. A2.18, A2.19 & A2.20 – Two different paint coatings can be found on Elevation 5 along corroding nails and screws from an earlier sign (top photo). The original sign on the wall was installed in 2012 (bottom left photo) & removed c.2015 (bottom right photo). The original entrance signs are present in the 2015 photo. Photos by Author, 2020; Andrés Rivera, 2012 & Luis E. Carraza, 2015.*

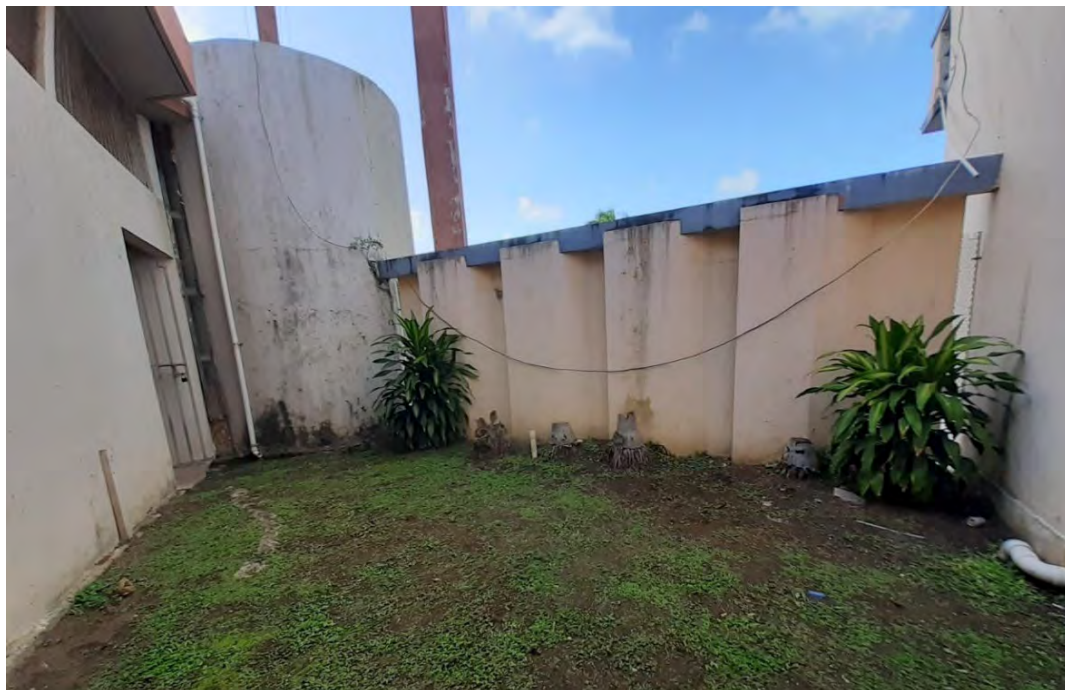
*Fig. A2.22 – Remaining palm trees and other large leafy plants close contact with the precast panels. The original paint from the church's exterior surfaces is also visible from this side. Photo by Javier Freytes, 2019.*

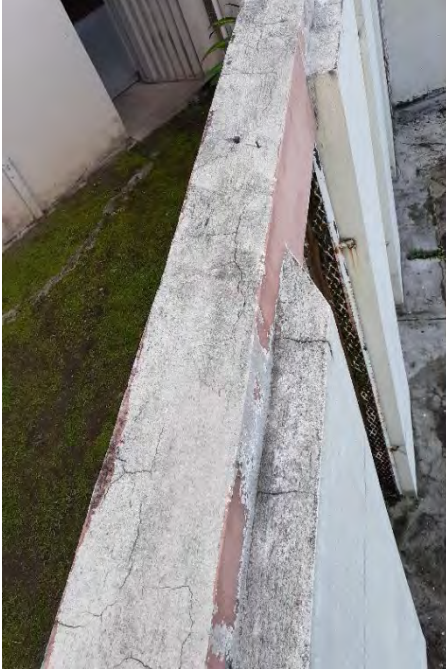
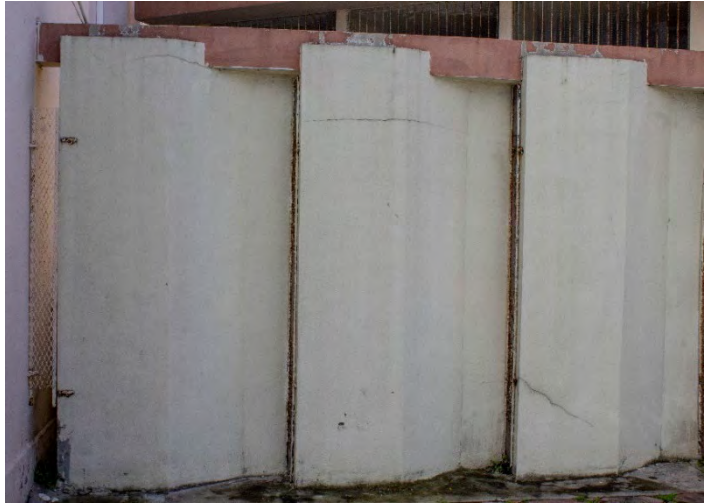
Fig. A2.26 & A2.27 – Cracking issues along the precast members of Elevation 6. Photos by Author, 2020.

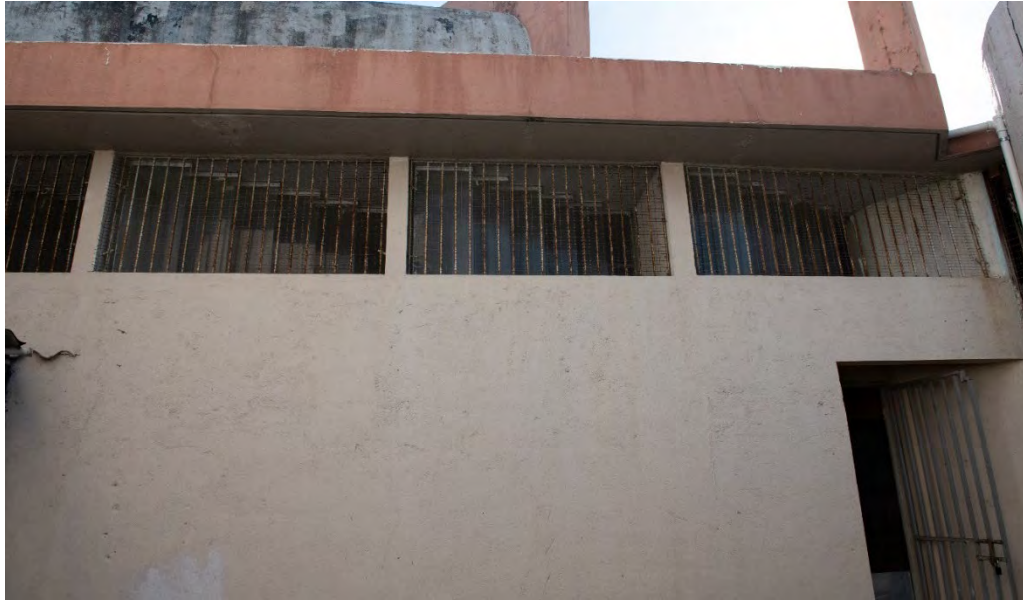
*Fig. A2.29* – Slight vertical cracking, paint peeling and soiling issues on the eaves of Elevation 7. Photos by Author, 2020.

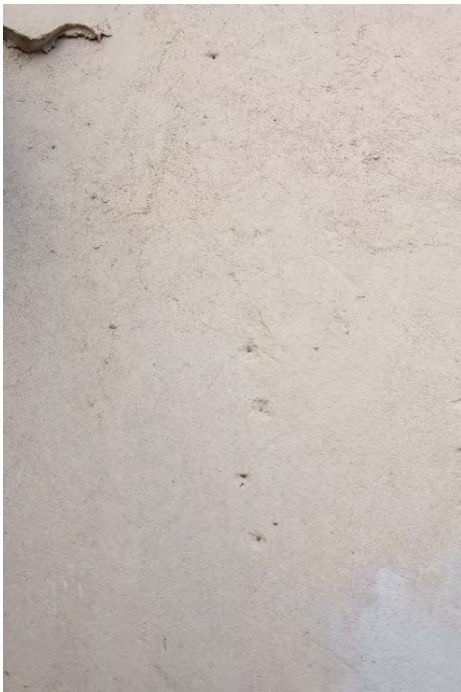
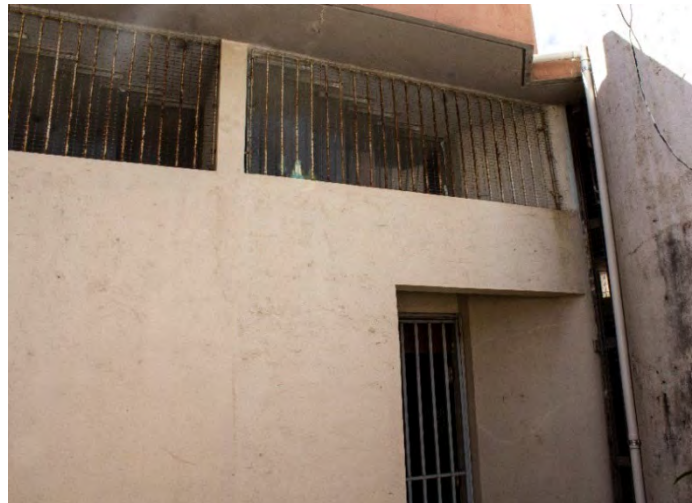
*Fig. A2.30 & A2.31* – Scaling of stucco and corrosion staining over the surfaces of Elevation 7. Photos by Author, 2020

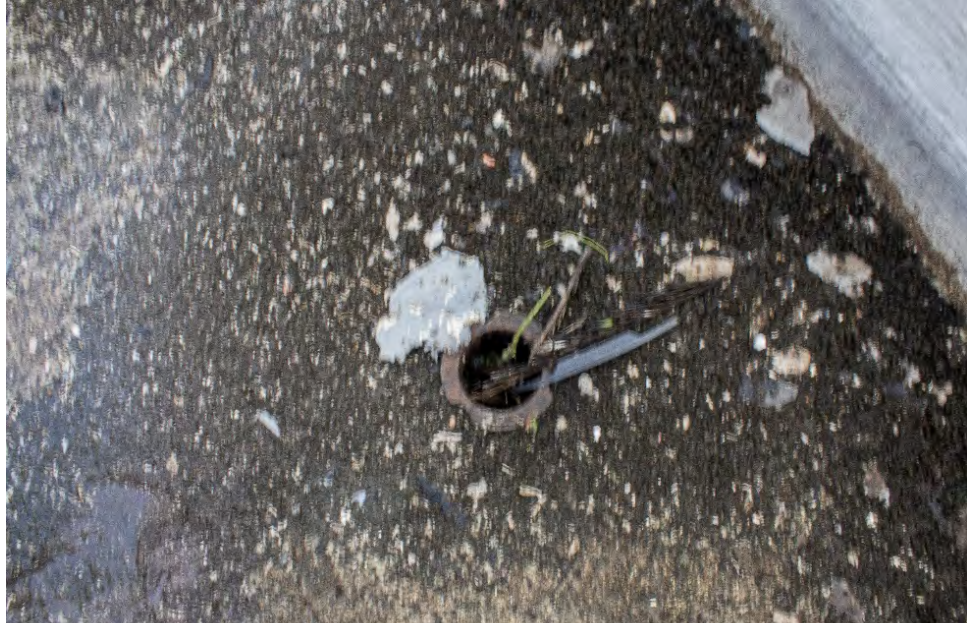
*Fig. A2.38*– Broken 'Type A' original roof drainage on roof slab near baptistry and confessionary – East side (bottom photo). Photo by Author, 2020

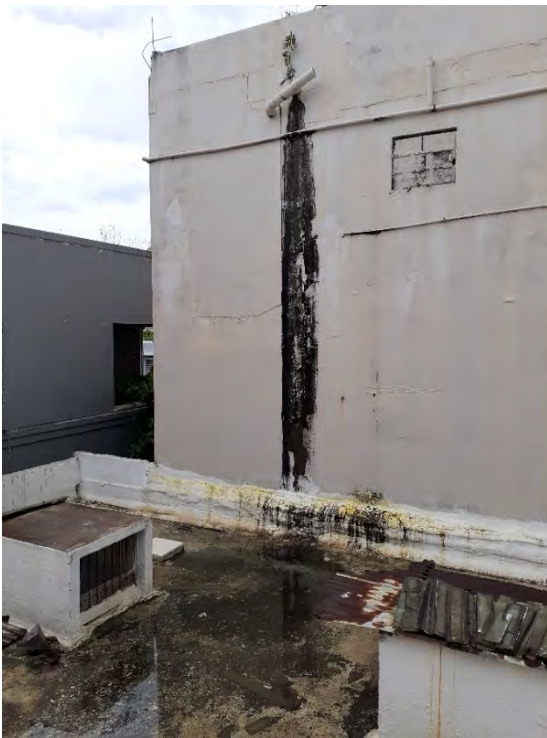
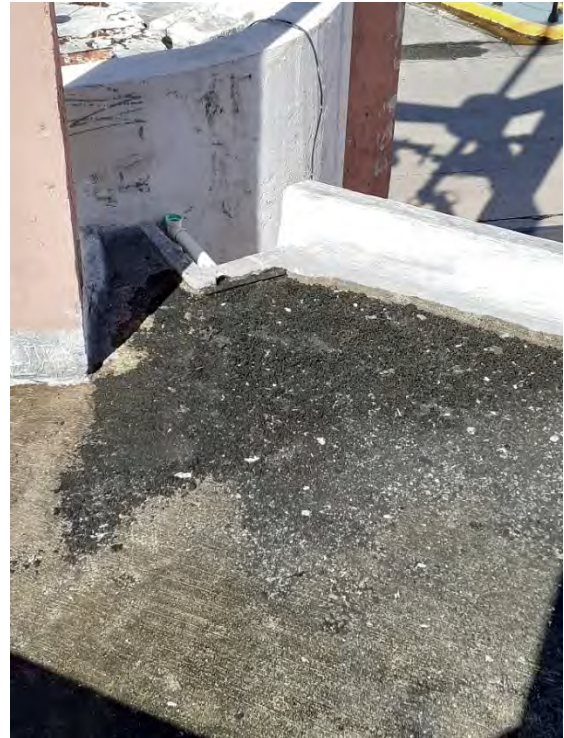
*Figs. A2.39 & A2.40* – A broken drainage from building on the west side of the church creates a massive water ponding issue on the roof slab. The two original 'Type B' drains are not working (left photo). New installed drainage which leads to water ponding, increasing moisture and bio-growth issues on Elevation 3. This new drainage is the only one properly functioning on the roof (right photo). Photos by Author, 2020.

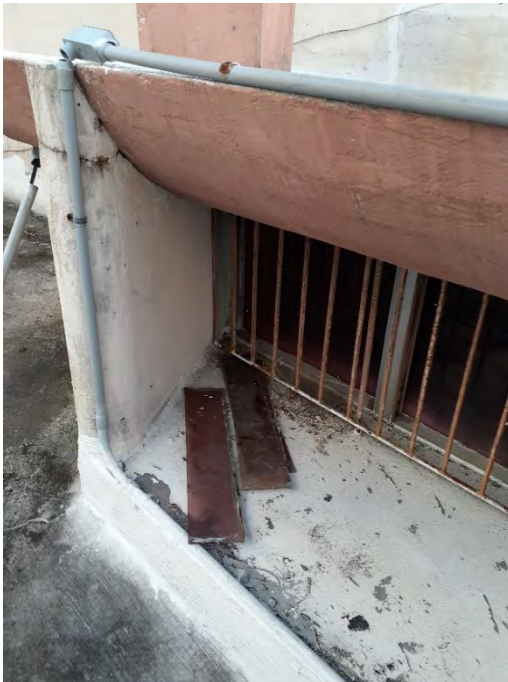
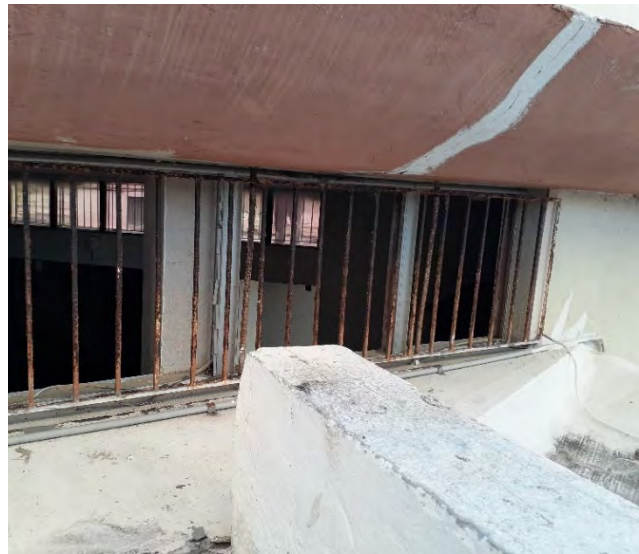
*Figs. A2.42 & A2.43 - The original glass louvers can be found at the roof (left photo). Cracking, an improper repair and discoloration of the eaves in Elevation 10A (right photo). Photos by Author, 2020.*

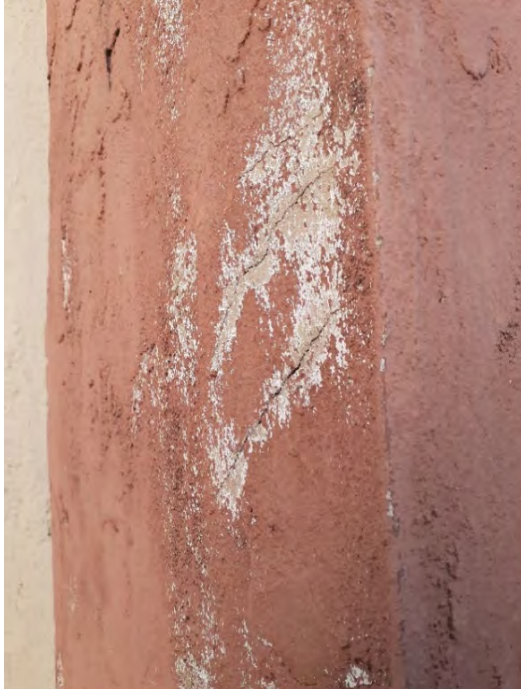
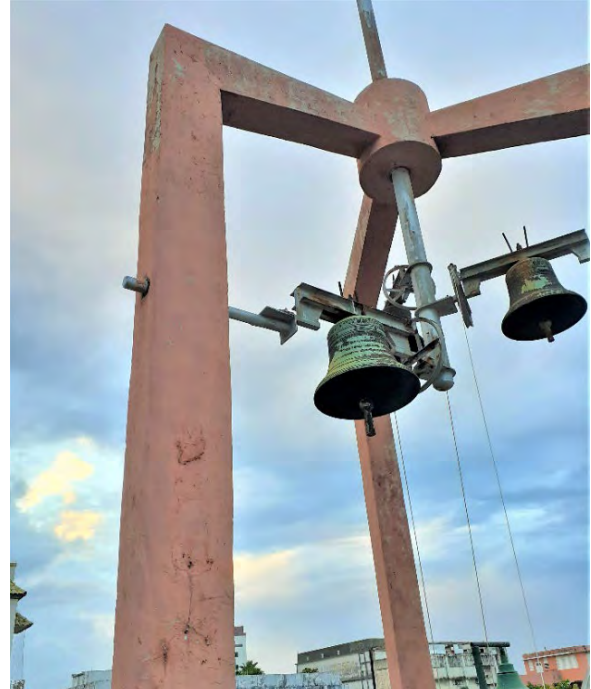
*Figs. A2.47 & A2.48 – Diagonal cracking, discoloration, scaling and paint peeling issues on reinforced concrete masonry belfry. Photos by Author, 2020.*

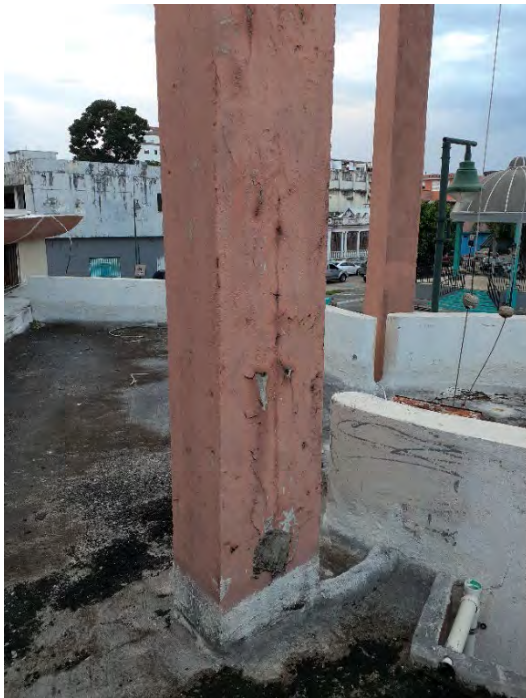
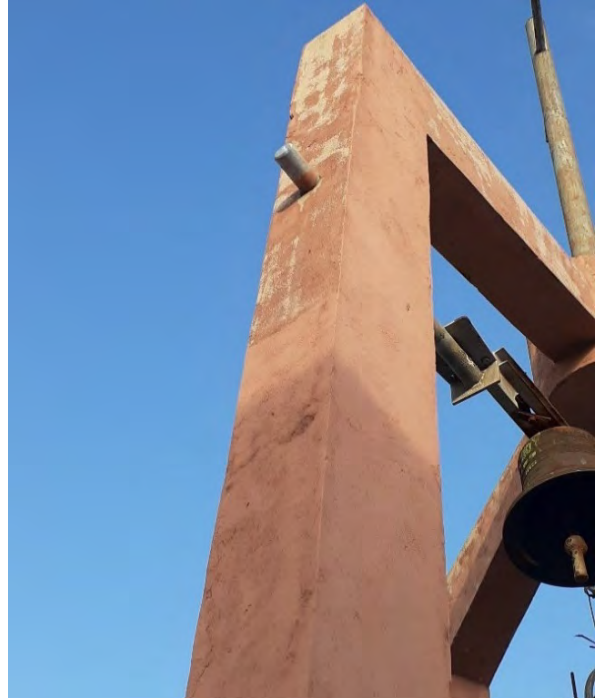
*Figs. A2.49 & A2.50 – Improper repairs, paint peeling, discoloration, humidity and possible alkali-aggregate reaction (AAR) issue (as defined by Poole & Sims, 2016) on Elevation 11C of the belfry. Photos by Author, 2020.*

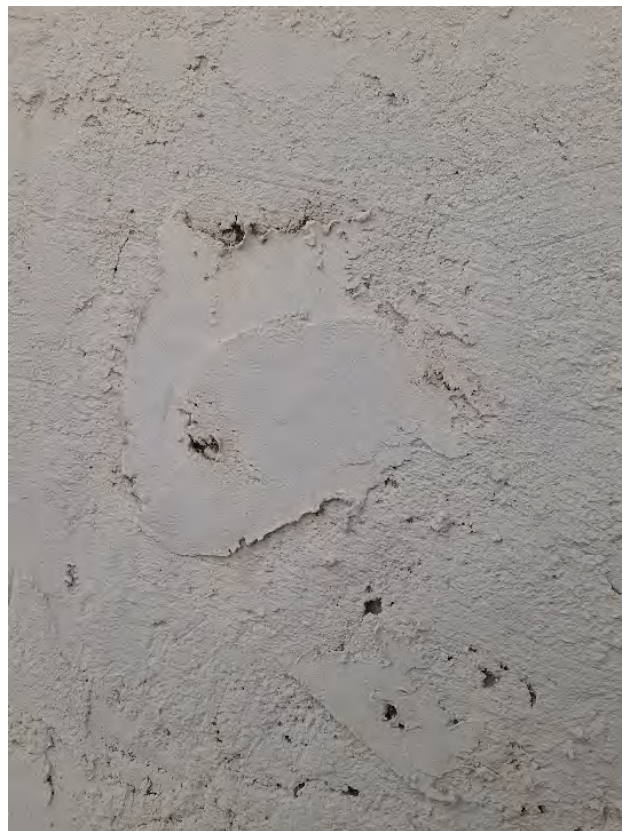
*Figs. A2.57, A2.58 & A2.59 – Highline cracks along discoloration sections and scaled portions of the stucco in Elevation 13 (top photos). Original stucco patches -now covered- show the uneven workmanship over the exposed surfaces. Photos by Author, 2020.*

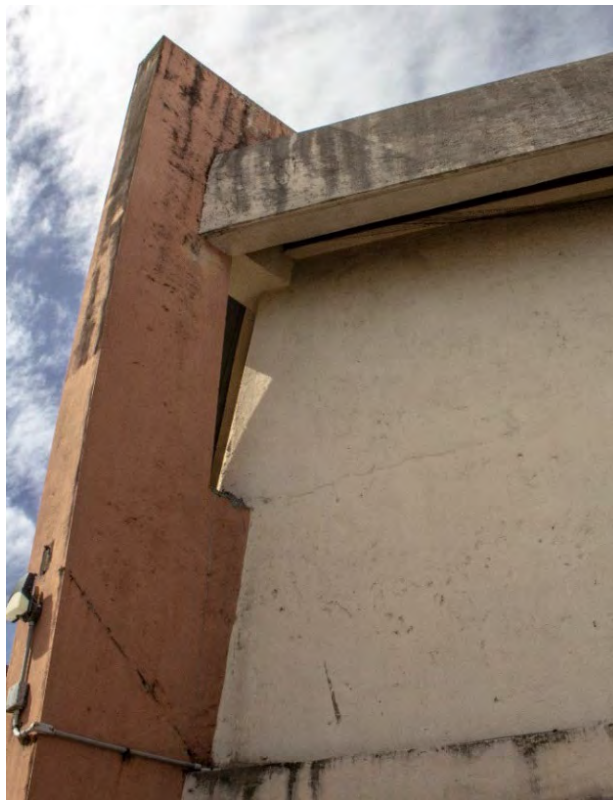
*Fig. A2.61* – A diagonal slight crack and soiling are among the conditions in Elevation 14. Photos by Author, 2020.

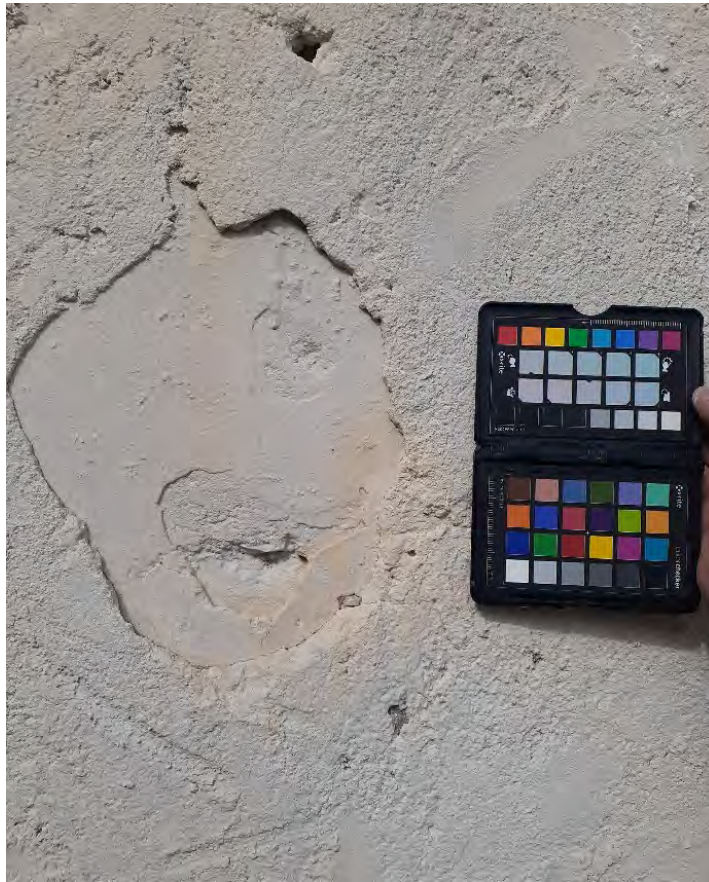
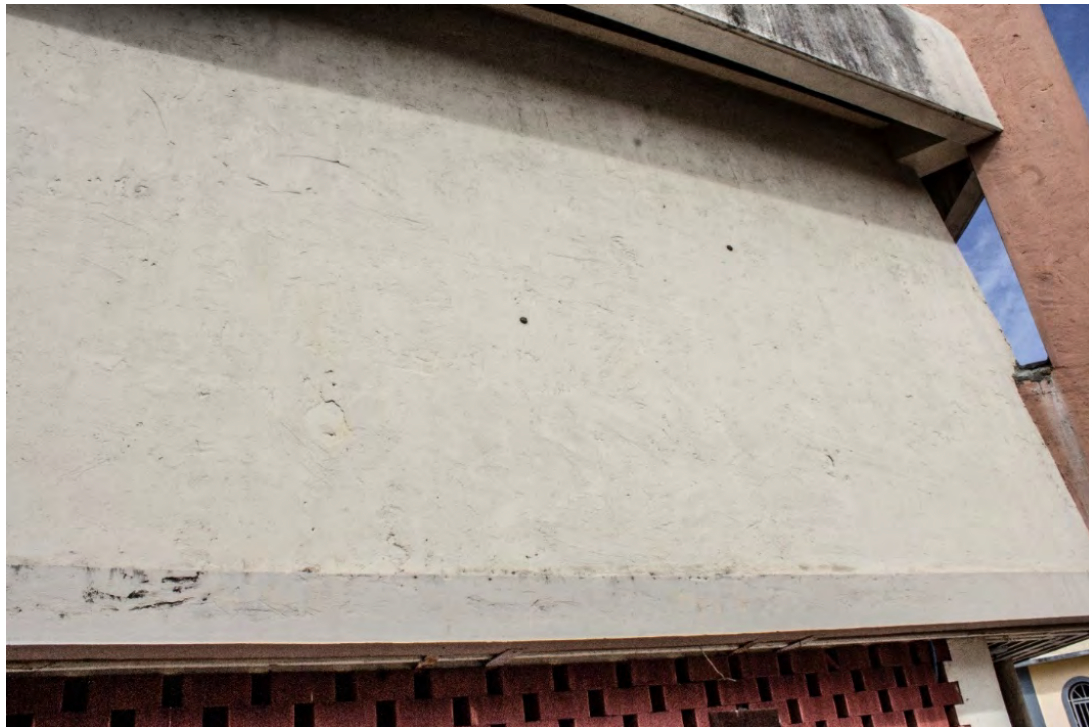
*Fig. A2.63 & A2.64* – Large scaled stuccoed surfaces, fouling and guano issues on Elevation 15. Photos by Author, 2020

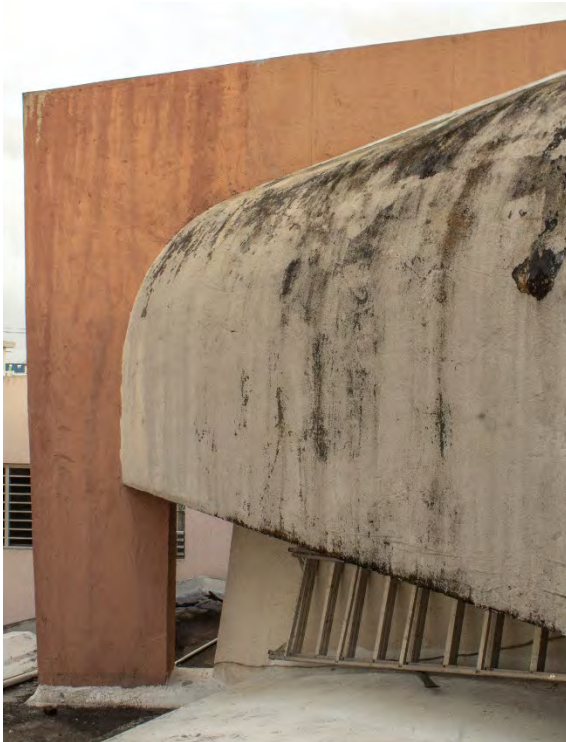
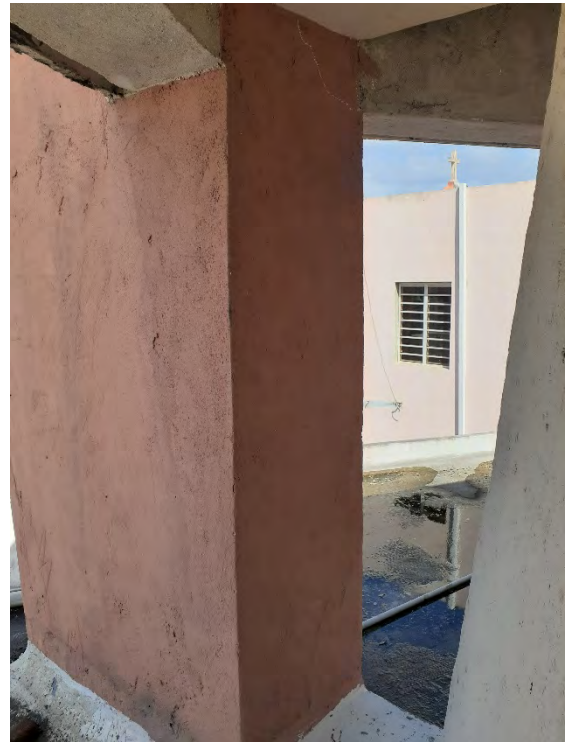
Figs. A2.71 & A2.72 – Discoloration, fouling and paint peeling conditions on Column A (left). Small detachment/debonding area behind Column A (right). Photos by Author, 2020.

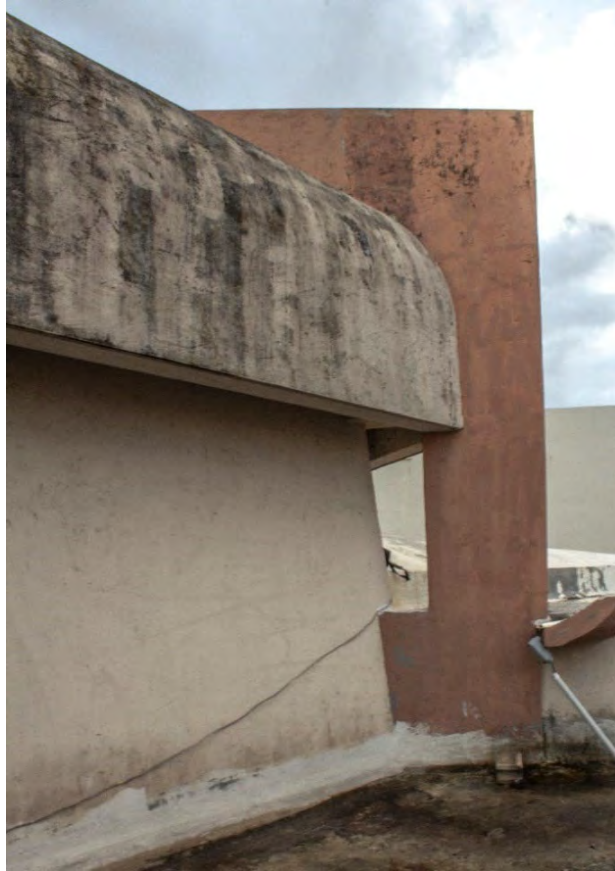
Fig. A2.73 – Discoloration, fouling and paint peeling conditions on Column A. Photo by Author, 2020.

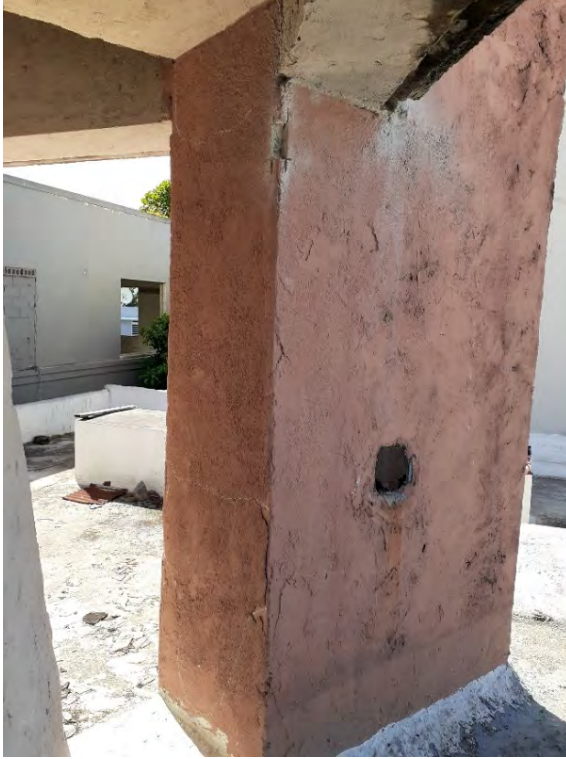
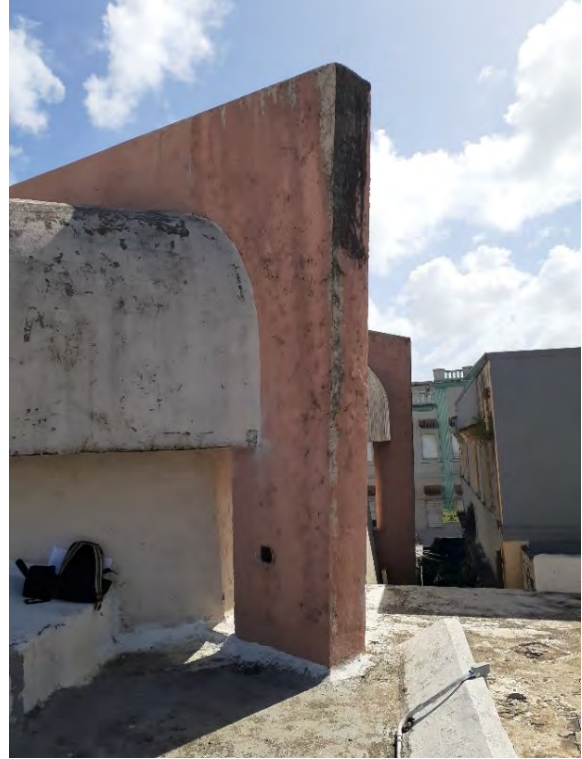
*Fig. A2.75 & A2.76 – Detachment/debonding areas on the back of Column B. Other conditions include scaling, discoloration, fouling, mold growth and paint peeling. A corroded electrical metallic socket can be seen on the lower part of the column. Photos by Author, 2020.*
