## **Belleza Desnuda: A Conservation Assessment of the Exterior Concrete Surfaces of Henry Klumb's Parroquia Nuestra Señora del Carmen in Cataño, Puerto Rico**

# Belleza Desnuda: A Conservation Assessment of the Exterior Concrete Surfaces of Henry Klumb's Parroquia Nuestra Señora del Carmen in Cataño, Puerto Rico

BELLEZA DESNUDA: A CONSERVATION ASSESSMENT OF THE EXTERIOR  
CONCRETE SURFACES OF HENRY KLUMB'S PARROQUIA NUESTRA  
SEÑORA DEL CARMEN IN CATAÑO, PUERTO RICO

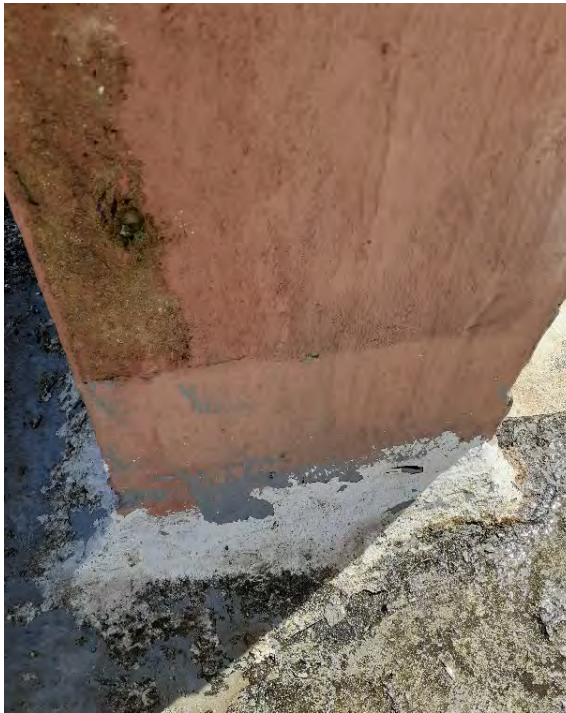
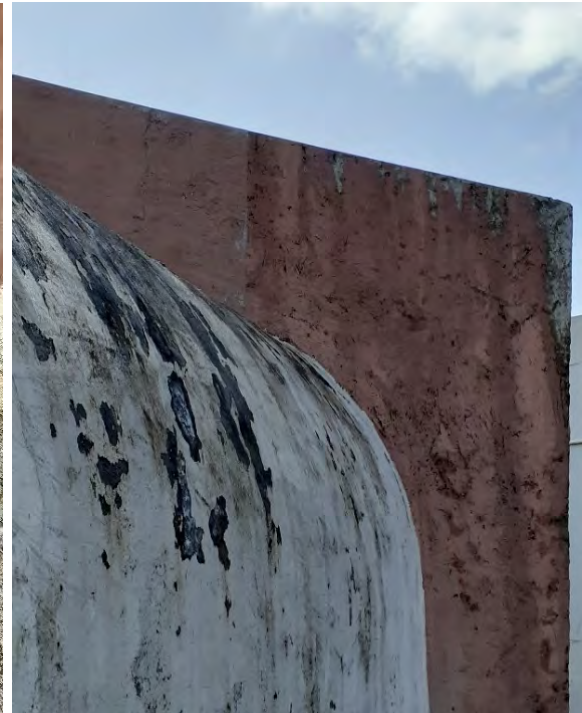
*Fig. A2.77 & A2.78 – The roof sealing paint was applied to the base of both Column B and Column A. Also, the gray sealing coating was applied in the upper parts of the column (see the differences in layers). Photos by Author, 2020.*

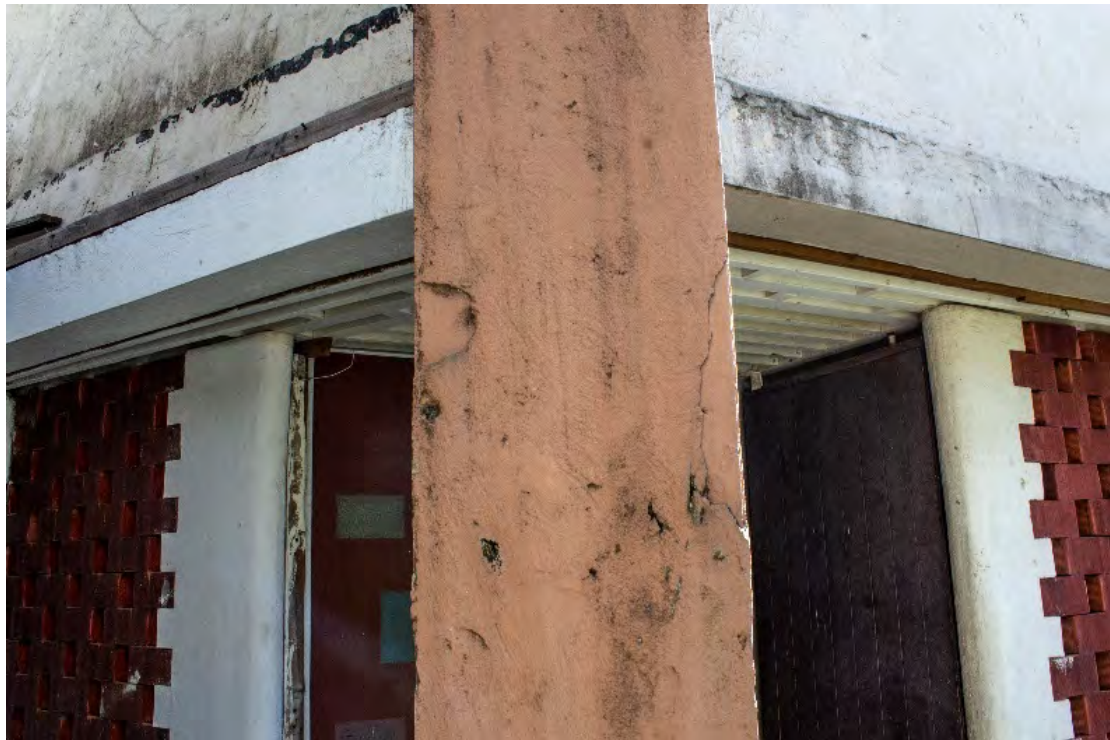
Fig. A2.80 – Scaling and fouling issues on Column C. Photo by Author, 2020.

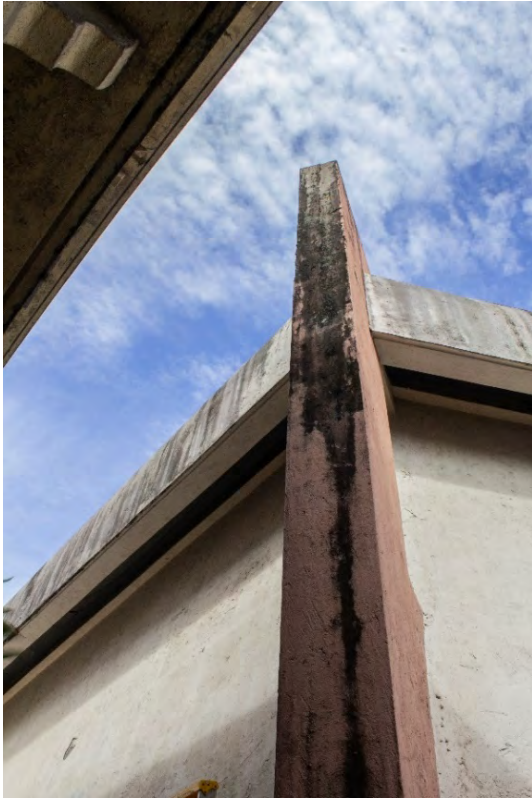
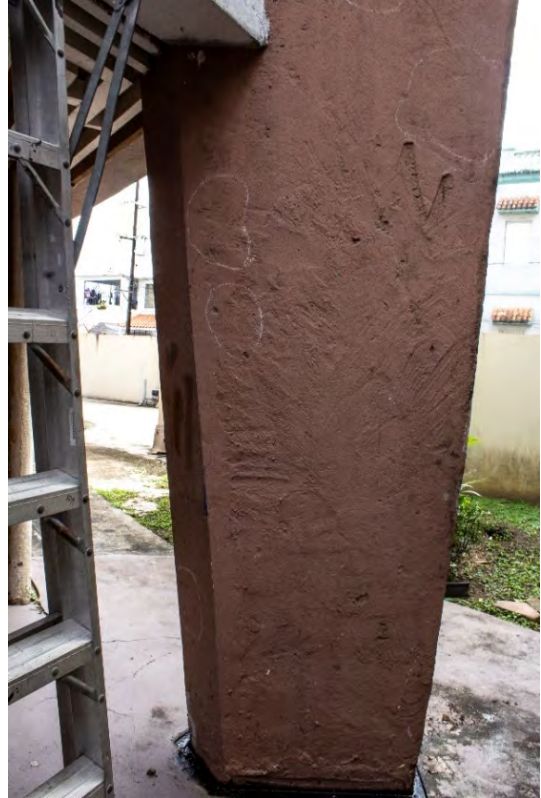
Fig. A2.81 & A2.82 – Surface fouling, mold growth and paint peeling on Column C (left photo). Small detaching/debonding areas on the base of Column C (right photo). Photos by Author, 2020.

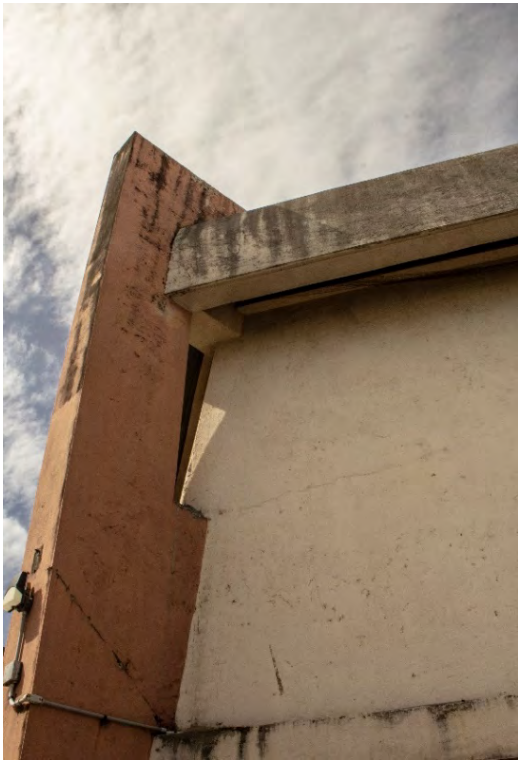
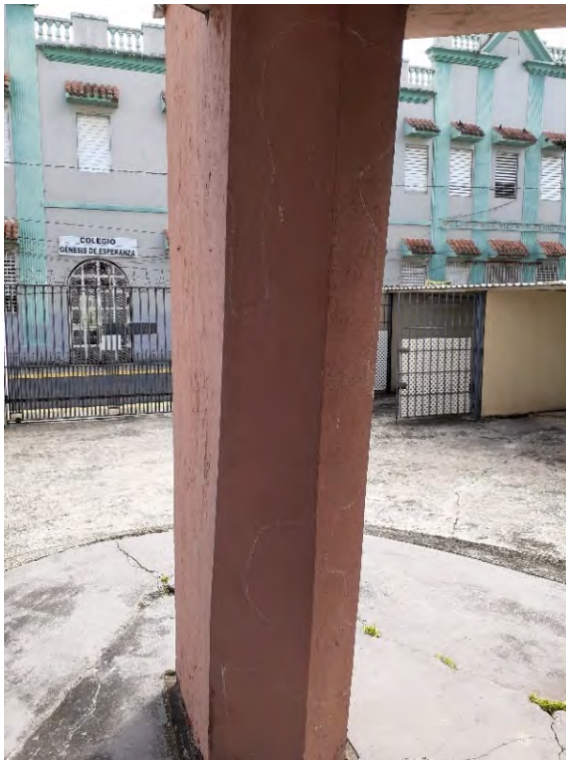
*Fig. A2.85 & A2.86* – Fouling, mold growth and scaling of the surfaces along Column D (left photo). The largest detaching/debonding area on a structural column in the Church is seen on the back of Column D Photos by Author, 2020.

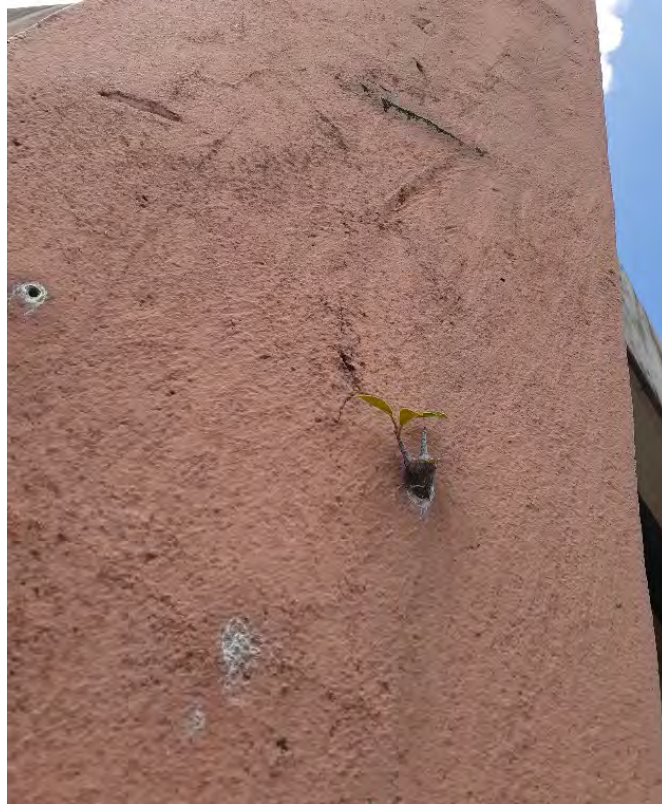
*Fig. A2.90* – Small leafy plants growing along the stuccoed surfaces of Column E. Photos by Author, 2020.

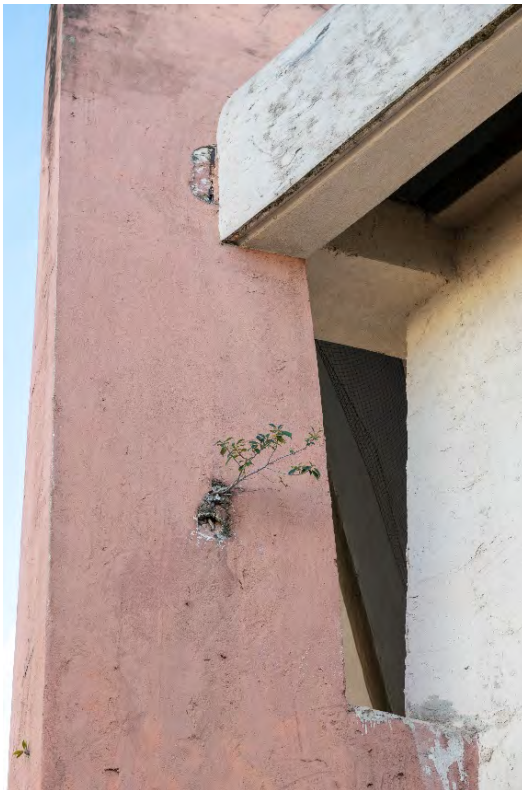
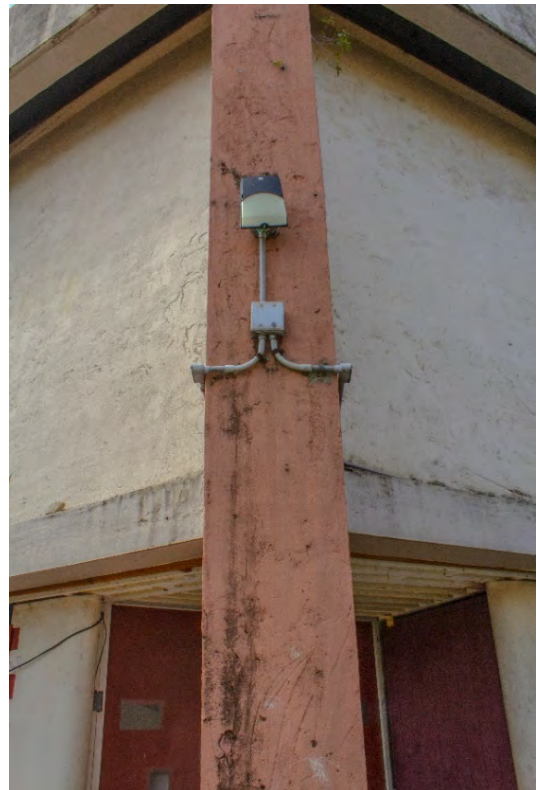
*Figs. A2.91 & A2.92* – Scaling and leafy plants growing on the stucco surfaces of Column E. Lamps have been installed on Columns D, E and F, attaching them to the stuccoed surfaces. Photos by Author, 2020.

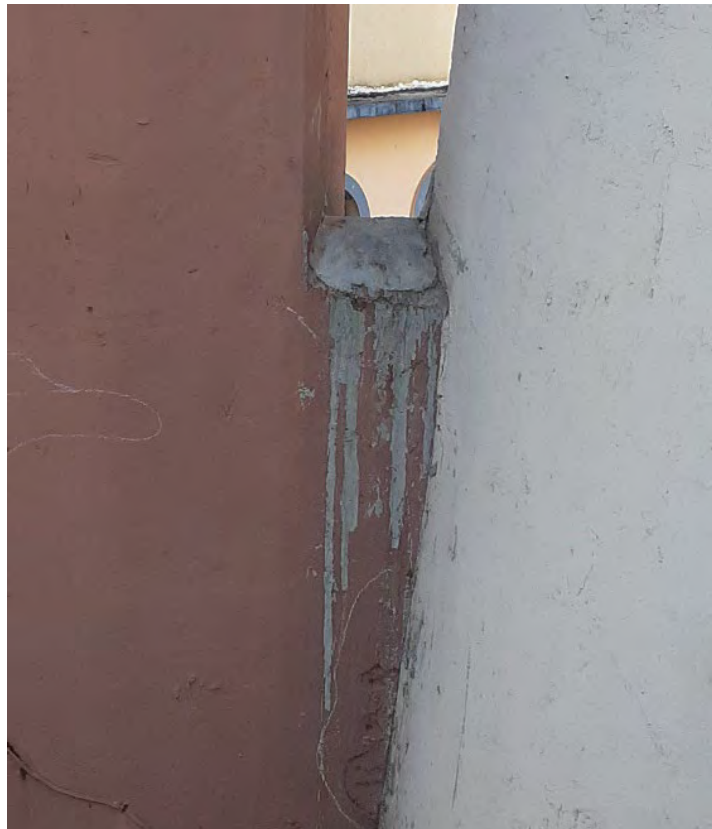
*Fig. A2.94* – The installation of bird spikes with this silicone adhesive was used between the stuccoed surfaces of the tilted walls and columns C, D, E & F. Photo by Author, 2020.

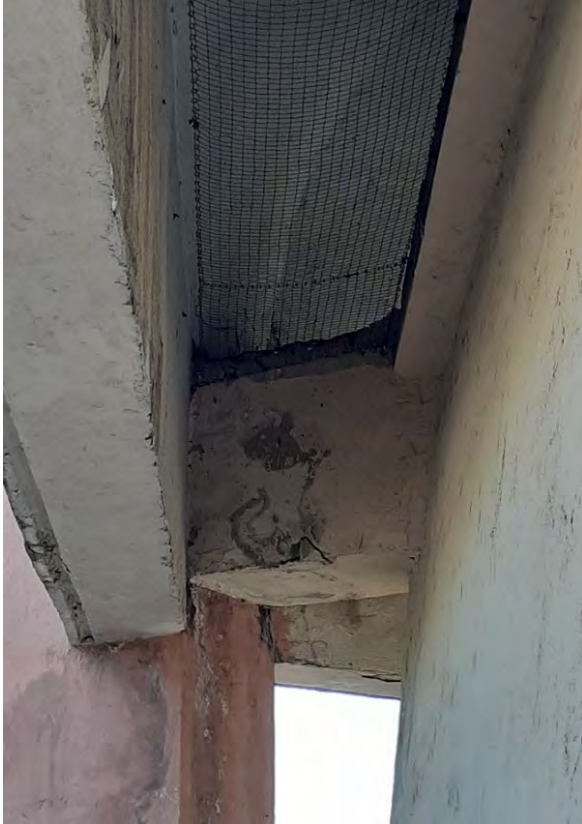
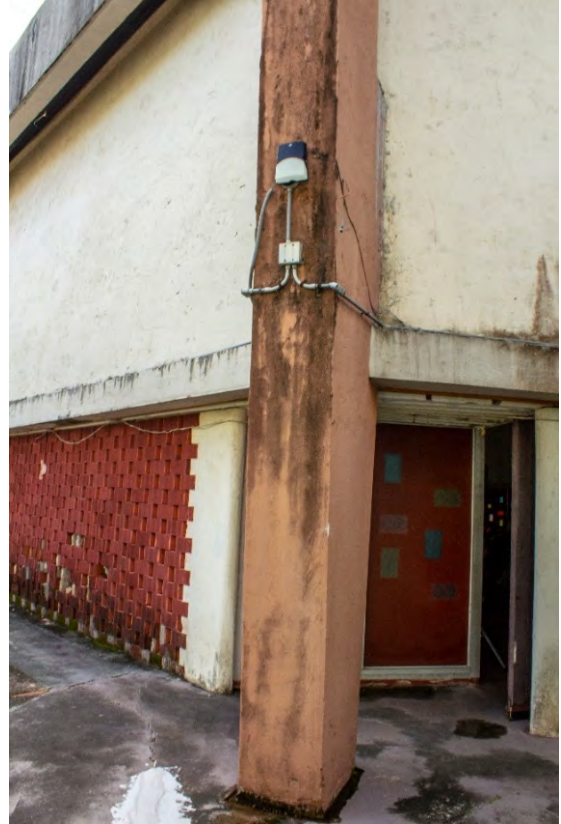
*Fig. A2.95, A2.96 & A2.97 – A failing previous repair behind Column F (top left photo). Fouling, scaling and vertical/horizontal cracking issues on the top of Column F (top right and bottom photos). Photos by Author, 2020.*

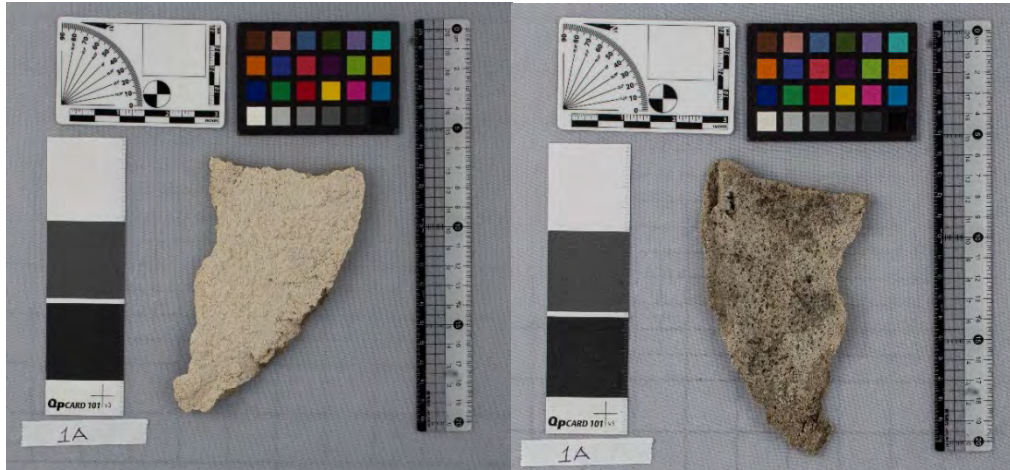
SAMPLE 1A-1

Samples	Observations	Selected for Thin Sections
Samples 1A		
1A-1	Back surface – Less porous and flat than the front	X
1A-2	Big chunks of lime visible	
1A-3	Shows a non-deteriorated area and deteriorated areas (transition)	X
1A-4	Shows deteriorated areas	
1A-5	Shows deteriorated areas	X
Sample 1B	Shows big stone aggregate Shows clear composition and defined stucco layers	X
Samples 2A		
2A-1	The most complete sample – shows clear composition, layers, and deteriorated areas	X
2A-2	Shows composition and deteriorated areas	X
2A-3	Shows deteriorated/exposed areas	X
2A-4	Shows deteriorated areas	
Sample 2B	The transition between Stucco and concrete substrate difficult to see	X
Sample 3A	Shows deteriorated areas	X
Sample 3B	A visible area with less aggregate – Variations	X
Samples 4		
4-1	Sample - less porous compared to Samples 1A Sandy aggregate visible	X
4-2	Sandy aggregate visible	
4-3	Sandy aggregate visible

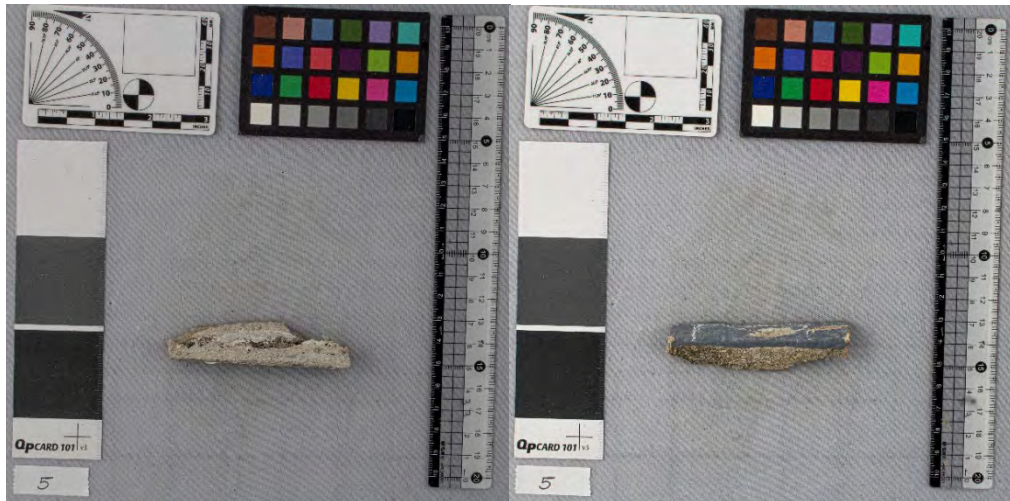
SAMPLE 5

Sample 5	Few pores are seen compared with other samples It is not known if there are any stucco coatings (layers)	X

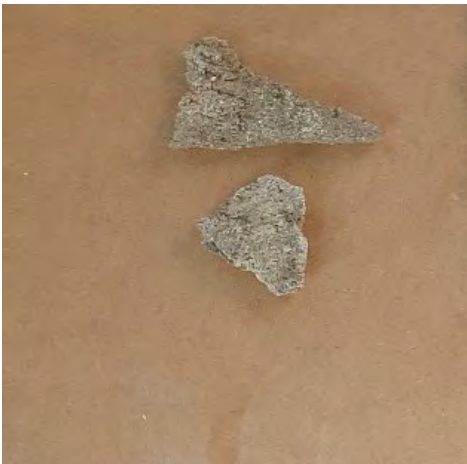
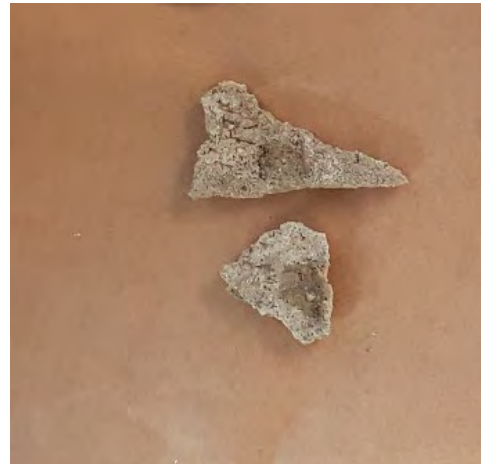
#### SAMPLE 1A

After the application of Phenolphthalein ( $C_{20}H_{14}O_4$ ) indicator – Results: Clear reaction-Full Carbonation

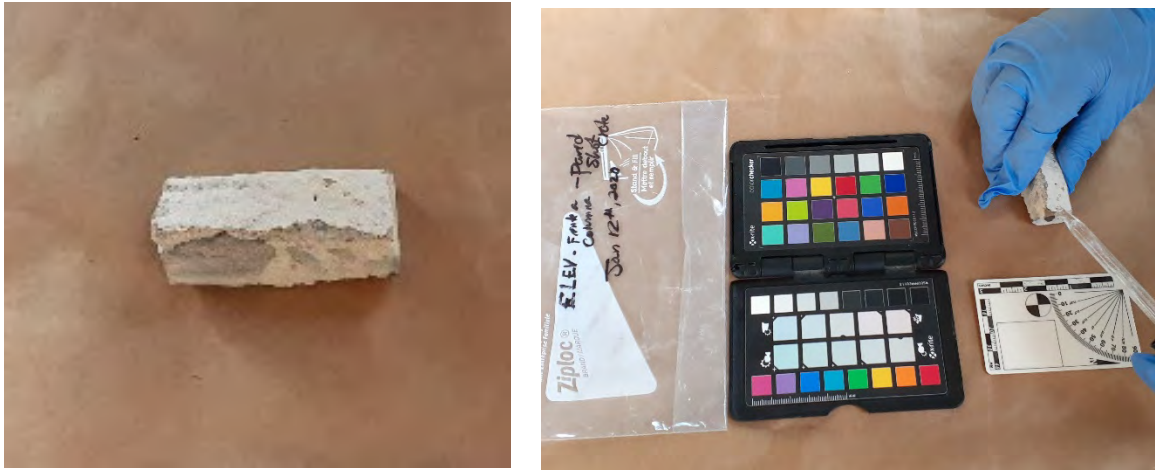
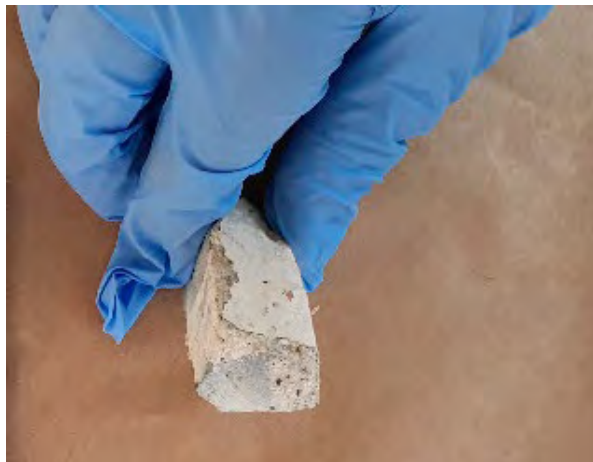
SAMPLE 1B

After the application of Phenolphthalein ( $C_{20}H_{14}O_4$ ) indicator – Results: Clear reaction-Full Carbonation

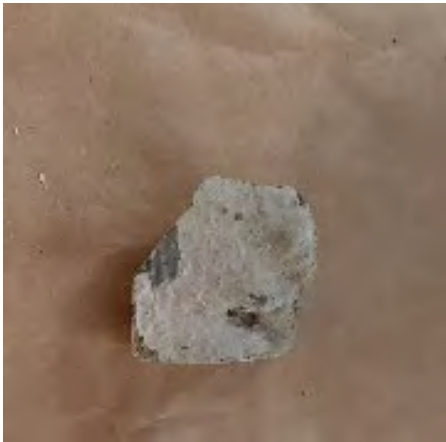
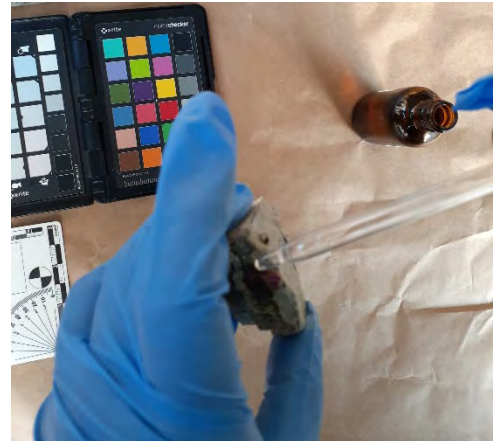
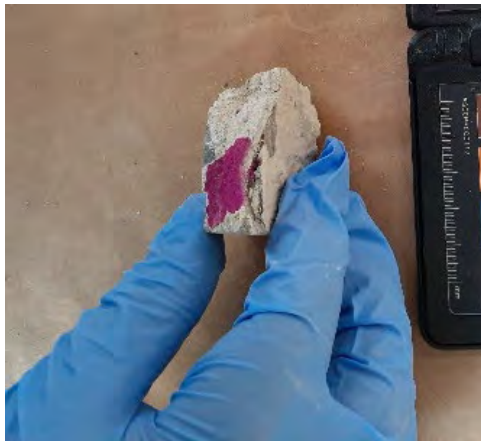
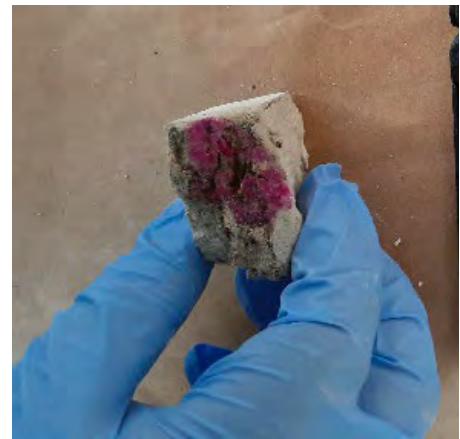
SAMPLE 2A

After the application of Phenolphthalein ( $C_{20}H_{14}O_4$ ) indicator  
Results: No Carbonation on the Substrate, Partial Carbonation of Stucco

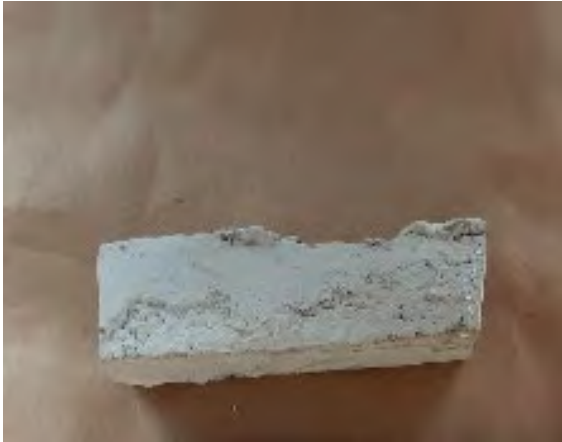
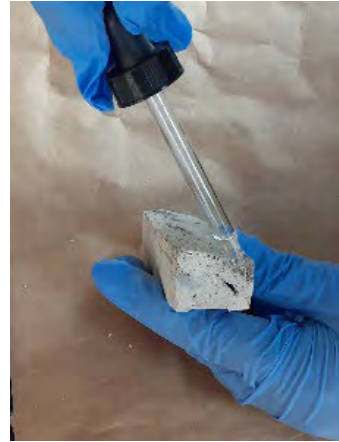
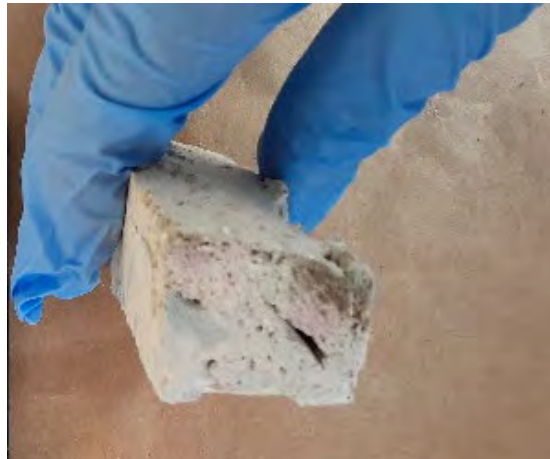
SAMPLE 2B

After the application of Phenolphthalein ( $C_{20}H_{14}O_4$ ) indicator – Results: Clear reaction-Full Carbonation

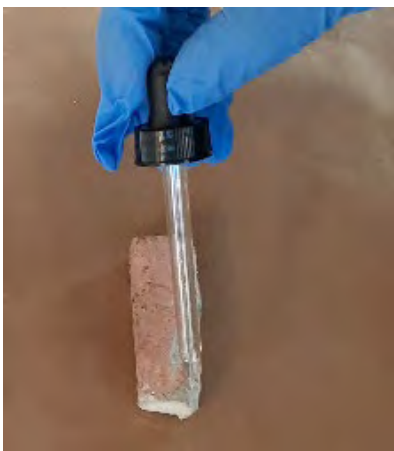
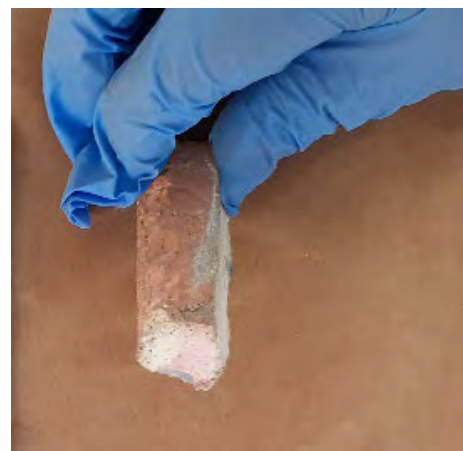
SAMPLE 3A

After the application of Phenolphthalein ( $C_{20}H_{14}O_4$ ) indicator – Results: Clear -Full Carbonation

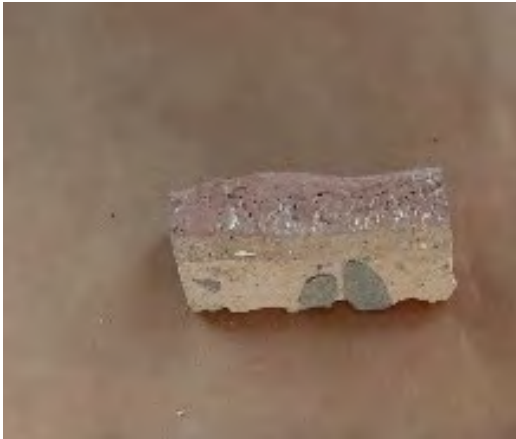
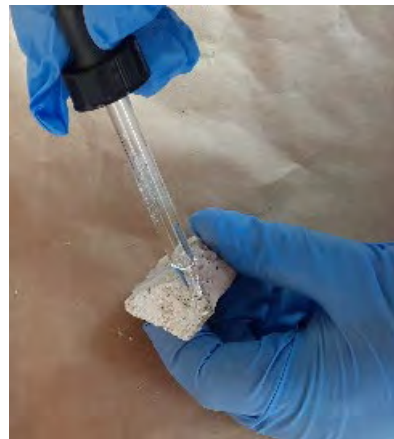
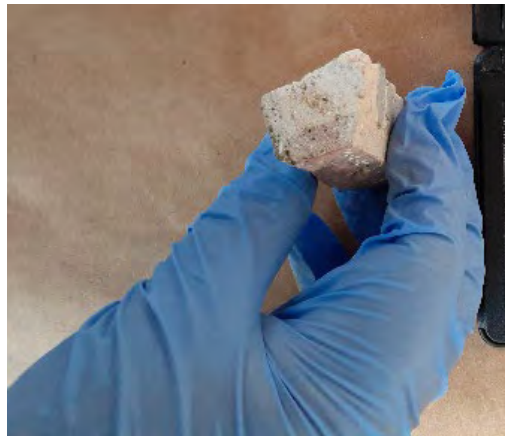
SAMPLE 3B

After the application of Phenolphthalein ( $C_{20}H_{14}O_4$ ) indicator – Results: Clear reaction-Full Carbonation

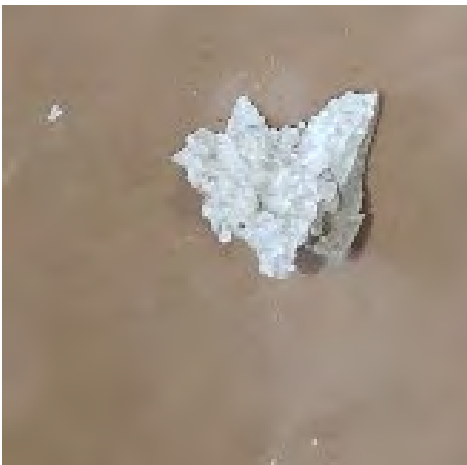
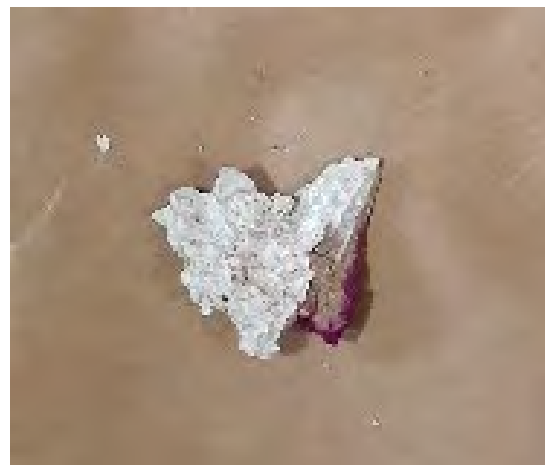
SAMPLE 4

After the application of Phenolphthalein ( $C_{20}H_{14}O_4$ ) indicator – Results: No Carbonation

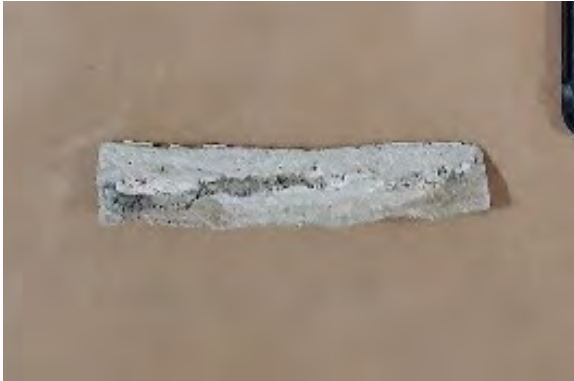
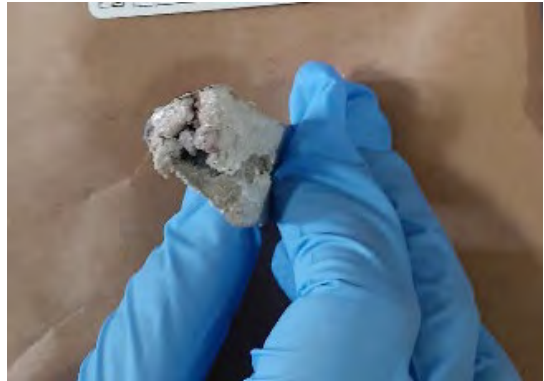
SAMPLE 5

After the application of Phenolphthalein ( $C_{20}H_{14}O_4$ ) indicator – Results: Clear reaction-Full Carbonation

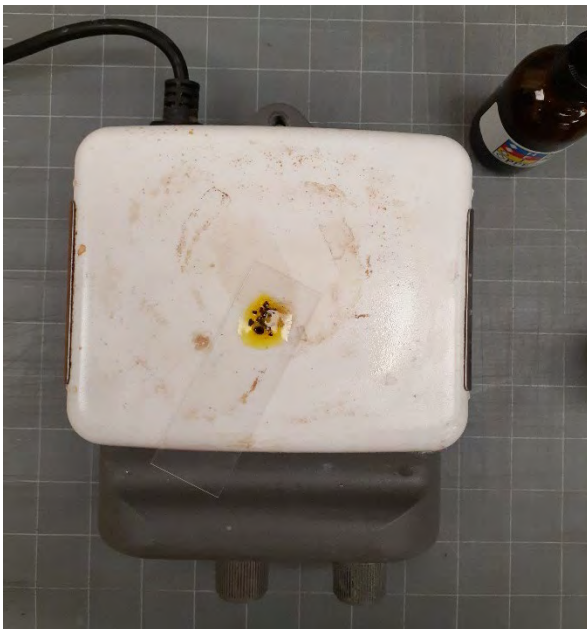
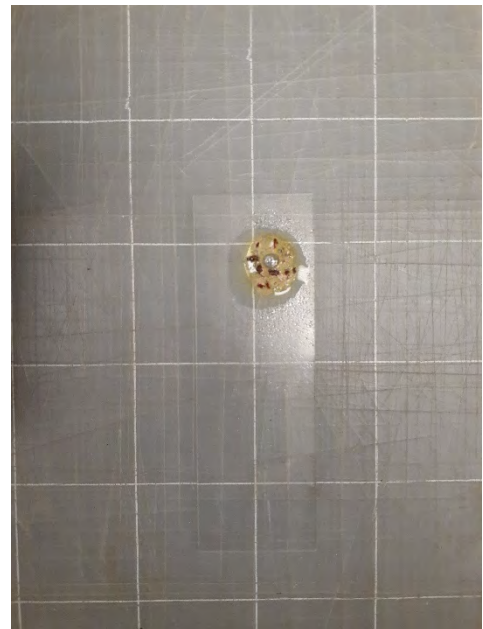
Remnants of Samples 2A-1 & 2A-3 were ground with a mortar and pestle. Fine ferrous metallic aggregates were selected for the test.

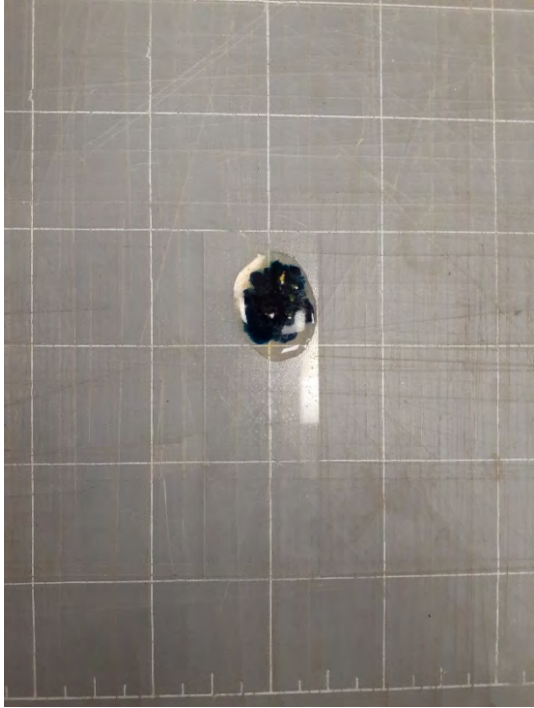
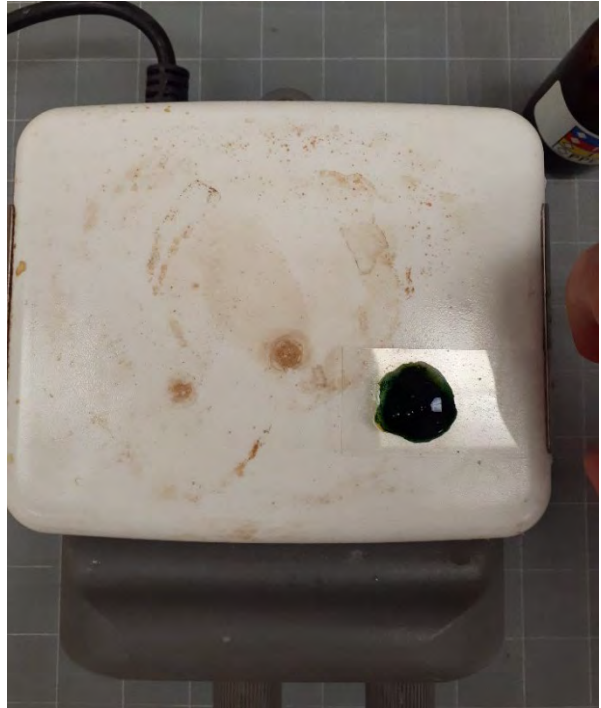
The fillings were dissolve in hydrochloric acid soln. and heated, then redissolved in 2 drops of deionized water.

A drop of potassium ferrocyanide soln. was added and it turned to an intense blue (Prussian Blue -  $C_{18}Fe_7N_{18}$ )

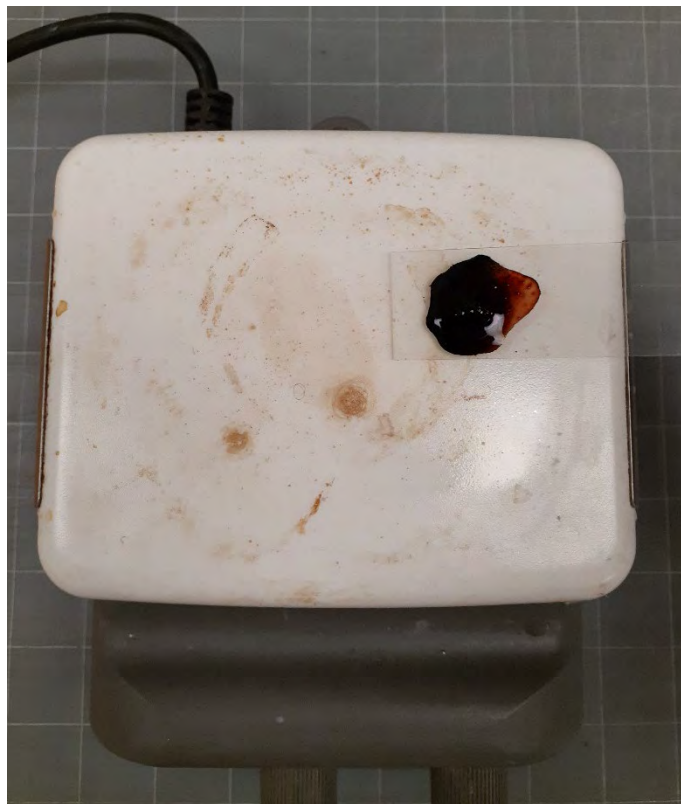
A drop of ammonium thiocyanate soln. was added, and the solution transformed to a blood red color, confirming the presence of iron in the fillings.

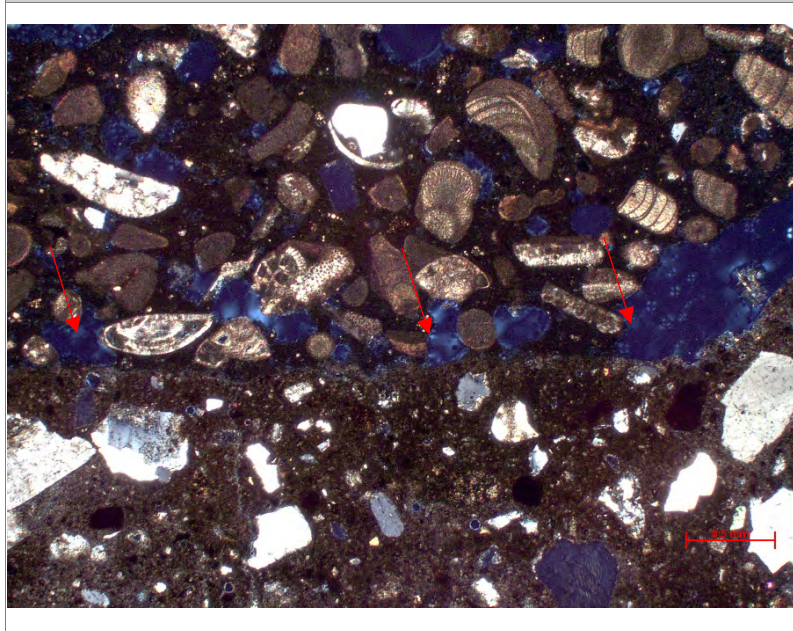
<p><b>NOTES:</b> Poor bonding between Sprayed stucco and the poured-in-place concrete substrate.</p>

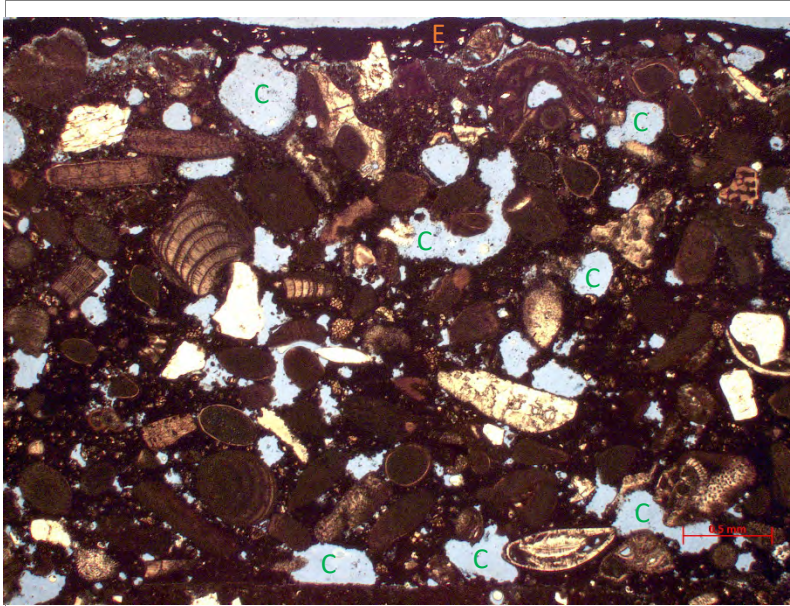
**SAMPLE 1B**  
**Sprayed stucco and Substrate**  
**THIN SECTION – PPL**

**NOTES:** Porosity on the Sprayed stucco shows very poor compaction.  
 C – Voids  
 E – Paint Layer

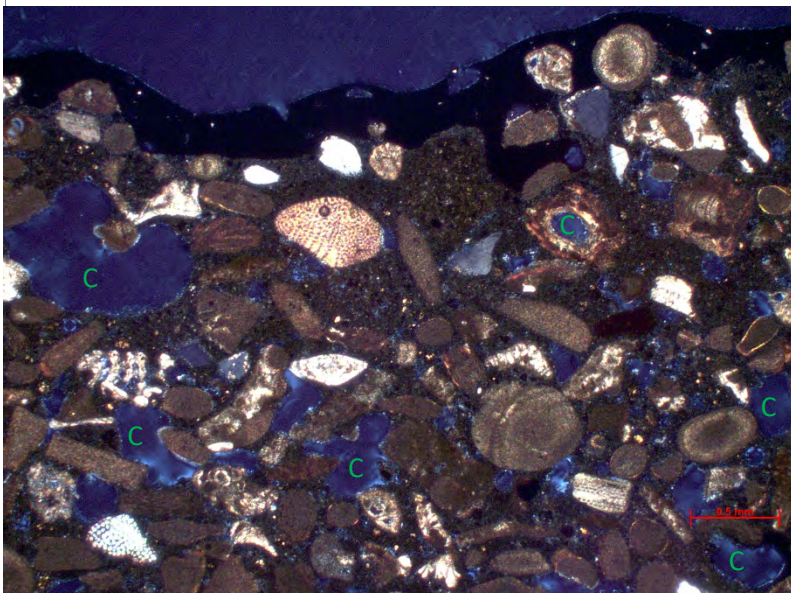
**SAMPLE 3B**  
Spayed stucco and substrate  
THIN SECTION – XPL

**NOTES:** Porosity and medium compaction of Sample 5.  
C – Voids

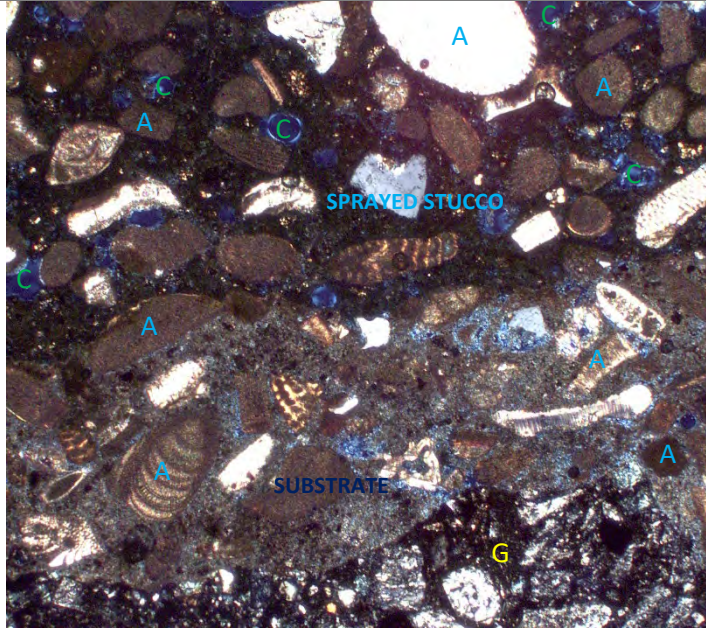
**NOTES:** Layer differences on Sample 3B  
 A – Biogenic Marine Sand – Fine Aggregate.  
 C – Voids  
 G – Coarse aggregate in Substrate - Rock fragment

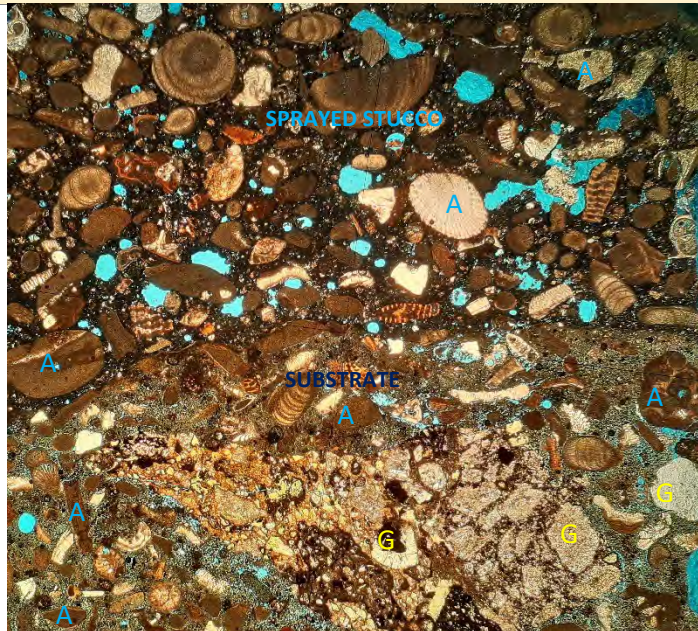
**NOTES:** Layer differences on Sample 3B  
 A – Biogenic Marine Sand – Fine Aggregate.  
 C – Voids  
 G – Coarse aggregate in Substrate – Rock fragments

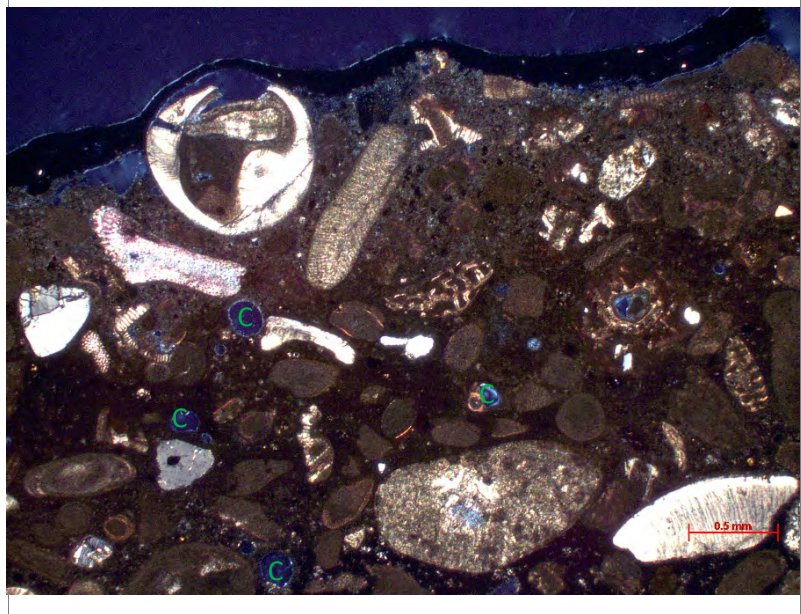
**SAMPLE 4-1**  
**Hand Applied Stucco**  
**THIN SECTION – XPL**

**NOTES:** Porosity and good compaction of Sample 4-1.  
 C – Voids

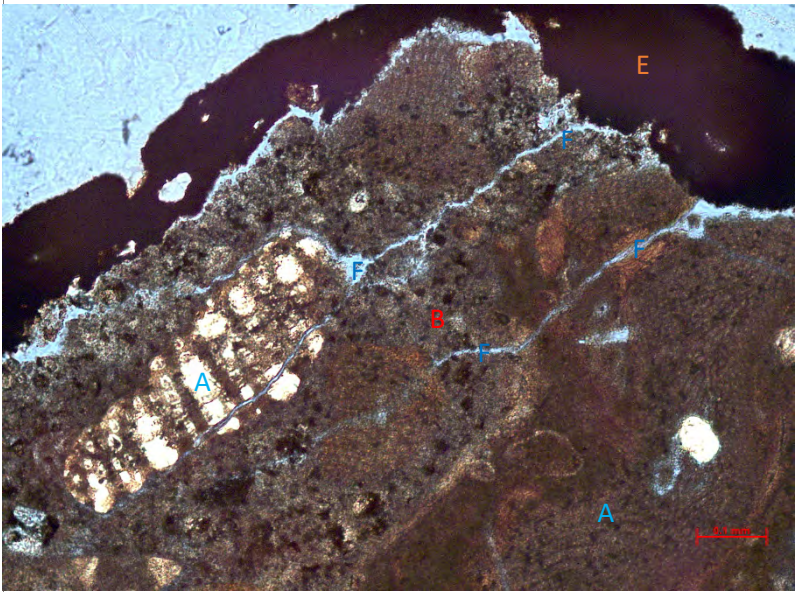
**NOTES:** A – Biogenic Marine Sand – Fine Aggregate. Coarse aggregate includes Hydrated lime (not shown).  
 B – Portland cement matrix  
 E – Paint Layer  
 F – Microcracks product from Sulfate attack, which is usually seen with an extensive system of fine cracks.

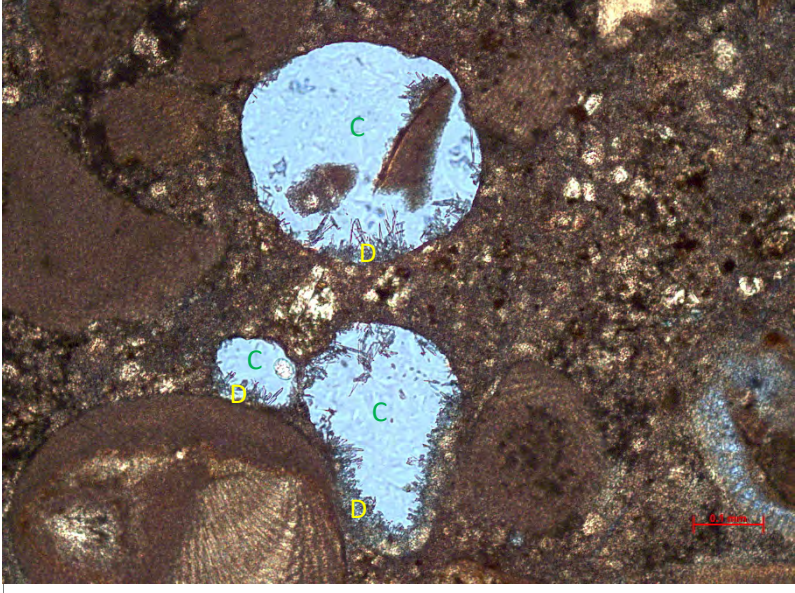
**NOTES:** Ettringite formation in voids on Sample 4-1  
 C – Void  
 D – Ettringite/Salts
