## Load-deformation analysis on a slope at Gunung Pulai water treatment plant, Sultan Ibrahim Reservoir

To cite this article: K Azman *et al* 2019 *IOP Conf. Ser.: Mater. Sci. Eng.* **527** 012031

K Azman\*, M Mushairry<sup>1</sup>, A R Ahmad Safuan<sup>1</sup>, O Mohd Hanim<sup>1</sup>, I Izni Syahrizal<sup>1</sup>, V Mohammadreza<sup>1</sup>, C A Sophia<sup>1</sup>, M A Mohd Azreen<sup>1</sup>, A Rini Asnida<sup>1</sup>, S Radzuan<sup>1</sup>, H Muhammad Azril<sup>1</sup>, A Mohd Nur Asmawisham<sup>1</sup>, M A Mohd For<sup>1</sup>, T Sahrul Nizam<sup>1</sup>, A R Afif<sup>1</sup>, K Kamrul Zaman<sup>1</sup>, H Hairul Hairi<sup>1</sup>, A W Zulkifly<sup>1</sup>, D S A Ismail<sup>1</sup> and M A R Muhammad Fateh<sup>1</sup>

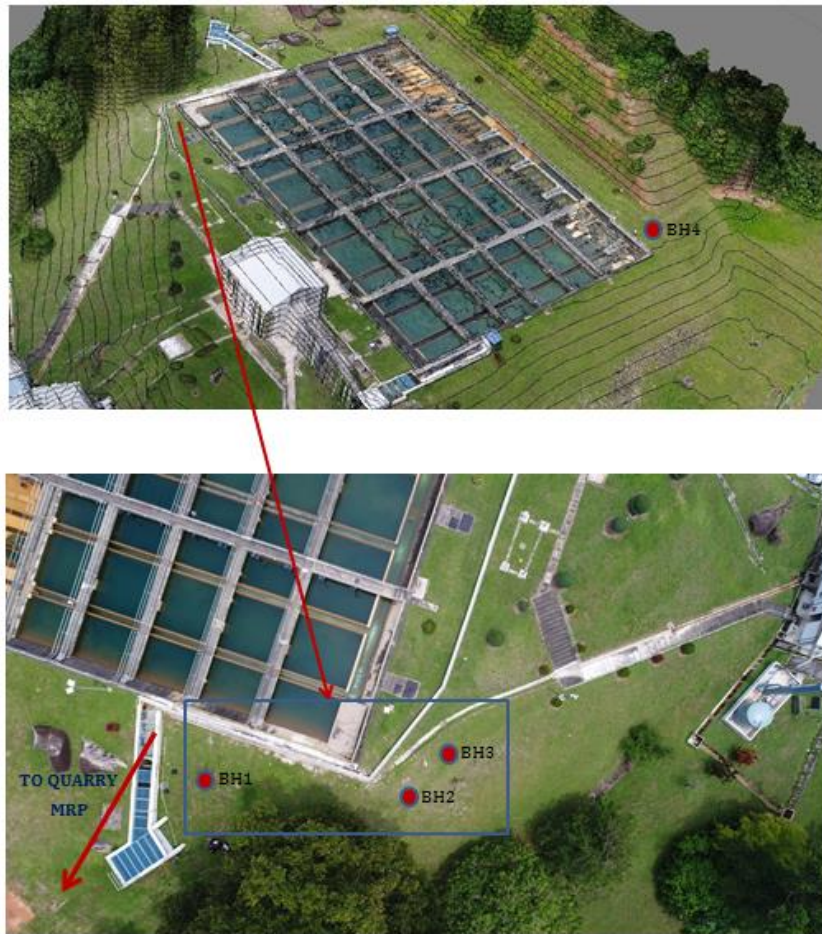
**Figure 3.** Location of BH1, BH2, BH3 and BH4.

The rotary boring was carried out in accordance to the British Standard Code of Practice BSI 5930: 1999 – “Site Investigation” and laboratory tests are accordance to BSI 1377: 1990. Altogether four (4) numbers of boreholes were conducted at the proposed site as shown in Figure 3. The borehole was advanced by mean of Rotary Boring Machine (YWE). However, due to condition on site, none of pneumatic piezometer and inclinometer has been successfully installed.
