Micro-CT Scanning in the Investigation of Squat Defects in Rail Steel

Shaun Earl

*Submitted for the degree of Doctor of Engineering in the
Department of Materials Science and Engineering at the
University of Sheffield, UK.*

January 2021

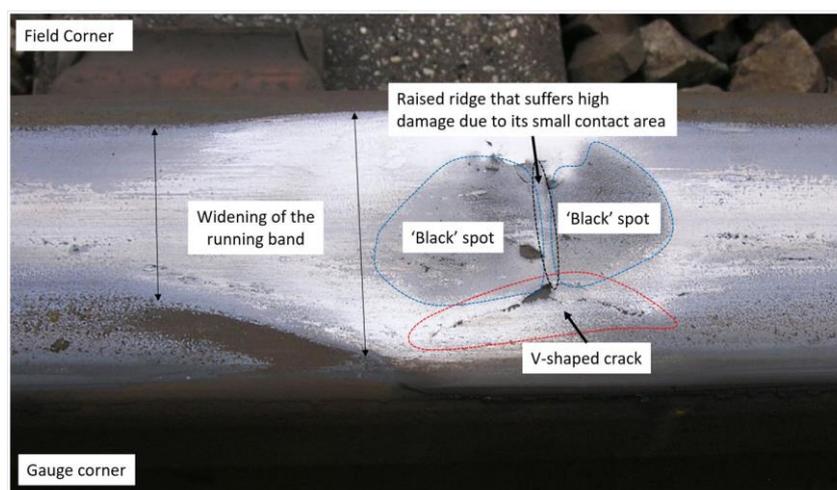
Squats are classically a rolling contact fatigue (RCF) related defect in the running surface of a rail. A pair of cracks that grow beneath the surface, allowing the surface to deform and depress, resulting in two black lobes or spots to appear on the rail surface. These black spots are the typical signature that there is a Squat in the rail (Figure 1). The localised deformation also leads to a widening of the running band, which is the shiny part of the railhead. The initiation of the defect is usually on or very close to the surface so another typical feature, a V-shaped crack, also develops as the crack plane grows.

Figure 1: A typical Squat showing the associated annotated features. Original image courtesy of British Steel

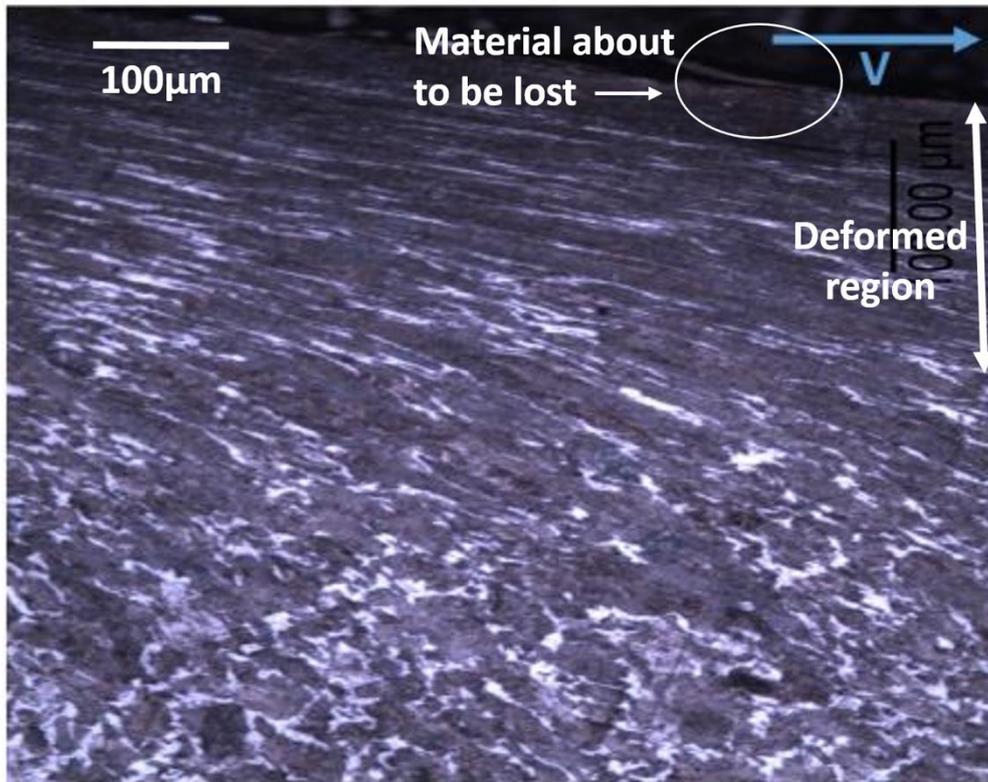
Under Hertzian contact conditions the peak shear stress is below the surface. This requires that contact is elastic and that the friction between rail and wheel is low. However, when the friction rises to 0.3 or above, the peak stress moves to the surface. Shakedown is most severe where the peak stresses from the wheel contact occurs, and is exacerbated by traction forces. This shakedown of the subsurface material can lead to subsurface material flow that when combined with a metallurgical imperfection, can lead to subsurface crack initiation [16]. As seen in Figure 9, exceeding the plastic shakedown limit causes ratchetting. Ratchetting is an incremental collapse of the material at the surface of the body in contact. The material exhausts its ductility and deforms, folding over into a weakened microstructure that is prone to crack initiation and material loss. The deformed material seen in the surface region of Figure 10 is due to ratchetting.

Figure 10: Ratchetting of rail steel in a disc sample. Material loss can be seen on the surface in the top of the image.

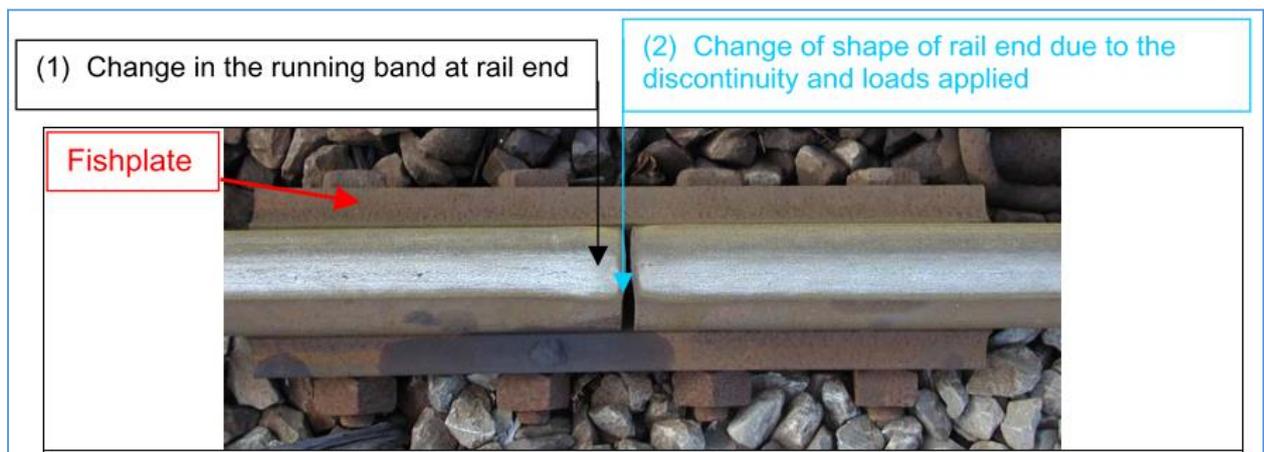
on the rail becomes very high as the wheel passes from one rail to another, causing material failure and plastic flow on the butt (end) of the rail. Another issue is that the bolt holes that in the fishplates and rail are exposed to high shear stress that leads to cracks forming at the edge of the bolthole and propagating outwards (Figure 18). This effect can be somewhat counteracted using a tapered drill-bit for drilling the holes, known as Cold Bolt Expansion. The drill-bit radius gets larger as it passes through the rail, introducing compressive stresses into the holes edge, thereby counteracting the tensile stresses experienced by the hole.

Figure 17: Aerial view of a two fishplates bolting two rails together. The deformation of the butt of the rail due to the gap between the rails is highlighted [34].

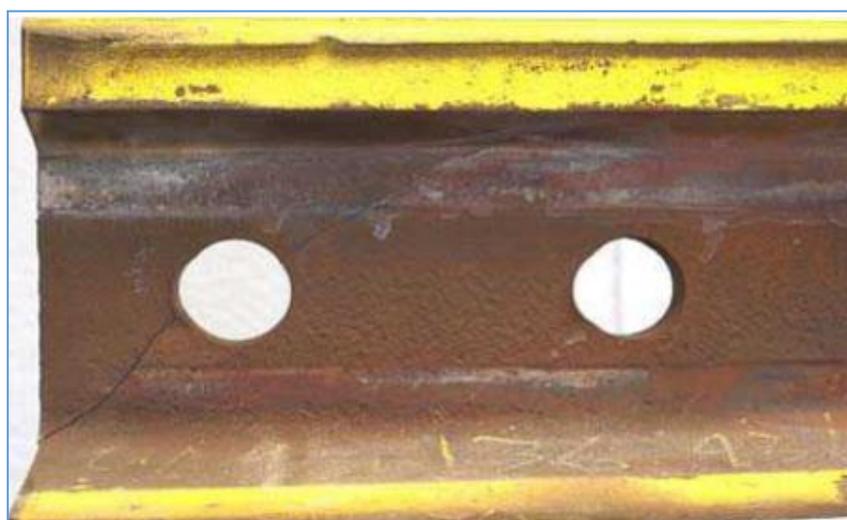
Figure 18: Bolt hole cracking [35].

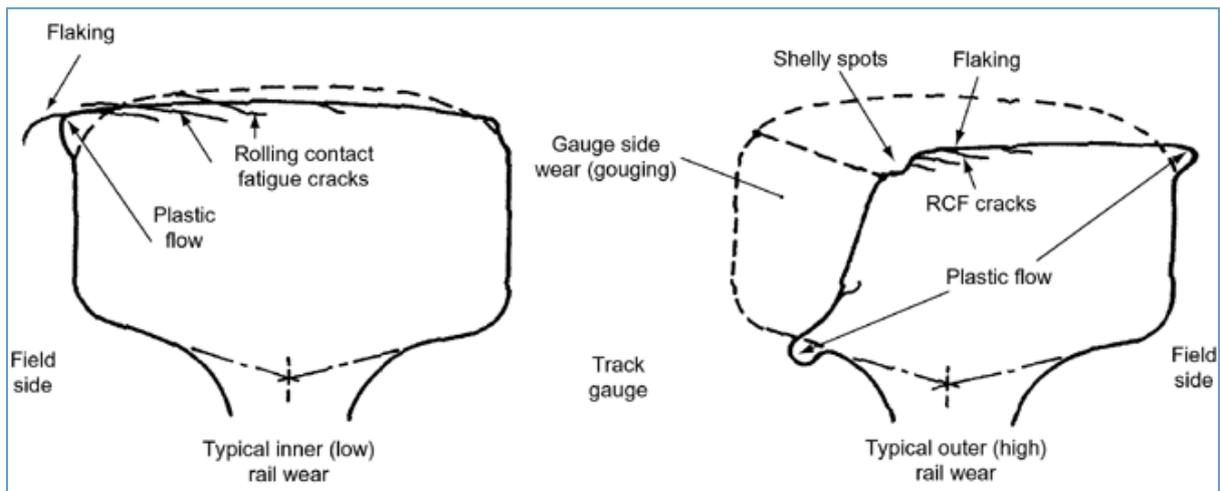
Figure 20: The effects of wear, RCF and plastic flow on a high and low rail profile. Grinding is needed to help to prevent this extreme degradation [37].

10 years [116]. Grinding was first introduced to remove corrugation, which plagued rails in the 1960s and 1970s [37]. Grinding involves the use of large grinding stones spinning as a group at various angles to remove the upper layer of the rail. This allows the removal of the damaged upper layer of a rail as well as the re-profiling of the rail back to a standard. If a rail is not re-profiled, it can become deformed (Figure 20) and provide very poor profile matching.

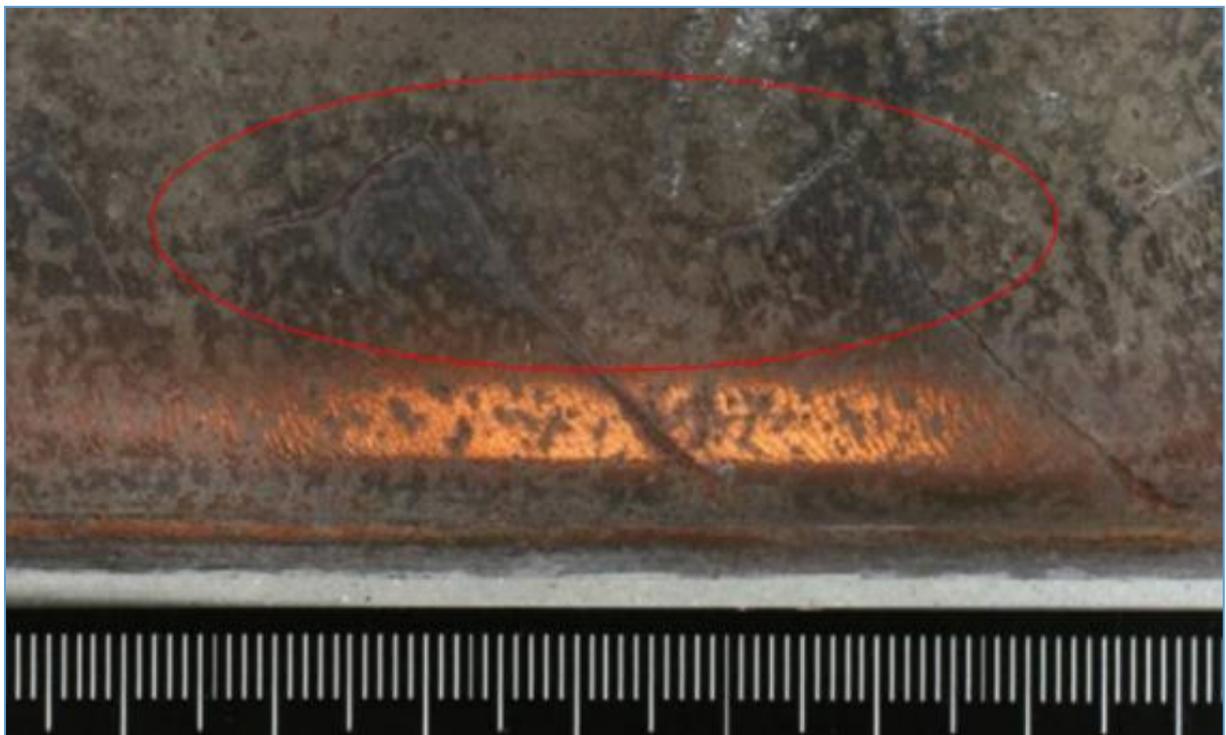
Figure 41: A GCC trailing into a Squat in a 370LHT rail. From a shallow curve in the Netherlands. The Squat is identifiable by the v-shaped cracks that are forming [76]. The GCC cracks are ~30mm apart, which is different from the cracks found in head hardened rail in Japan (Figure 42).

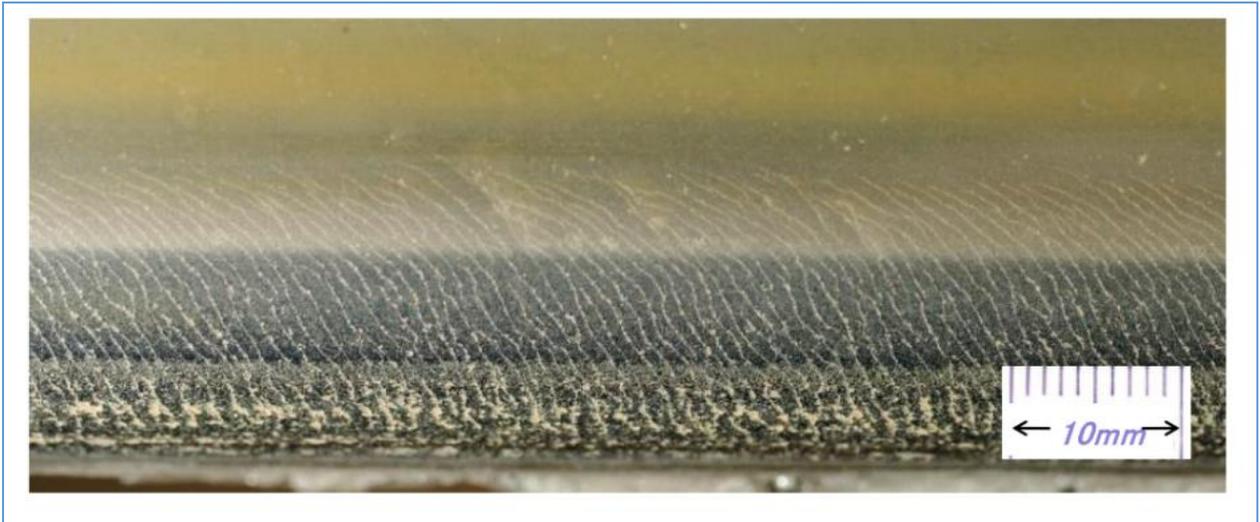
Figure 42: GCC in head hardened rail [84].

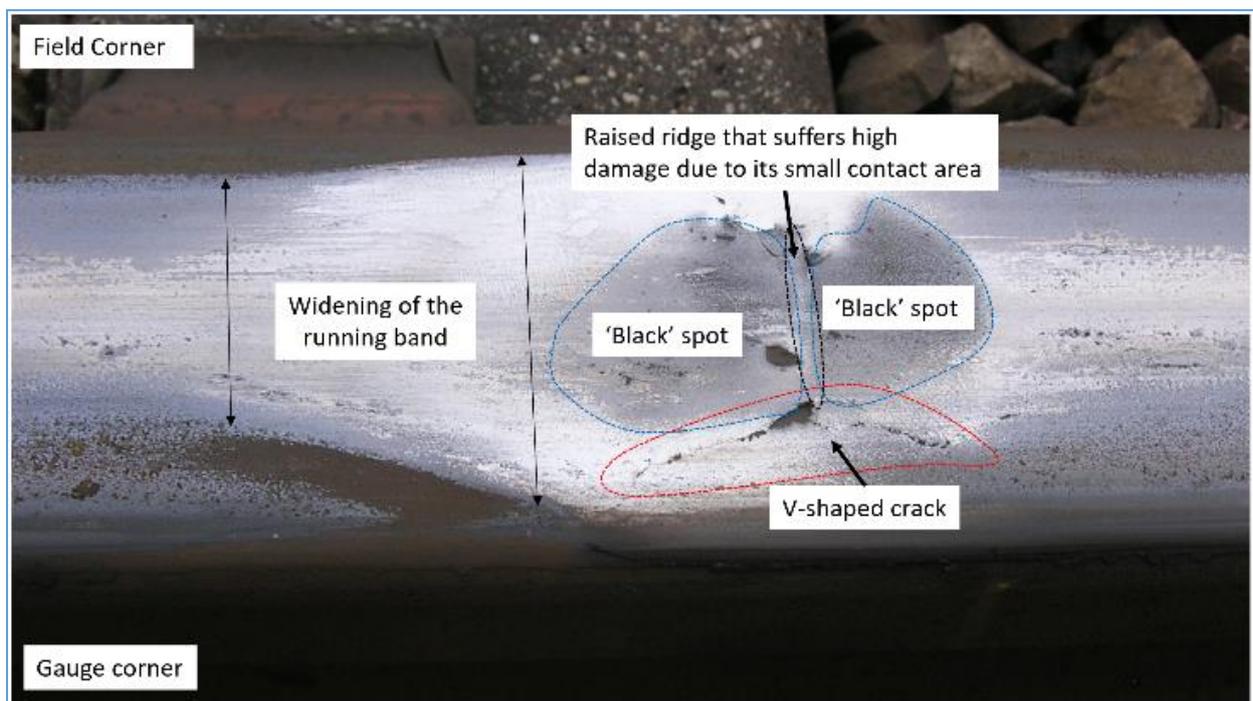
Figure 43: Typical features of a Squat. Original image courtesy of British Steel.

likely to be a Squat, especially if there is widening of the running band and a surface crack near them (Figure 43). Sectioning the rail to reveal the crack paths can clarify this. A non-destructive technique (NDT) is also possible by CT scanning the initiation site [101], [102]. This allows a 3D inspection of the crack structure without making irreversible cuts into the defect.

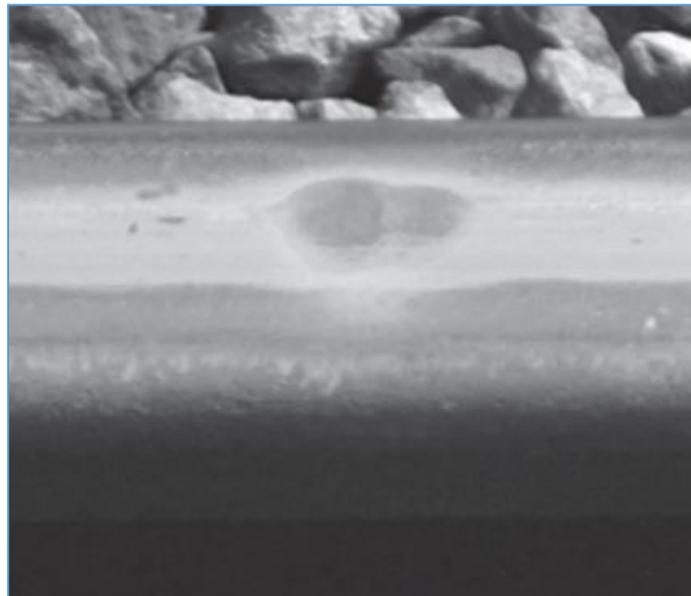
Early stage Squats can share similar features to wheelburn due to the presence of WEL, making Squats harder to identify. Squats have developed from wheel burns [96] as seen in Figure 44. So perhaps a wheel burn could also be considered a precursor to a Squat developing? Alternatively, perhaps this is a developing Stud instead? A review of Squat research suggests a continuum from Squats, through Studs and into wheelburns and finds thinner WEL with lower carbon contents, so low carbon bainitic steels could be a solution [48].

Figure 44: A Squat developed from a wheelburn [96].

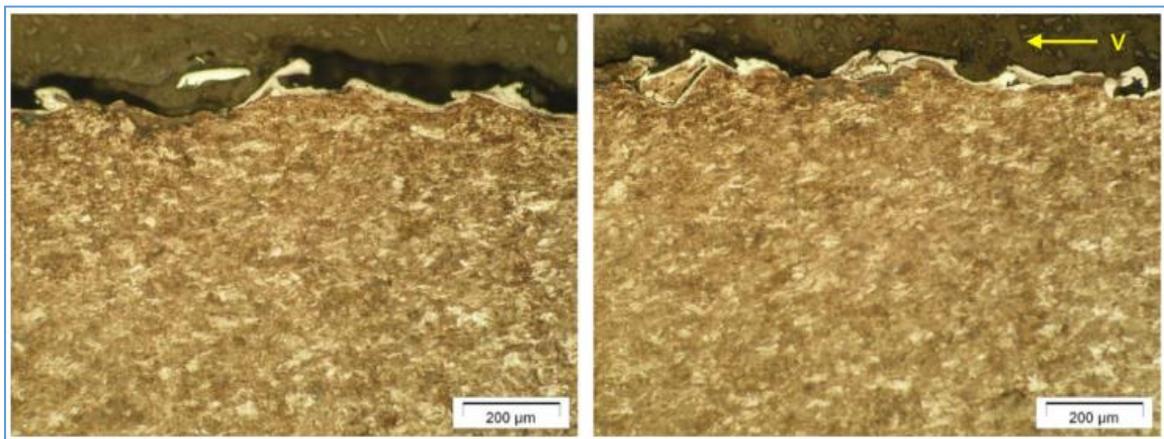
Figure 45: WEL immediately after grinding on a R260Mn standard rail. Images are of the longitudinal orientation [80].

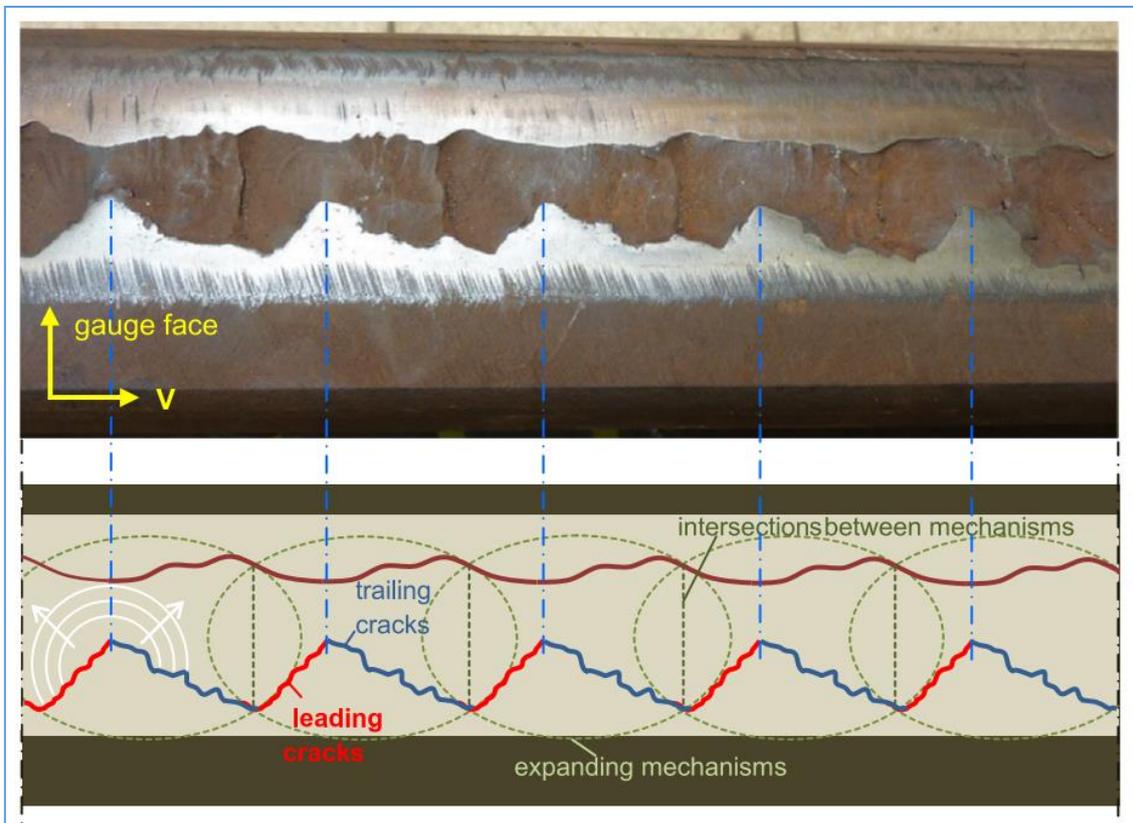
Figure 52: Periodic Squats that have fully developed and shelled. Although this looks like a case of severe shelling, the V-shape cracks made up of leading and trailing cracks make these Squats [8].

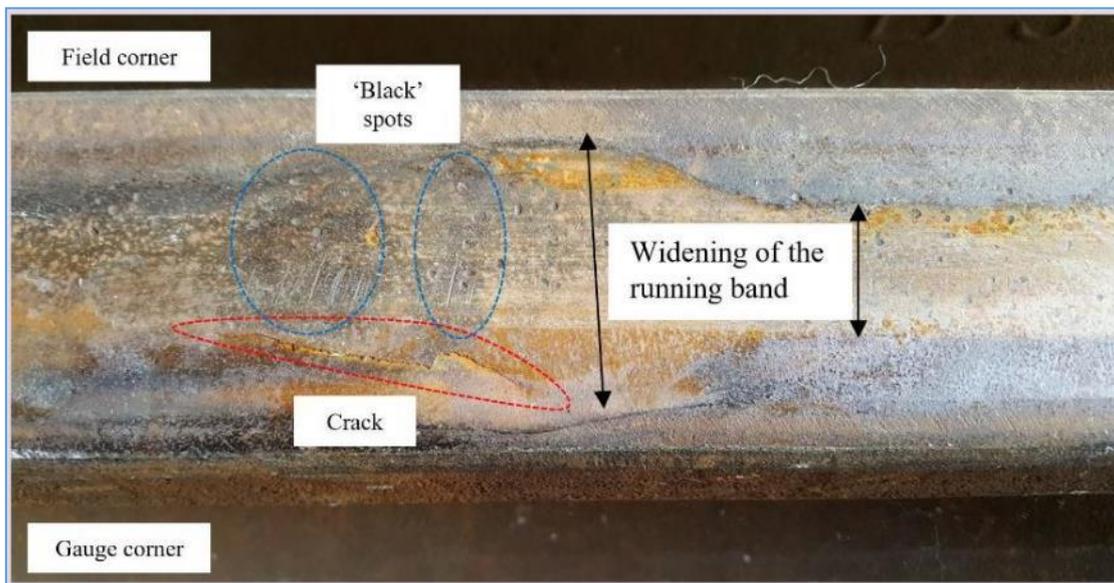
Figure 53: A Stud from a metro line with the widened band, large crack on the gauge corner (bottom of image) and a smaller crack on the field side. There is not much obvious surface plastic flow and the rail has little wear.

Looking at the surface in Figure 53, Studs also have a widening of the band just like Squats. The surface is smooth in both directions due to the lack of ratchetting [30], as opposed to rough in one direction. They can have surface breaking cracks just like Squats and the subsurface crack structure is very similar to a Squat as it branches down in an inverted V-shape. There are noticeable black spots on the surface due to the subsurface cracks, but without the plastic flow. High contact stresses on the thermally damaged surface area leads to cracks on the surface, either on both the gauge corner and field corner sides of the defect or just on one side, depending on the contact patch [94].

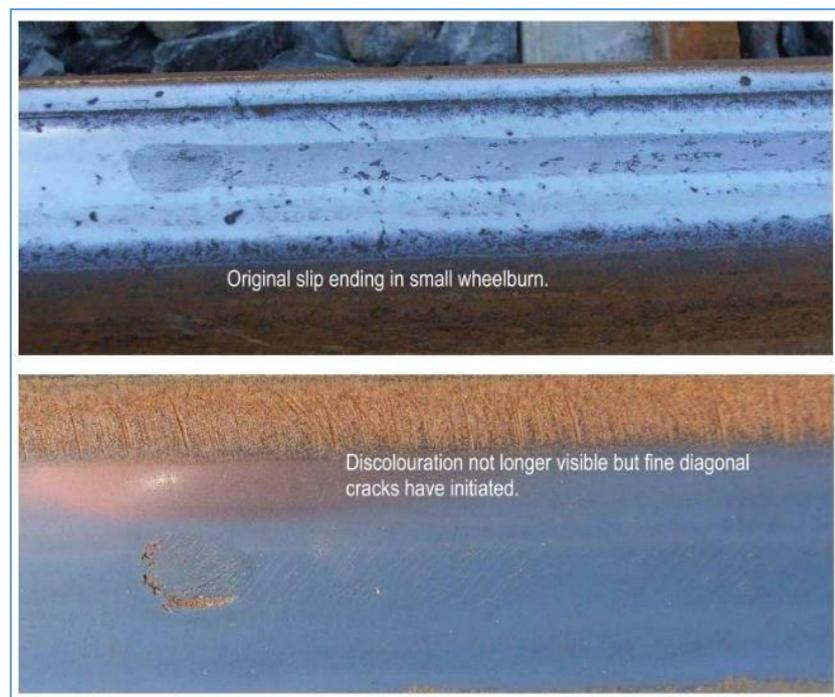
Figure 54: Damage/ WEL caused by slip that resulted in cracking of the surface in the future. Above) Just after the event, depicting the contact band for the wheel. Below) 11 months after the event [107].

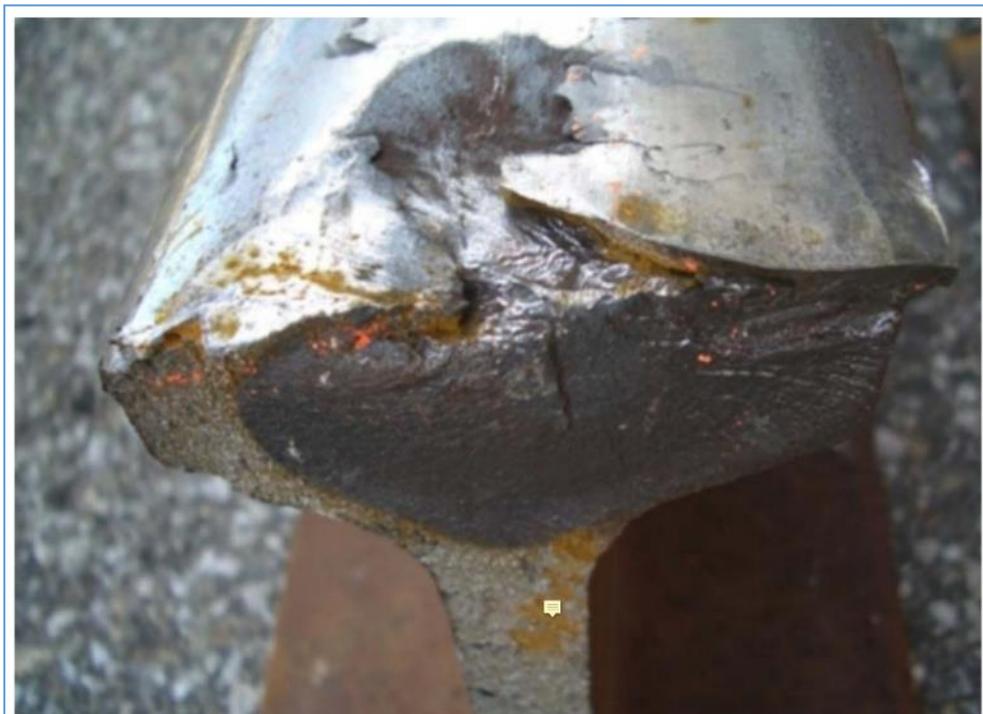
Figure 56: Engine burn fracture [109].

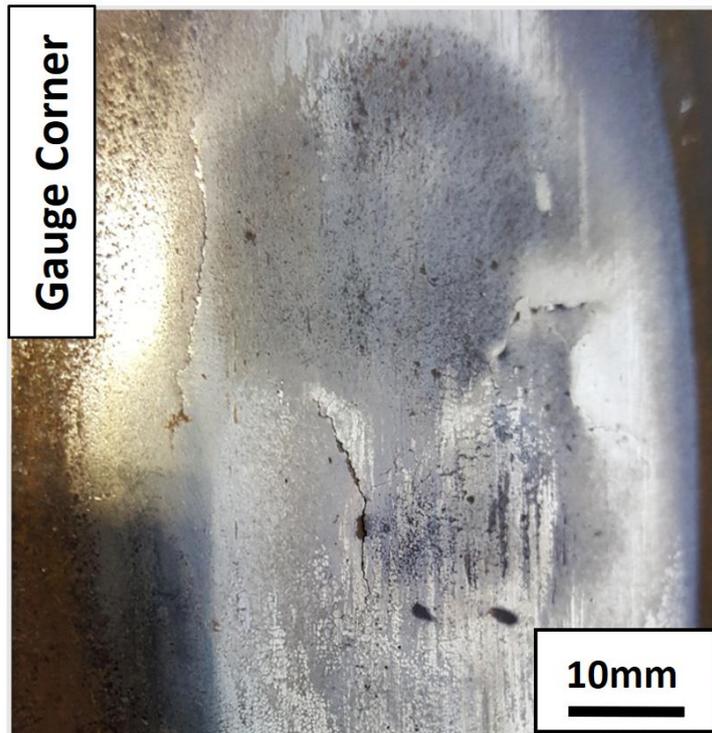
Not much is known about the track location and traffic experienced by Sample 1 (Figure 77) other than it was from an inclined track near a station on a metro line. It shows signs of sliding surface damage and the dark spots are quite well developed. It contains a lot of surface damage including four obvious surface cracks, streaks of white etching layer (WEL), a pit in one of the cracks, what seems to be ‘snakeskin’ damage just outside the widened running band. ‘Snakeskin’ is also known as running surface checking or flaking and is a precursor to spalling of the rail surface [6]. There is also the very common V-shaped crack that Squats are known to exhibit, although the angle within the V in this crack is more obtuse than expected. There is a faint series of small cracks along a ridge that extends from the apex of the V-shaped crack out between the two lobes which is often observed as Squats develop [7].

On initial inspection, the presence of some lipping on the gauge corner of the sample combined with the typical black spots and v-shaped cracks, made this sample appear to be a Squat. The features that makes it more likely to be a Stud are the lack of any significant WEL on the surface of the rail and the minimal plastic deformation. The only plastic deformation found was in the vicinity of cracks and the decarburised lip on the gauge corner. The decarburised lip suggests strong gauge corner contact during sliding conditions and so the inclined track may have also contained a curve.

Figure 77: The surface of Sample 1. The dark regions are corroded as the surface has depressed and the bright areas show where wheel contact has occurred recently.

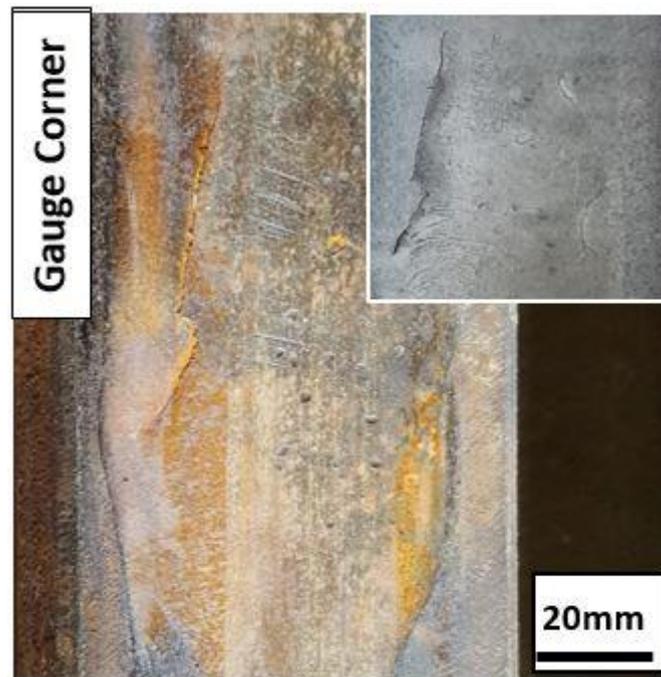
Sample 2 is shown in Figure 78, and is post MPI (magnetic particle inspection), a non-destructive test that uses magnetic ink on a white contrasting background to highlight defects in the surface. The expected V-shaped crack typically seen in a classic Squat is present in two locations, signifying the possibility of two defects. The overall defect is well developed as it contains a long crack on the gauge side where the crack plane has surfaced. The crack also has sharp edges unlike the embedded cracks found on the other samples, possibly a sign that the crack surfacing is very recent.

Sample 2 also has significant pitting/ discrete material removal. These look like corrosion pits, but are more likely localised delamination and flaking characteristic of “ratchetting” [8]. Ratchetting is incremental plastic deformation of the upper surface of the rail material due to cyclic strain build-up. These pits are discussed more in Chapter 5.

Figure 78: Sample 2. Inset) magnetic particle inspection image (MPI) to show the cracks

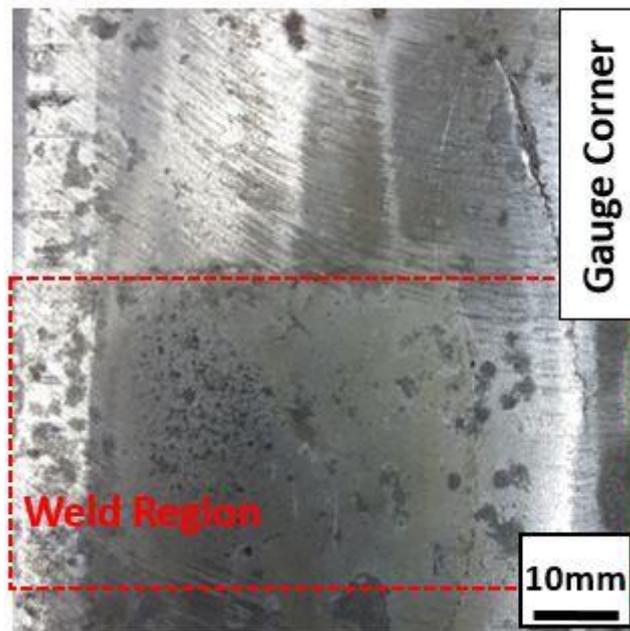
Sample 4, shown in Figure 80, was identified by the track operator as a Squat on a weld. Following an initial ultrasound test after its removal, it was believed to be a combination of a Squat interacting with a weld defect. The longitudinal crack that runs along the edge of the sample shows that the Squat is slightly elongated, possibly linked to the higher train speeds [10]. The lack of deformation in the Squat and the traffic total of ~28MGT makes it likely that this is in fact a Stud, although a study has shown that 17% of Squats are found at welds [11].

Figure 80: Sample 4 formed on the edge of a alumino-thermic weld.

As with Samples 1 and 2, Sample 4 has a large crack on the gauge corner side, but not the v-shaped crack that is usually expected of a Squat. The sample showed extensive grinding marks across the surface, not including the depressed region of the defect, which was in the weld region. Grinding marks were more extensive than the other samples, but this could simply be because grinding had occurred more recently. Grinding marks and other features that increase the roughness of a surface, such as crack mouths and the pits seen in Sample 2, can increase the subsurface stress by a factor of eight compared to smooth surface contact [12].

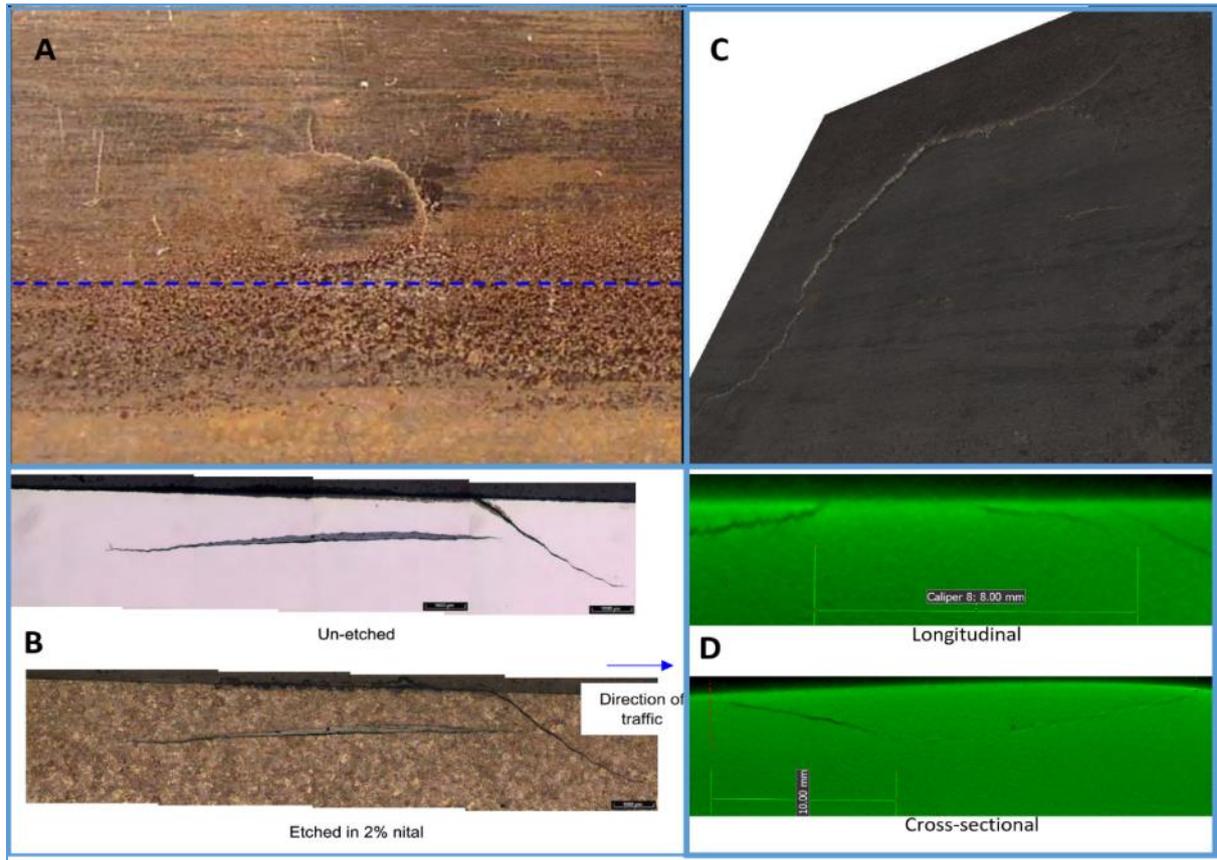
Figure 83 shows the Y-shaped cracks in Sample 1 and the Tata Steel report as surface and subsurface defects. As the Y-shaped crack was the only surface crack in the Tata Steel report it can be assumed that this crack forms first. The shallow depth of the defect in the report compared to Sample 1 also suggests that Sample 1 is much more developed. Both samples are believed to be from the same metro network. The presence of the two cracks suggests the possibility of one crack initiating subsurface whilst the other initiated on the surface. Using the X-ray scanned volume that Figure 83d was taken from, it can be seen that moving through the sample towards the field corner shows that the cracks stay separate, although they may have connected within the region that was worn away. Moving through the sample towards the gauge corner shows the two cracks connecting as a very shallow crack parallel to the surface that makes up the bottom portion of the Y shape (when viewing the Y as written here).

Figure 83: Comparison of features of a Squat from a Tata Steel report [13] with scan results from sample 1. a) The surface of the Squat from the report, b) Longitudinal cross sections from the report, c) Surface scan from Alicona of sample 1, d) Longitudinal and cross sectional X-ray scans of sample 1 (blue dotted line shows where orthogonal slices cross).

Comparing images from the report to the scans makes it highly likely that the initiation was in this area, and the branching of the longitudinal crack occurs within 4mm of the longitudinal slice in Figure 83d, moving towards the gauge corner. Given that the Y-shaped crack is closer to the field corner than the gauge corner suggests that a two point contact between the wheel and the rail may have been responsible. High surface temperatures occur with lower creepage and train speed when the contact patch is reduced like in a two point contact [14]. Sample 2 also contains a similar Y-shaped crack in a similar region but the clarity of the two cracks is not as clear, although a higher resolution scan of that area is planned for future work due to the branching of a possible transverse crack being in the same region. The L-shaped crack tracks the boundary between the dark lobe of the Squat and the shiny surface of the running band, it

also appears to contain islands of a different phase of steel, possibly martensite. This crack will be the subject of further investigations.

The presence of Y-shaped surface cracks on the field side of Sample 1 and 2 matched an early stage Squat from the literature (Section 4.5.1, Figure 83). A crack developing early on the field side of the rail can be explained by hollow wheel profiles. Hollow wheel profiles were confirmed as being present for sample 2, highlighting the need for good wheel-rail profile conformity to distribute the load evenly.

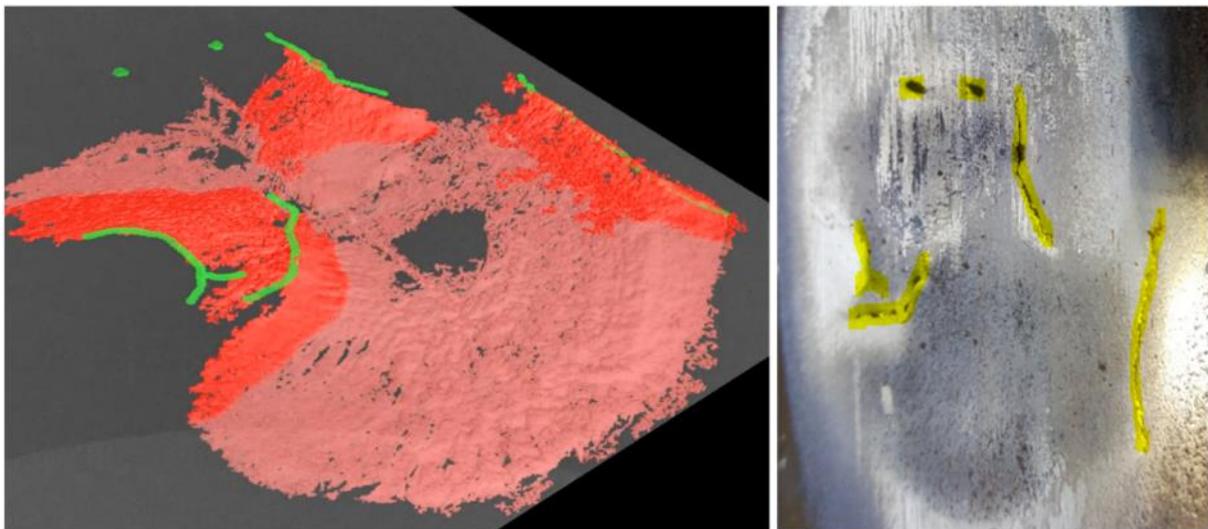
Figure 84: Left) A model of the crack plane in sample 1, created in VGStudio MAX. Right) a photographic reference of the surface cracks that are green in the model and yellow in the photograph.

Figure 84 shows that the basin of the crack plane with the hole in the centre lies directly beneath the larger dark corroded lobe. The other basin is not as developed and this is mirrored in the smaller size of the corresponding dark lobe near the two spots. The crack plane continues through the hole in the centre of the model: this region is undetectable by the automatic construction module, but the crack was discernible by eye. The crack plane also extends slightly further beyond the two green dots on the model but not in enough clarity to be automatically detected. Beneath the smaller basin is another crack plane that only showed up faintly in the scan.

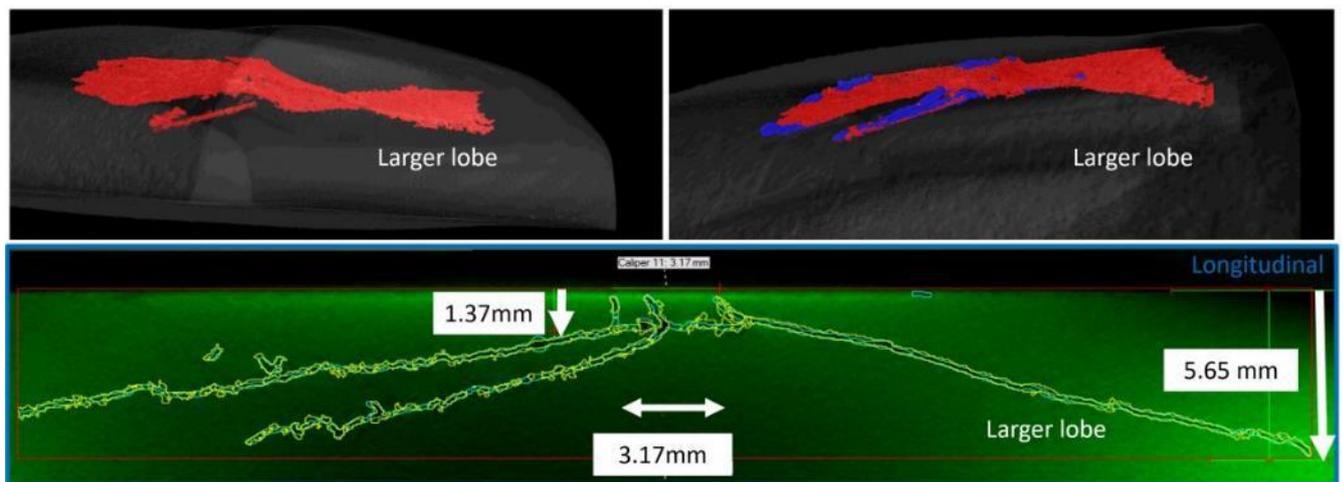
Ultrasound also struggles to detect these lower cracks, which is part of the reason they are so potentially dangerous. In Figure 85 the lower branch was visible to the human eye and there were enough dark voxels to be able to determine its path so blue colouration was added to the model to show where manual additions had been made, as these are subject to user discretion whereas the automated function is repeatable by any user.

Figure 85: Upper) Models of Sample 1 showing the crack that branches downwards slightly, with the automatically detected sections in red and the manually added sections in blue. Lower) An orthoslice of the defect showing the lower crack after being manually highlighted.

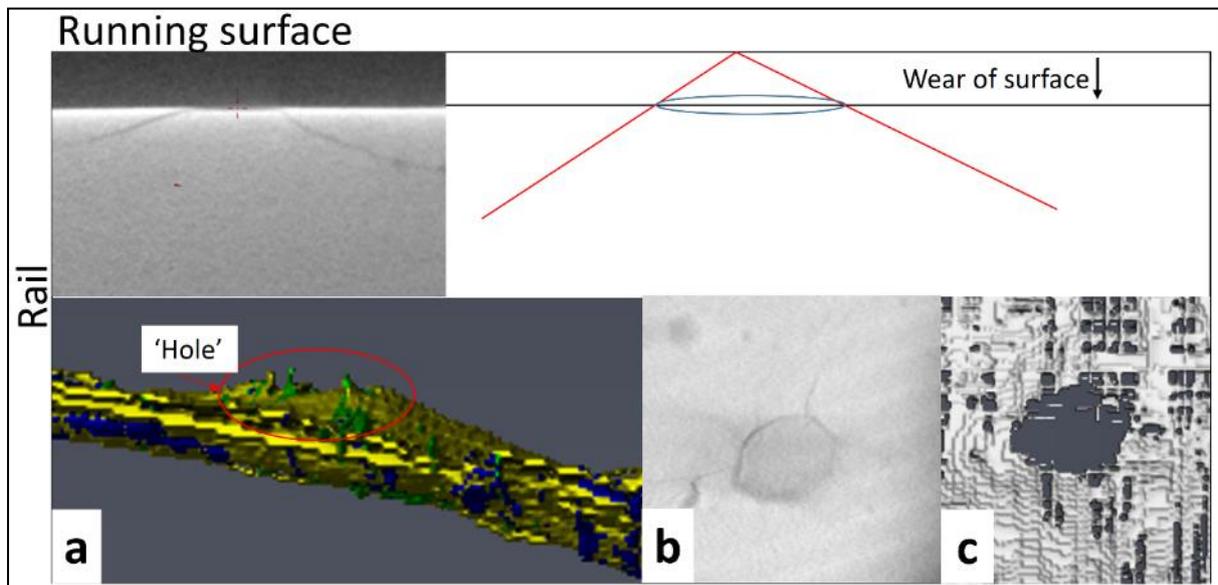
Another detail that showed through the full construction of the models was that the ‘O’ shaped cracks found in the centre of the surface of Sample 2 was the location where the inverted v-

shaped crack had been truncated by wear (Figure 86). Sample 1 did not have this feature but Sample 3 had a surface breaking crack in the same region but of a different morphology.

Figure 86: A diagram showing how wear truncates a pair of cracks to leave what is seen in the scan slice. Inset; a) The 'hole' from the longitudinal view as modelled in the Avizo model of sample 2, b) The original scan image of the surface of sample 2, c) The same view as (b) from the Avizo model.

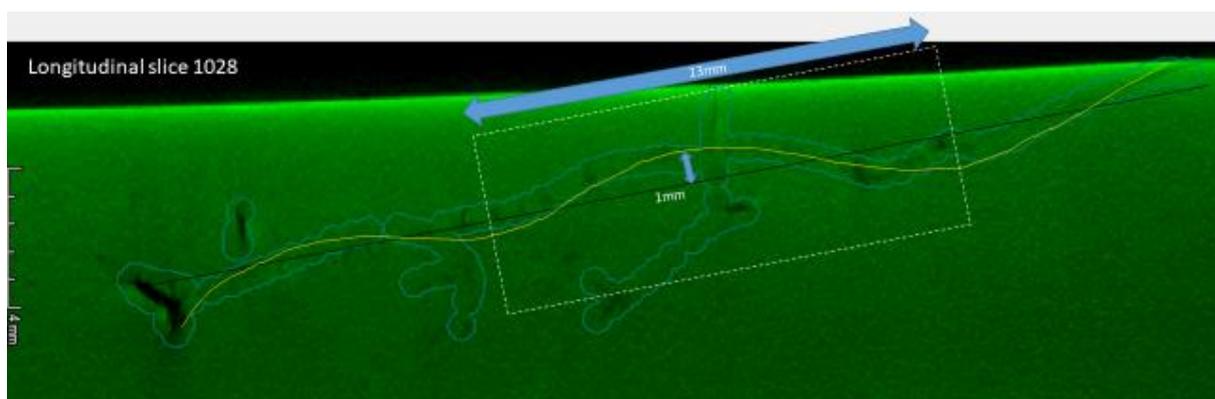
Figure 87: Longitudinal orthoslice of the downward branching section of sample 2. The crack follows a waveform pattern of roughly 1mm amplitude and 13mm wavelength.

Sample 2 had much more damage than expected. Figure 87 shows a longitudinal section from the scan, although the resolution of the scan is low due to the size of the sample, parts of the transverse crack can be discerned up to 8mm deep into the railhead. Cracks can be seen

reaching 10mm deep in other regions of lower clarity. The waveform of the defect was noticed after the initial crude model was built, though this observation is not pursued further within the scope of this work. The automated crack detection method developed for this work was used to build the model for Sample 1, detailed in Chapter 3. This method was not successful for the full defect scan of Sample 2 (Figure 88). Therefore, a higher resolution scan was needed in the downward branching region of the defect. The aim was to identify the region that caused the crack to start growing into what could become a transverse defect.

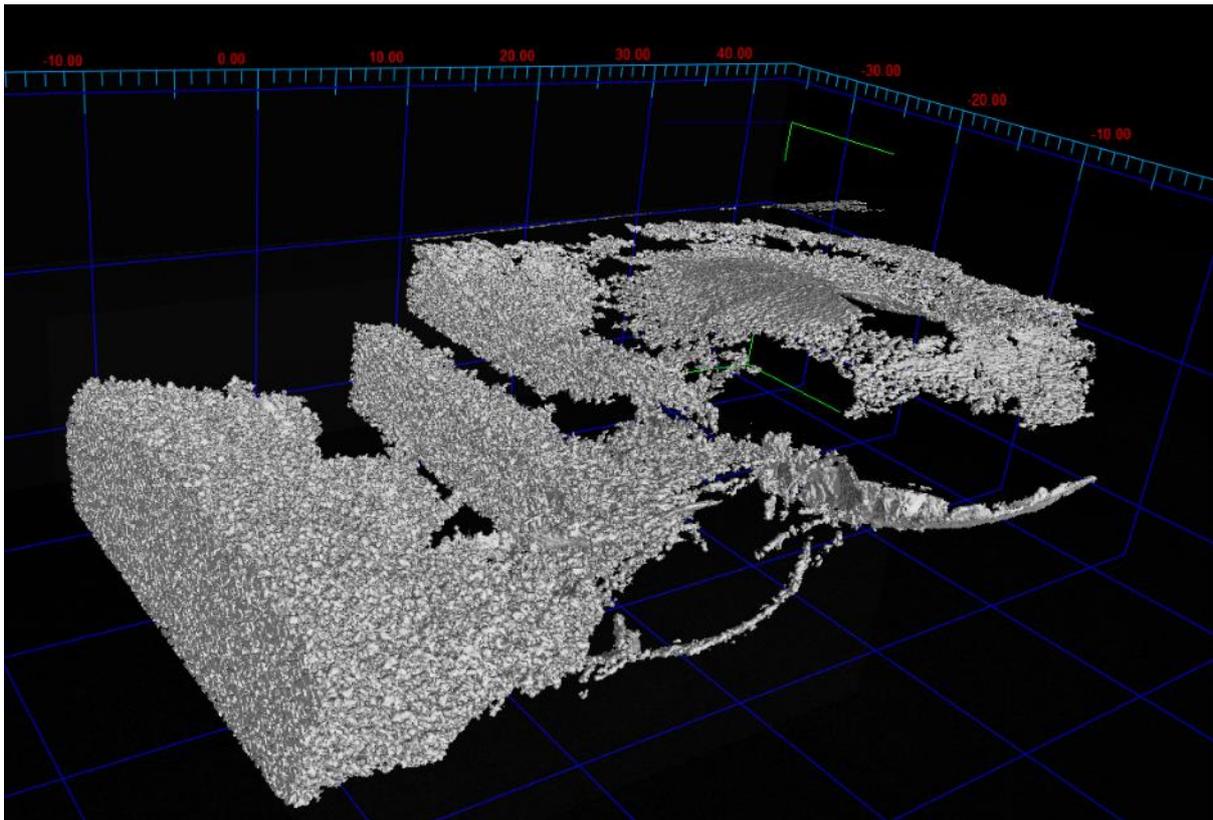
Figure 88: The result of attempting to use the automated crack detection method on Sample 2. Although the top right portion shows detection of some of the main crack plane, distinguishing between the many branching cracks was very difficult. The bottom left portion of the structure was the subject of the higher resolution scan.

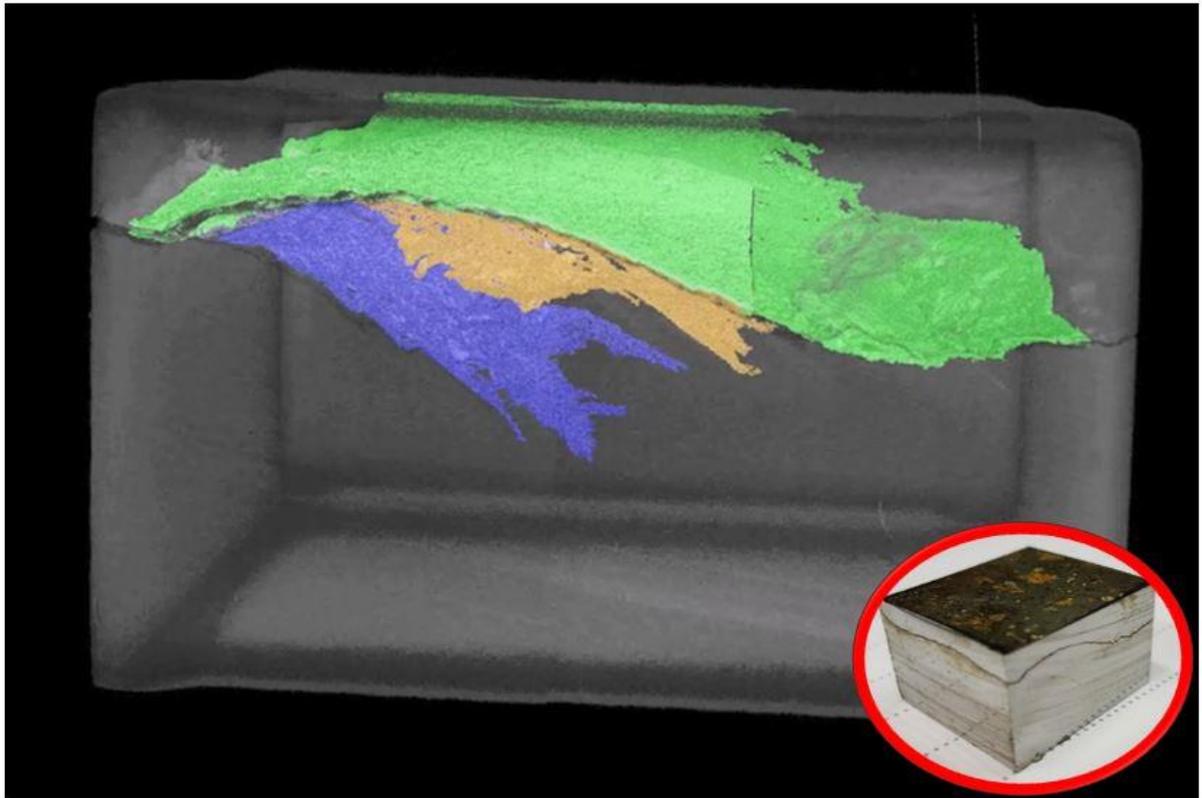
Intermittent shadows, which may or may not have made up a continuous crack in the full defect scan, were clarified in the detailed scan as being multiple crack planes branching out like the roots of a plant. Figure 89 shows the model with the main three crack planes showing the upper crack plane in green with two branching downwards in yellow and blue. The two separate branching cracks were hard to discern initially as they link together later in their growth. One side of the crack model was very different in its general shape to the rest and the deciding factor in this dilemma was the discovery of the downward cracks origins. Their origins, or initiation sites, are discussed in more depth along with their causes in Chapter 6. Various crack planes were left out of Figure 89 for clarity including surfacing cracks, but the extent of the branching can be seen in the semi-transparent model in Figure 90.

Figure 89: A simplified model created from the high-resolution scan of the region of interest within Sample 2. Inset: the region of interest cut from the defect showing the curved crack that is green in the model.

Isolating the main crack plane (green in Figure 89) and applying a plane parallel to the surface provided a sense of depth, improving the visualisation of the cracks topography. It showed that as well as growing longitudinally deeper into the rail, it grew upwards to the right, and probably left to create the surface cracks seen inset of Figure 91. This is no surprise but it is unclear if the defect began subsurface and grew up towards the edges or if it began on an edge and grew down into the rail.

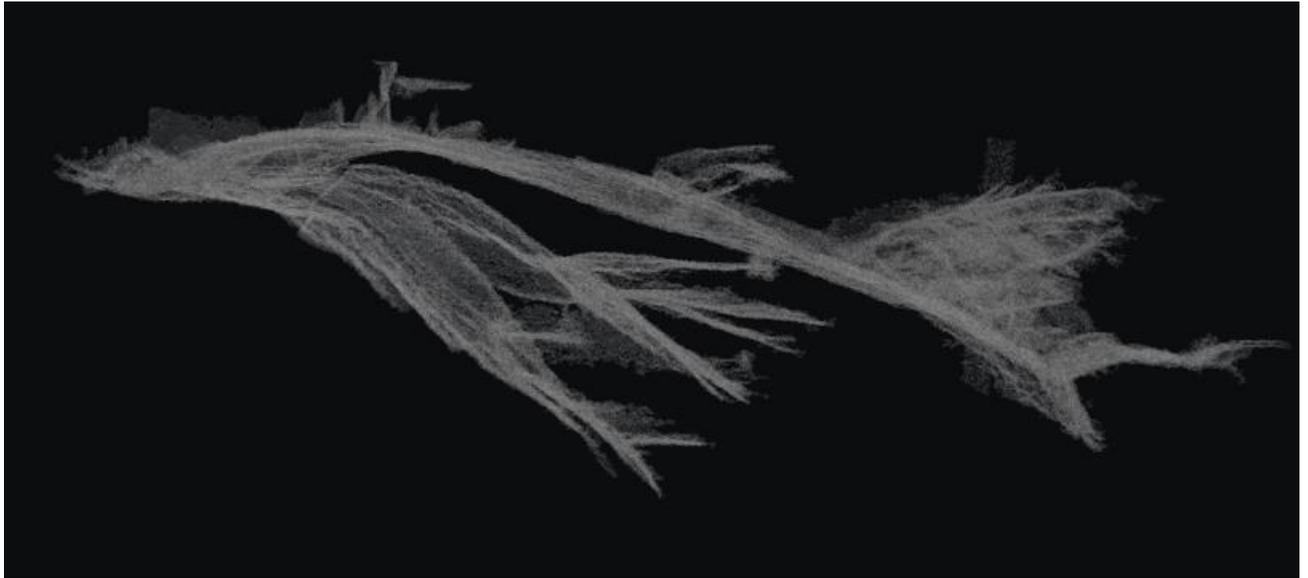
Figure 90: The same model as Figure 89 but showing all cracks to demonstrate the extent of the crack network that resembles a lightning pattern in the way the crack propagate.

The blue downward growing crack developed at quite a steep angle to the surface, to the extent that it was highly likely to have become a rail break if it had not been removed as diligently as it was. The cause of this potentially disastrous transverse defect became a key focus of this work, as solving the mystery of why some cracks grow downwards whilst others resurface and shell could greatly reduce the potential risk of these defects. Chapter 5 microscopically investigates the paths that cracks take through the microstructure and why they branch. The origin of the downward branching cracks is covered more in Chapter 6.

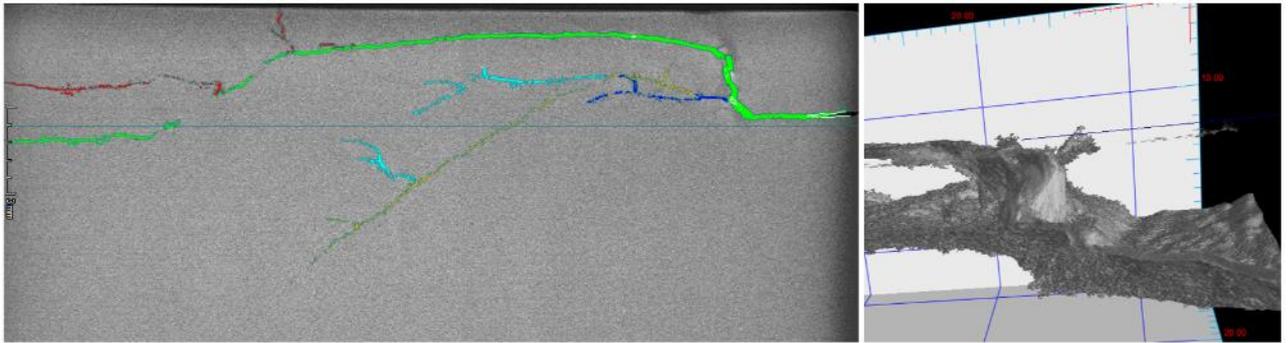
Taking a longitudinal view of the crack plane, from right to left of the perspective in Figure 91, shows that where the crack reaches the surface on the right (marked by red dashes), the morphology is erratic. If the crack was well developed and was resurfacing as the last stage of the crack growth it would expect to be a fairly smooth planar shape, like the deeper regions of the crack in Figure 91. Instead, it consists of a cliff-like feature (Figure 92) formed from a vertical crack with horizontal cracks branching from its base and peak. The cracks branching from the vertical crack are quite wide suggesting they are from earlier in the defect's development. It is more likely that the vertical crack formed first and then cracks grew horizontally away from it, rather than the crack took two sharp turns. The vertical crack is investigated using metallurgical techniques in Chapter 5.

Figure 92: The cliff-like feature made up of a vertical crack with horizontal cracks branching from it. Left) A 2D orthoslice taken from the post-processed volume of the high-resolution scan (scale bar = 3mm). Right) The ‘cliff’ isolated from the 3D model (grid is in mm).
