Micro-CT Scanning in the Investigation of Squat Defects in Rail Steel

Shaun Earl

*Submitted for the degree of Doctor of Engineering in the
Department of Materials Science and Engineering at the
University of Sheffield, UK.*

January 2021

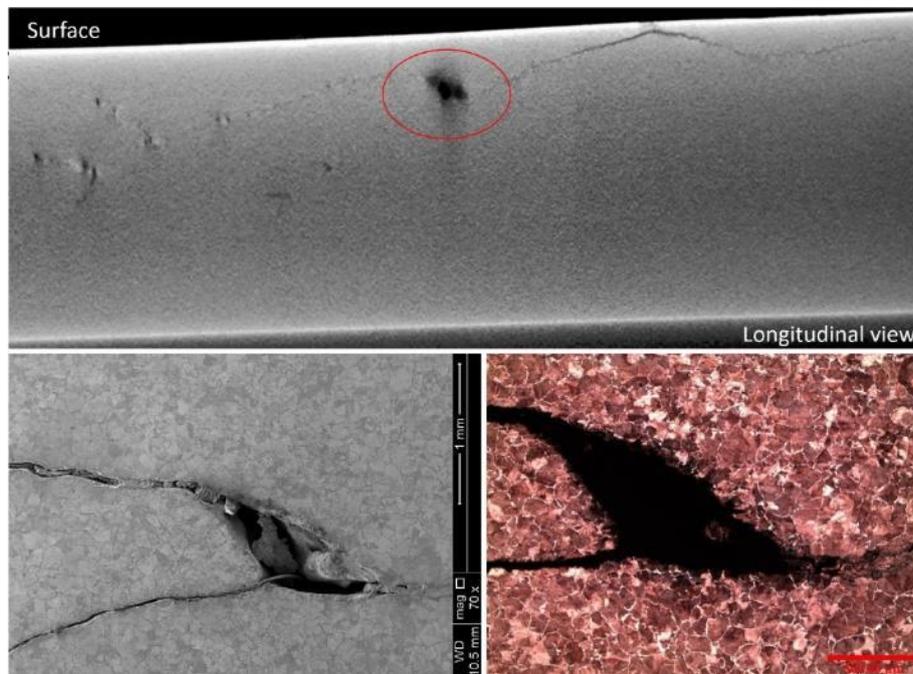
A second potential initiation site was also identified. This site appeared as a void in both the scan, optical and SEM images (Figure 93). This was identified as a crucial feature as it is where the transverse defect, that could have broken the rail, initiated. The reasons for why the void was believed to be an initiation site, how it developed and its connection with the transverse defect are discussed in depth in Chapter 6.

Figure 93: Above) The void (circled) from the CT volume of Sample 2 creating a large shadow. Below) SEM and optical images of the void showing the transverse defect growing from the bottom left corner of the void.

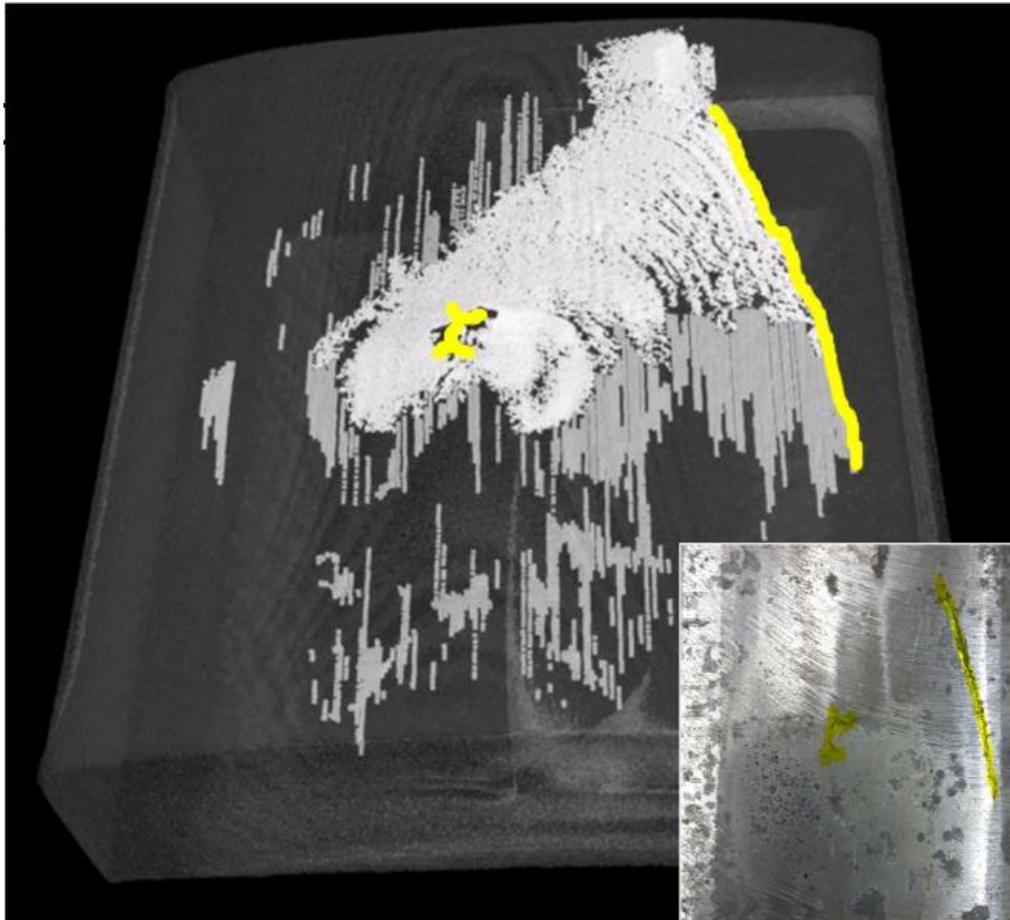
Sample 4 had much less damage than expected, based on the results of the ultrasound tests. The ultrasound gave reason to expect a weld defect as well as the surface defect. However, there was no sign of a weld defect in the upper 26mm of the head and the welds heat affected zone (HAZ) did not seem to have much influence on the crack planes overall morphology. The crack plane was extensive but travelled at a fairly constant angle with few deviations other than

the C-shaped hole (Figure 86a) where it probably initiated. This initiation is on the boundary between the weld and the rail.

Figure 95: The model of Sample 4. Common features with the inset photo are highlighted.

The clarity of the crack plane in the Sample 4 model was lower than the other two samples, with only the bright white area being automatically detectable. Other areas were noticeable and so were added manually (in dull white), but only the parts that were dark enough to be considered cracks. Reasons for the lower clarity may have been because this sample was 26mm deep compared to the 15mm of Samples 1 and 2 but the weld may have been a factor too. If the areas found were interpolated it would make quite a simple, non-branching crack plane that begins in the centre and breaks the surface at the edge. This simple crack plane morphology shows during traditional sample preparation and is covered in Chapter 5. This makes Sample 4 the most benign of all of the samples as it was the only crack network that did not branch.

Contamination in the very upper part of the weld is believed to be responsible for the initiation of the defect in Sample 4. The contamination consists of just a few spheres/bubbles of unknown composition (probably gas or slag) very close to the surface. Cracks were observed between these spheres/bubbles.

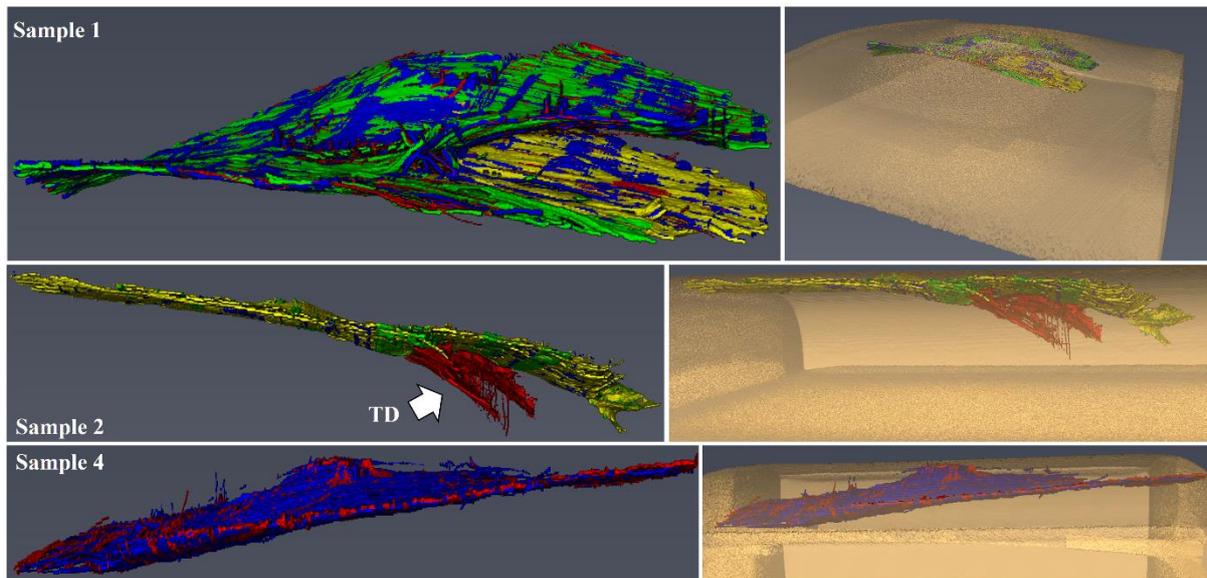
Chapter 4 has already shown that the three defects scanned all showed a different morphology to each other, as visualised in Figure 96. A fifth sample will be introduced in Chapter 6 that also has a different morphology, but this is because it did not develop a trailing crack.

Figure 96: Early models of the crack planes in Samples 1, 2 and 4. Both as free crack networks and inset into the rail: created by manual drawing in Avizo. Colours are not indicative of anything important. The red section of the crack network in Sample 2 is the TD.

It was shown visually in Figure 96 that the overall morphology of the defects share the familiar inverted-V shape seen in the literature on Squats, but vary as they develop.

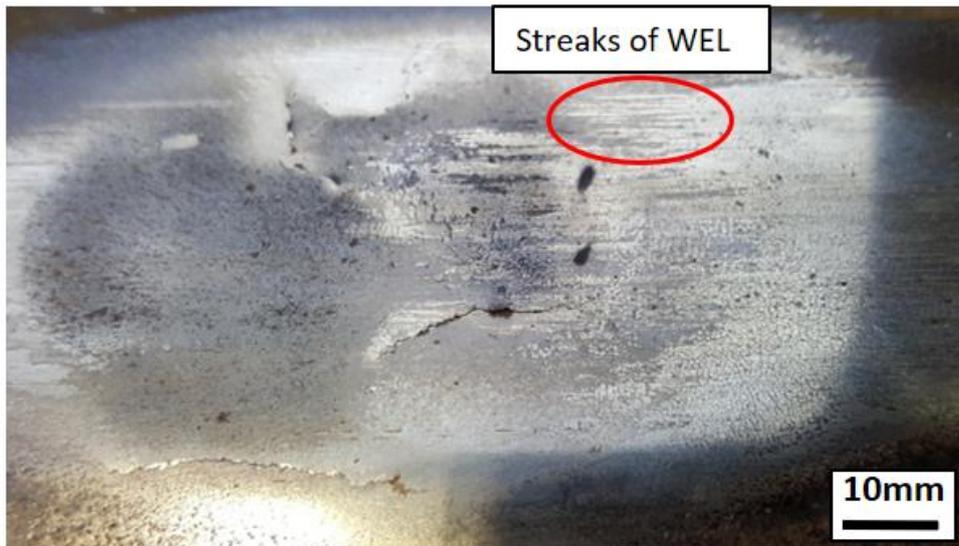
WEL varied in its appearance; it appeared as both islands and long stretches, with distinct and diffuse boundaries, often within the same sample. An aerial view of the railhead showed long streaks of WEL and some are visible as contrast in the right image of Figure 97. This is probably partly explained by whether the sample is cut in parallel or perpendicular to a streak. The other aspect to consider is that WEL breaks away easily due to its brittle nature. Figure 98 shows one of the more unusual WEL areas found and is taken as a longitudinal slice from between the crack with a pit and the more central of the two black spots (refer to Figure 97). It shows a bright white, fairly continuous band of WEL that seems very brittle as it has spalled in several places. This is on top of another layer of WEL that covers 1.5mm of the 2.5mm long sample. This lower layer has a distinct boundary with the bright upper layer and a more diffuse boundary with the parent steel. The lower layer also seemed tempered by the upper layer, theorised from the darker shade of brown in its upper portion. The dark brown layer was not an etching effect, as it did not exist where the WEL had broken away slightly. It was nano-indented to see if softening had occurred due to the tempering. The results were inconclusive because the sample needed a light etch to reveal where the layers were, but this etch affected the results of the nano-indentation. This multi-layer WEL suggests that the sample suffered multiple heat inducing events of different magnitudes, some possibly incrementally building up the thicker layer.

Figure 97: The surface of Sample 1 with bright streaks of WEL orientated in the longitudinal direction.

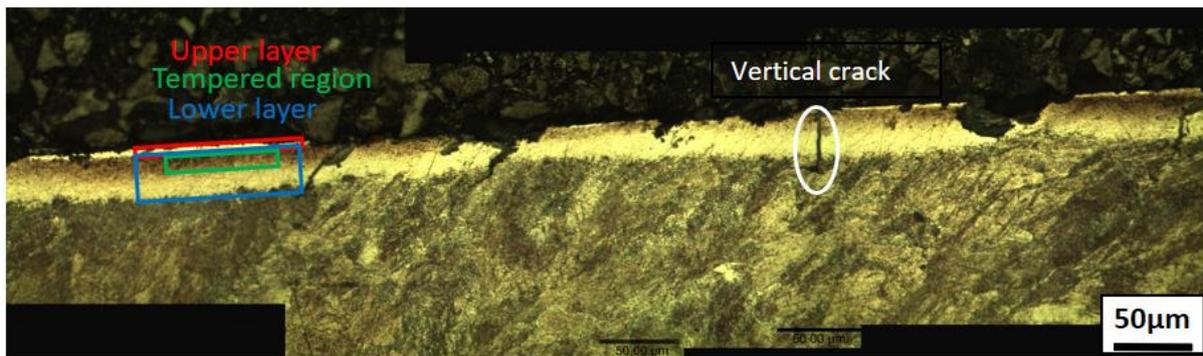
Figure 98: Two layers of WEL. A thin upper brighter WEL and lower duller WEL with a tempered upper surface. The upper layer is ~5 microns thick and the lower layer is 18-35 microns thick. Cracks grow vertically through the WEL and into the parent material.

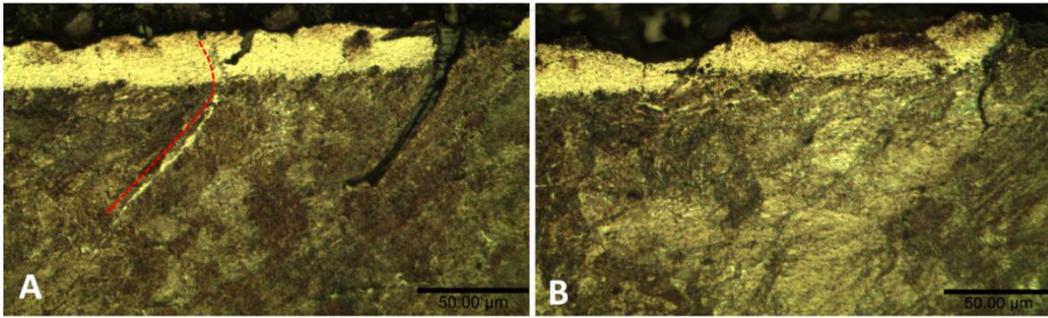
Figure 99A shows how ferrite, that has been retained within the WEL, provides weaker pathways for cracks to grow along into the parent material. This shows that cracking simply due to the brittle nature of WEL is not the only explanation for the presence of cracks. Retained ferrite is also seen in Sample 2, so will be discussed more when Sample 2 is discussed. WEL is not always smooth either as shown in Figure 99B, which was taken from just next to the crack with the pit. The rough WEL suggests it is a remnant of grinding, reducing the contact area to the peaks of the WEL.

Figure 99: a) Ferrite pathways for cracks to develop along seen next to a crack that has already formed in the same orientation, shown by the dashed line; b) Uneven WEL from within the running band. A crack can be seen where the WEL ends.

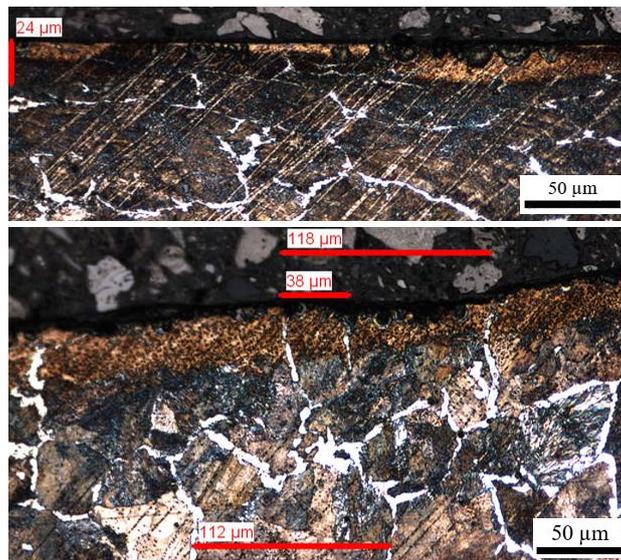
WEL was found at a fairly consistent depth of 5-10 µm in some locations inside and outside of the defect. There were some locations where the thickness of the WEL varied even in a very small area, such as in Figure 100. Figure 100 also shows one region that was found very close to the field side of the running band, where the widened band started to narrow again. This region contained WEL with the ferrite from the grain boundary still visible, also seen in the first documentation of a Stud [1].

Figure 100: Above) WEL thickness varying from 1 - 24 microns thick in Sample 2. Below) Ferrite grain boundaries still visible within the WEL.

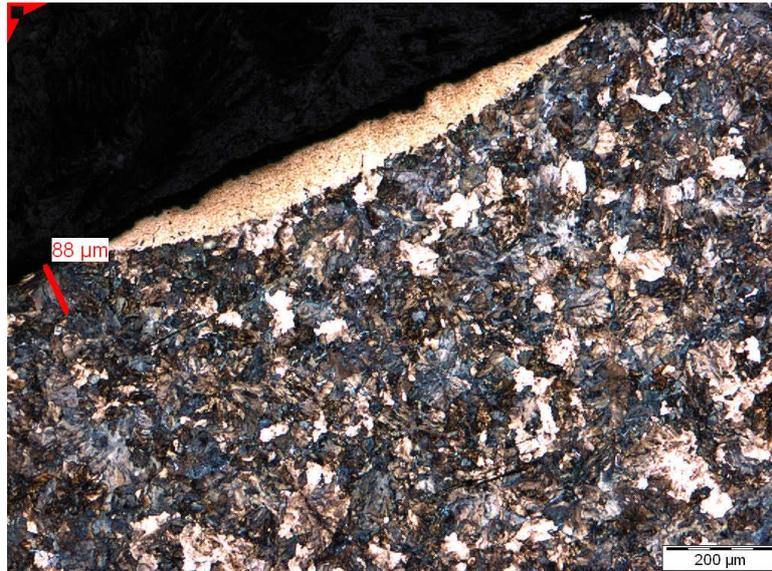
WEL was found in thick islands in cross sectional micrographs from the gauge corner of Sample 3 as shown in Figure 101. This is one of three discrete, but deep, patches of WEL from just before the defect / widening of the band. This is believed to be from rough grinding stones making discrete contact in the area.

Figure 101: Thick white etching layers on the gauge corner of Sample 3.

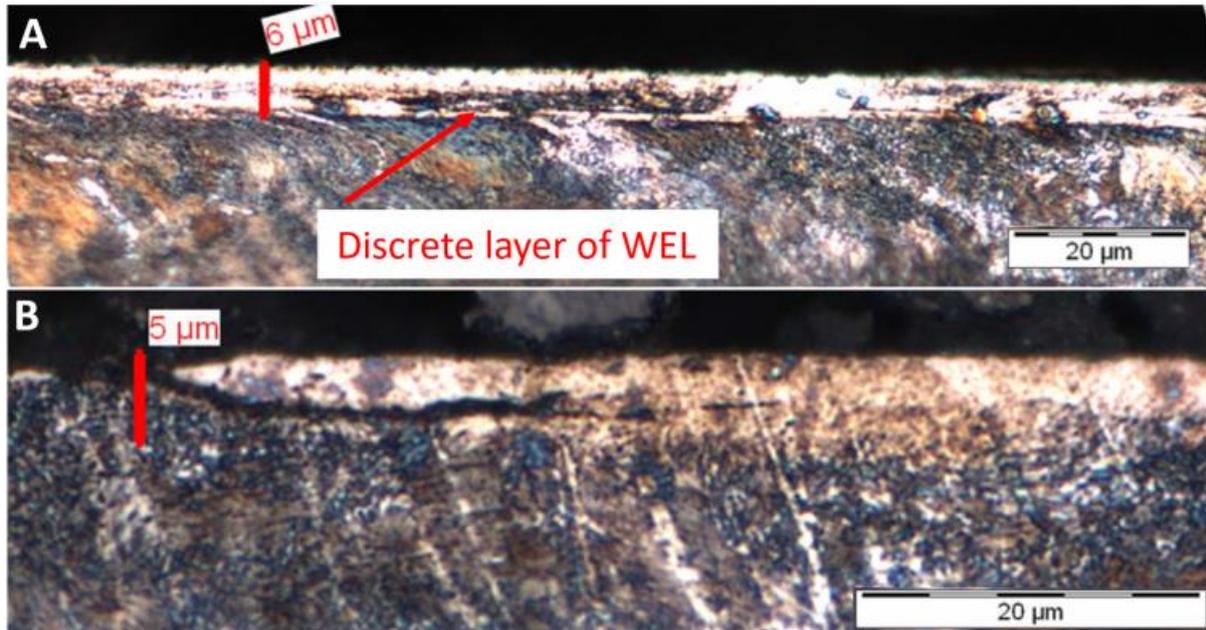
WEL was found at a very consistent depth of 5-7 microns inside and outside the defect (Figure 102). The visible grinding marks on the surface make it probable that this WEL is due to the grinding process. The WEL inside the defect had a more distinct boundary with the parent material compared to outside the defect.

The WEL from within the defect was also unusual because there was a layer of WEL within the parent material (Figure 102a). Creating such a discrete area of WEL through heating and cooling seems unlikely, as the entire region from the surface down to the discrete layer of WEL within the parent material should have transformed, like in Figure 102b. This suggests that an event occurred to cause high enough stress to create a transformation at a very specific depth. Lubricated surfaces transfer the peak stress to a deeper region than unlubricated. Strain or deformation induced phase transformations from pearlite to martensite have been recreated in

pearlitic wire [2] and stainless steel. Therefore, coupling the two aforementioned factors suggests that the lower layer of WEL was formed due to high strain causing a crystallographic change from pearlite to martensite. This mechanism has been proposed previously [3]. Replicating this strain-induced martensite in a rail could unlock valuable details about the contact conditions that cause defects. This is not conducted within this work. It should be reiterated at this point that this sample was from a high speed line.

Figure 102: a) WEL from within the defect. b) WEL outside the defect.

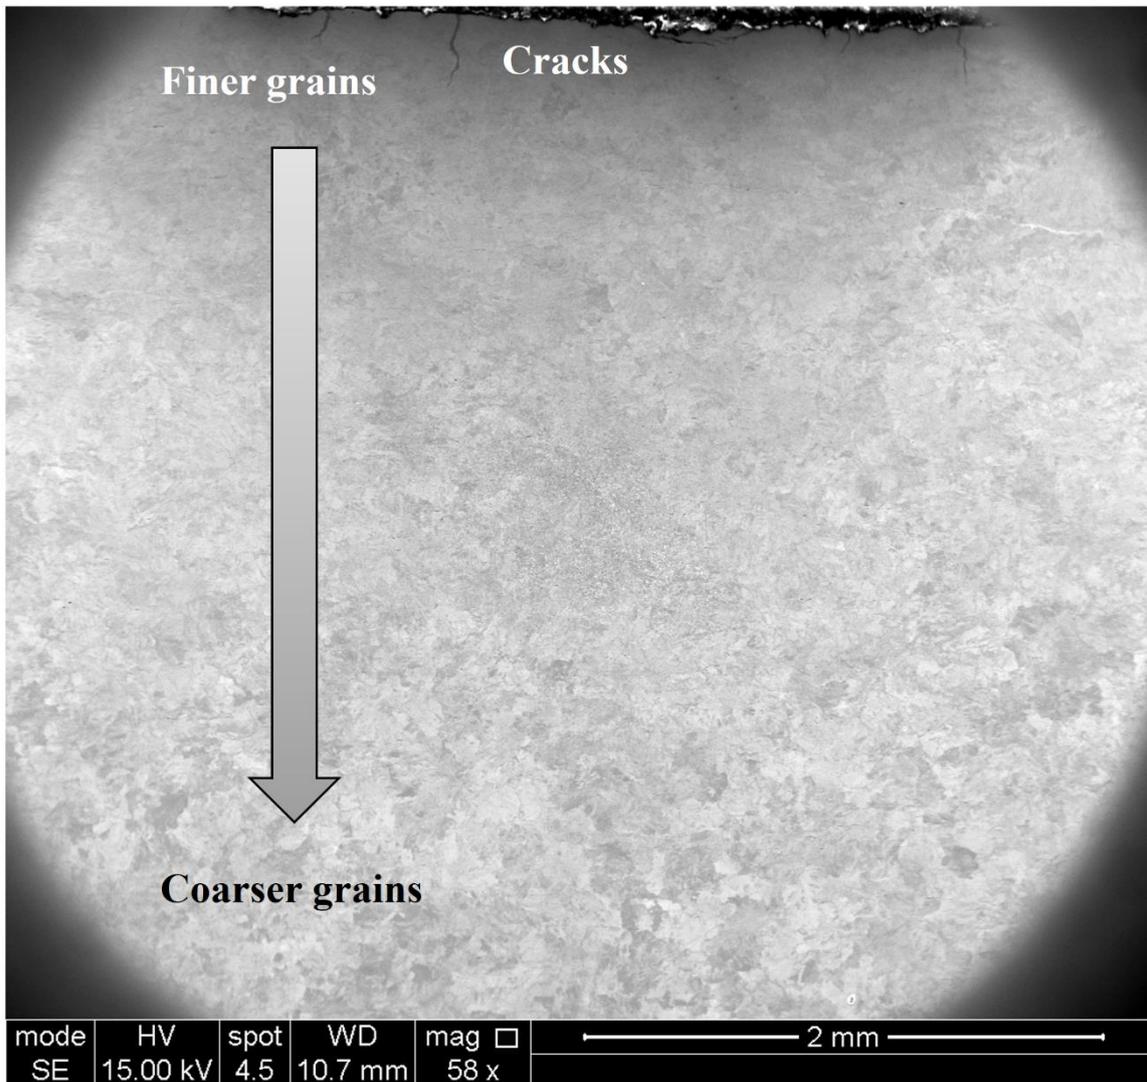
Figure 103: SEM image from the running band of Sample 1. Vertical cracks are at the surface, a finer structure is close to the surface and the original structure is at the bottom of the image.

cracks, but the acute angled section has worn away. However, it is still also possible that vertical cracks are due to thermal shock. The presence of many vertical cracks grouped together and some grain refinement (Figure 103) is more suggestive of thermal shock whereas isolated vertical cracks could have developed from RCF cracks. Even if the cracks began as RCF, it is still curious that they develop into more of a vertical crack, rather than levelling out and running parallel to the surface as seen in Squats and shells.

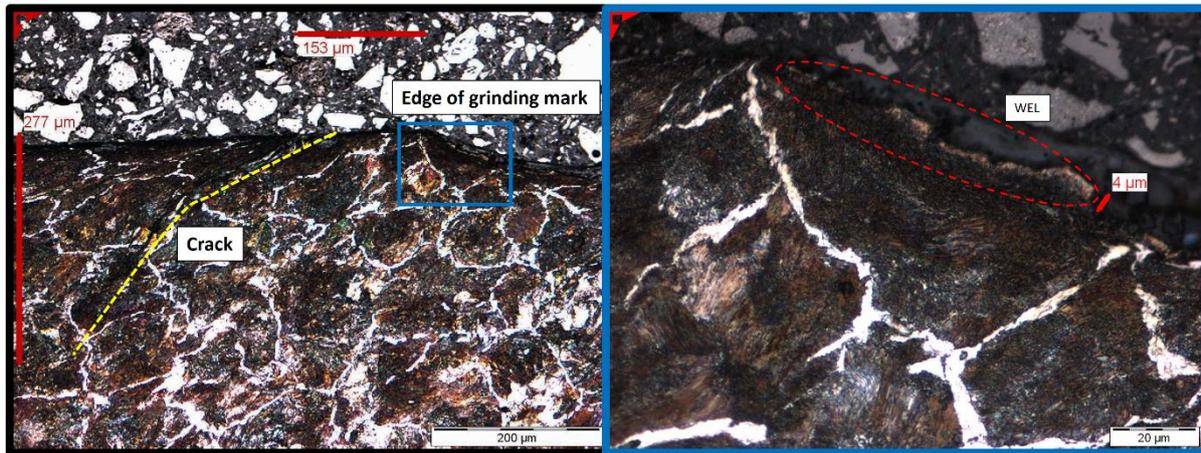
Figure 104: A grinding mark in Sample 2 with a crack developing next to it. The zoomed image in the blue box shows the WEL that made the distinction between a grinding mark and a shallow pit.

Grinding marks create an area of very high contact pressure of the edge of the pit, so cracking is not surprising. However, the combination of partially developed delamination pits and vertical cracks (Figure 105) is less obvious because the contact patch of the wheel has not yet been reduced by material loss. The presence of a vertical cracks on pits and grinding marks raises questions about how many vertical cracks do not initiate independently, but because of surface irregularities such as grinding marks and pits. Figure 105 is an example of pits developing in the same region as vertical cracks. Crack propagation will be determined by a combination of the weakest path, which appears to be the prior austenite grain boundary (left side of Figure 105) and the stress state, which probably accounts for the vertical cracks (right side of Figure 105). Figure 105 shows an example of where the prior-austenite grain boundaries may be. The grains are typically completely round or elliptical.

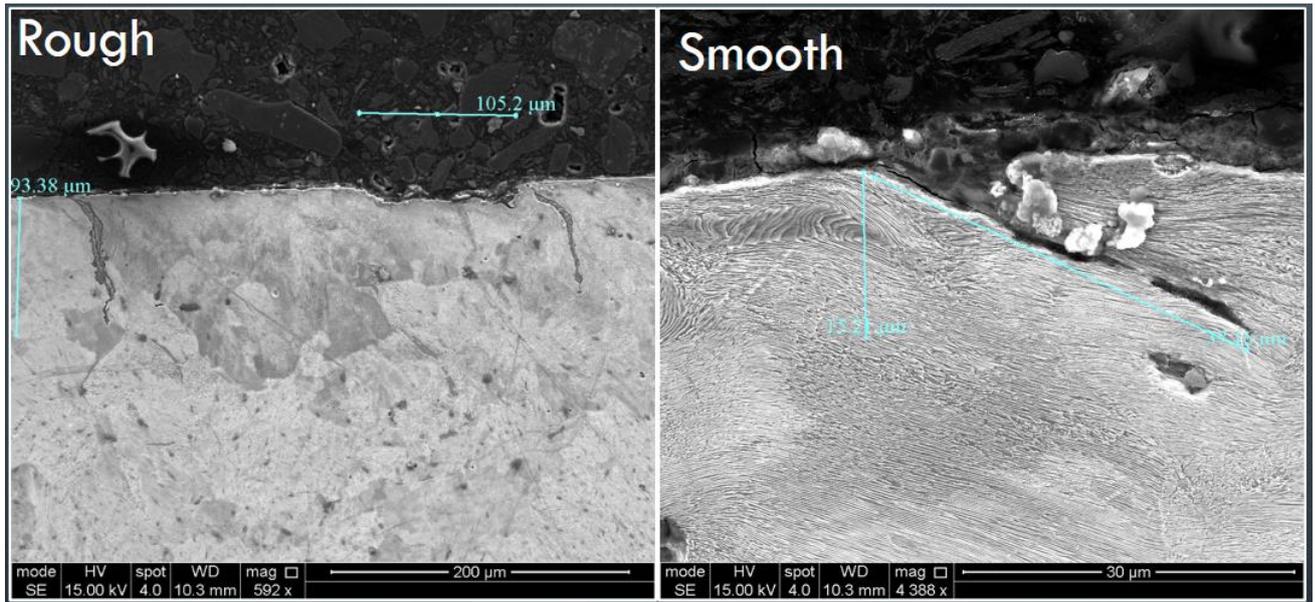
Sample 4 gave an excellent opportunity to investigate the difference in surface cracks in smooth and rough samples because it contained a transition from a patch covered in grinding marks to a smooth region. It was possible that any damage in the smooth area was created before it became smooth, as it will probably have been ground too at some point, unless it was a dipped weld. However, the cracks seen in the smooth area were noticeably different to those seen in the rough area. The rough area had vertical cracks developing, often from grinding marks. The smooth side had no vertical cracks, only typical RCF cracks that ran at a shallow angle to the surface of the rail. The rough cracks grew at an acute angle to the surface before becoming vertical. If this sample is representative then rough surfaces with heavily reduced contact areas, meaning higher contact stress, produce vertical cracks instead of angled cracks typically seen in RCF.

Figure 106: SEM images showing examples of only vertical cracks in the rough region of a sample and only a few RCF style cracks in the smooth region.

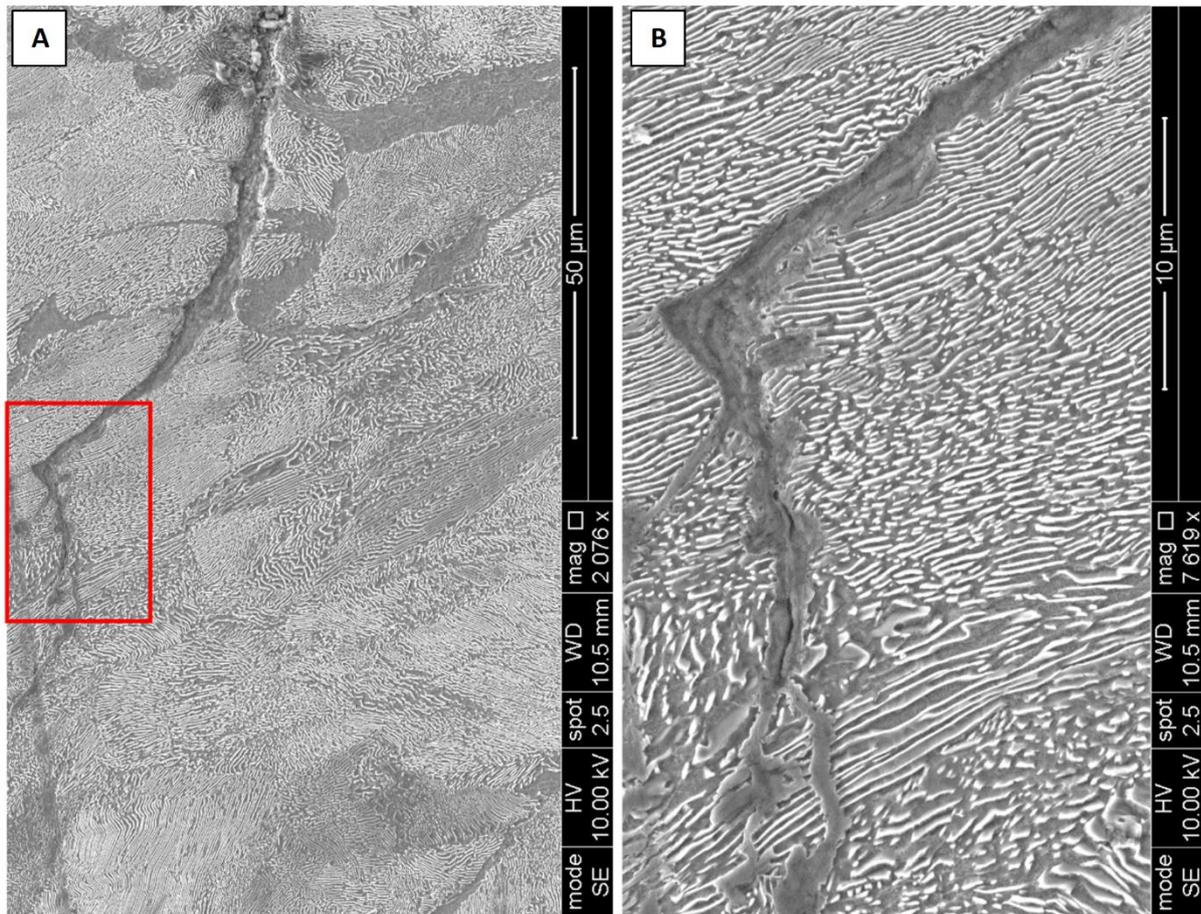
As seen in Figure 108, the cracks travel between lamellae plates a majority of the time, but not always. They seem to be able to change direction when the plates become small and more spheroidal. There are places where this is not true such as the bottom of the right SEM image where the cracks cut straight through plates. This could be because the crack was already orientated parallel to the lamellae of a neighbouring grain and so continued in that orientation as it propagated. Looking at the CT scan data in 3D the crack plane grows down into the rail and diagonally across the rail as it propagates longitudinally and laterally at the same time. This means that the initial crack path through the microstructure cannot be viewed in its entirety within one micrograph.

Figure 108: a) SEM image of the box from Figure 107 showing that the crack still prefers to travel between the lamellae plates of the pearlite when cutting across grains; b) magnified view of the box in the left image.

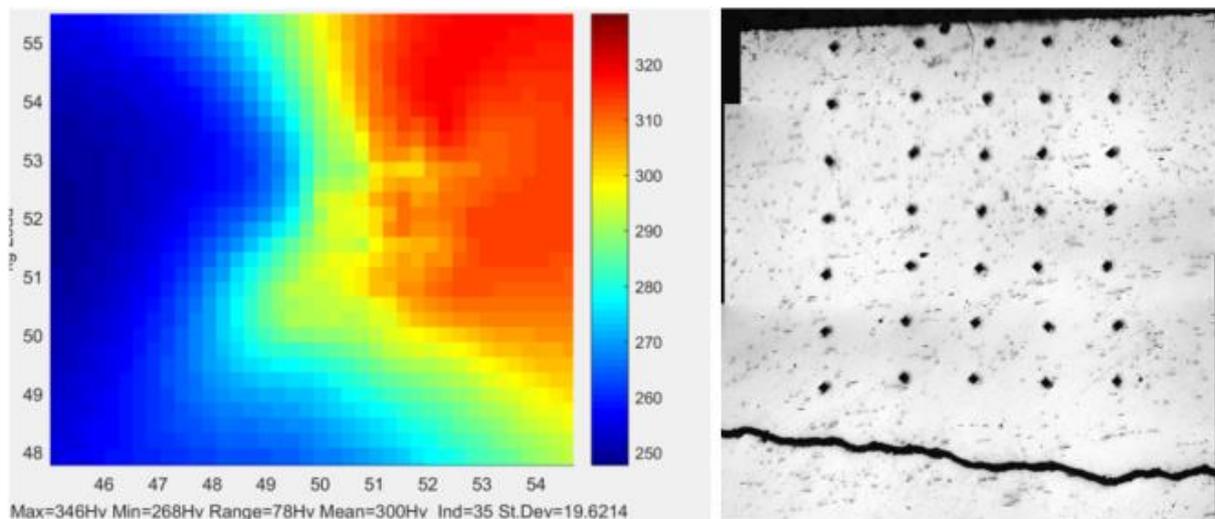
The running band of Sample 1 has two regions: a brighter region where the wheel clearly made contact (R1) and the darker half of the defect where the lobe is (R2) (See Figure 69 and Figure 77 for clarification). Figure 109 gives a clear indication that there is a hardness differential present in the rail. The lobe region shows some increase in hardness longitudinally and with depth. The variation is not significant though. Work hardening is expected to harden the upper surface consistently. Thermal input can soften the material, so if work hardening has occurred, it may have later been softened in places by thermal input.

Figure 109: Hardness map for R1 in Sample 1, the lobe region. Points are 0.5mm apart.

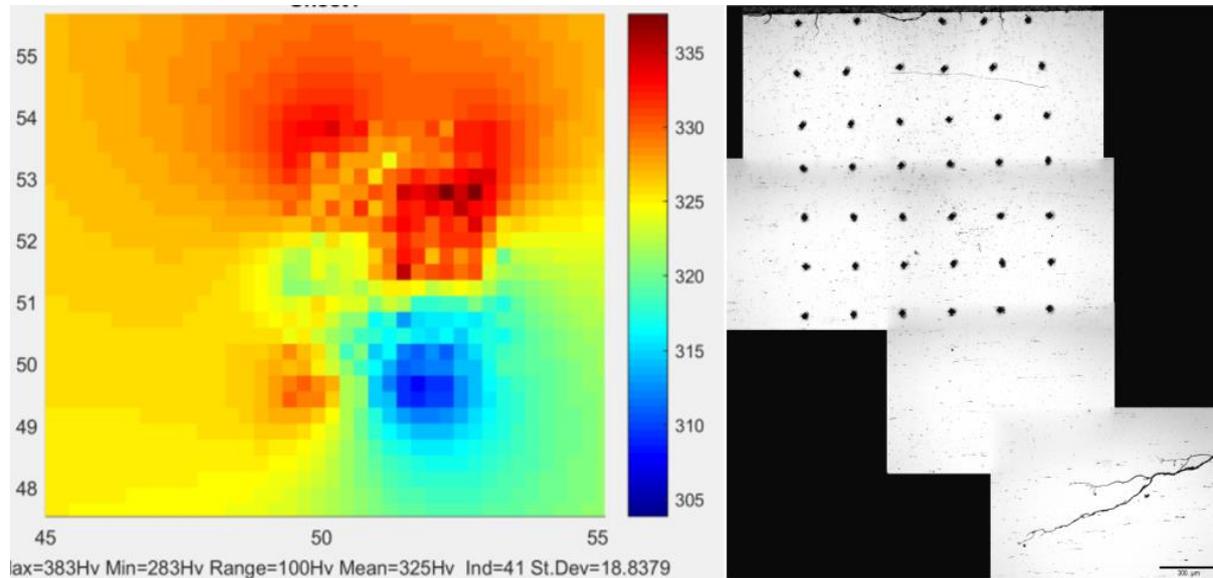
R2 has a clearer reduction in hardness with depth, which was what was expected (Figure 110). The high 383HV reading affects the pattern slightly. This is probably due to a harder grain, which could be due to carbon content or crystal orientation. This gradient of hardness is consistent with the gradient of grain size seen in Figure 103.

Figure 110: Hardness map for R2 of Sample 1, the brighter region. The same region seen in Figure 105. Points are 0.5mm apart. Scale bar reads 500microns.

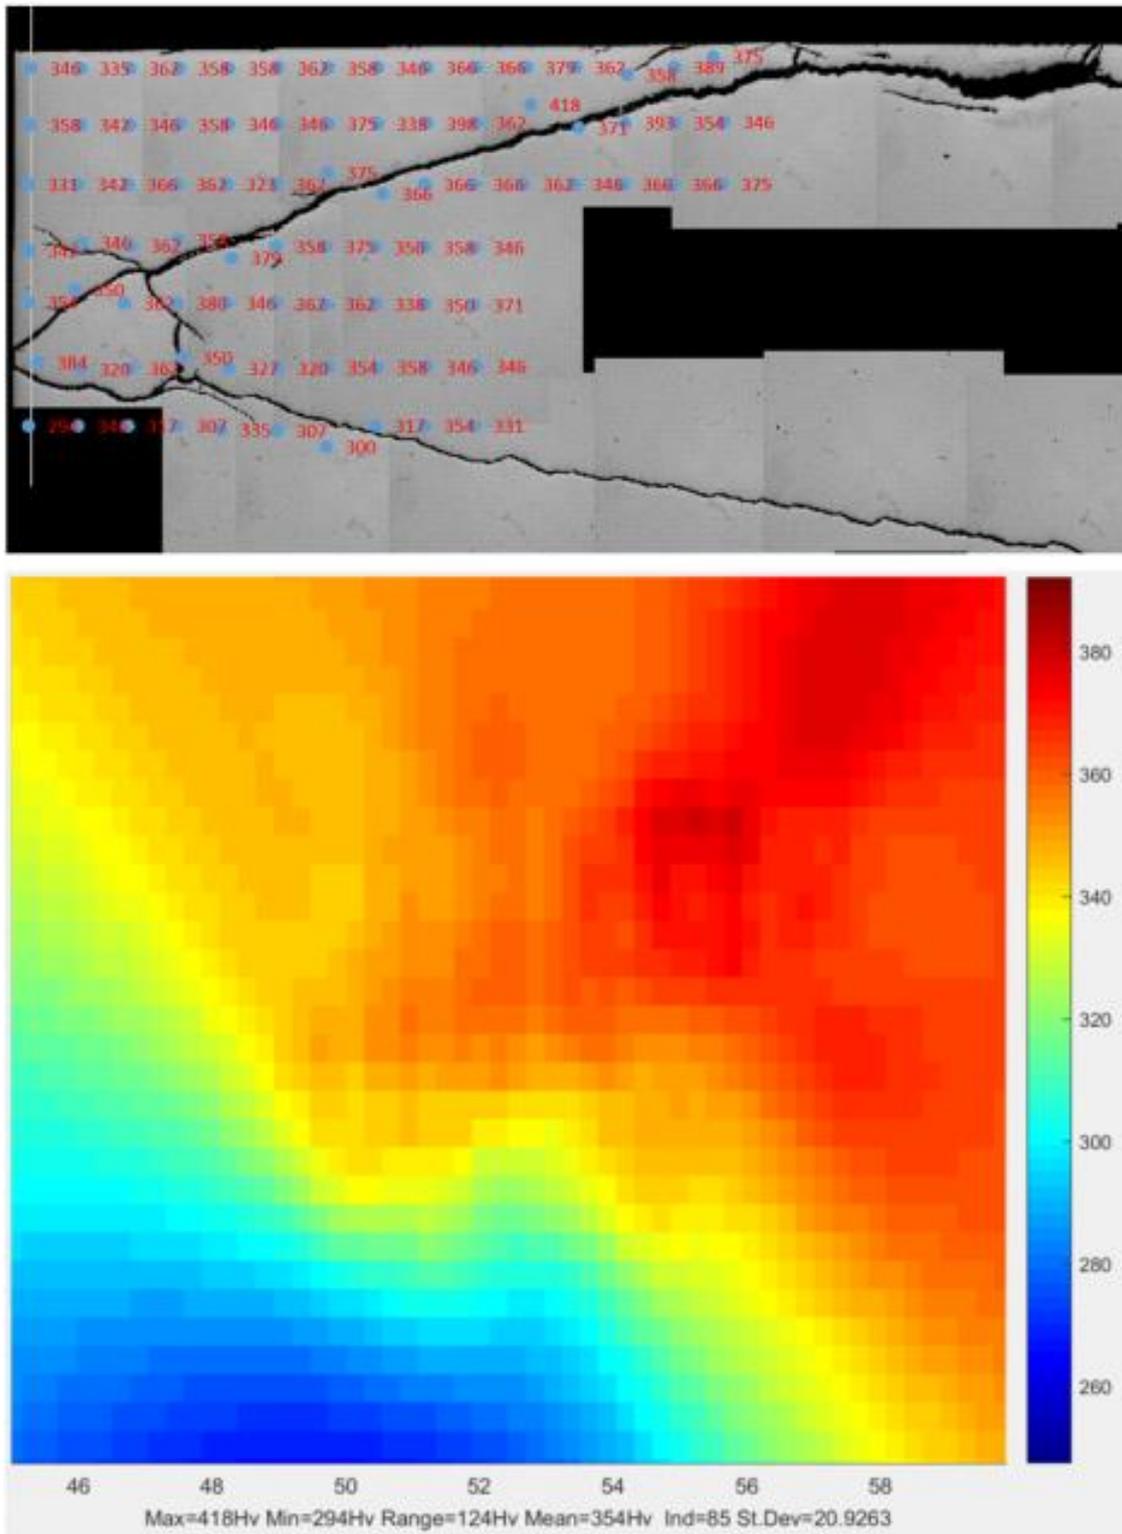
The hardness map for R3 delves 3mm deep into the rail and shows a good decrease in hardness with depth like R2 (Figure 111). The highest values are seen in the thin region between the surface and the crack. This is expected as isolated thin strips of material are often seen to deform dramatically in rails. The contour map within Figure 111 shows the softer blue region is found below the lower crack of the defect, with the crack being somewhere within the green band. This is consistent with the idea that the lower crack developed first due to sudden heating and cooling of the material, with the crack appearing on the interface between the heated surface and the cooler subsurface. The red region is found where the surface cracking and void is, which again matches the expectation of strain accumulation in the upper surface. The red region in the lower right of the contour map may need to be ignored. It is interpolated from the points around it because that area was not indented.

Figure 111: Hardness values and their approximate locations from R3, a sample from the centre of the rail, next to R2. Contains the cylinder feature discussed in Chapter 6. Points are 0.5mm apart but some adjustments were made to avoid cracks.

This gradient from the severely transformed WEL down to the closer to grade hardness of the rail supports the idea that thermal input followed by rapid cooling occurred. However, the lobe region has been out of contact with the passing wheels since dropping below the contact area due to the subsurface crack development. This could explain why the hardness gradient is not found in the lobe region: perhaps the thermal input due to wheel spins occurred after the contact patch was reduced, due to the lobe development. Alternatively, perhaps gentle heating and cooling from nearby regions has allowed the area under the lobe to normalise from a thermally damaged state since its initial development.

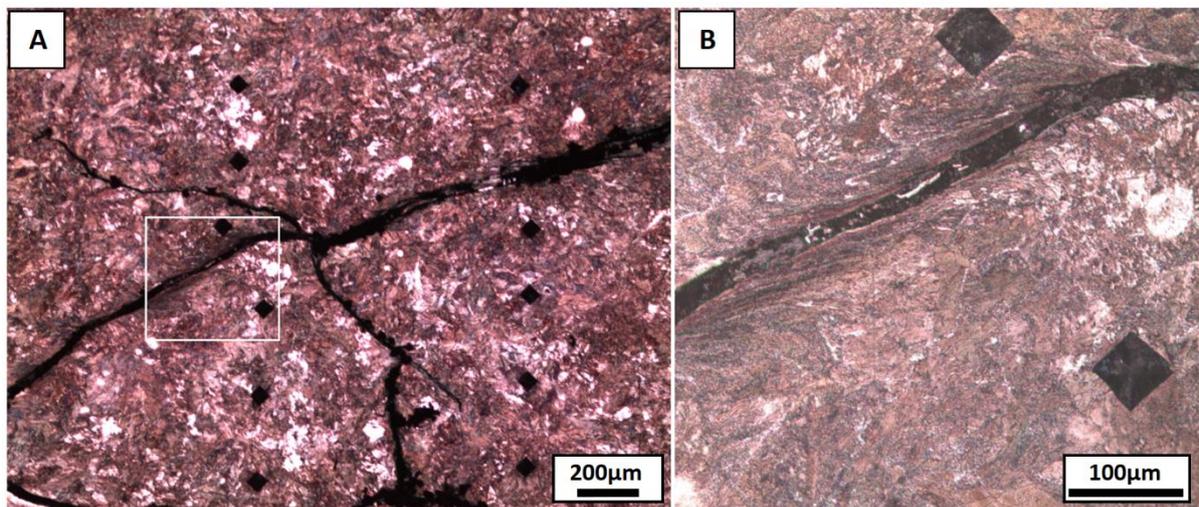
Figure 112: Sample 1: a) The upper part of the cylinder; b) Magnified image of the white box, showing the deformation of the crack faces due to rubbing.

To evaluate the deformed region within the cylinder seen in Sample 1 (Figure 111 and Figure 112) further, nano-indentations were performed. The cylinder is discussed in more detail as part of Chapter 6. Hardness measurements were taken from the region (visible in Figure 112 as black diamonds) were unable to detect any significant variation in hardness. With nano-indentation, 20 measurements were taken per line from above and below the crack magnified in Figure 112. Reference measurements were taken from the centre of the circle and 2mm above the very bottom of the entire sample. The results of these rows are displayed in Table 7 as a summary and in more detail in Figure 113.

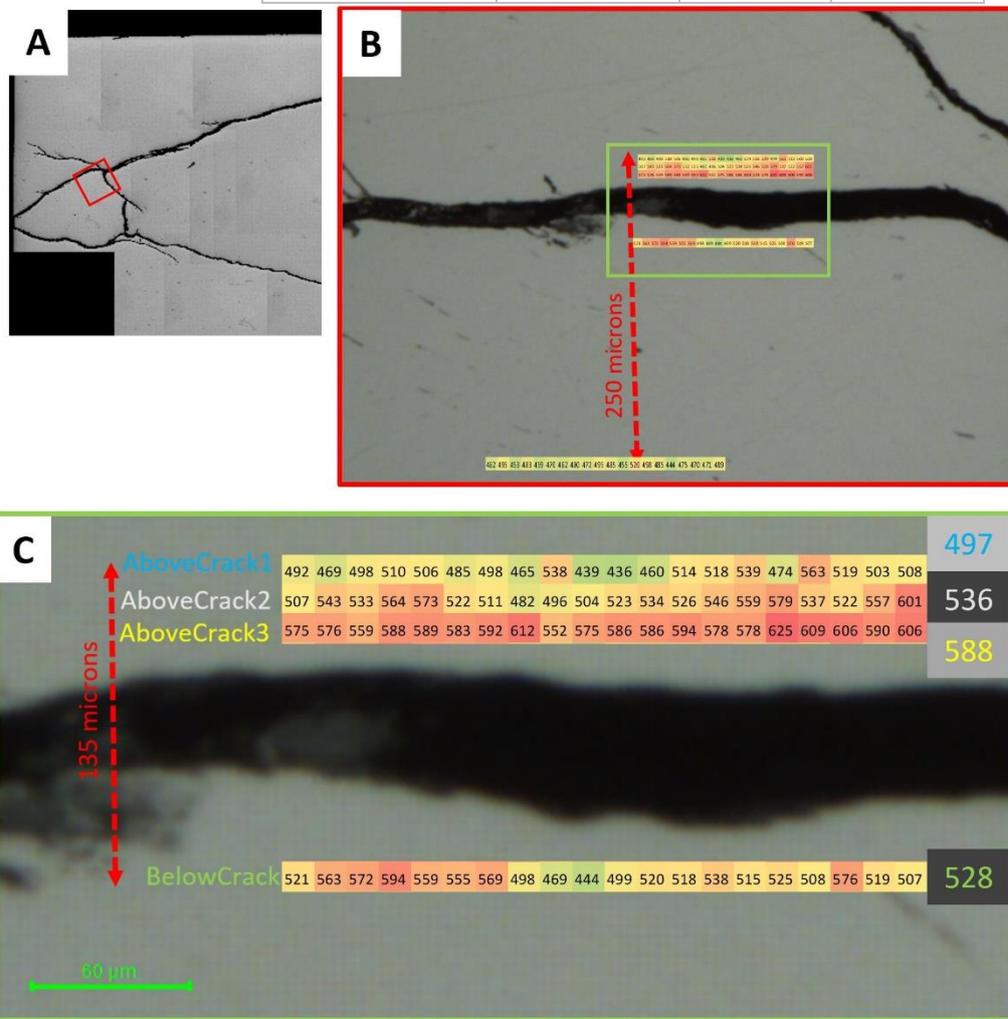
Figure 113: a) An un-etched micrograph of the area; b) Overlaid results for the centre of the circle, above and below the crack; c) A magnified image of the crack to show numbers and the mean hardness for each row.

The results are not surprising with regard to the hardness increasing with proximity to the crack face. The higher hardness for the 'CentreCircle' reference (compared to the main reference) shows that the hardness increase was not localised to the deformed crack edge. The hardness was quite high close to the crack edge, consistent with the expected 800HV+ expected from WEL. WEL was in very thin layers on the crack edge where the measurements were taken from. Other areas along the crack showed no WEL or deformation, but had a rough edge. This suggests that the deformed part of the material had broken away due to the rubbing. Only the indented region showed deformation around the crack edge.

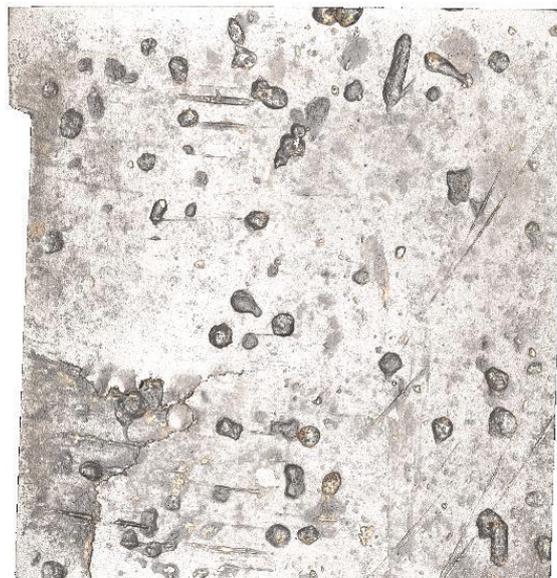
This section is the investigation into the surface pitting that will be discussed more contextually in Chapter 6. Pitting is found both inside and outside of the running band of Sample 2 as well as Sample 5 (introduced properly in Chapter 6), a sample from the same railway track section as Sample 2. Figure 114 shows the surface of a 25x25mm piece of Sample 5 covered with pits of varying morphologies. Pits are distinguishable from grinding marks because they are usually quite smooth and have a layer of oxide. Grinding marks often have WEL in them and a rough morphology to a pit. The large quantity of pits led to an investigation of how they could have formed other than by typical corrosion pitting.

Figure 114: The running band of Sample 5 as a 25x25mm piece with various pits, grinding marks and cracks.

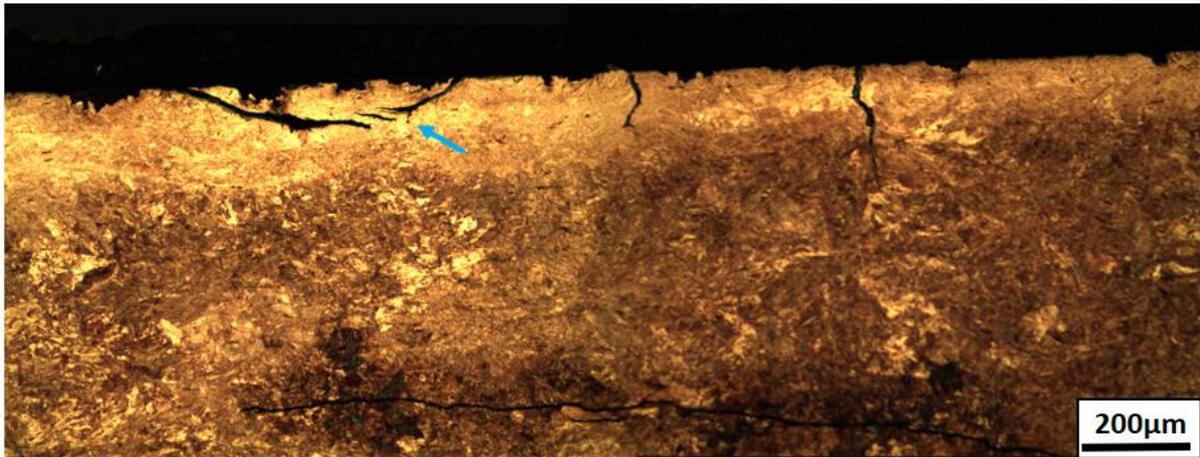
“Delamination pitting” was a possibility and was observed in the partially transformed upper surface of the sample micrographs (Figure 115 and Figure 116). The cause of the pits forming in such shapes is believed to be due to the cracks following the prior austenite grain (PAG) boundaries of the microstructure. The PAG is more prone to crack growth as it is softer [4]. Initial etching in picric acid showed that some cracks followed prior austenite grain boundaries. This could explain the varying morphologies seen in a localised region in Figure 115 as well as the branching of the cracks into vertical offshoots. Figure 115 is from sample 1, which has few pits, but does have snakeskin on the surface. Snakeskin that spalls would produce pitting. Figure 116 is from pitted Sample 2, though most observed pits had already shelled and were oxidised, finding that micrograph of one almost formed was by chance.

Figure 116: A delamination pit developing alongside vertical cracks in Sample 2. A potential vertical crack has just initiated on the border of the pit, indicated by the blue arrow.

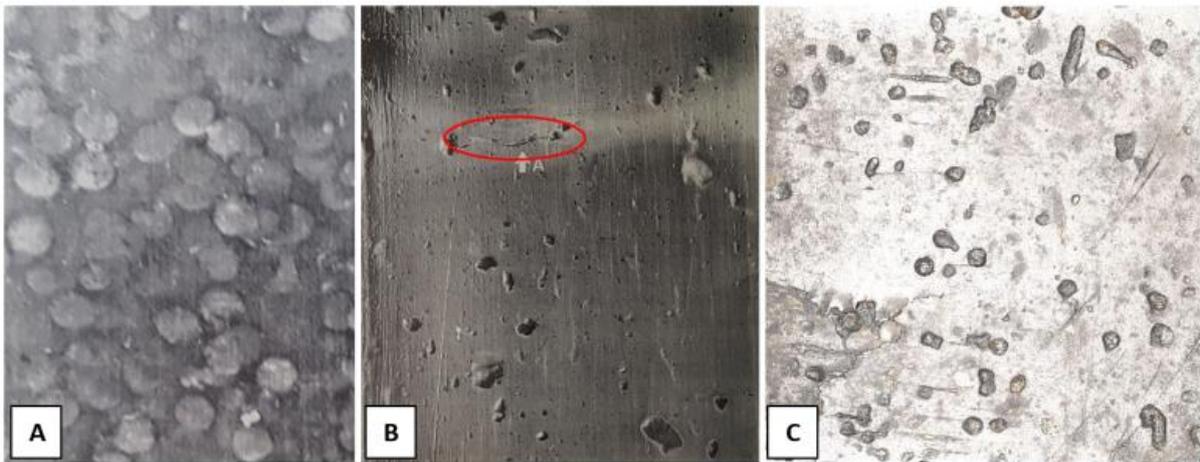
Figure 117: Examples of possible causes of pitting (other than typical corrosion or localised delamination) from literature on bearing steel failures [5]: a) Electric erosion showing very round and overlapping pits; b) Embedded ductile particles producing varied pits and cracks (circled); c) Sample 5 showing various pit morphologies.

Trying to determine what caused the variety of pits found on the rail surface led to a few possibilities (Figure 117). For electric erosion to occur, a current must pass through the contact, arcing from one interface to the other. Samples 2 and 5 were taken from a system that used third and fourth rail, so current from the train should not have been passing through the track that the wheels sat on. However, flashover in the DC traction motors [6], that are associated with the rolling stock on the track where sample 2 and 5 came from [7], provide a plausible

The embedded ductile particle pit morphology is found in bearing steels when contamination gets into the lubricant. It is unlikely that many of the pits were caused by trapped ductile particles as the pits are very circular in nature. Third body particles are more likely to be forced out of the contact that trapped within, although entrapment in a lubricant may be a factor. Some pits may be from embedded particles as the rail is known to have been a soft grade (R220), probably softer than the wheel: the softer of the two contacts tend to become embedded [9].

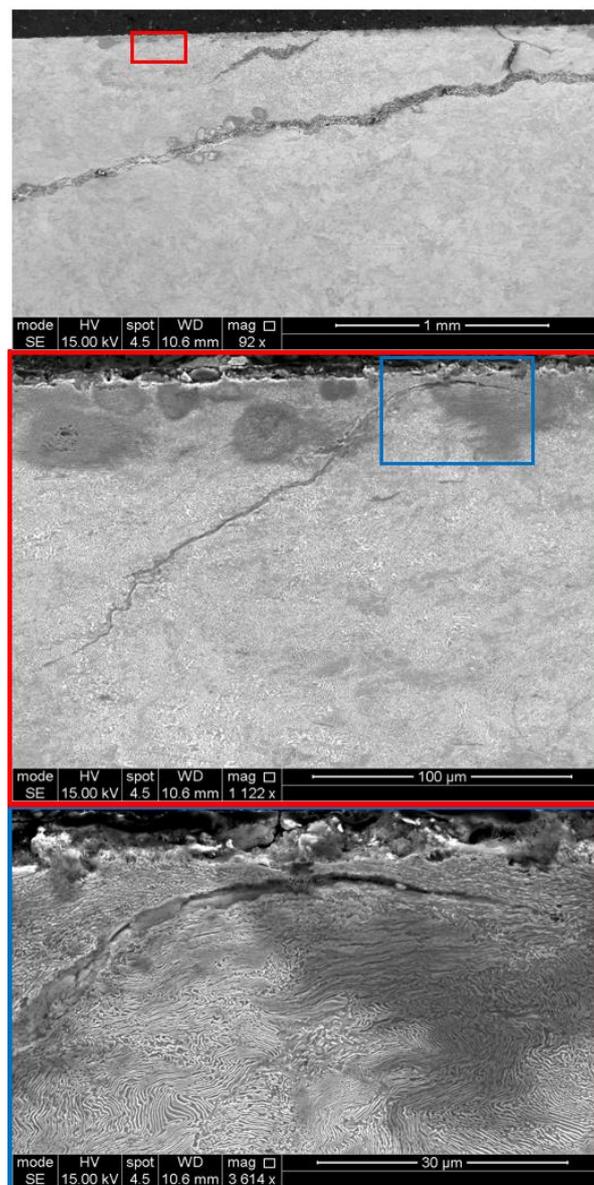
Squats are often confirmed in micrographs by their signature inverted V-shaped crack that causes the two dark lobes on the surface. These cracks grow unevenly, with the leading crack growing first and the trailing crack growing later at a faster pace. Therefore an early stage Squat could be found with only one of the branches developed, which is the case for Sample 5, discussed in Chapter 6. Two small crack structures were found in two separate samples, each matching this early stage Squat like structure. One was only ~200 microns across and was found close to the surface breaking region of the Sample 1 defect (Figure 119).

Figure 119: A 200-micron wide crack structure that resembles a Squat type defect.
