Micro-CT Scanning in the Investigation of Squat Defects in Rail Steel

Shaun Earl

*Submitted for the degree of Doctor of Engineering in the
Department of Materials Science and Engineering at the
University of Sheffield, UK.*

January 2021

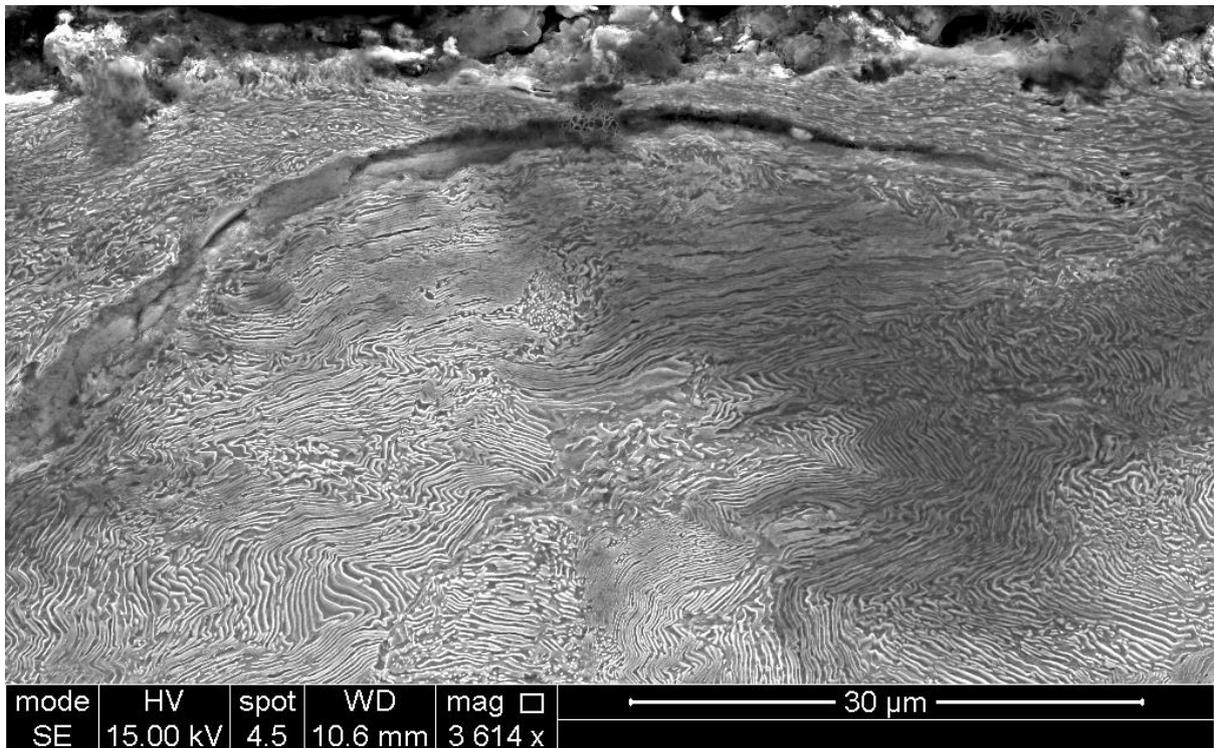
The magnified images of the crack show that it is just about below the surface, even though some of the thin surface material has broken away. The parallel orientation of the peak of the crack suggests a subsurface initiation. This initial stage to the crack is orientated parallel to the lamellar structure, meaning it appeared between the cementite lamellar (clarified in a higher resolution image in Figure 120). This could mean that subsurface initiations preferentially occur in grains that have lamellar parallel to the running surface. If the grain was perpendicular and a crack developed between the lamellar, this would create a vertical crack, which would surface easily, but may not develop into the structure seen in Figure 119.

Figure 120: Higher resolution image of the peak of the crack structure in Figure 119.

The presence of such a small crack within a well-developed defect suggests that many more Squats initiate than develop. Perhaps many are worn away before the crack growth rate becomes too high. This does beg the question of why do some grow whilst others do not. It could simply be that the small crack only recently developed. If this crack had grown it would probably have linked into the much larger crack below it.

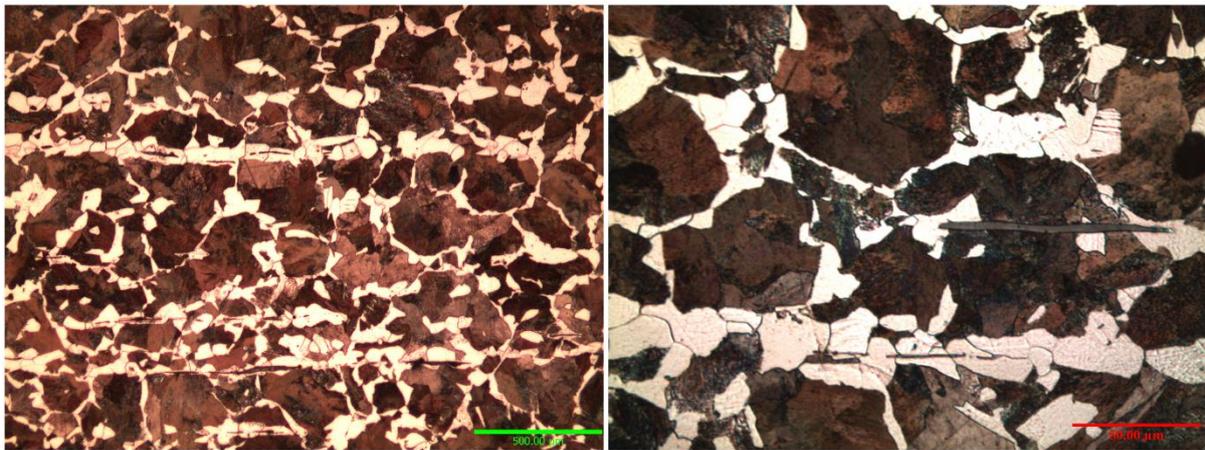
Sample 3 was of interest due to failing in track via a TD that broke the rail. Microstructural analysis of the steel quickly verified the presence of many long manganese sulphide (MnS) inclusions in the steel. MnS inclusions are known to weaken steel and were found orientated parallel to many of the cracks in the defect. Inclusions are distributed throughout the steel orientated in the rolling direction, the same direction as the unusual ferrite ‘stripes’ within the microstructure. Most cracks that travelled through the subsurface of the rail also match the orientation of the inclusions and ferrite ‘stripes’ and so there is a very good chance that this unusual microstructure was the cause of the defect development, shelling and the failure of this rail via a TD.

Figure 121: Micrographs of Sample 3 at two different magnifications, showing the unusual microstructure and the inclusions found throughout the steel. Rolling direction was left to right.

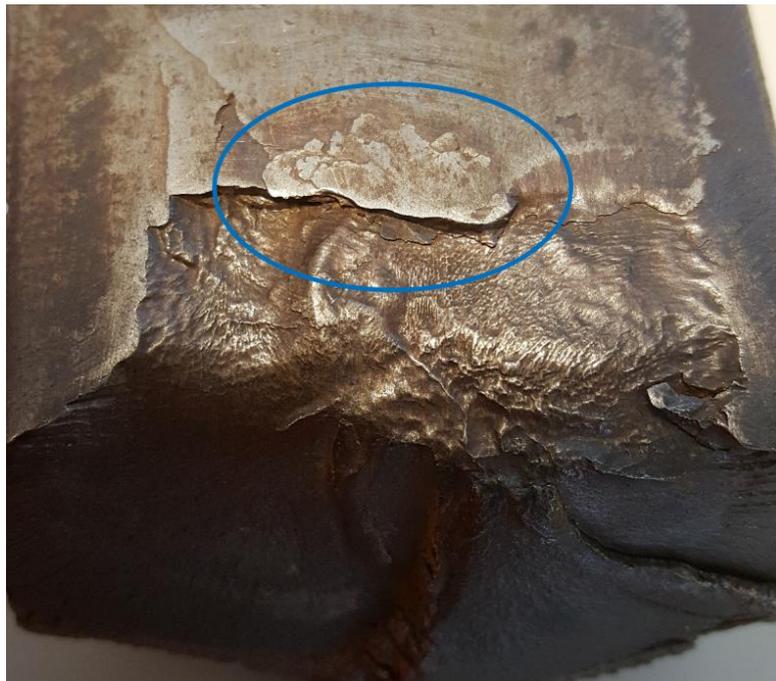
The long inclusions running parallel to the running surface also explains a possible reason for the lipped material found at the edge of the break in the rail (Figure 122). The micrographs showed that the lipped material was less deformed than the material below (Figure 123). It was expected that the deposited material would have been deformed more. A reference sample that

did not contain the deposited steel was used to confirm that the identification was correct. This oddity can be explained by considering the lipped material delaminating or shelling from the bulk material, due to a long subsurface inclusion. The train wheel then deposited the detached material onto a region of the rail that had already suffered plastic deformation over time. The deformed region would have been the ridge between the lobes, which is known to take a high contact stress and can crack as a result. It is unclear if this transfer occurred during the rail break or before.

Figure 122: The lipped region next to the rail break, highlighted by the blue circle.

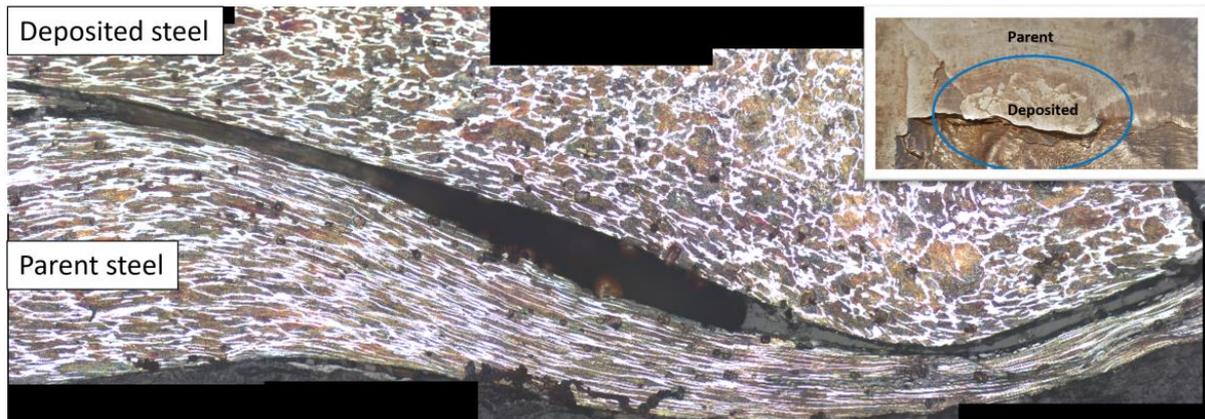
Figure 123: A micrograph of the deposited steel on the parent rail showing the deformation in the parent rail, but not the deposited steel.

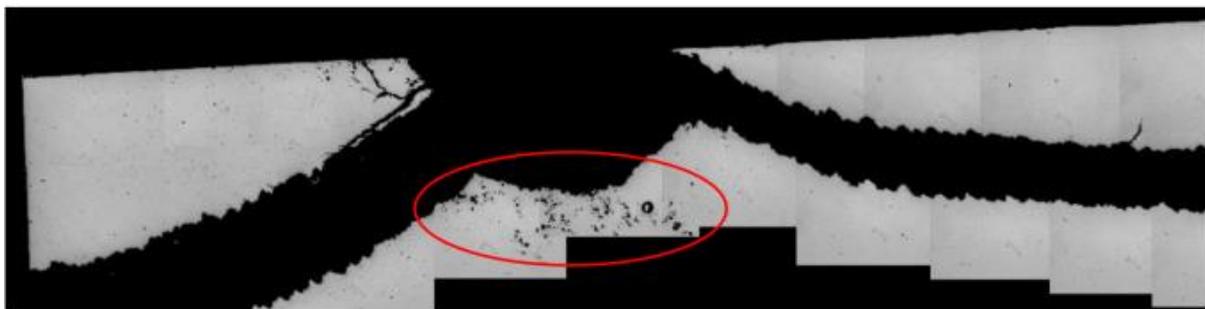
Sample 4 is a defect on a weld so a microstructural factor is a strong possibility. The c-shaped crack in the centre of the running band is believed to be the initiation site, with the only other cracks being where the defect surfaced at the edges of the rail. The model produced by the CT scan supports this theory. One of the cuts through the defect was made through the C-shaped crack. Even in its unetched state many little dark spots could be seen just under the initiation site (Figure 124).

Figure 124: The unetched micrograph of the initiation site showing spots below the initiation. The centre of the C-shaped crack detached and was lost during cutting, hence the large pit.

Figure 124 shows a magnified etched image of the larger of the dots, showing spheres with some material within. These spheres are believed to have been either trapped gas or slag from the alumina-thermic reaction used to create the weld. If the spheres were gas voids, they were filled by Bakelite during polishing, possibly explaining the retained metallic fragments. Small

cracks travel between these spheres in the region directly below the cracks. A subsurface initiation is most probable, as these micro-cracks exist in the shallow subsurface.

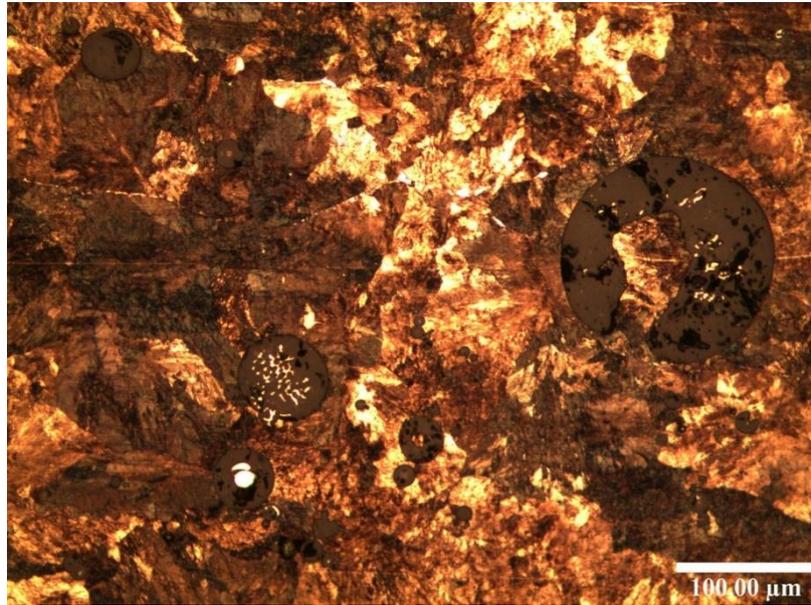
Figure 125: Spheres or bubbles found in the microstructure of the weld edge of Sample 4 within 2mm of the running surface. Probably either gas trapped in the melt, or slag from the welding process.

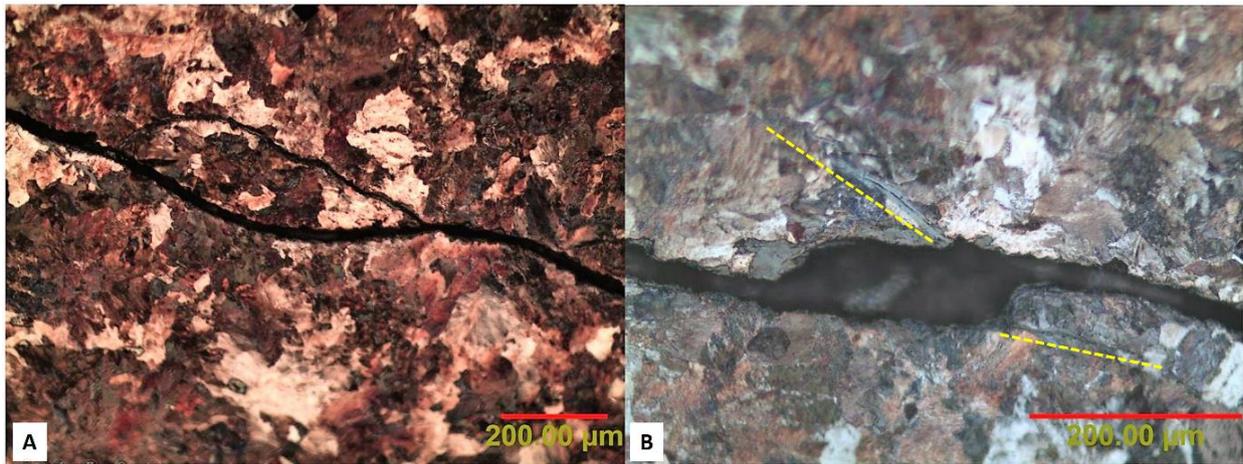
Chapter 4 showed scans of the crack network with shadows along the crack path, with a brief description of the cause, which will now be extended here. Upon investigation these shadows were seen to be caused by cracks being very close together, such as when one crack branches into two. Sometimes, a recently branched crack would remerge, creating an ‘island’ that could later break down into a void. Figure 126 shows one of these ‘islands’ as well as a void that may have formed when one of these islands deteriorated. Figure 126b has two smaller cracks growing from the void, highlighted by the dashed line. This type of cracking used to be seen as star cracking, from bolt holes drilled into rails for fishplates. A problem that was fixed by introducing compressive stresses into the edges of the bolthole when drilling. Consequently, cracks growing from a ‘hole’ in the material is a known problem, which becomes worse as the material becomes increasingly compromised by a developing crack network.

Figure 126: Micrographs showing ‘islands’ due to branching cracks such as the one seen in Chapter 4 Figure 2b. Image (b) is a small void that probably developed to look like (a) before the material detached.

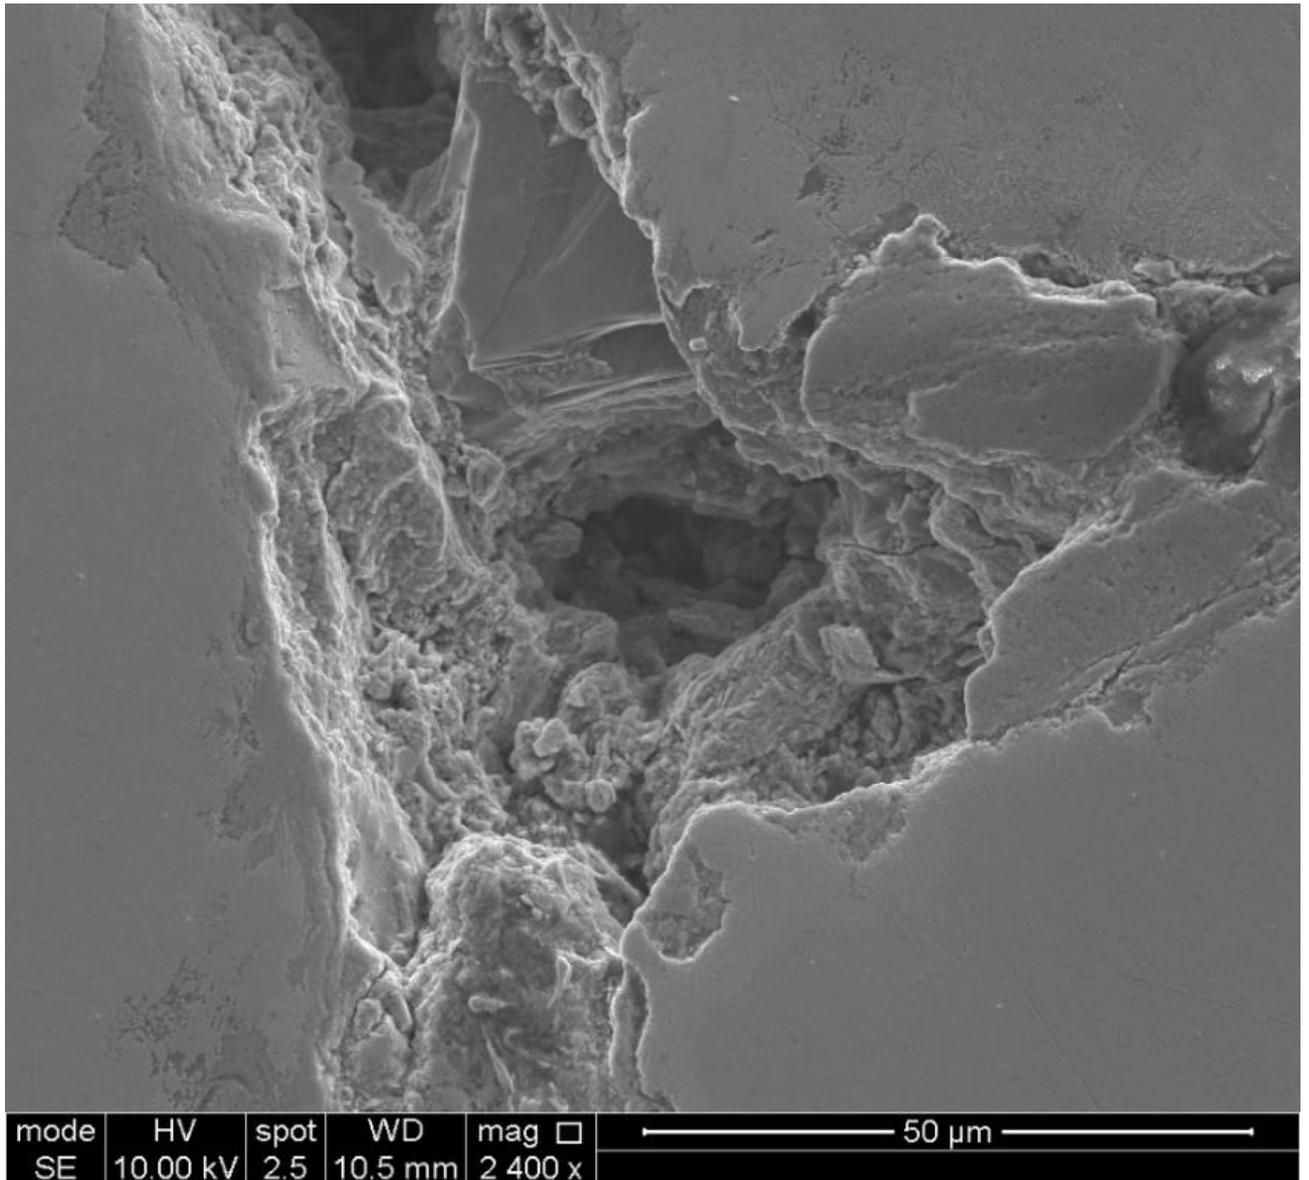
If cracks grow from voids that have formed due to branching cracks, perhaps branching cracks could also lead to small voids developing as shown in the SEM image in Figure 127. The void is from the circular crack in Figure 111, where cracks are branching out in various directions. Deeper into the crack two very thin cracks can be seen entering a large cavern or void. This suggests that sample preparation has made the crack appear wider than it should be near the surface. Moreover, the void could be a result of the extensive cracking or the cracks could have developed from the voids. It becomes akin to the “chicken or the egg” conundrum.

Figure 127: SEM image of a junction where a crack branched off deeper into the rail.

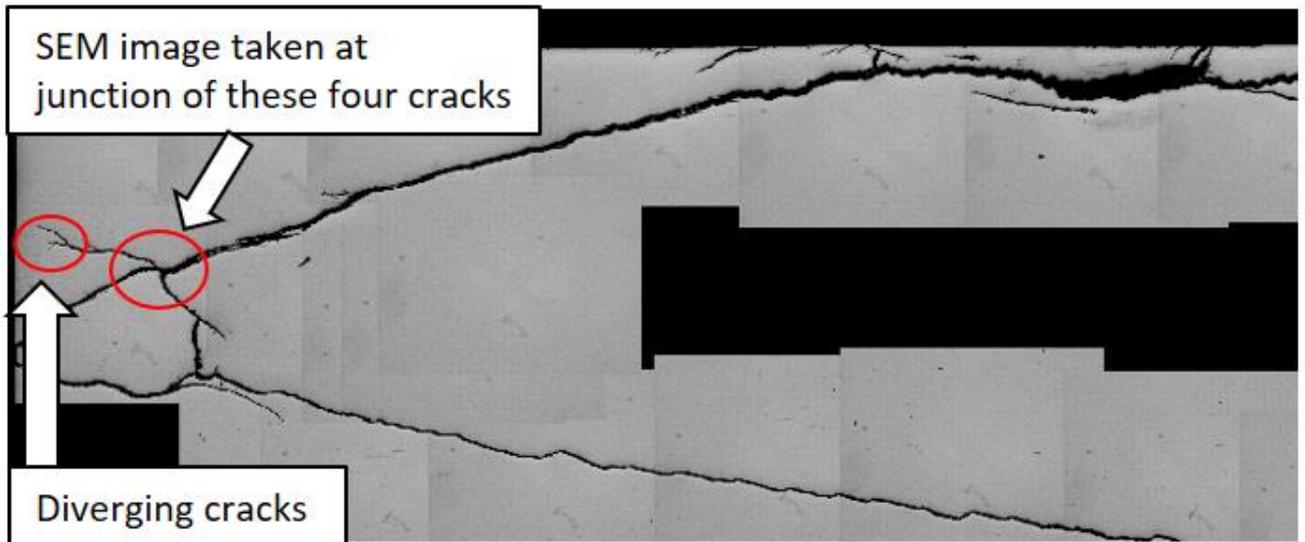
Figure 128: Location of SEM image in Figure 127 and an example of a crack diverging.

the branch source, which is the easiest component for a crack to grow through. Figure 128 shows an example of what could become an island in the form of two diverging cracks.

The main benefit of looking at crack branches was the identification of an unusual crack structure in Sample 1 (identified in Chapter 4 and shown in Figure 128). This cylindrical crack seems to have formed from a crack diverging from the original lower crack plane to the surface and then smaller cracks linking these larger cracks together. The reason why the lower crack plane existed first is discussed more in Chapter 6. The erratic path of the lower crack as it passes the bottom of the cylinder suggests that the cylinder is the original cracked region that then propagated out as two subsurface branches. SEM images of subsurface initiated cracks with no observed surface connection are shown in Figure 129. These subsurface cracks are from the centre (longitudinal slice) of Sample 4 and are outside the weld zone. The weld may have caused vertical excitation that created these small crack clusters. Track information is not available to confirm this theory.

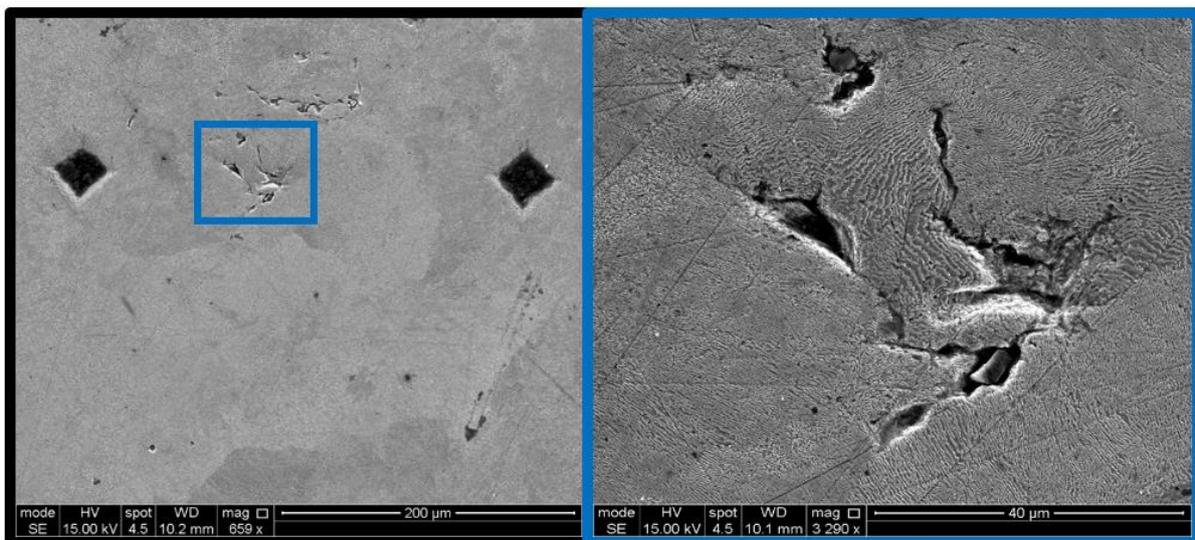
Figure 129: Examples of subsurface initiations growing into clusters of cracks growing in no specific direction. No surface cracks were observed in this region.

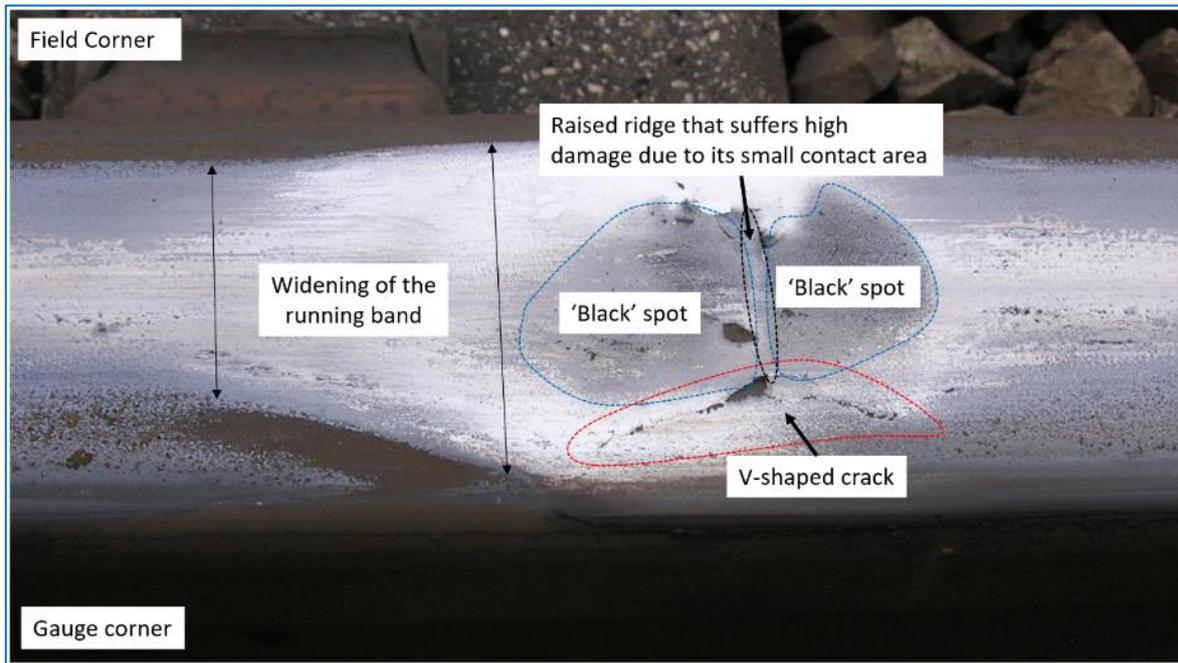
Squats and Studs appear to be very similar both on the surface and in the subsurface crack morphology. Figure 130 shows the surface features associated with Squats, which develop due to the crack growing beneath the defect, meaning that a Stud defect appears the same on the surface. The differences are found in the micrographs and through checking the traffic history.

Figure 130: A typical Squat with its usual features highlighted. Original image courtesy of British Steel

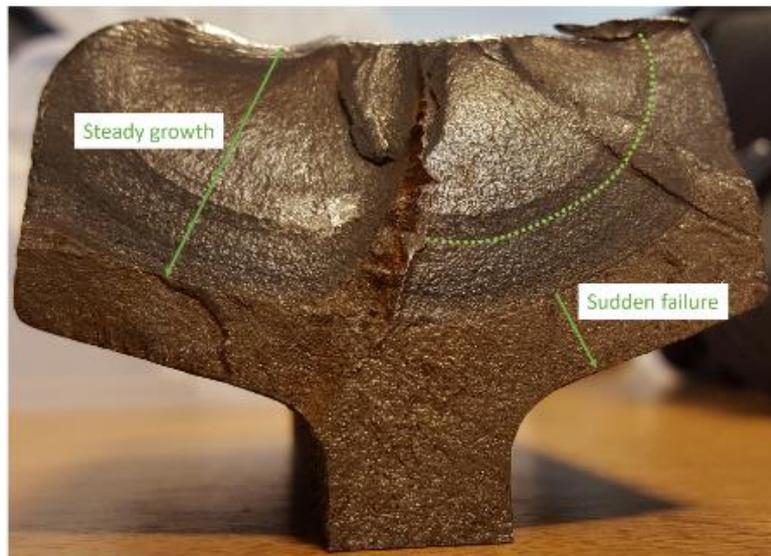
Figure 131: A railhead that has failed due to a transverse defect (TD) that developed from a Squat. The green dotted line highlights the beach-marks that show the crack growth speed increasing with crack length.

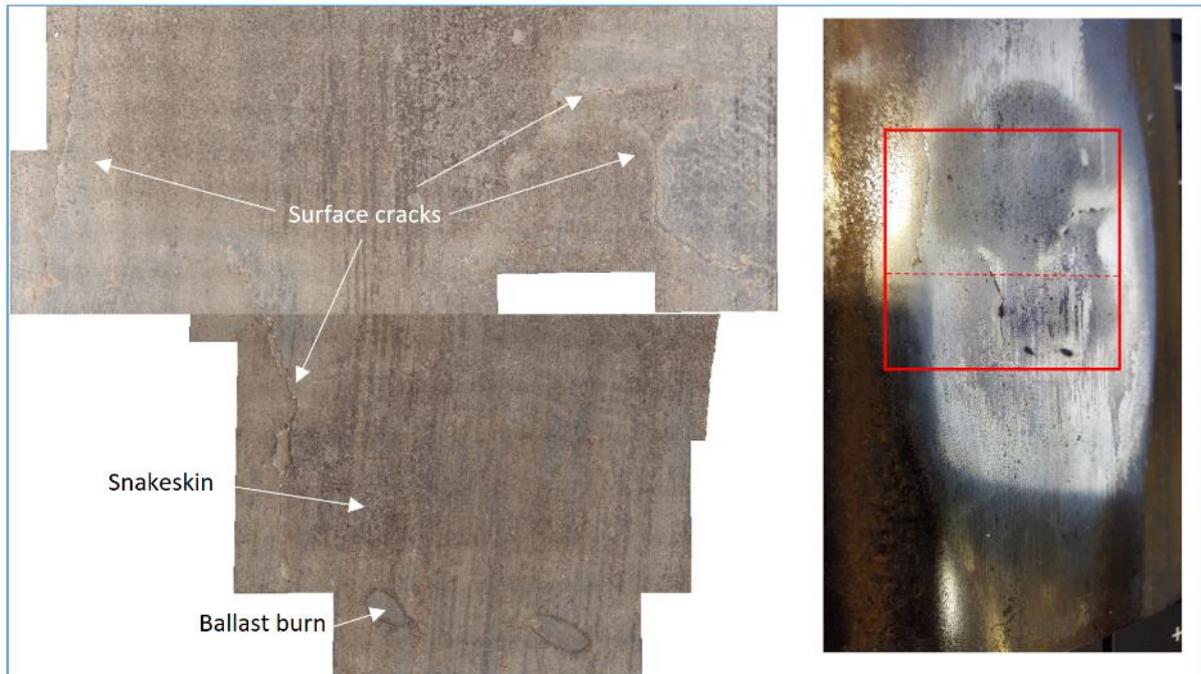
Due to the multitude of cracks on the surface of Sample 1, the entire Sample 1 region was scanned to produce a large surface map (Figure 133). The maps encompassed all surface cracks, the dark lobes, ‘snakeskin’ and the two dark spots believed to be ‘ballast burn’.

Figure 133: Left) Surface map of Sample 1 comprised of two scans stitched together. Right) The region of the rail scanned with the stitched region marked as a dotted line.

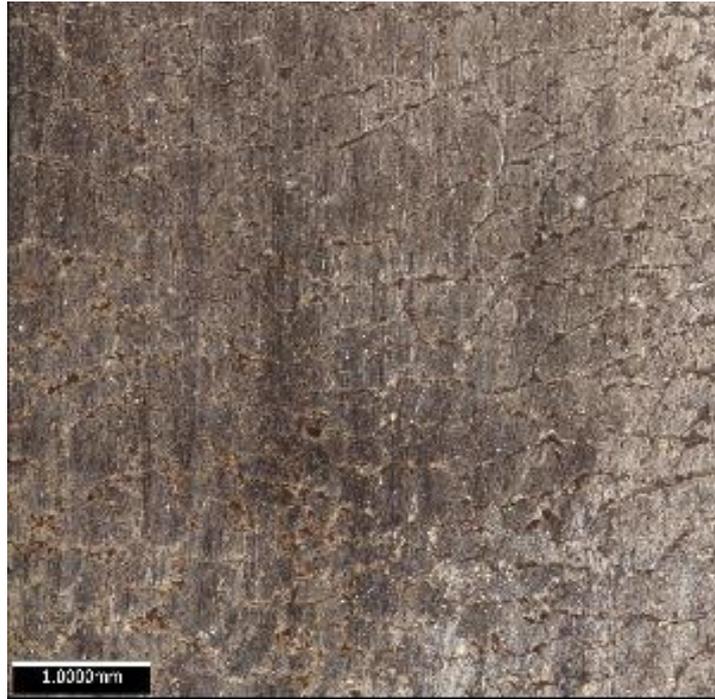
‘Snakeskin’ (Figure 134) is microcracks on the rail surface, often seen on low rails due to very high contact stress. WEL can often have a similar surface appearance. Ballast burn is when small debris from ballast stones become trapped in the contact and cause damage to the rail.

Figure 134: 'Snakeskin' on the surface of Sample 1

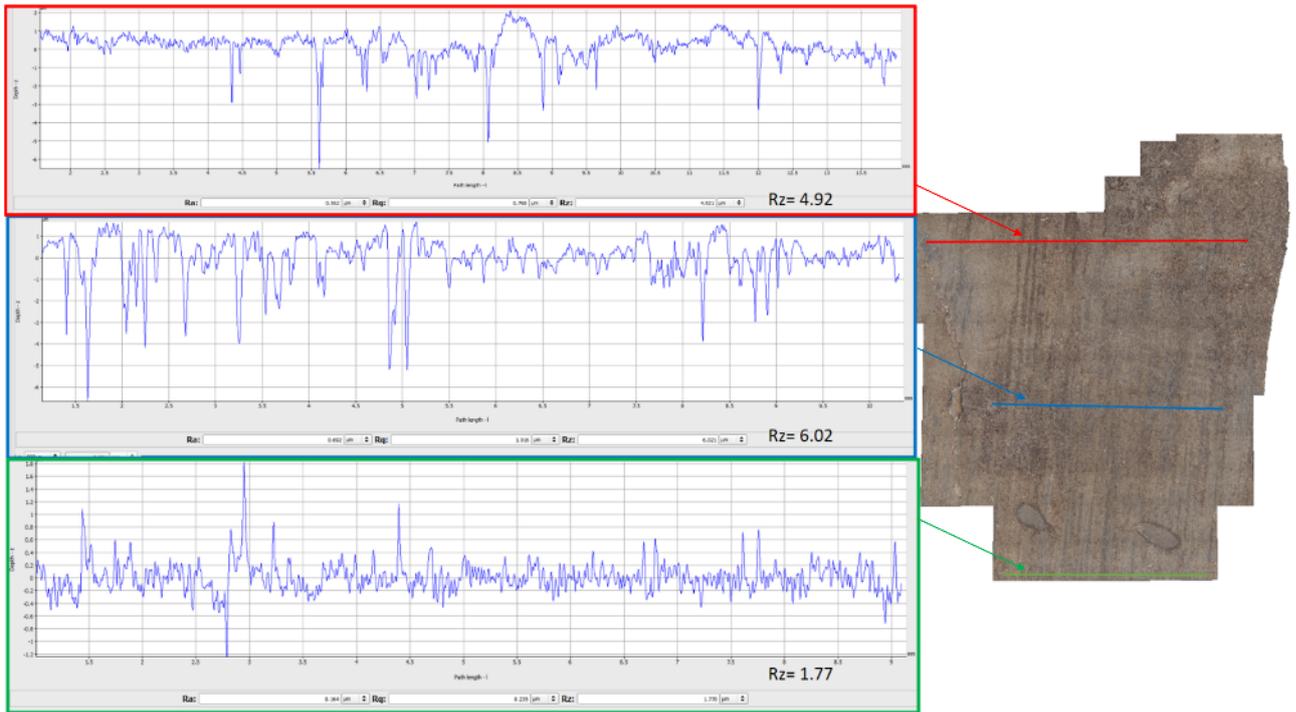
The dark lobes show where the surface has depressed due to developing subsurface cracks. They are dark because oxide can build up, because the wheel passes no longer remove the oxide layer as it has depressed out of contact. The cracks are seen on the boundaries between the darker and lighter areas, the brighter areas experience high contact stresses as they are the few places that the wheel contacts. These bright areas are also much smoother than the dark areas as shown by the roughness graphs below in Figure 135.

Figure 135: Roughness measurements along varied surfaces on the lower half of Sample 1. The Y-axis reads the depth in microns and the X-axis reads the distance along the line drawn. Rz is the mean roughness depth. Coloured borders around graphs match the coloured lines that the graph was drawn along.

Figure 135 shows that the roughness varies along the wheel's path, and there are some significant valleys (sharp downward peaks) within each measurement line. This could be due to roughness of wheels that passed before the region depressed, third body contaminants, uneven corrosion or most probably, a combination of all three. The oxide makes it difficult to assess the roughness of the surface pre-defect even though it has depressed to below the wheel contact zone.

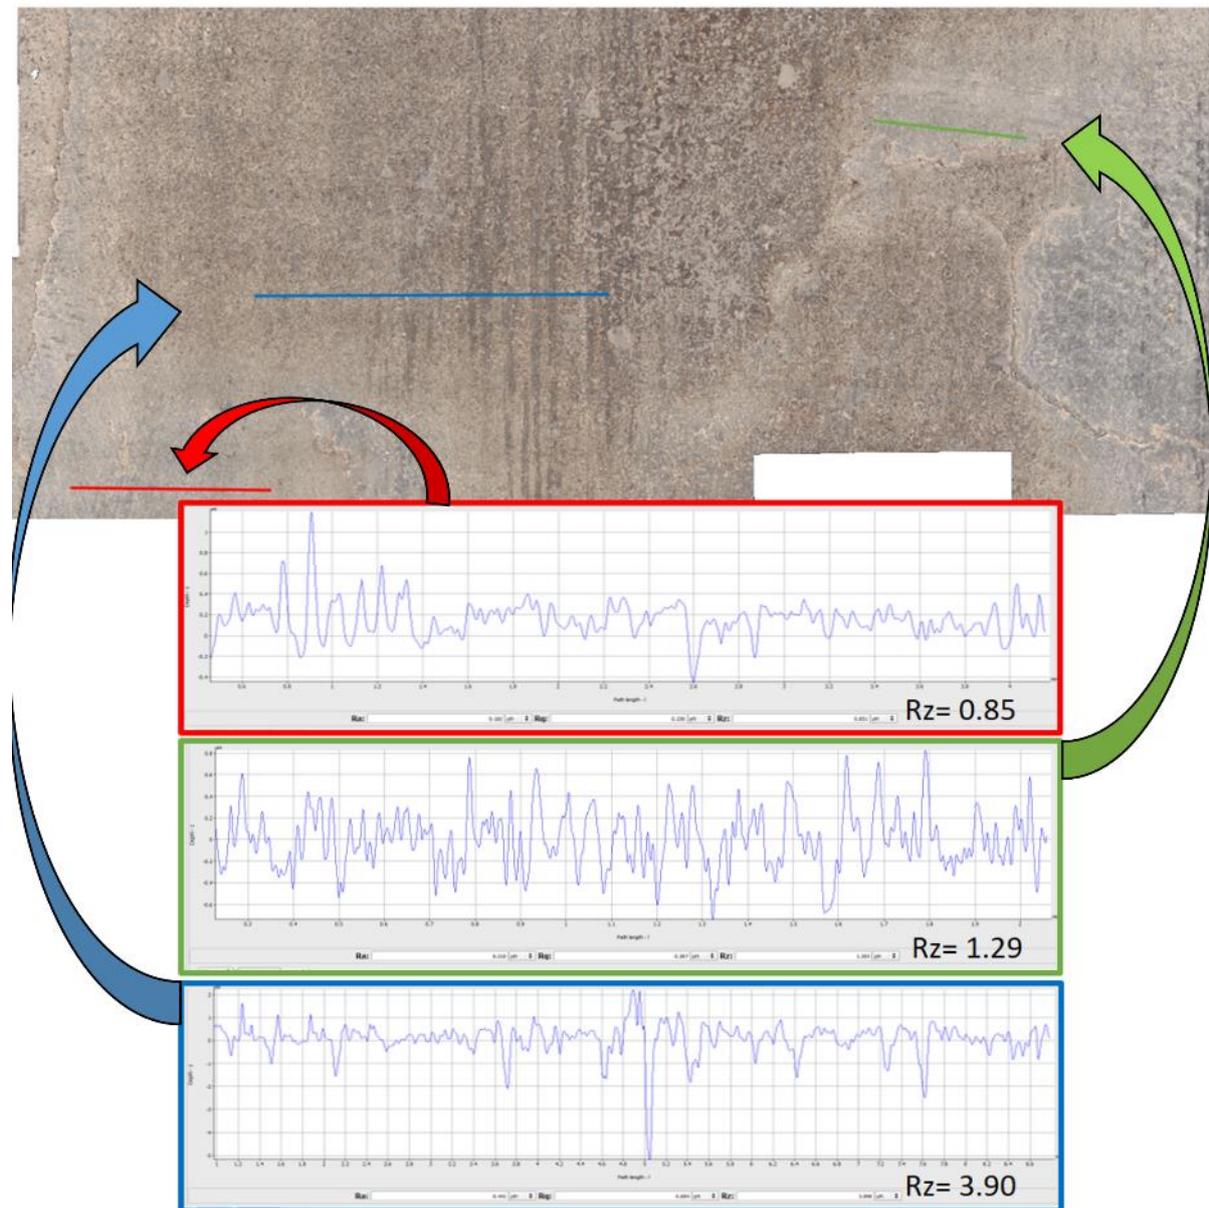
Rz can be deceptive if the measurement line crosses rough and smooth regions. Figure 136 shows roughness measurements of the upper portion of Sample 1, but only across small areas to give better Rz values for lighter and darker areas. Using the values of Rz from Figure 135 and Figure 136, approximate Rz values are ~2 microns outside the defect, ~1 micron for the 'smooth' or bright areas within the defect and ~5 microns for the oxidised dark region. The value for the oxidised region was more for comparison, because it has little significance to the recent wheel rail interaction as contact is not made. However, the Rz values for the bright area

show that, for this sample, not only is the contact area severely reduced, but also the roughness is lower. This can negatively affect the friction/ traction of the train's wheel. Wheels are known to slip on defects due to poor contact areas, which is why axle accelerometers have been investigated for Squat detection.

Figure 136: Roughness measurements across shorter areas for more representative R_z values.

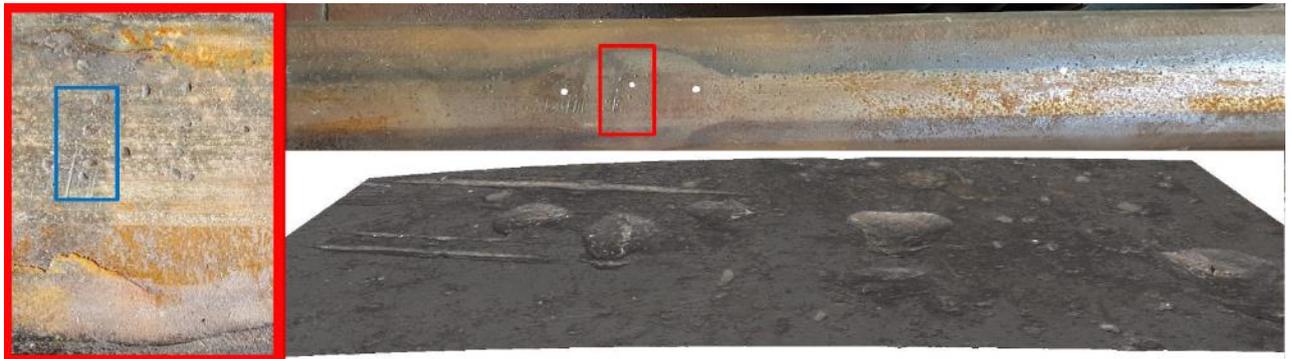
The most striking surface features on Sample 2 were the numerous corrosion pits scattered across the surface, both inside and outside the contact band. There were also a few grinding marks still visible within the running band, although these were limited to the area above the defect. Figure 137 shows a photo and surface map of an area of interest in the centre of the defect, which was identified using the CT scan volumes. This area sits directly above a feature that will be discussed more later in this Chapter.

Figure 137: Sample 2. Above) Overview showing how clear grinding marks are. Left) Magnified image showing region of interest. Below) Surface map of region of interest rotated 90 degrees clockwise

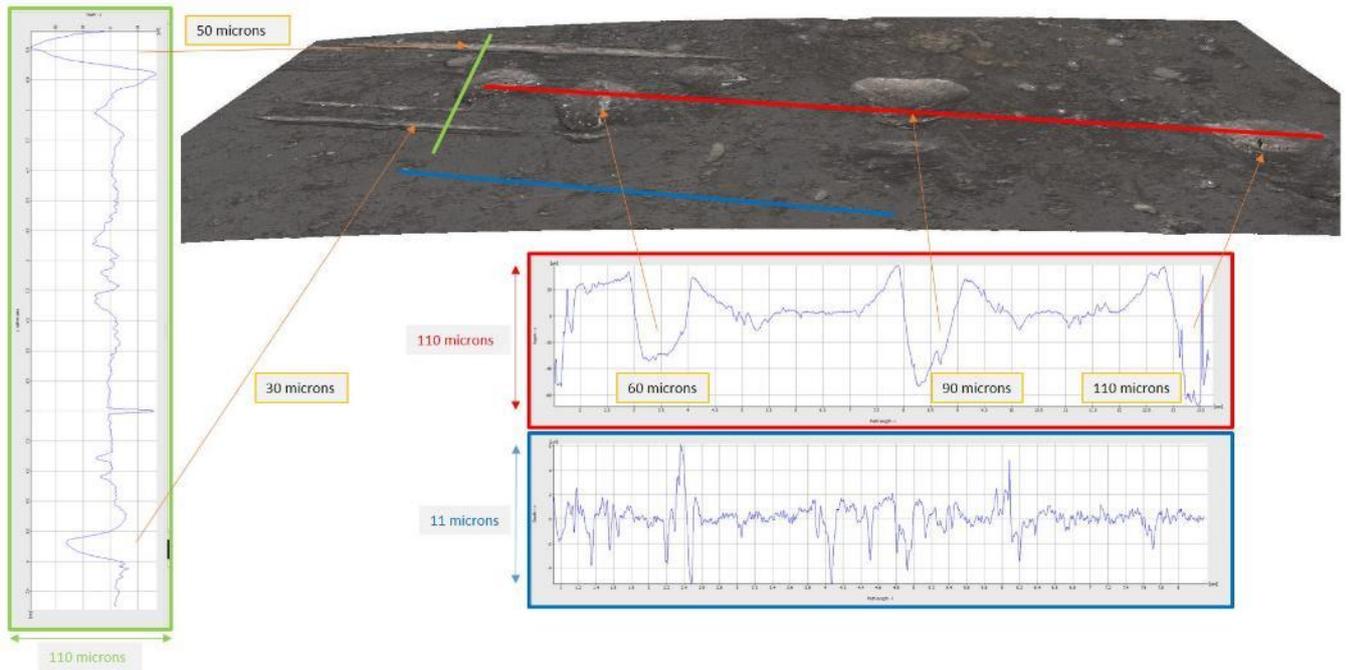
Figure 138 shows the depths of the features of interest. The grinding marks are 50 and 30 microns deep. Considering that most of the grinding marks on the rail have been worn away, these marks were either very deep to begin with or the wheel made very little contact in these areas. Alternatively, perhaps some wheels made little contact and some made some contact, but the grinding marks were also deep. The importance of these grinding marks will be discussed later in this Chapter. The Rz value for the smoothest areas around the region mapped in Figure 137 and Figure 138 are ~6 microns, with even the lightest pitting increasing this value to 10 microns.

Figure 138: Roughness measurements obtained using an Infinite Focus Microscope. Orange arrows link the graphs to the image along with depth measurements and the double-headed arrows show the range of the depth scale.

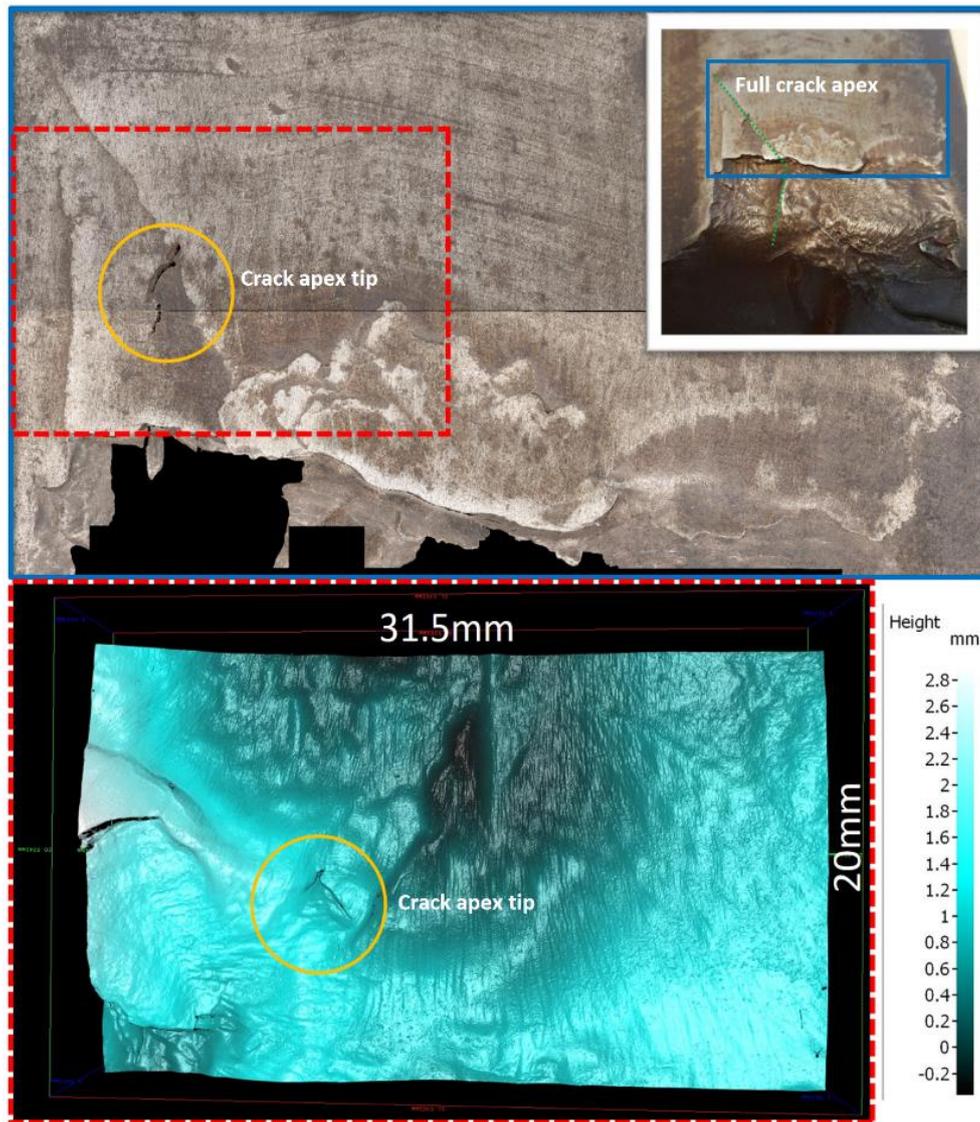
The in-service breaking and shelling of Sample 3 left only a small section to scan. The focus was on the intact lobe, which had its upper surface removed to expose the crack plane below for scanning. Figure 139 shows the surface map for the crack plan that created the intact lobe in Sample 3. The other lobe was lost due to shelling but can be seen exposed in the inset image. Sample 3 shows the apex crack on the gauge corner that is associated with Squats, shown as a green dotted line in Figure 139. The apex of that crack was probably the initiation site.

Figure 139: Surface map of the crack plan that makes up the intact lobe of Sample 3. Above) The surface of the rail. Below) The crack plane below the rail surface within the red dotted box. The orange circles aligns a common feature in the two images.

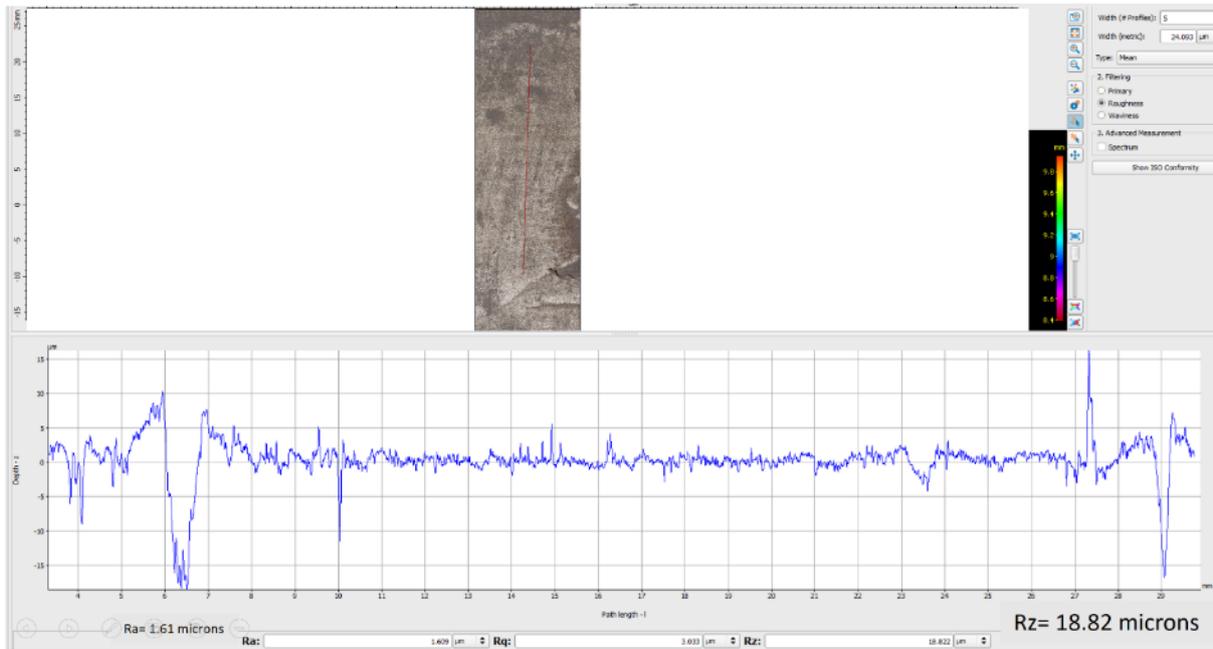
The remnant signs of grinding marks can just be discerned in Figure 139. Figure 140 shows the roughness of the region. Across most of the red line, the surface is smooth, barely deviating more than 5 microns. However, at each end of the red line, just before the two surface cracks, there are two dips. The wider dip seems to have shoulders, meaning the line rises on both sides before in dips. This suggests a third body particle became trapped in the contact. The narrow dip is attributed to the depth of the grinding marks still present, as ~15 microns was found to be the approximate depth of the grinding marks still visible on Sample 4 too. Defect free areas of the surface yielded Rz values of 3 to 4 microns.

Figure 140: Roughness of Sample 3 just before the shelled region of the defect

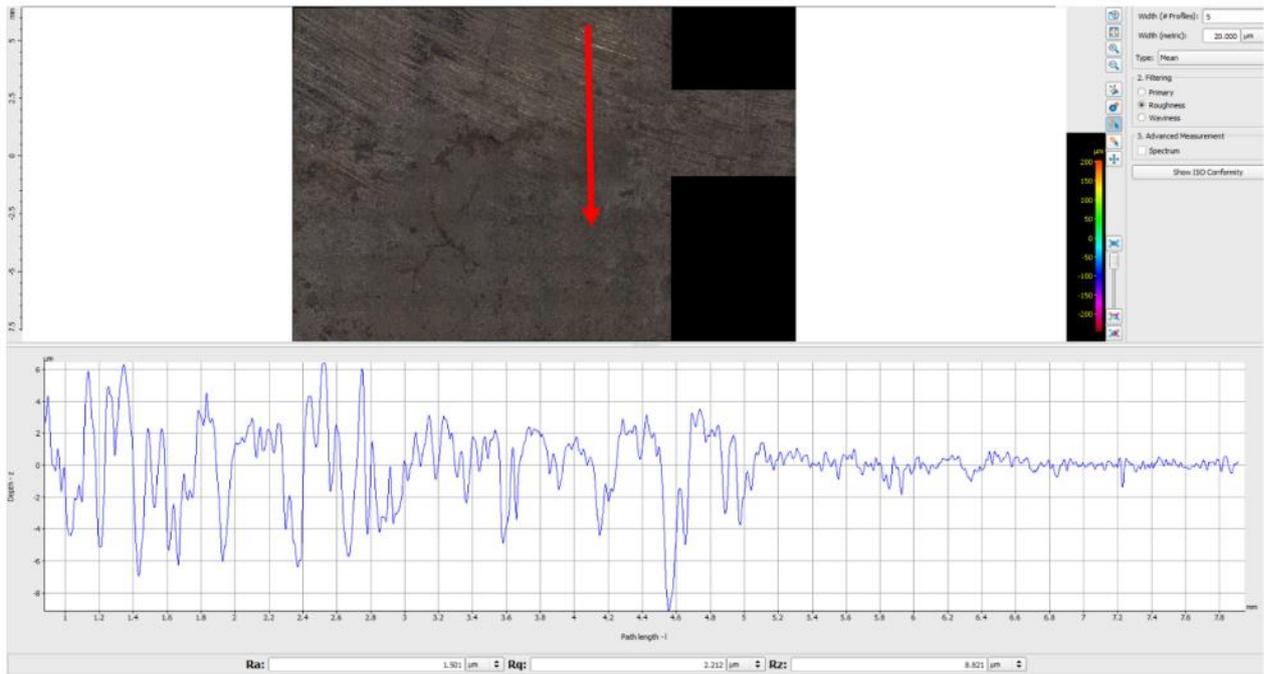
The surface of Sample 4 consisted of both a rough area displaying grinding marks and a smooth area. The smooth area seemed quite consistent with the area above the aluminothermic weld. The initiation of the defect was on the border of the rough and smooth regions. As with one of the marks in Sample 3, the grind marks in sample 4 seem contained to within a 15 micron range (Figure 141). The transition from rough to smooth may have been a factor in a slip value change for the wheel passing over Sample 4. On the other hand, the smooth area could have occurred during to the development of the defect, perhaps due to decarb from the weld process. With very little information about where the sample came from, and the traffic it experienced, it is very difficult to be certain. The main value in the roughness measurement of Sample 4 is that it gives a reasonable value for the depth of typical grinding marks. Grinding mark depths obviously reduce with wear, more dramatically at first, but some range of numerical values needs establishing to determine if a grind mark is typical, or too deep.

Figure 141: Roughness measurement for the transition from the rough region to the smooth region. R_z is 8.8 microns.

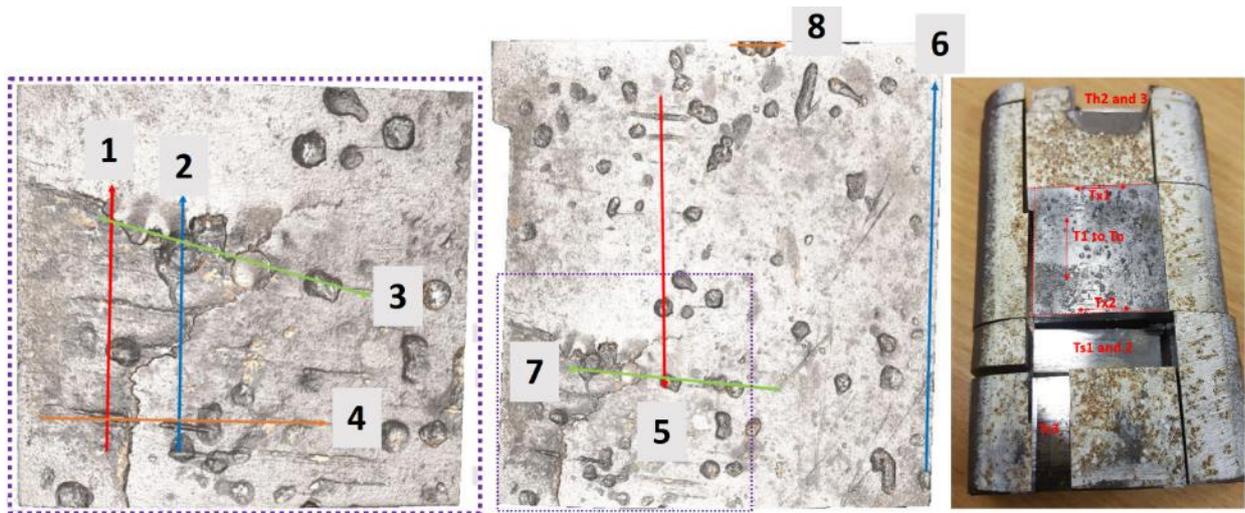
Being from the same railway line as Sample 2, Sample 5 shares both the pitting and the grinding marks, but the surface was mapped in more detail. The region mapped can be seen in Figure 142, with the R_a and R_z values in Table 12 and some of the graphs in Figure 143.

The pit's depth dominates R_a and R_z values when the measurement line includes pits. In measurement 5 there are two grinding marks of 20 and 30 microns deep, alongside a pit that seems to be ~35 microns deep, but looks ~65 microns deep if the shoulders are included. The depth of the features is of some interest, because shallow features should wear away faster than a deep one, and deep grinding marks have been associated with defect development in the literature. The width of the pits is also significant because it reduces the contact patch with the train wheel.

Figure 142: Locations of the measurements taken from Sample 5, with the bulk being from the centre of the rail and the initiation site indicated by the dotted box.
