Micro-CT Scanning in the Investigation of Squat Defects in Rail Steel

Shaun Earl

*Submitted for the degree of Doctor of Engineering in the
Department of Materials Science and Engineering at the
University of Sheffield, UK.*

January 2021

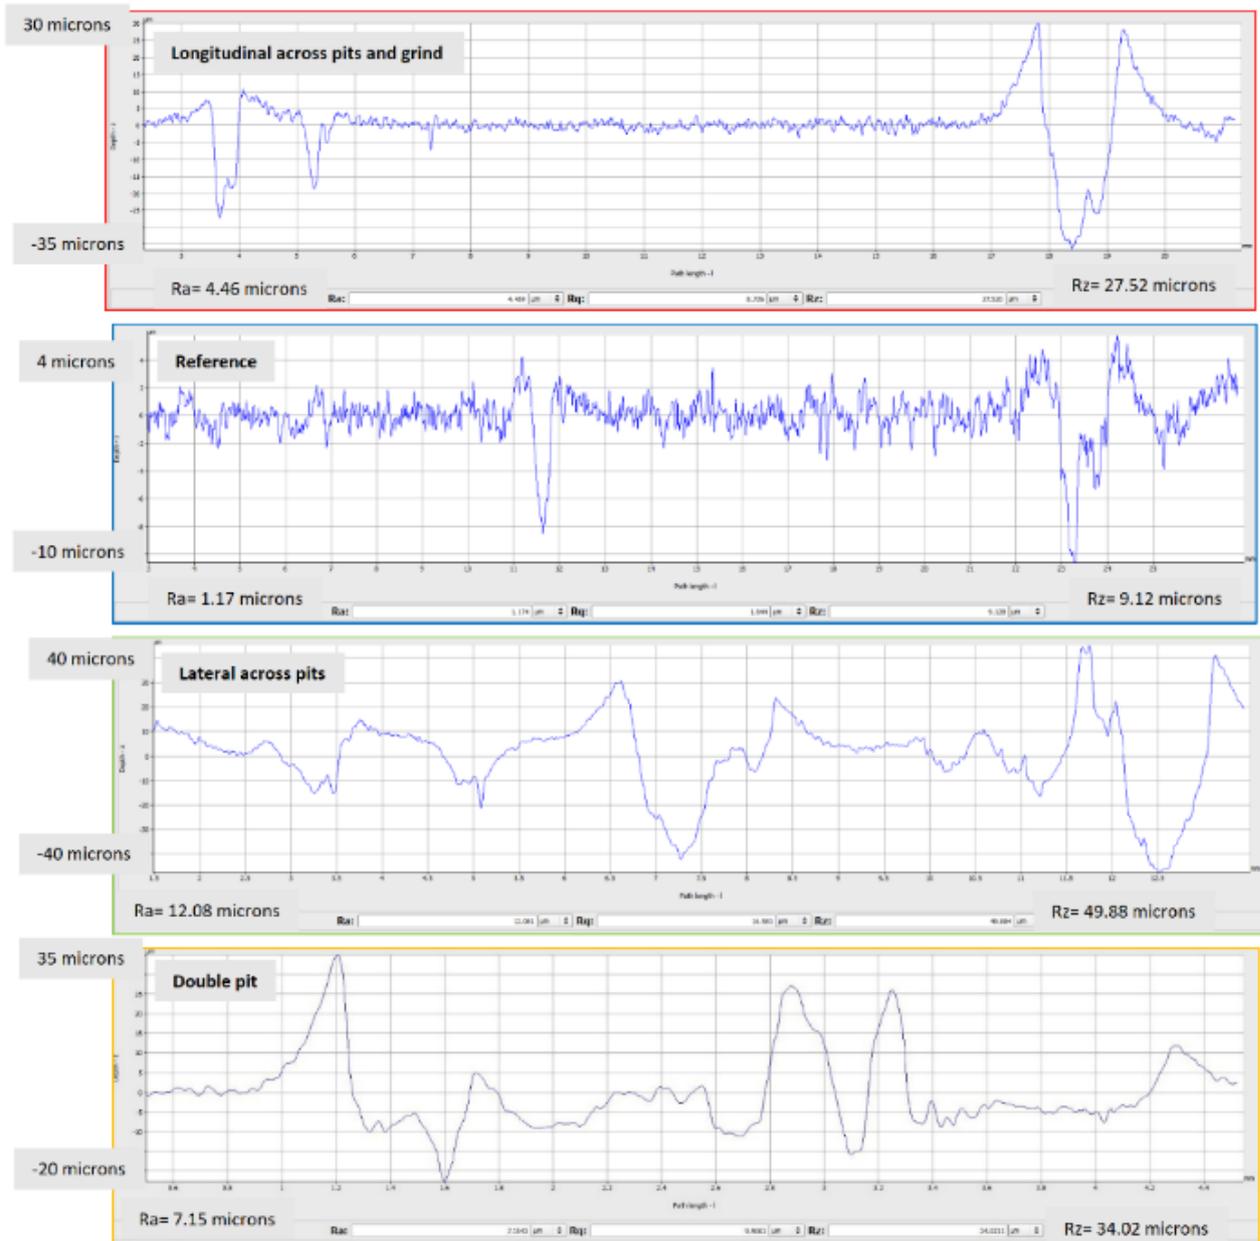
The pit's depth dominates R_a and R_z values when the measurement line includes pits. In measurement 5 there are two grinding marks of 20 and 30 microns deep, alongside a pit that seems to be ~35 microns deep, but looks ~65 microns deep if the shoulders are included. The depth of the features is of some interest, because shallow features should wear away faster than a deep one, and deep grinding marks have been associated with defect development in the literature. The width of the pits is also significant because it reduces the contact patch with the train wheel.

Figure 143: Roughness graphs for measurements 5 to 8, taken from Sample 5 (see Figure 142)

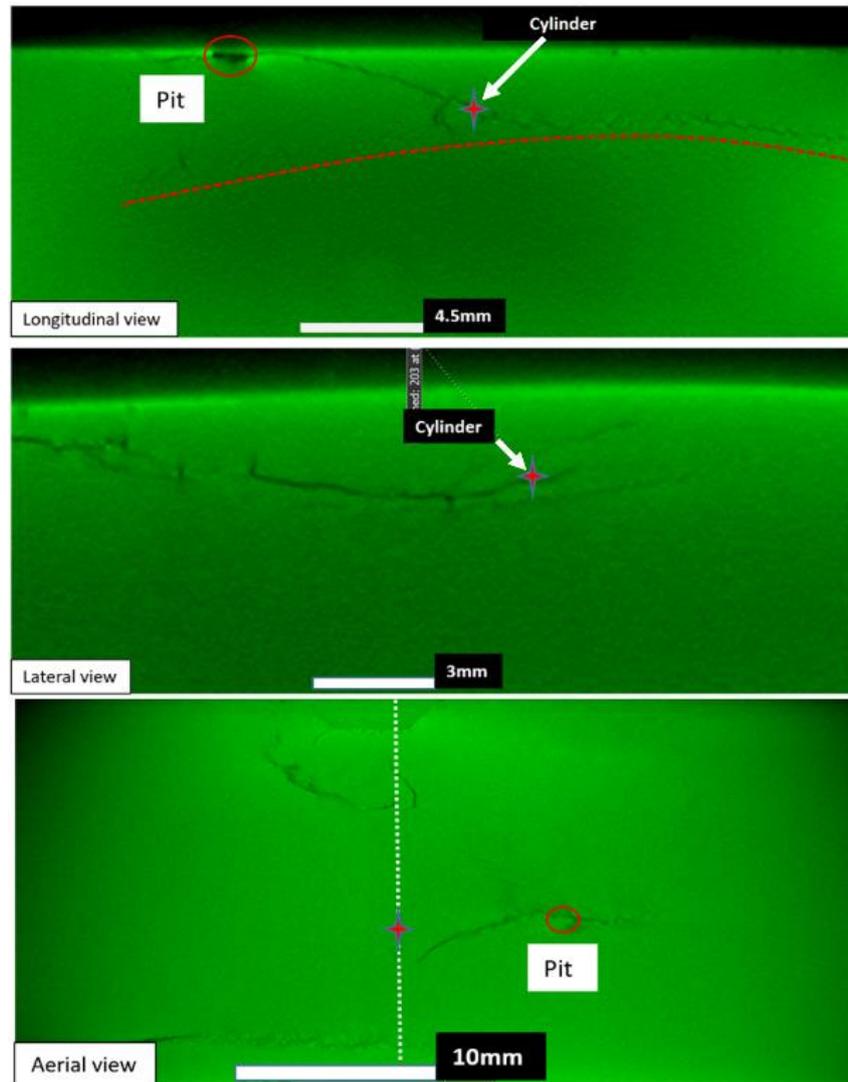
Another interesting feature is the cylindrical crack that exists where the only major branch from the initial leading and trailing cracks are, seen in the longitudinal view of Figure 145. This cylinder probably began as a branch from the main crack before the close proximity of the two cracks caused a small crack to cross the gap, creating a circle/cylinder. An interesting question is which crack was present first. Looking at the longitudinal image in Figure 145, it seems reasonable that the upper crack existed first and the crack grew downwards. However, ignoring the surface breaking crack, the lower crack lines up smoothly with the other side, as shown by the dotted red line. Therefore, it is plausible that the lower crack developed first as a subsurface crack, and then the surface crack grew later, connecting the pitted region on the surface to the subsurface crack.

Figure 145: Orthogonal orthoslices from the scan of Sample 1 showing the location of the ‘cylinder’ feature (red star). The longitudinal view shows the 2D circle of the cylinder with a red dotted line highlighting the faint lower crack. The lateral view shows the cracks that make up two sides of the circle alongside an extra crack above. The aerial view provides a comparison of the location to the photo in Figure 156. The white line is related to the comment in the text.

Given that this defect is believed to be caused by a severe slip event, a subsurface initiation is plausible. Heavy decarburisation and plastic flow of the gauge corner of the rail in the same region as the defect supports the concept of a thermally caused initiation.

The slip will have created a heated upper surface that, when rapidly cooled due to the heat sink effect of the rest of the rail, caused a small crack to form parallel to the surface due to the

thermal shock. The lower crack contains a small crack parallel to the surface just to the right of the cylinder feature.

The lateral view shows how there is extensive cracking at various depths, which will allow some movement in the railhead. In the aerial view, it can be seen that if a line was drawn through the cylinder's location, 3 of the 4 surface cracks begin or end at that line. The line is sometimes referred to as the ridge between the two lobes of a Squat.

It is possible that the ‘cylinder’ in Sample 1 was simply caused by the branching cracks passing close enough to each other that a smaller crack connected them during the defects growth. The ‘cylinder’ is not believed to have been the first initiation point in Sample 1: the first initiation is believed to have been on the field side of the defect for reasons explained previously (Figure 9 in Chapter 4). Looking closer at the cylinder after metallographic preparation shows that one of the upper cracks of the cylinder has experienced high shear forces. The crack faces had rubbed together with enough intensity to cause plastic deformation as documented in Chapter 5 using nano-indentation. The area of deformation is on the upper edge of the cylinder.

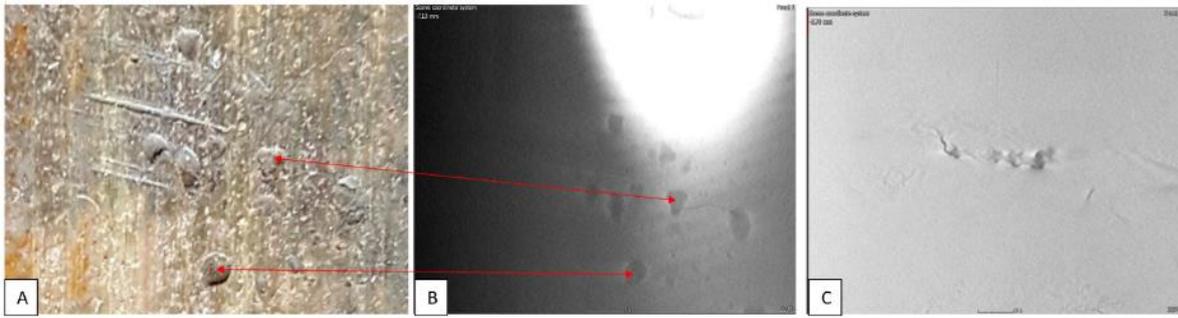
Figure 147: a) Photograph of surface, b) same surface as 'a' but from the scan with examples of the same pits linked by arrows, c) the same region as 'b' but ~3mm deeper into the rail

The width of pits make them reduce the contact patch more than grinding marks. They are also deeper. This is expected as the corrosion in the bottom of the pits allows them to keep growing deeper whilst grinding marks are slowly worn. This means that in the early stages of the defect development, the grinding marks will have been more significant than the pits in terms of depth. Figure 151 shows the location of some of the pits that were above the high-resolution scan region. These pits seem to correlate with the crack growth route. This is believed to be because the pits caused subsurface stresses, damaging the subsurface material, making it an easier path for crack growth.

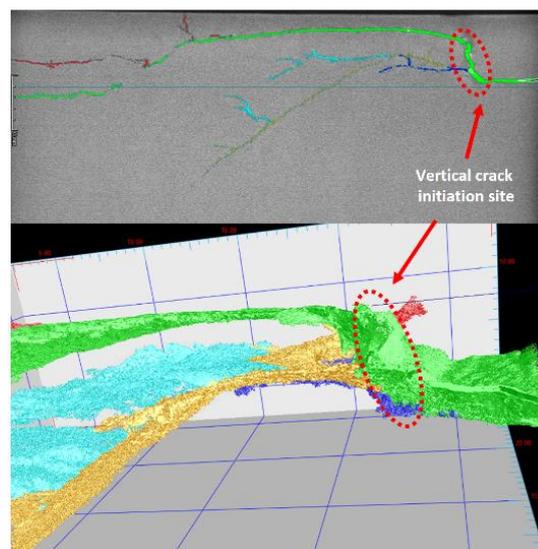
The vertical crack initiation site is believed to have occurred earlier, assuming both crack planes grew at a similar rate, because the crack planes meet at a distortion closer to the voids than the vertical crack. This initiation is a vertical crack that developed longitudinal cracks from its upper and lower crack tips (Figure 148). The vertical crack was identified as an initiation site because the region around the vertical crack was chaotic, and the crack path becomes more continuous and smoother further away from either of the two initiation sites. Vertical cracks can occur, although they are usually seen surface breaking. Therefore, cracks growing from the top and bottom of a vertical crack is much more plausible than a crack making two ~90 degree turns in quick succession, if at all.

Figure 148: The vertical crack initiation site as a 2D and 3D image. The 3D image is isolated from the rest of the defect for clarity, with a scale in mm on the grid.

The vertical crack is close to the field side of the rail, suggesting a hollow wheel creating high contact stress. Hollow wheels were confirmed as an issue at the site where this sample was extracted. As for why the crack is vertical, there must have been a point in the microstructure that failed first.

In some areas, grains were noted to align their borders so that there is a line of ferrite running vertically into the material. Given the thicker ferrite layers on grain boundaries seen in this grade (R220) and the normality of cracks appearing on grain boundaries, it seems that the occurrence of this subsurface vertical crack was the result of a 'perfect storm'. That is, the high contact stress, probable slip event and the favourable orientation of the grains in a grade with softer grain boundaries.

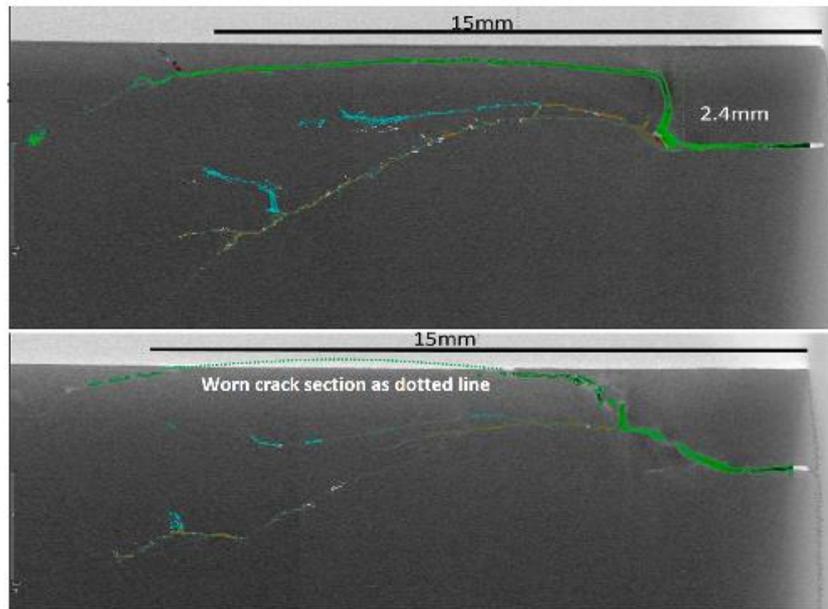
Figure 149 demonstrates how the main crack plane (green) is still present in one region, but has worn away 1.5mm closer to the field corner, probably where the hollow wheel was contacting. Because the rail has worn more in this area, it makes it look like the original green crack is rising to the surface. Consider the 3mm depth that both the voids and the bottom of the vertical crack reside at. When looking at other areas of the rail where the crack is closer to the surface, the 3mm depth now coincides with the location of the transverse crack. This suggests that the first crack developed at a depth where the peak subsurface contact stress was, and then as the rail wore, the depth shifted with the new surface location, causing another crack to initiate at the same depth, but below the original crack plane. This situation was only observed on the field side, and is the explanation for the yellow downward growing crack (Figure 150), which was not as steep as the blue one, but was also a separate crack plane until the two eventually linked up in the later stages of growth.

Figure 149: Above) CT orthoslice of the vertical crack that initiated the orange downward crack. Below) 1.5mm closer to the field corner, showing how the upper crack has been worn away

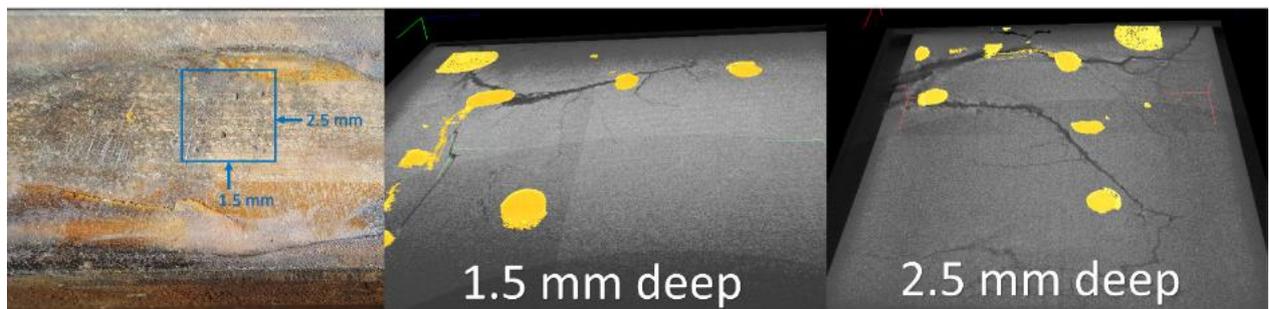
Figure 151: Pits are shown in yellow from the high-resolution scan of Sample 2, showing a correlation between the pits locations and the cracks growth path. The blue arrows show the direction of view for the two other images.

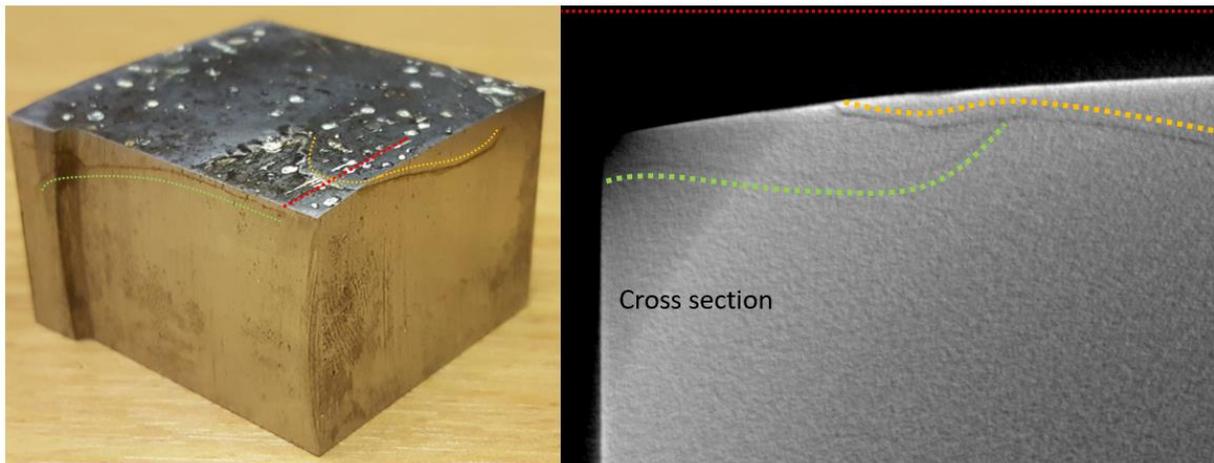
Sample 5 was taken from the same line as Sample 2 but is not as mature, providing an insight as to the development of Sample 2. Sample 5 has only developed the leading crack, the trailing crack occurs when the defect matures [9]. Initially the crack seems to branch out laterally and longitudinally from the same initiation but the CT volume shows that the cracks pass each other at slightly different depths, although they do link up eventually (Figure 152).

Figure 152: A comparison between the two cracks running longitudinally (green) and laterally (orange) with a CT cross section orthoslice. This shows that they are not the same crack plane even though they link up eventually.

The typical growth from the apex initiation is distorted slightly by the initiation on the grinding mark, the same distortion that causes the ‘figure of 8’ in Figure 153. However, one of the crack planes (green in Figure 152) appears as a subsurface crack parallel to the surface like in sample

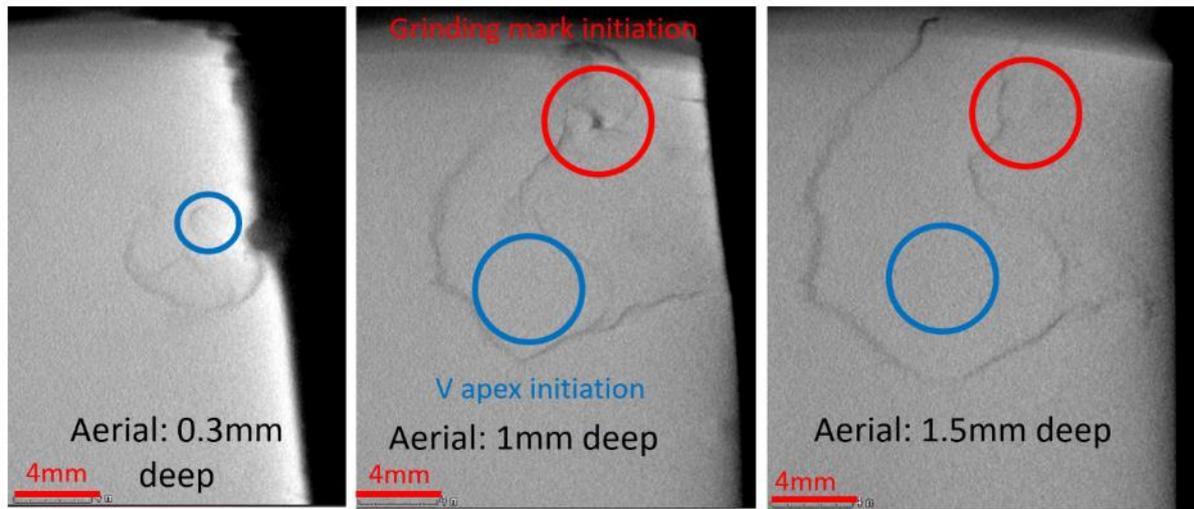
Two initiation sites were present, as the typical conical growth of a defect in its early stages became distorted into a ‘figure of 8’, when the two cones meet as they grow down into the rail (Figure 153). One of these initiations is where a grinding mark and a surface crack cross (Figure 155). The other initiation is at the apex of the V-shaped crack that is often seen in Squats, although this one is on the field side rather than the gauge side. This has been seen before, although that defect was identified as a spalling defect [10]. The circular surface crack means that some wear has occurred since the apex crack initiated, as the tip of the cone has been truncated [3].

Figure 153: The two initiation sites in volume T, at different depths in aerial view showing the 'figure of 8' forming. The cross section shows how the cracks link up as they get close.

It is difficult to be certain which of the initiations in Sample 5 came first, although the larger spread of the V-shaped initiations cracks apex (Figure 153) sways opinion towards it being first. The interest in the cylinder is its similarity to the cylinder/ fretted region of Sample 2 that was the source of a potentially dangerous TD. Both features are ~3mm deep in the rail (variation could be attributed to different wear rates of the surface since development) and both cylinders are ~1.2mm across at their largest point. This could be coincidental or it could be a sign that the development of enough cracks (i.e. the cylinders) in a defects growth can lead to branching that becomes a TD. Both cylinders sit below a damaged surface that results in higher subsurface stresses. Therefore, if these cylinders are responsible for TDs developing, surface quality is a crucial component of preventing TDs.

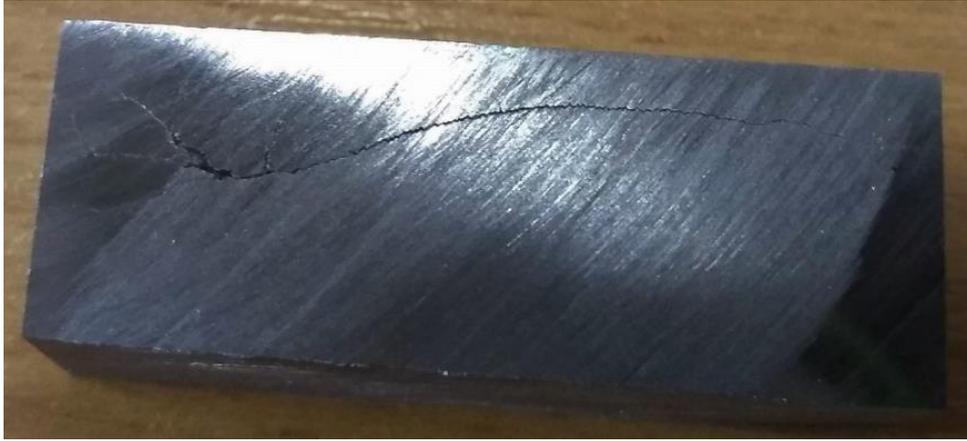
Sectioning Sample 5 in a region where a shadow was found in the CT scan revealed a familiar feature. The shadow was caused by the branching of the crack network in multiple directions, resulting in the release of material that was lost when sectioning the sample (Figure 154). A crack can already be seen growing vertically from this cluster of damage. If the vertical crack breaks the surface, corrosion can occur in this void, allowing the same rapid crack growth seen in Sample 2. Sample 2 growth is considered rapid because it is clearly much more developed, despite experiencing exactly the same traffic conditions as Sample 5. This branching feature was found directly below an elongated pit and a circular pit, i.e. a severely reduced contact area (purple circle in Figure 155).

Figure 154: Branching of the cracks and loss of material in Sample 5. Probable precursor to voids seen in Sample 2.

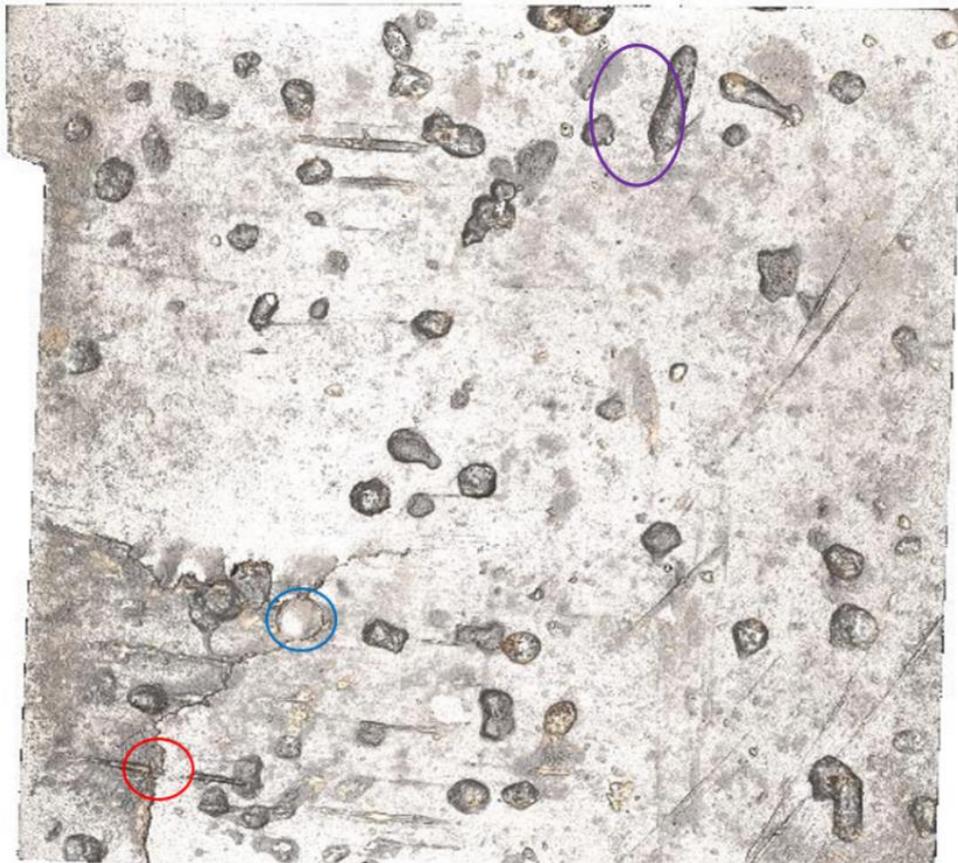
Figure 155: IF microscope map of the surface of Sample 5 showing the two circled initiations. The image is upside down compared to the CT viewer in Figure 153. The purple circle shows the location of subsurface damage shown in Figure 154. Scanned area = 40x40mm.

The roughness maps presented show that some grinding marks and pits are quite deep, even though it seems wear has removed many of the other grinding marks. This reinforces the principle that a good surface finish after grinding is important. Samples 2 and 5 show grinding marks that were deep compared to the others that have worn away (Figure 147 and Figure 155). Deep grinding marks were in the vicinity of an initiation site in Samples 2 and 5. Deep refers

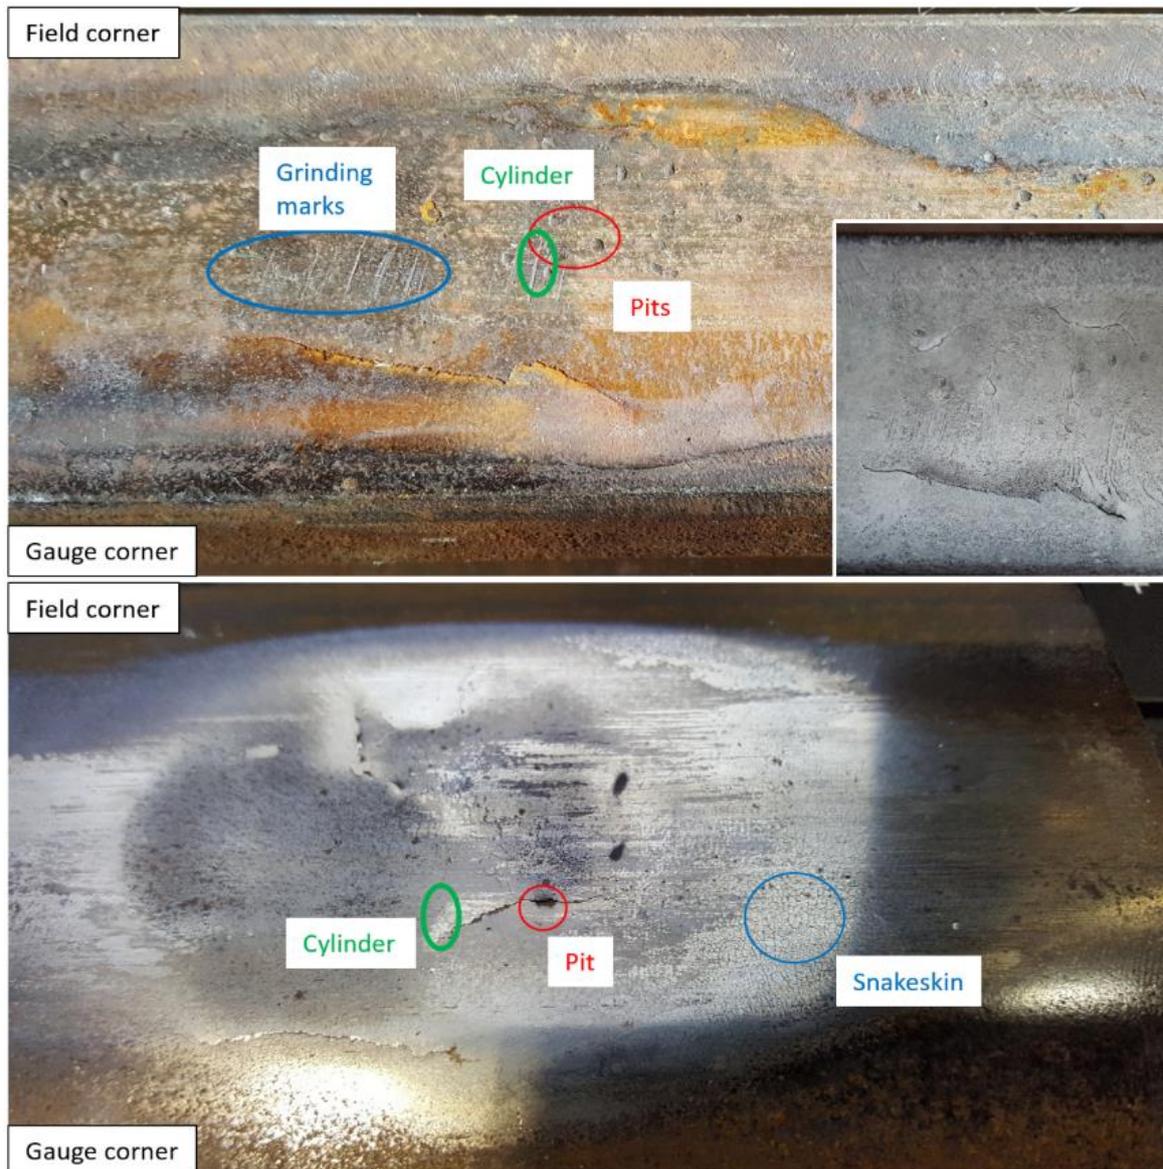
Figure 156 compares the surfaces of Samples 1 and 2, showing the common widening of the band due to the subsurface crack network and the surface breaking cracks on the field and gauge sides of the rail. Both samples have surface roughness, but from different causes. Sample 1 has 'snakeskin', which is a network of shallow microcracks that makes the surface look scaly. The small pit that sits on a crack on Sample 1 is believed to have started from the flaking away of one of these scales. Sample 2 and 5 have similar pits and grinding marks as they experienced the same traffic environment and maintenance.

Figure 156: Above) Sample 2 with surface damage highlighted and a contrasted image inset to show the cracks. Below) Sample 1 with 'snakeskin' cracks and the pit visible subsurface in Figure 145.

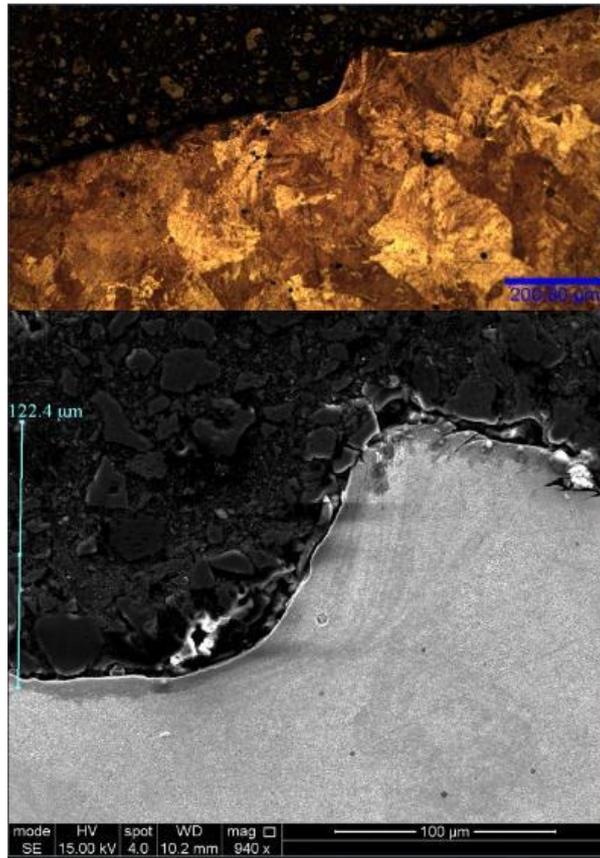
Grinding does not just produce valleys that reduce the contact area, they can also produce hills that are higher than the rail profile (Figure 157). These raised hills are compressed into the rail by the high pressure of a passing wheel if it were in the running band. As discussed in Chapter 2, this pressing of ground material into the surface of the rail creates residual stresses and initiation sites for cracks.

Figure 157: The hill created by grinding on the field corner of Sample 4. The peak of the hill has multiple cracks within it.
