The Dark Side of Bright Metal Coatings

THE DARK SIDE OF BRIGHT METAL COATINGS

Research Staff and Central Laboratory
Ford Motor Company

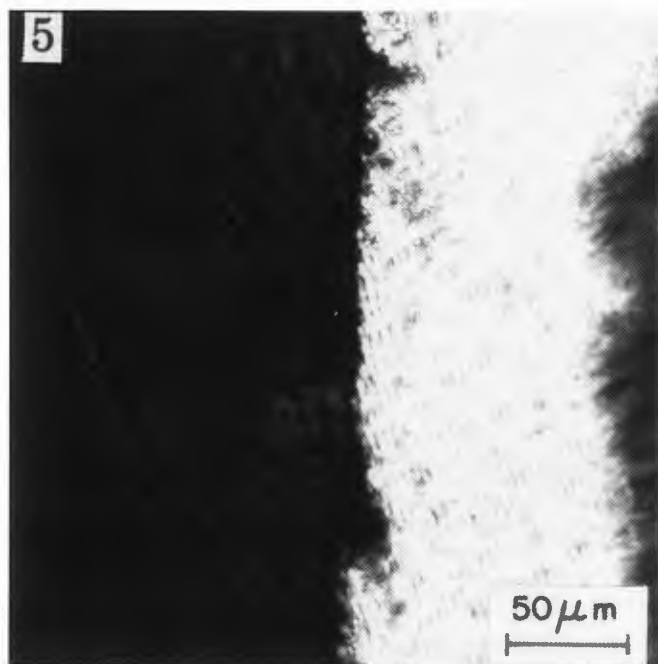
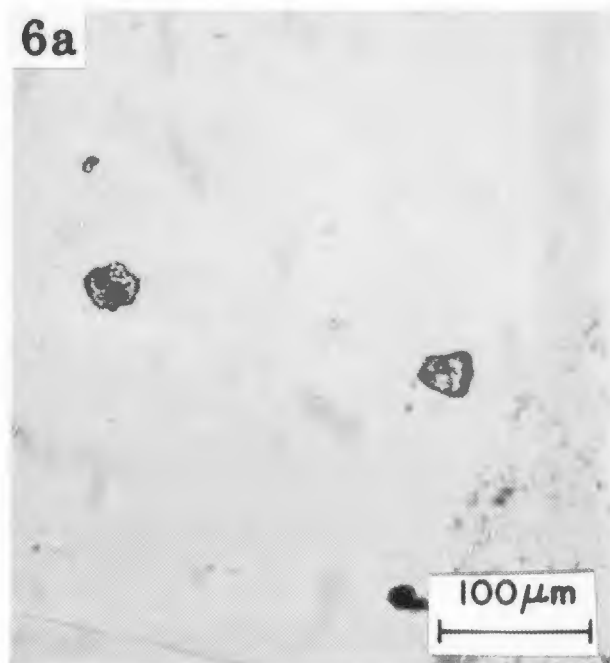
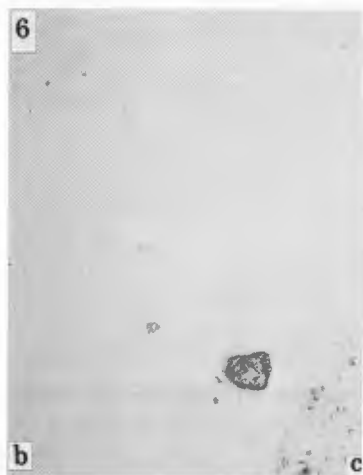
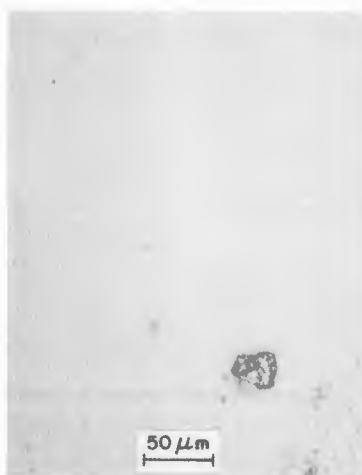
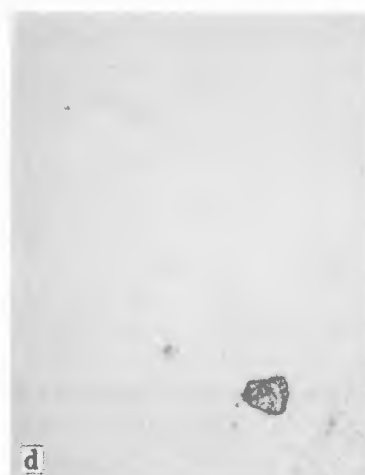
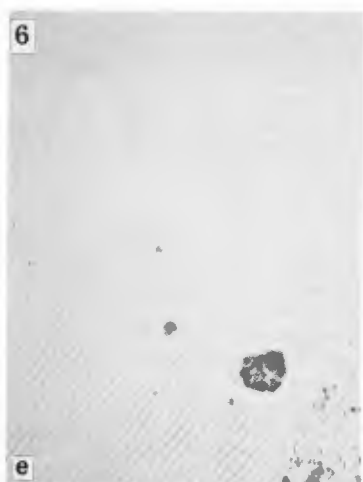
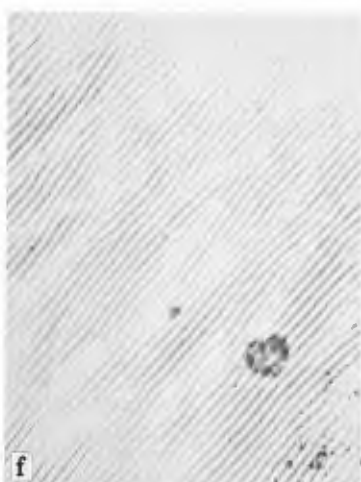
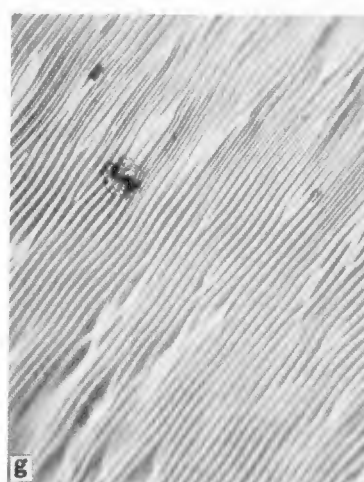
The sample was heated at the rate of 4°C per minute from room temperature to 110°C. The subsequent heating rate was reduced to 0.5°C per minute to permit visual observation of the changes. Figures 6b, c, and d, show only minor and gradual changes of the surface. The first major change in the surface appearance is seen at 139.5 °C and is shown in Figure 6e. In the lower part of the micrograph, the initial development of the line-type structure is visible. Above this area, the micrograph gives some evidence of the development process. The line-type structure development is a gradual process. These surface changes are controlled by the base coat because the aluminized layer is unable to resist the mechanical forces⁶. The precise behavior and role of the base coat is not clear, however. The observations suggest that the base coat surface wrinkling or ridging with temperature is similar to rapid-evaporation-caused

wrinkling. At 139.5 °C, and slightly above 140°C, the surface corrugations occur rapidly and they are coarse. At 142 °C the surface alteration is complete. Figures 6f and g, show the intermediate and the complete change, respectively.

The hotstage experiments were successful in approximately duplicating the appearance of the manufacturing induced interference colors. Exposing an uncured sample with base and top coat in the hotstage for 2 h at temperatures between 118°C and 125°C produced refined and directionally oriented line-type structures; Figures 8a and b are typical. It is worthwhile to repeat that higher temperature produced coarse surface corrugations (Figures 6f and g), but the initial surface changes may occur at temperatures as low as 118° to 120°C.

Fig. 6. Experimentally produced surface changes with the optical hotstage. (a) At room temperature and low magnification; (b) at 110 C; (c) at 120 C; (d) at 135 C; (e) at 139.5 C; (f) at 140.5 C; and (g) at 142 C. Figs. 6 (b) - (g) are at same magnification; note bar in Fig. 6 (c).

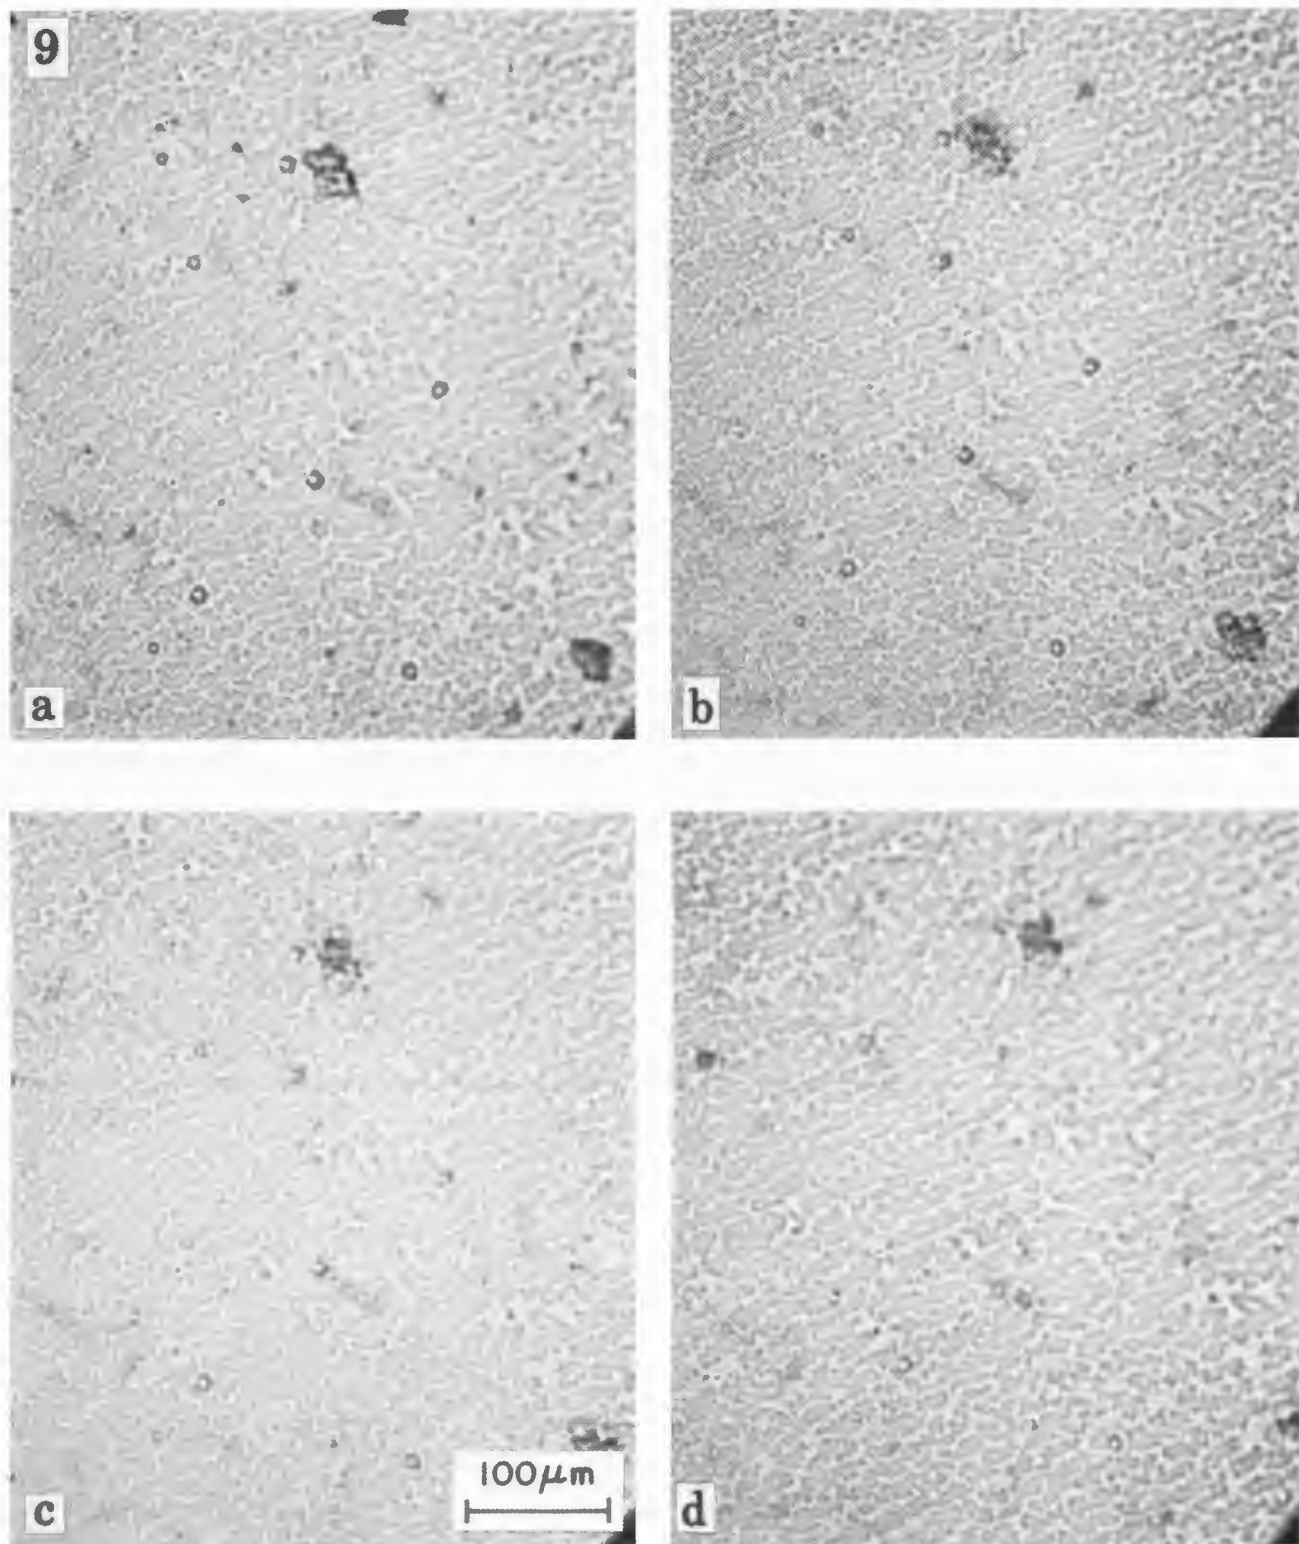
With extended annealing, the surface was substantially altered and Figures 9e through 9g show the changes. After two hours of continuous anneal (Figure 9g) the surface appears remarkably similar to the manufacturing produced surface shown earlier in Figure 7. The experiment indicates that the level of changes and fine details are time and temperature dependent. It is also interesting to note the gradual development of the lines from the coarse to the refined structure as shown with Figures 9e, f, and g. The coarse surface that developed during the first 20 minutes of anneal retains the basic structural character for an additional hour, but at the end of two hours at 122°C substantial changes have occurred. This sample had no base coat and the observed surface changes were caused by time and temperature, which can be associated with the stress relaxation of the reflector polycarbonate shell, and will be discussed later.

Fig. 9. Appearance of various surface defects produced with the optical hostage. The samples were uncured and without base coat. (a) at room temperature; (b) at 110 C; (c) at 120 C; (d) at 138 C; (e) after 20 minutes aging at 122 C; (f) after 1 hour aging at 122 C; and (g) after 2 hours aging at 122 C. Figs. 9 (a) - (d) are at same magnification, note bar in Fig. 9 (c); Figs. 9 (e) - (g) are at same magnification, note bar in Fig. 9 (g).

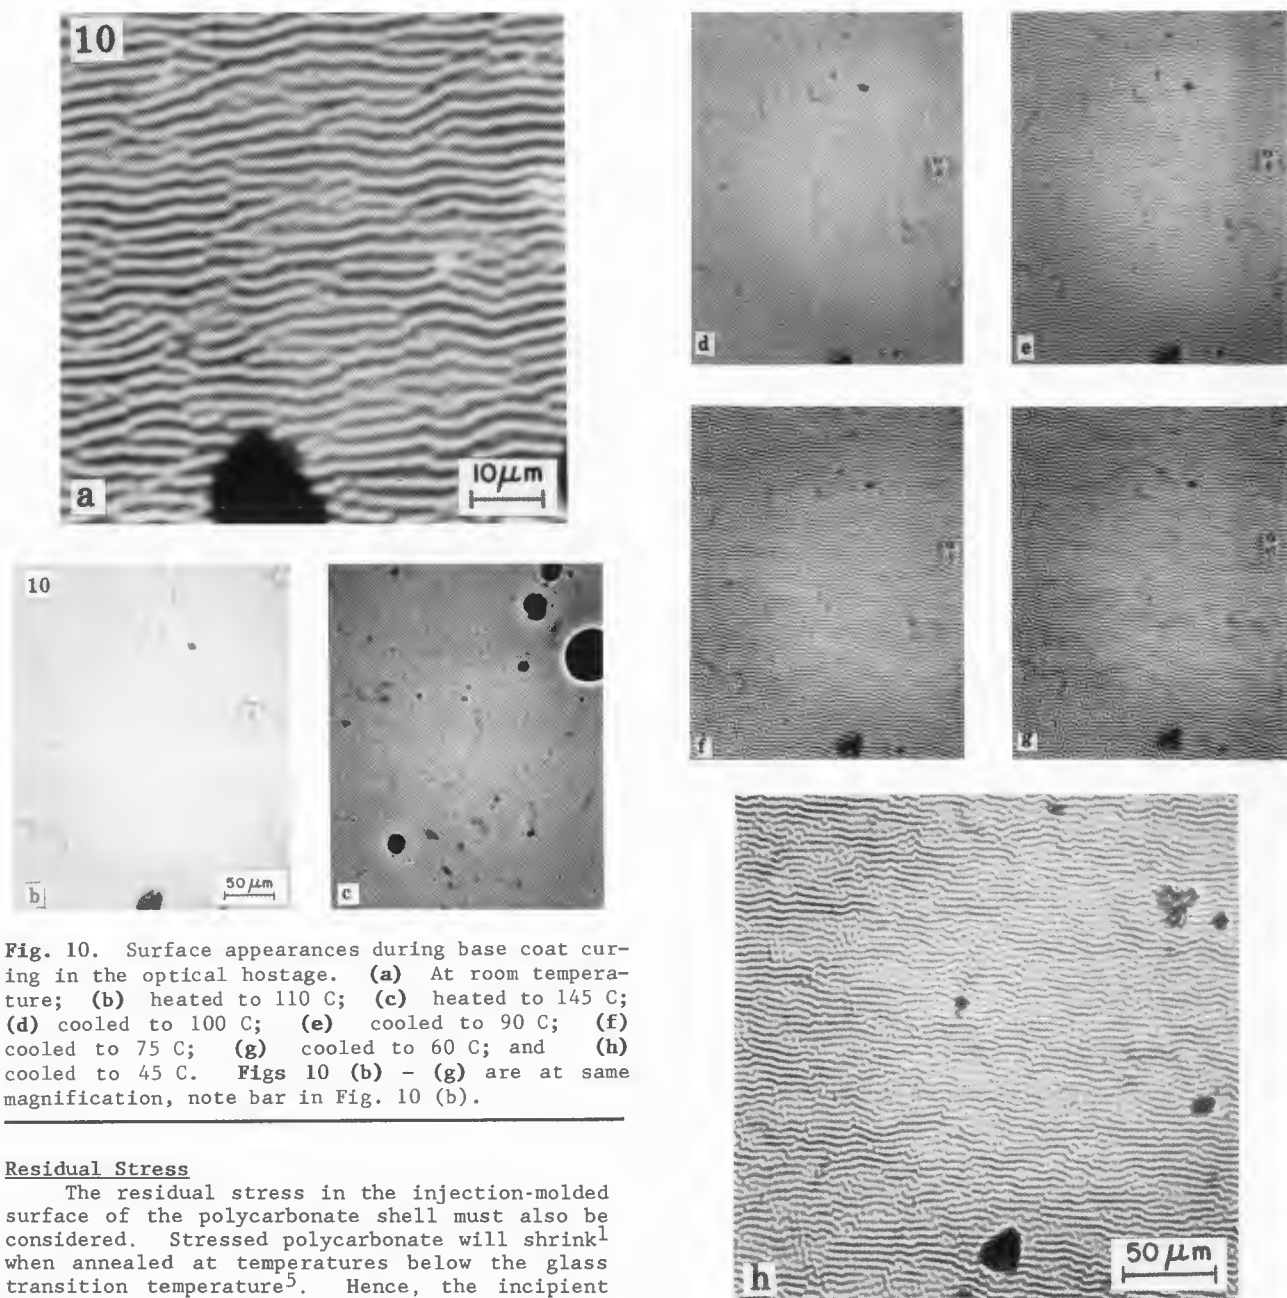
in the hotstage. With the exception of Figures 10a and 10c, one large contaminant at the bottom of all micrographs identifies the areas shown in Figures 10a - 10h. The hotstage experiments indicated that below 110°C the overall surface changes and the smoothing of the corrugations are minimal. The most noticeable changes occurred at 110 ° C or a few degrees above. Figure 10b illustrates the altered appearance. For all

practical purposes the surface rearrangements are "finalized" and there are no other appreciable changes even at higher temperature. To support this observation, Figure 10c shows the smoothed aluminized surface of an identical sample at 145°C, during a duplicate hotstage experiment; the images are almost identical.

The effect of the cooling rate on the surface structure is dramatic. Careful examination of the surface, cooled by only 10 ° C, (to 100 ° C) already demonstrates a stronger line-type structure, and in the center of Figure 10d, the emerging lines have some additional bends and extensions. The effect of further cooling is documented in Figures 10e through 10h. The continuity and shape of the individual lines appear to be "final" at 90°C (Figure 10e) but the detail visibly "matures" between 60°C and 45 ° C as shown with Figures 10g and h respectively.

During the hotstage heating and cooling experiment, the line-type structure of the surface changes from its pre-cure-produced appearance. Comparing the room-temperature image of the pre-cured surface (Figure 10a) to the images of the cooled surfaces (Figs. 10f, g, h), only minor changes are visible. The most noticeable is in the vicinity of the landmark contaminant. This indicates that after the pre-cure temperature of approximately 120 ° C, further changes have occurred in the base coat. This reasoning is reinforced by the second experiment using the 135 ° C pre-cured sample. Some microscopic surface smoothing was observed when heated to 110°C, but when the sample was cooled to 45 ° C there was no visible surface change from the corrugation produced by the 135°C pre-cure. This indicates that the base coat was fully cured and not prone to further change.

Fig. 10. Surface appearances during base coat curing in the optical hotstage. (a) At room temperature; (b) heated to 110 C; (c) heated to 145 C; (d) cooled to 100 C; (e) cooled to 90 C; (f) cooled to 75 C; (g) cooled to 60 C; and (h) cooled to 45 C. Figs 10 (b) - (g) are at same magnification, note bar in Fig. 10 (b).
