WHOI-91-34

ESOM I and II Final Report

Alessandro Bocconcelli, Henri Berteaux, Daniel E. Frye
and Dr. Bryce Prindle

Technical Report

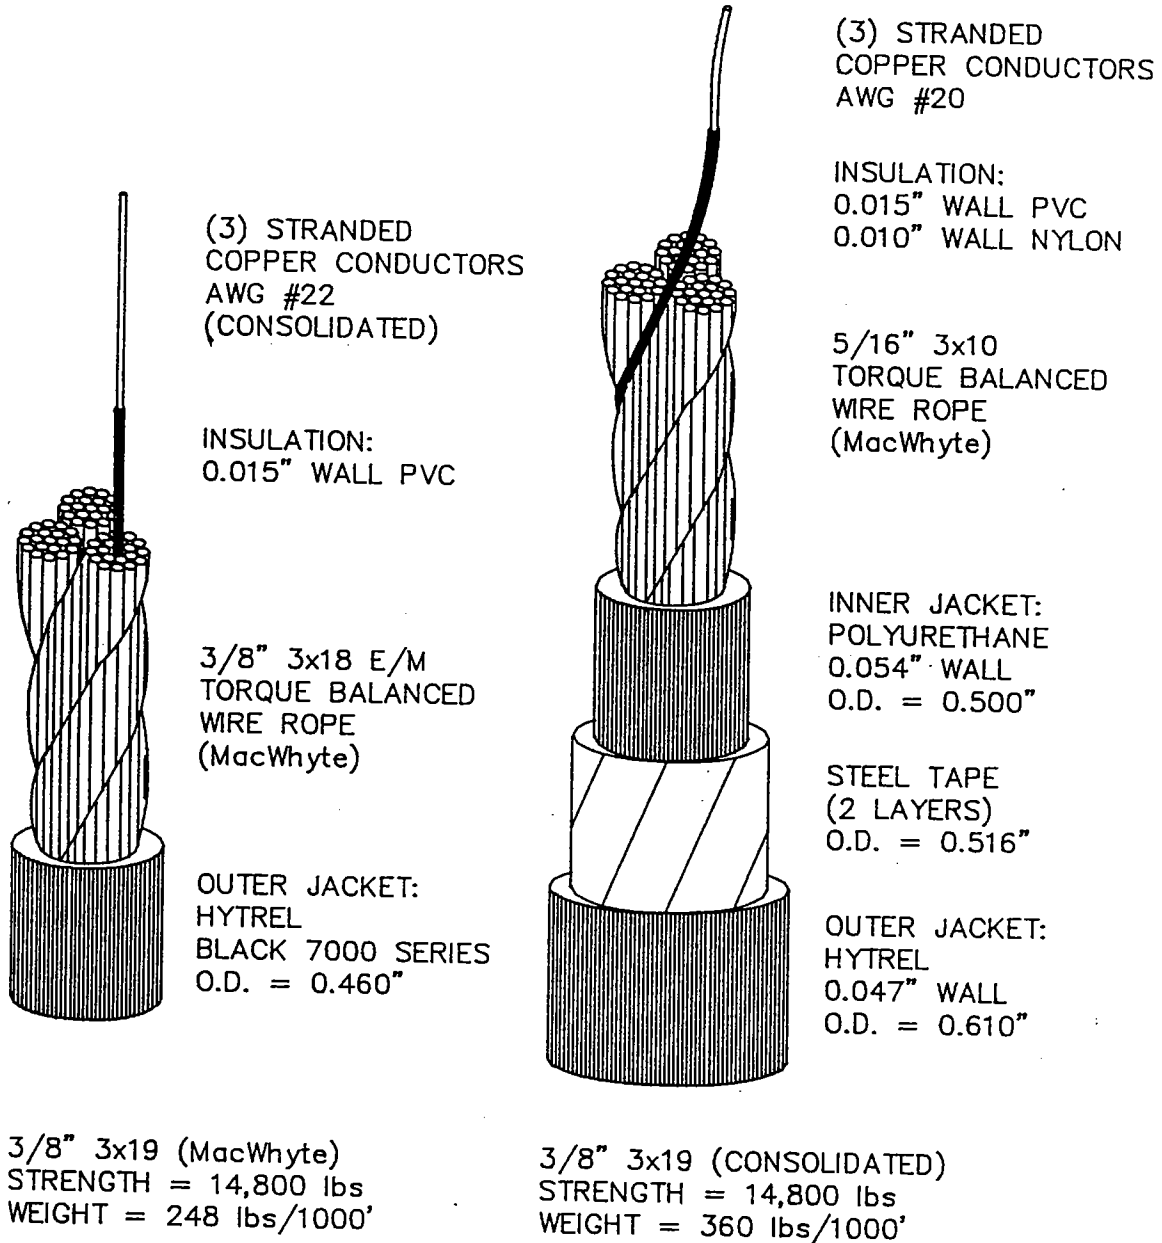
FIGURE 4: E/M cable samples

Two types of novel EM cables, using the proven 3x19 oceanographic rope construction were systematically tested (Figure 4). In the first type (MacWhyte Mfr.), the conductors are placed in the center of each strand. In the second type (Consolidated, Mfr.) the conductors are placed in the valleys between the strands [8]. Two self recording continuity meters periodically checked the EM cable electrical continuity.

During the turnaround cruise, all the EM samples were recovered, inspected and electrically tested. Data from the two continuity meters did not indicate any kind of electrical failure. The EM cable "long term" samples appeared to be in good condition, with no structural damage except for a few superficial cuts due to fishbites. The jacket damage was repaired and the three samples were redeployed for the ESOM II experiment. The "short term" samples were further tested at the BBSR and at WHOI. Item 18 (Figure 1) had a failed pigtail in the swage termination. The cable itself tested properly (continuity and leakage resistance tests).

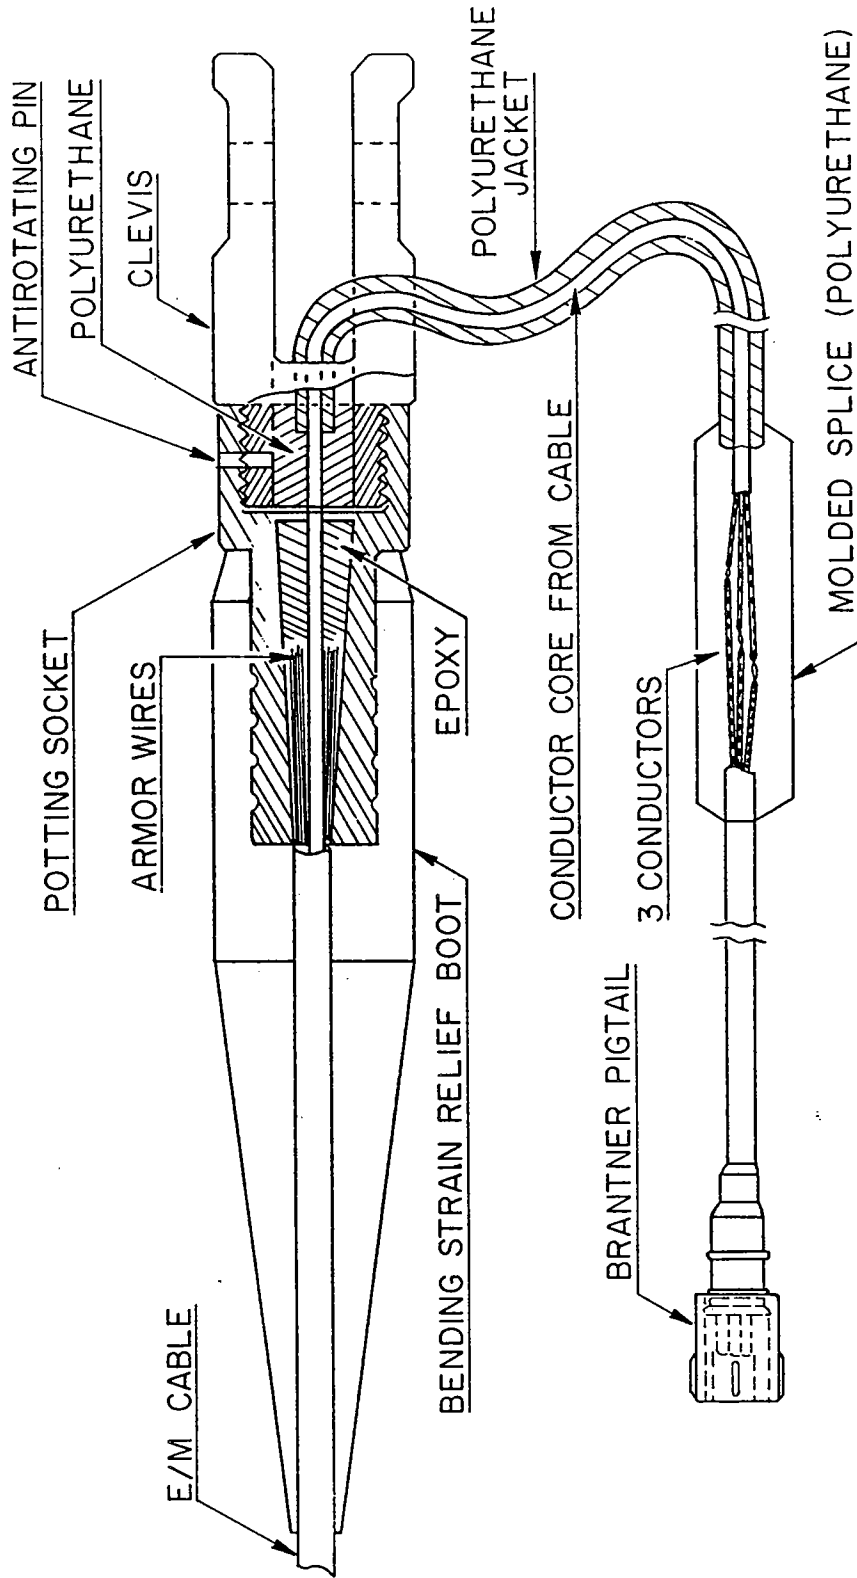
FIGURE 5: In-house epoxy termination

Two types of EM cable terminations, both designed and built at WHOI, were tested during the ESOM experiment. The "in house" epoxy termination (Fig. 5) for 3x19 EM cables had been previously during the six month STEM experiment with excellent results [9]. The new swage socket termination for the 3x18 EM cables (Fig. 6) was deployed at sea for the first time.

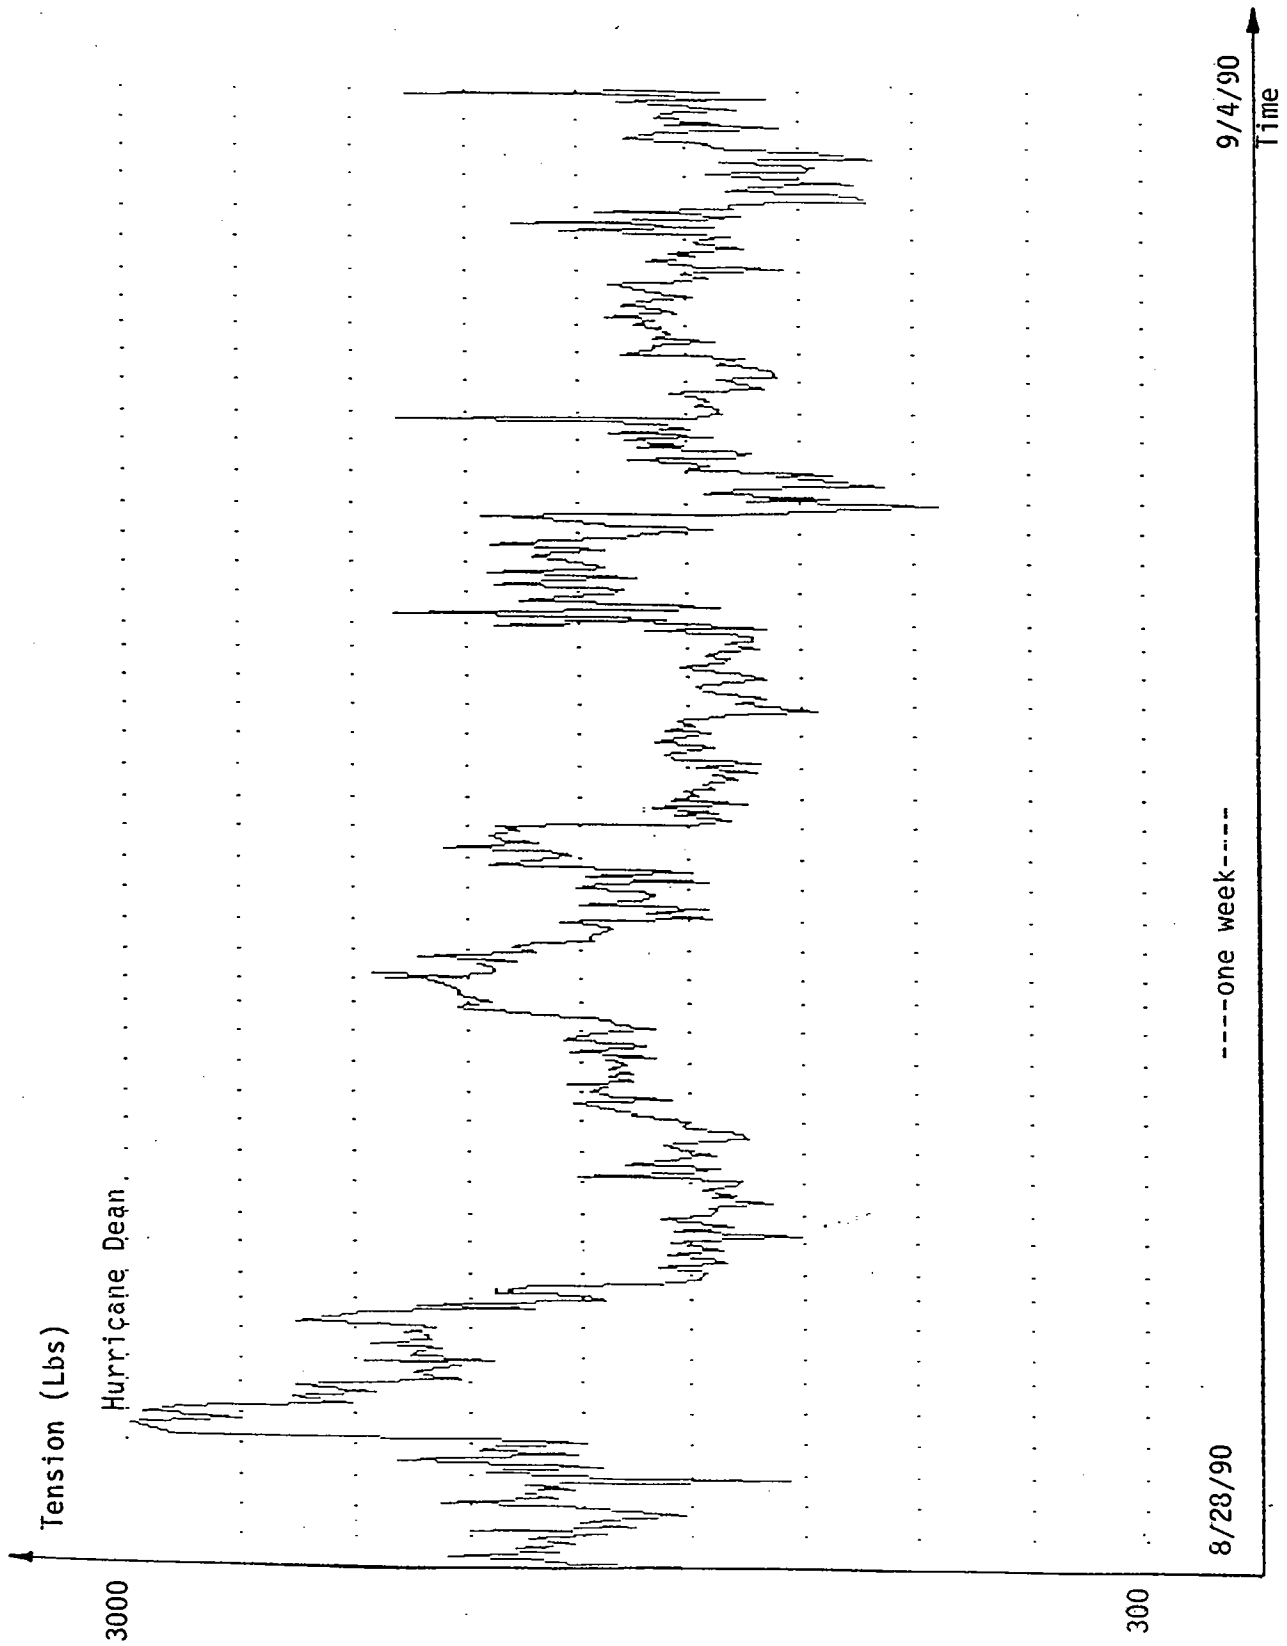
FIGURE 9: Tension cell data

A Teledyne Model 12367-20K tension cell, with a maximum capacity of 20,000 lbs, was mounted at the bottom of the surface buoy and connected through a shackle to the mooring. This sensor was carefully calibrated at WHOI prior to the deployment. Surface buoy tension data was transmitted daily to WHOI through ARGOS, to monitor buoy performance (Figure 9). When the surface buoy went adrift, the tension data clearly indicated a failure on the mooring line.

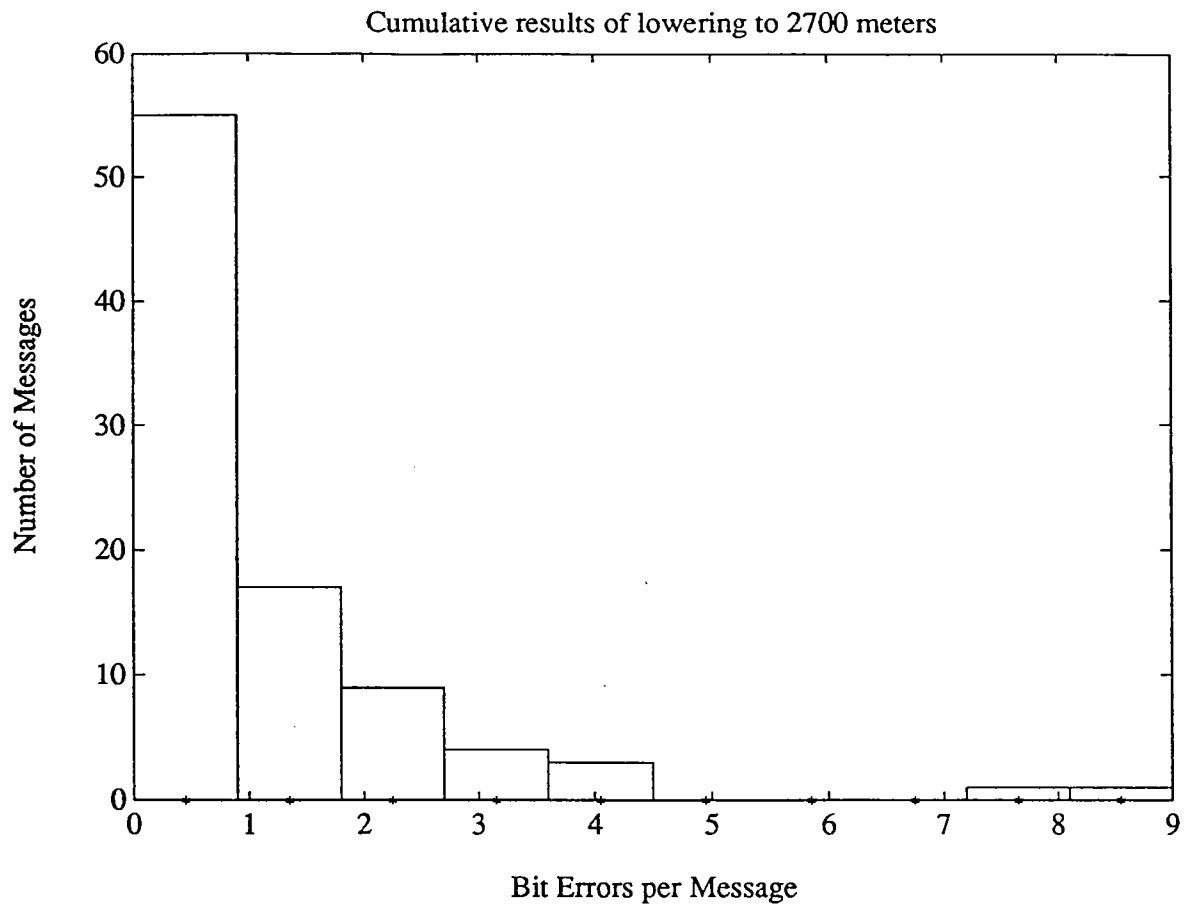
FIGURE 15: Cumulative results of lowering to 2700m

Prior to deployment of the ESOM mooring, two acoustic modems were lowered from the R/V Oceanus to 2700m depth to confirm their proper operation. Under calm sea conditions, with the receive hydrophone deployed at a depth of 6m, the average BER for both modems was about 4×10^{-4} (Figure 15). Only two of the data packets had more than four bit errors. BER at 2700m was only slightly higher than at 1000m and above.

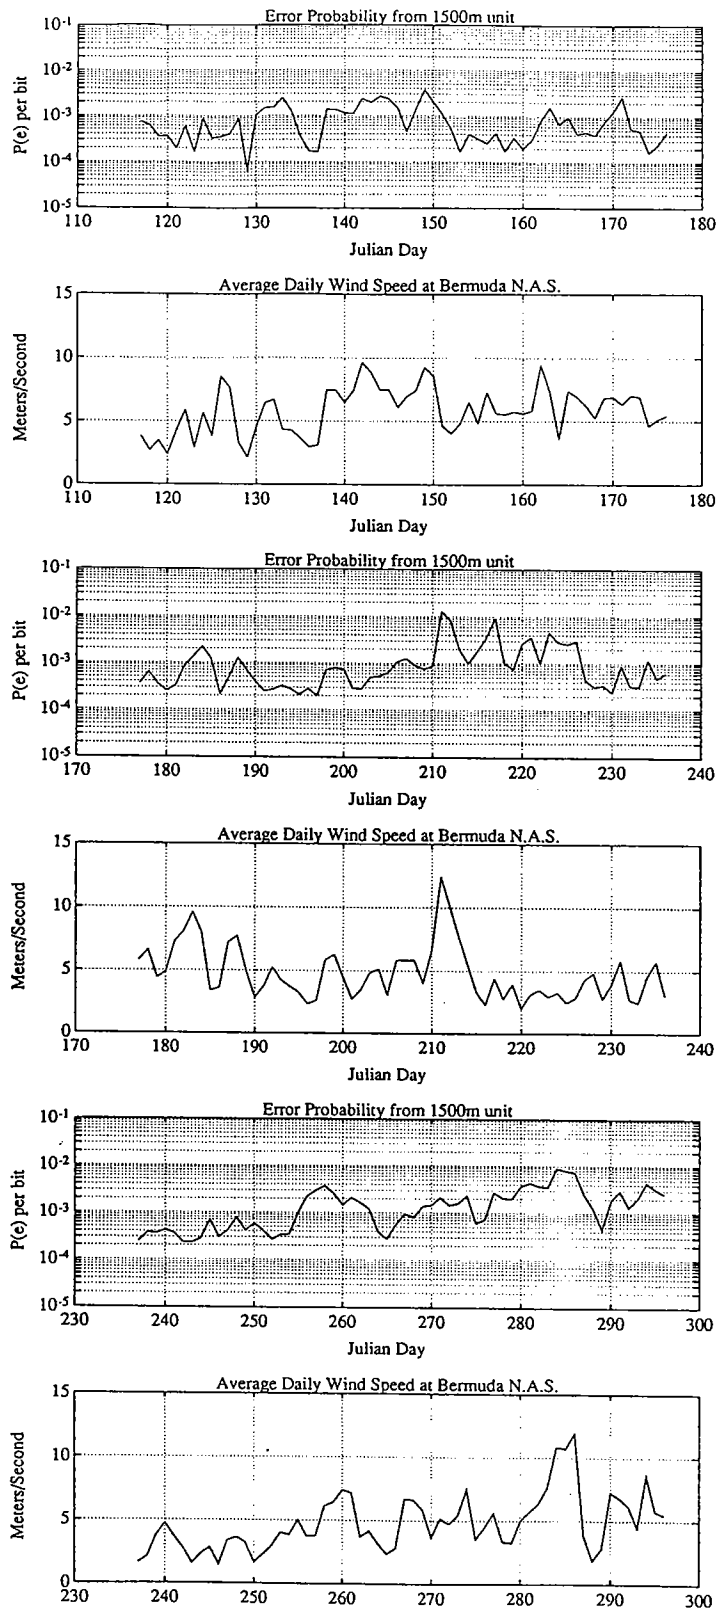
FIGURE 17: Wind speed and error probability data record

The source of the noise is believed to be surface waves and their interaction with the surface buoy and the hydrophone mounting system. This conclusion is based on data shown in Figure 17 (from [14]), which shows daily averaged wind speed at the Bermuda Naval Air Station (20km north of the mooring site) plotted above daily average BERs for the 1500m modem. A clear correlation between high average winds (and presumably high sea state) and high BER is evident.
